Open-File Report O-01-02

The Nisqually, Washington, Earthquake of February 28, 2001. Summary Report

2001

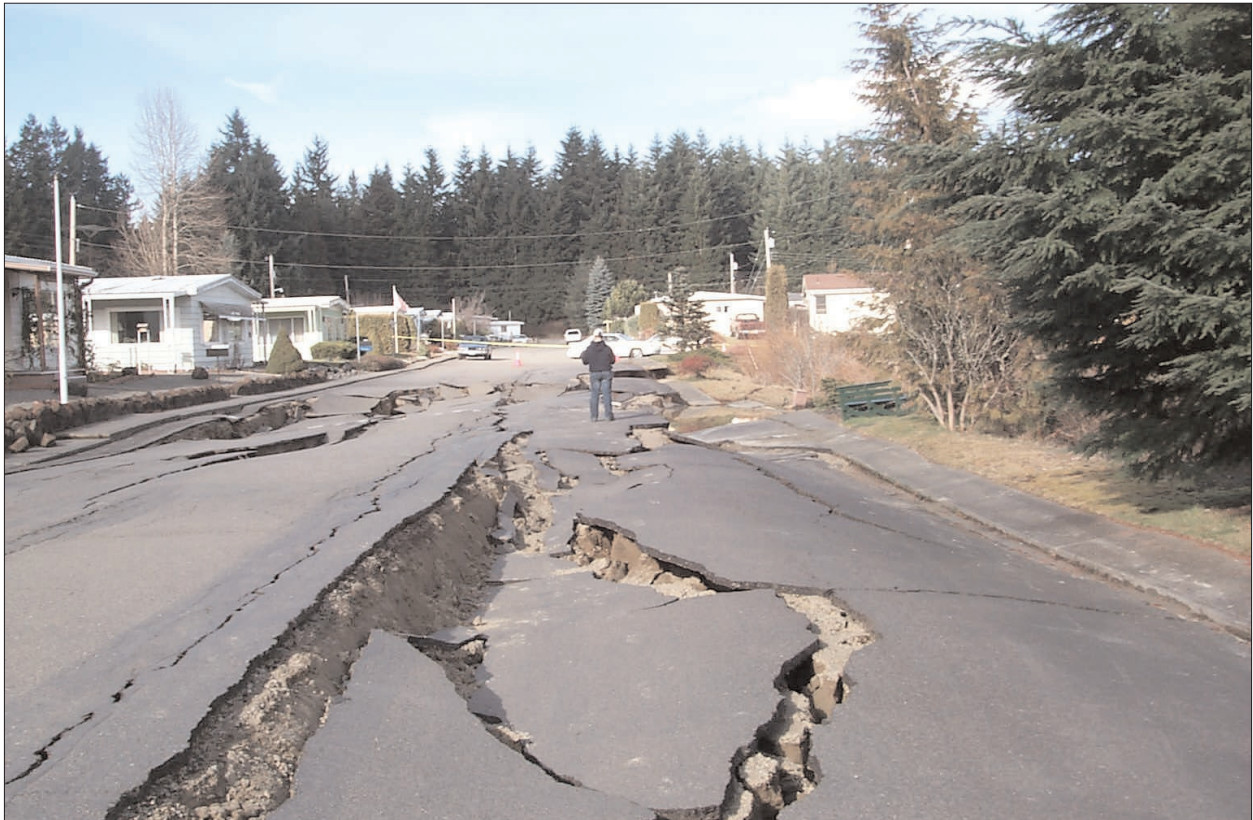
Cover photo

Damage induced by lateral spread along Sunset Lake in Tumwater.

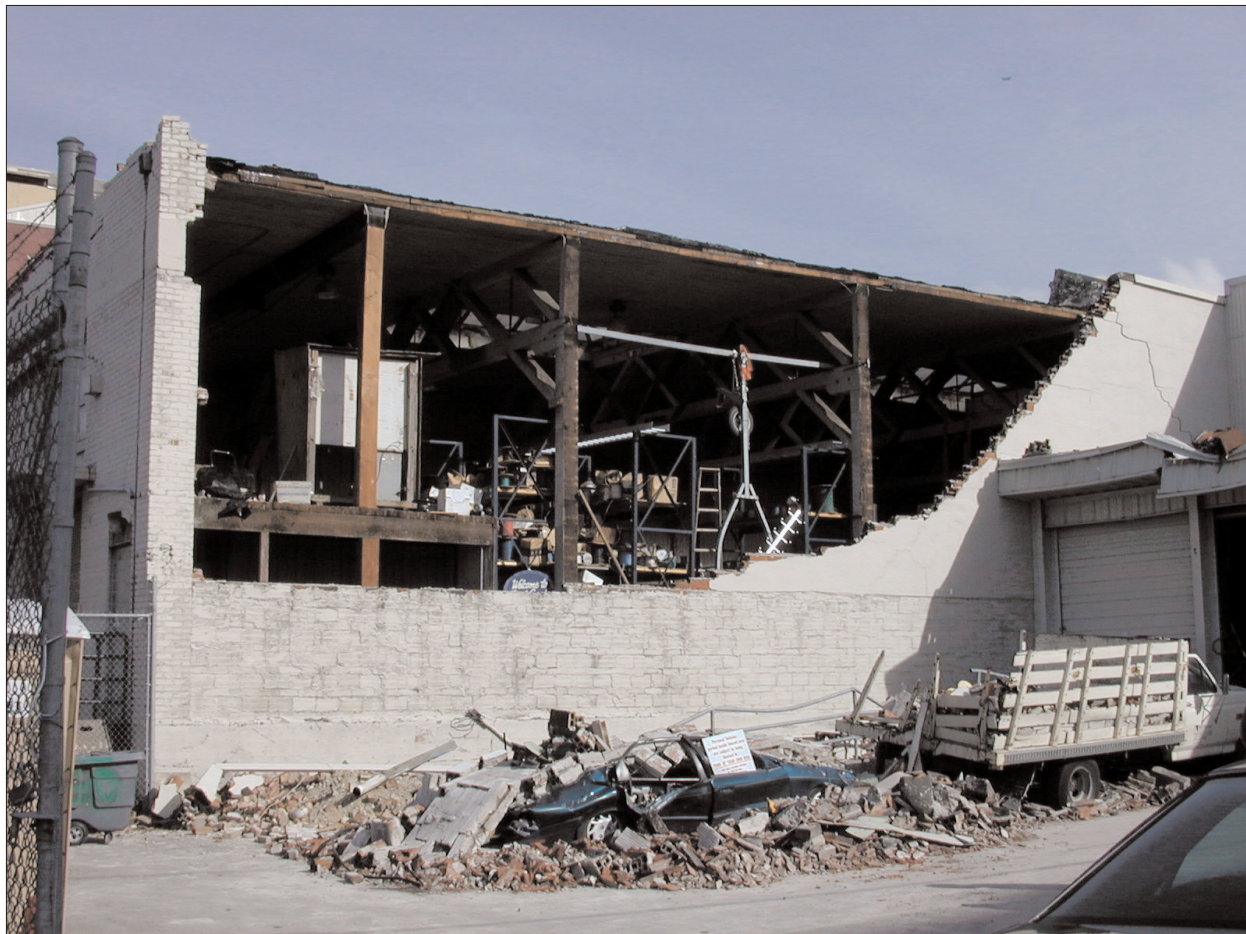
Photo 1. Collapsed hollow-clay tile wall at URM building located along Utah Ave. S in South Seattle.

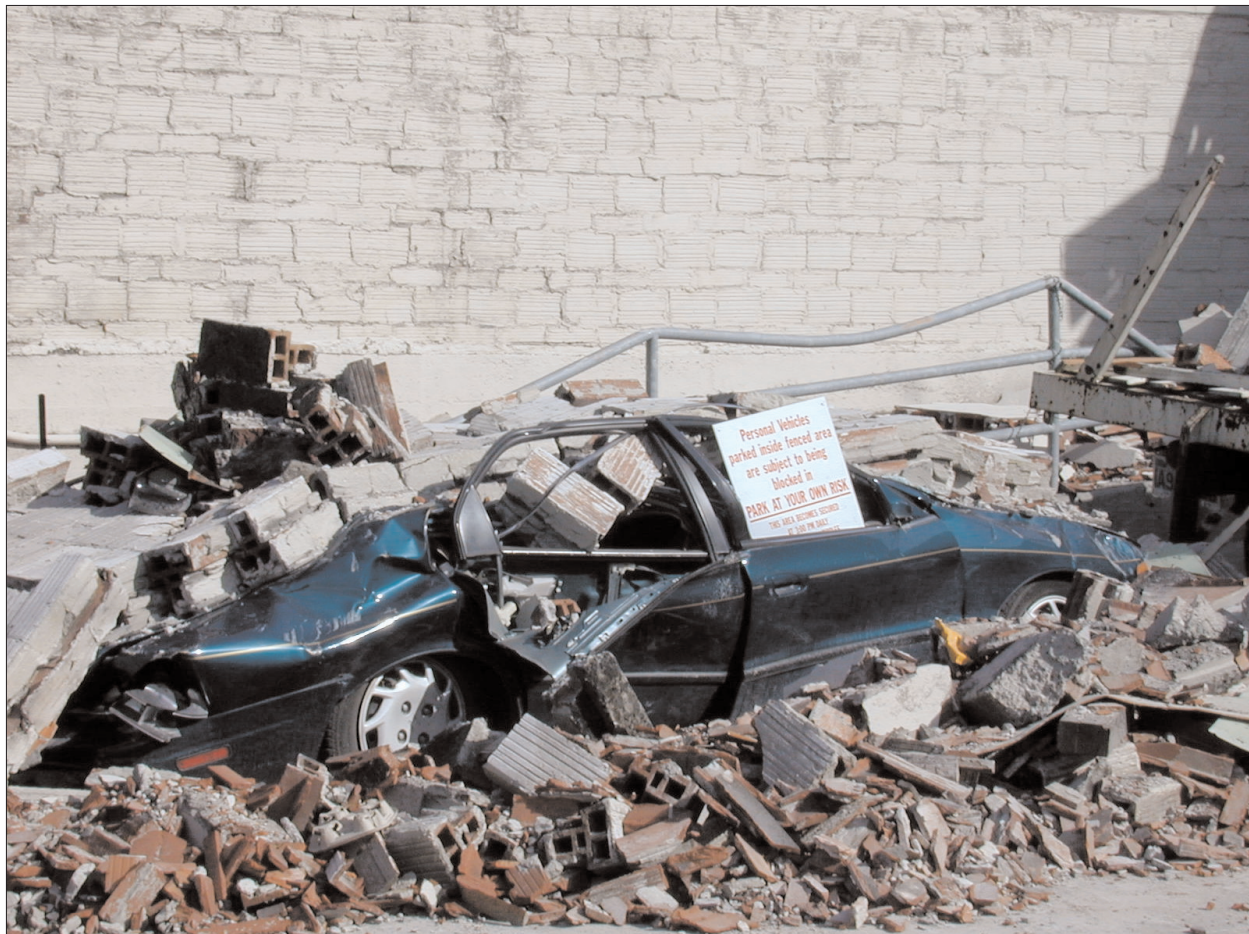
Photo 2. Close-up of a car crushed by the failed wall – the same building on Utah Ave. S in Seattle.

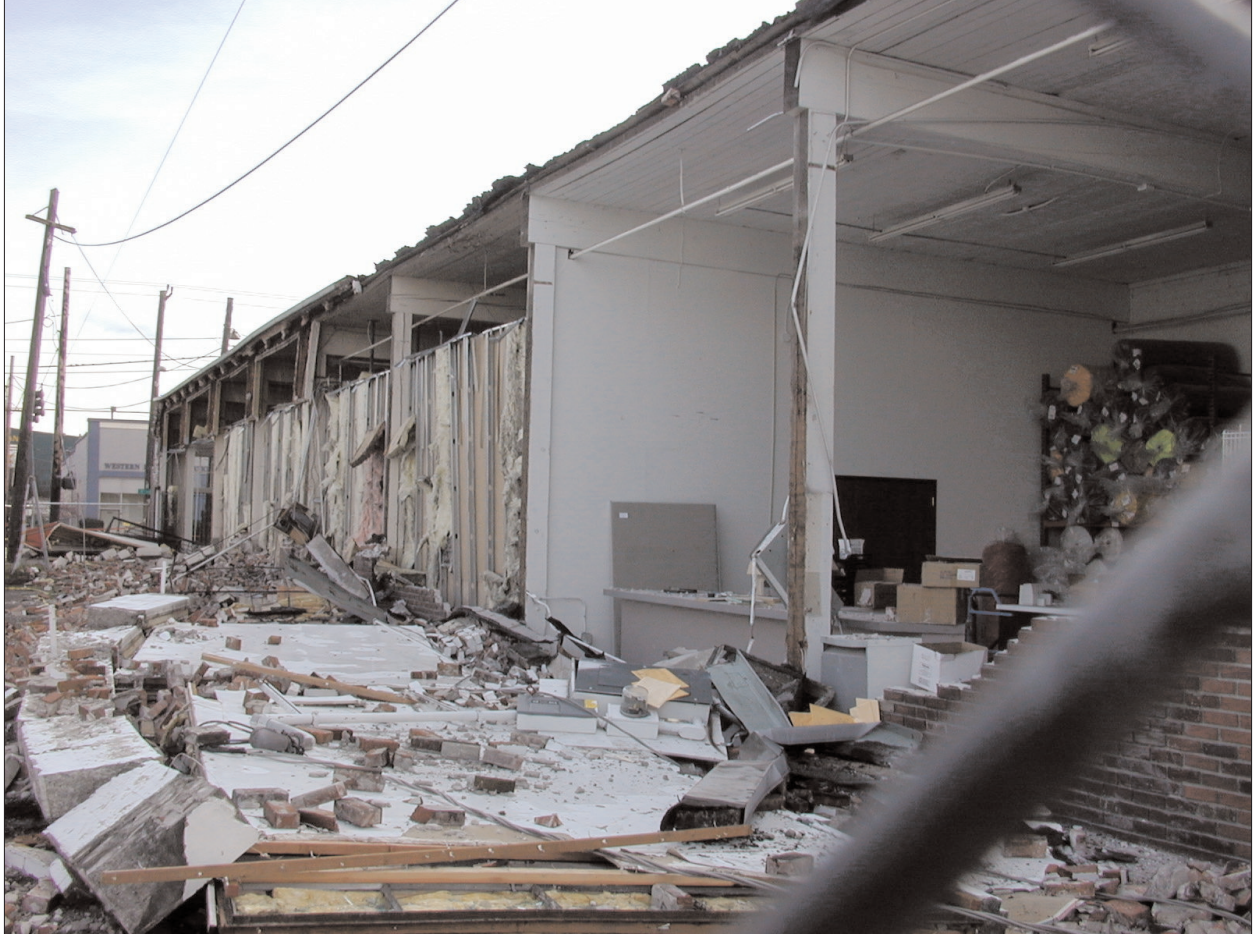
Photo 3. Failed concrete lintel above window bank not attached to girders in a URM building located near the intersection of S Forest St. and Utah Ave. S, Seattle.

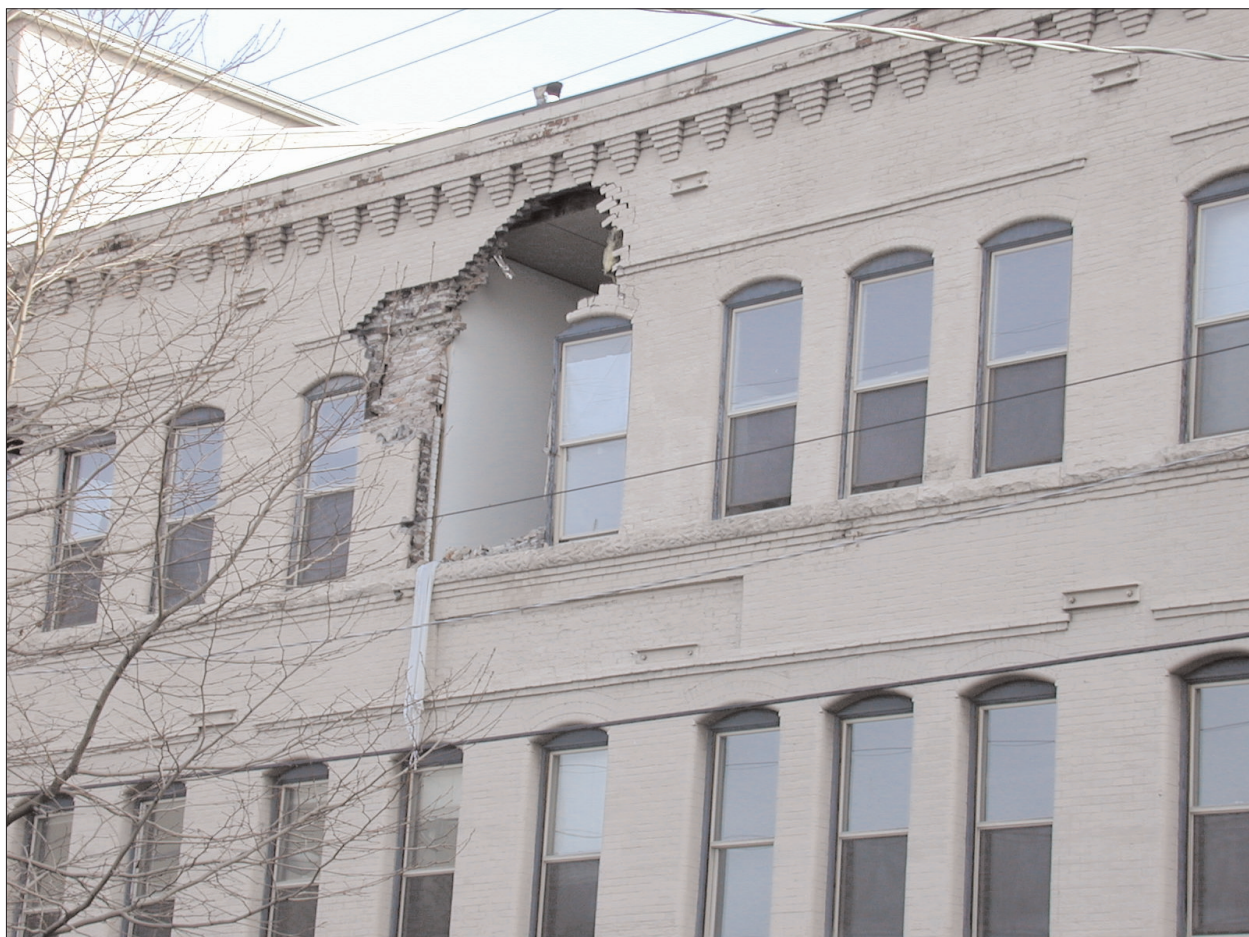
Photo 4. Damaged building located near the intersection of First Ave. S and S Dearborn St. in Seattle.

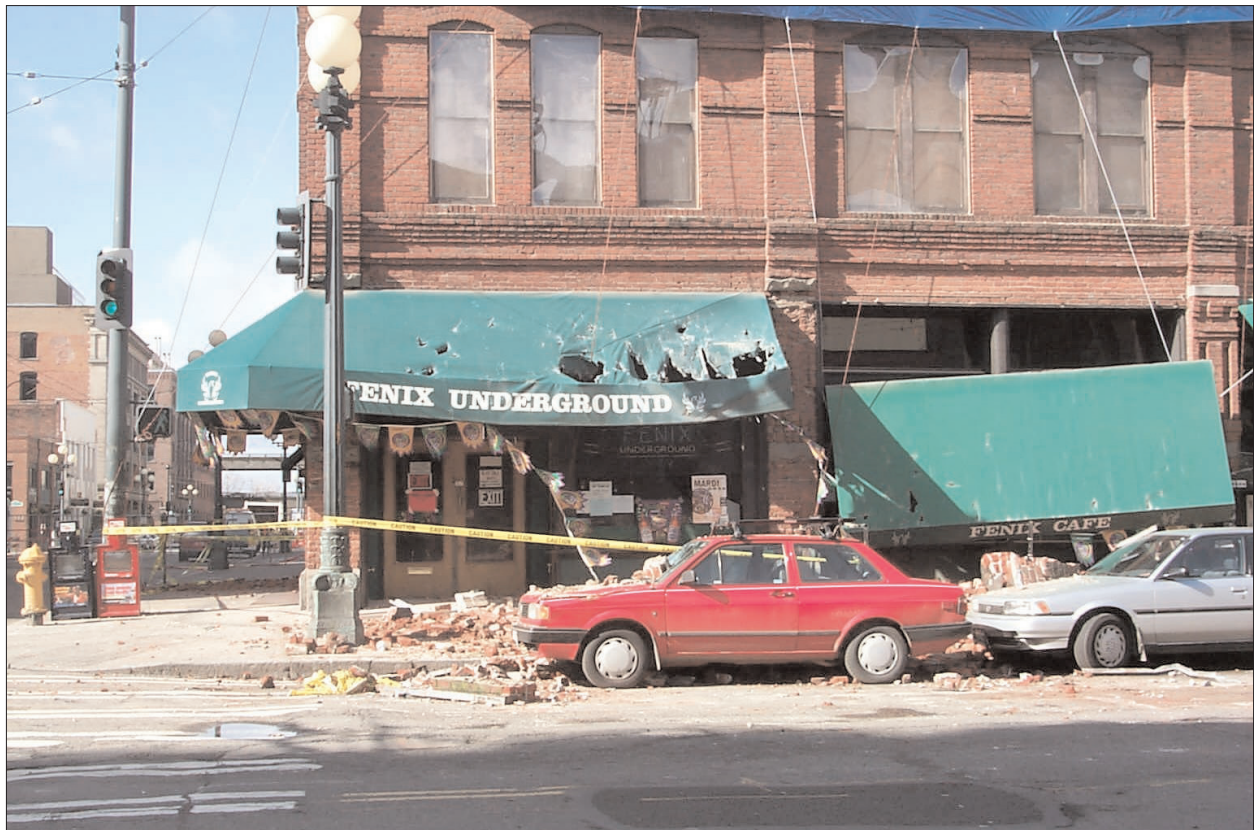
Photo 5. Building damage near the intersection of Second Ave. S and S Jackson St. – the Fenix Underground in Pioneer Square, Seattle.

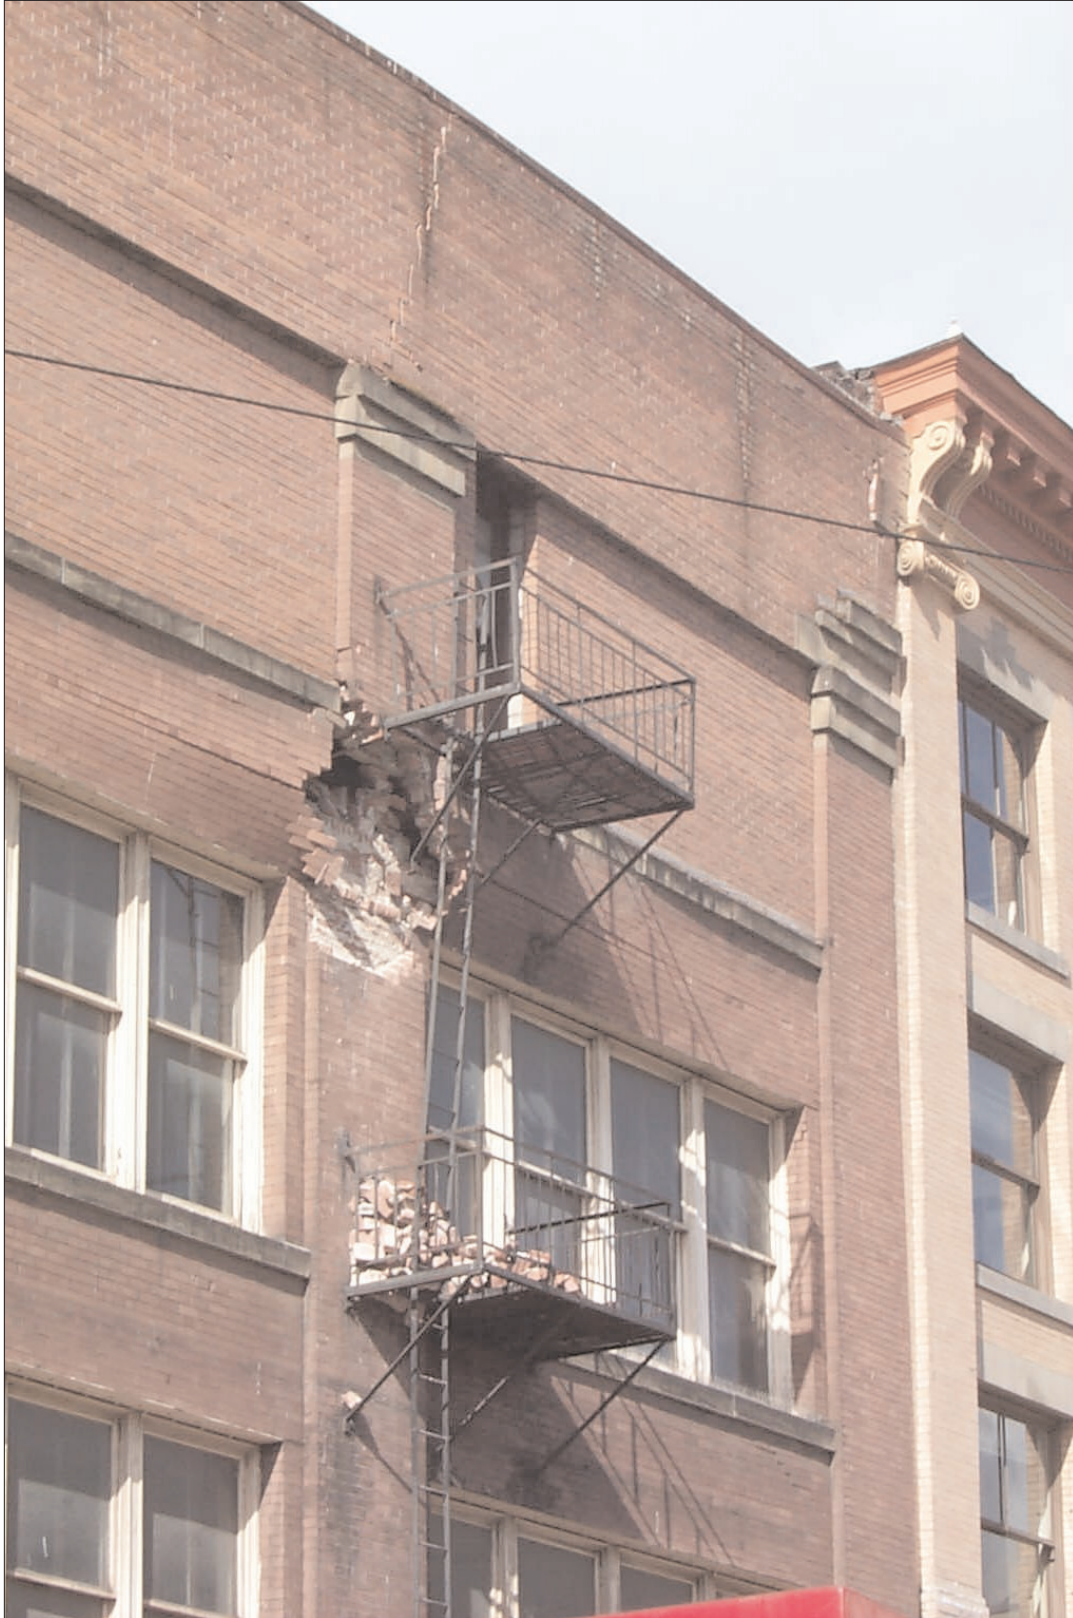
Photo 6. Building damage near the intersection of Third Ave. S and S Jackson St. – near Pioneer Square, Seattle.

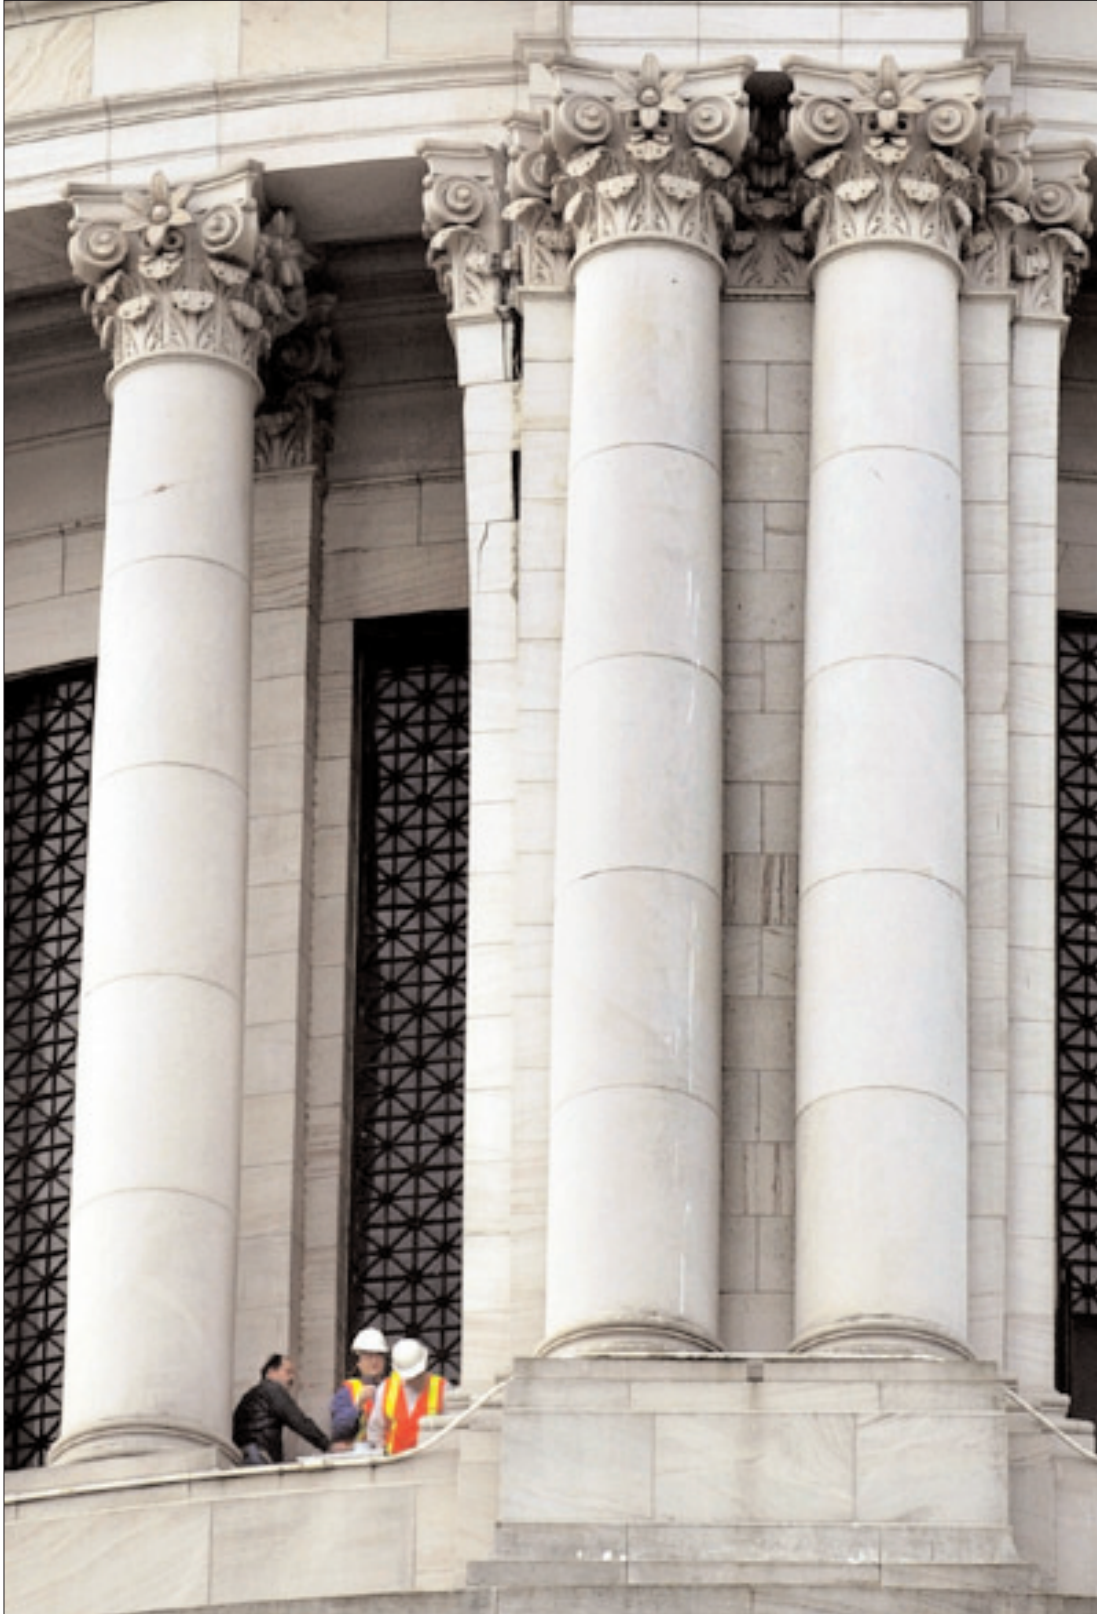
Photo 7. Cracking of the ornamental balusters at the Capitol building in Olympia (Photo by Mike Salisbury of The Olympian).

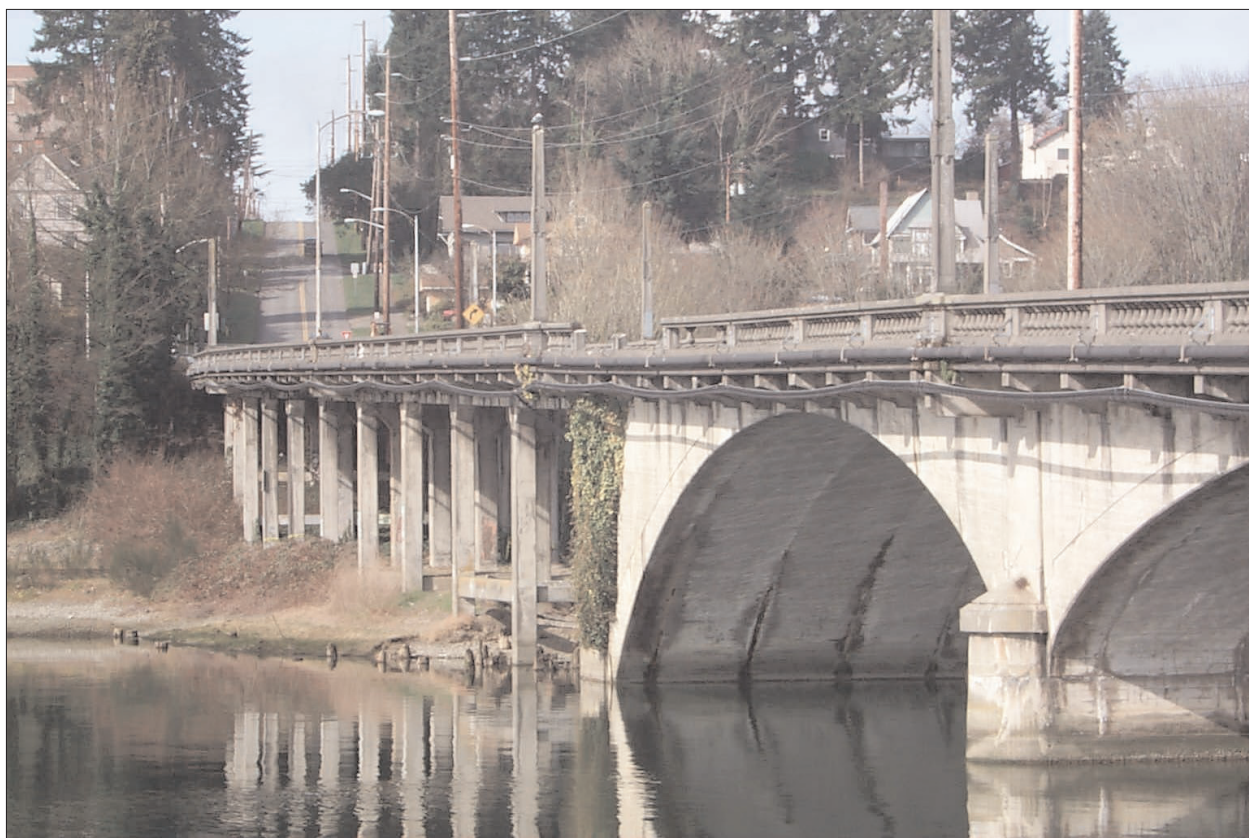
Photo 8. Damage at the Fourth Ave. Bridge in Olympia.

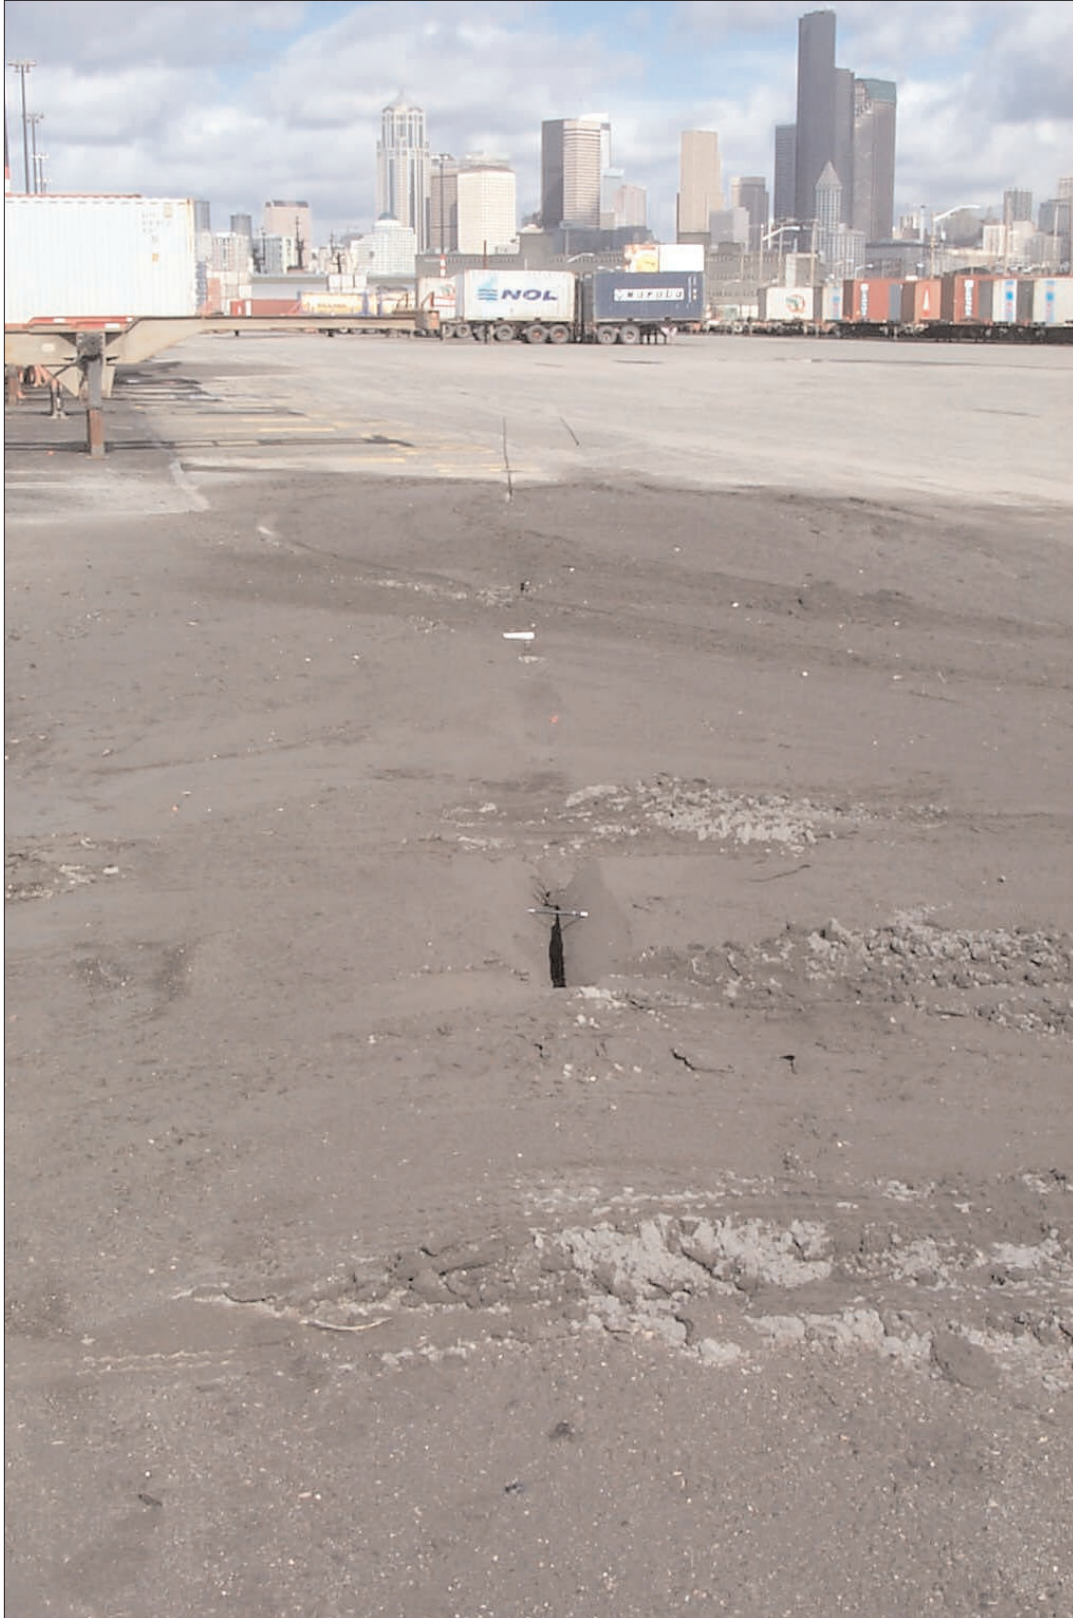
Photo 9. Sand boils from crack along utility trench in the Port of Seattle Terminal 30 – Seattle skyline in background.

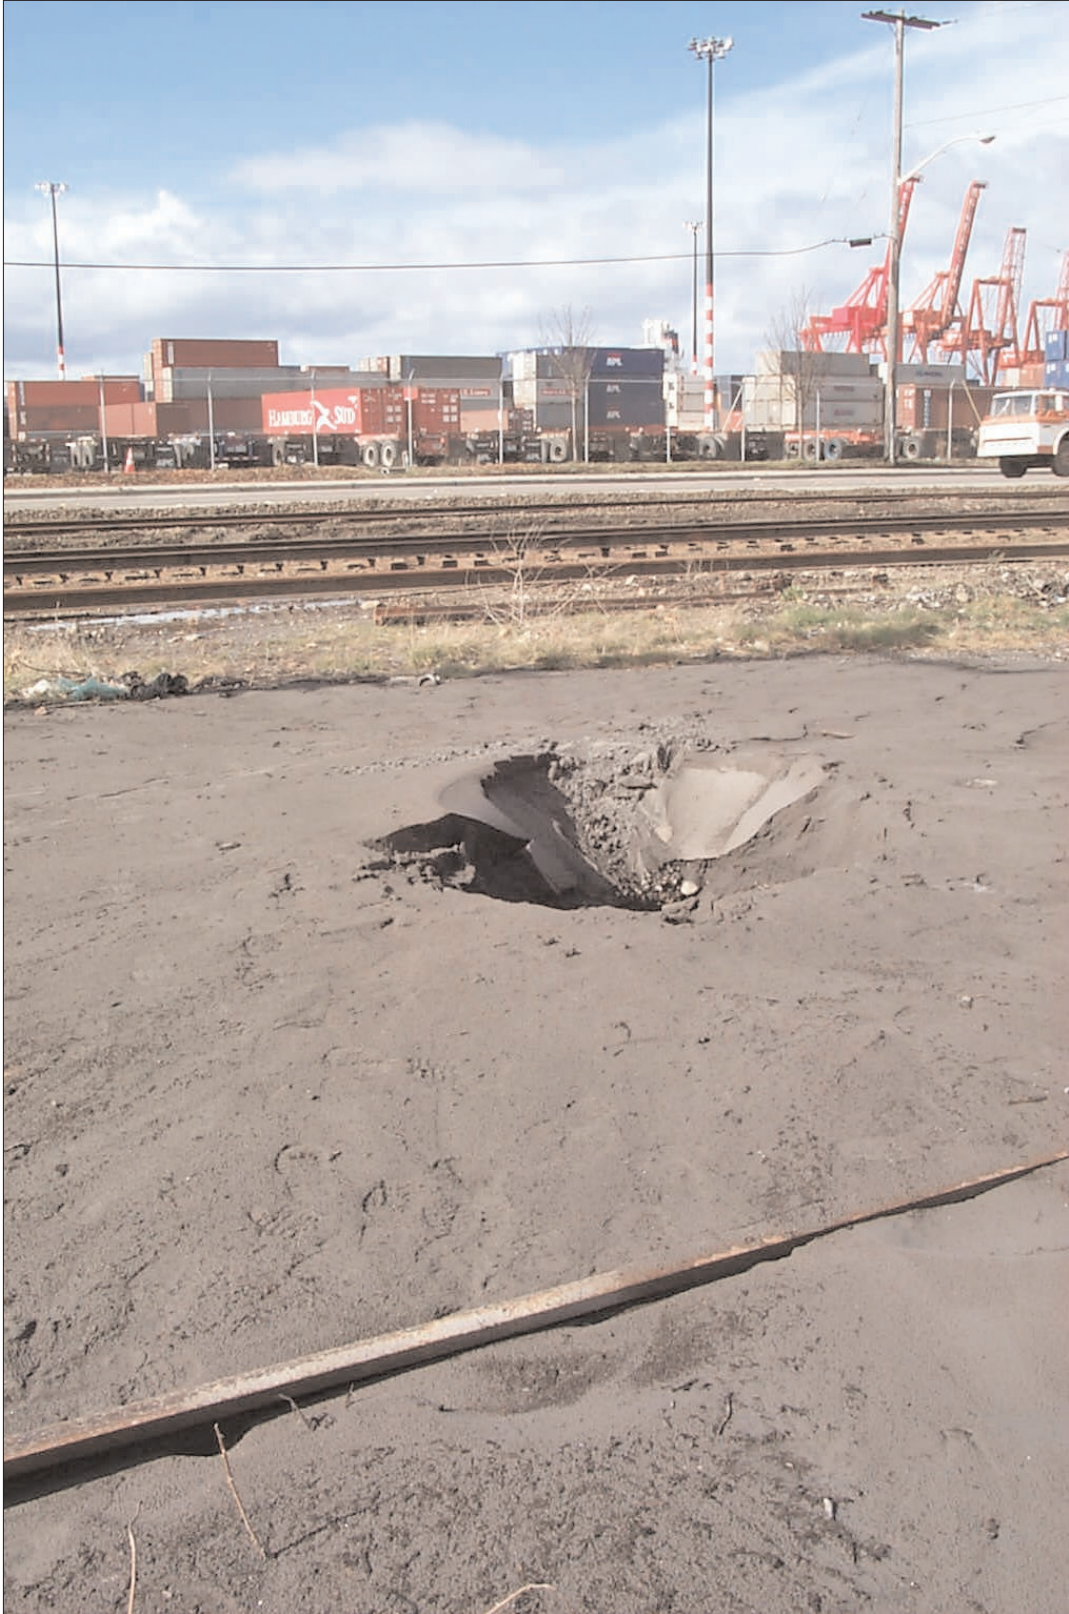
Photo 10. Sand boil along railroad tracks paralleling E Marginal Way in Seattle – Terminal 30 in the background.

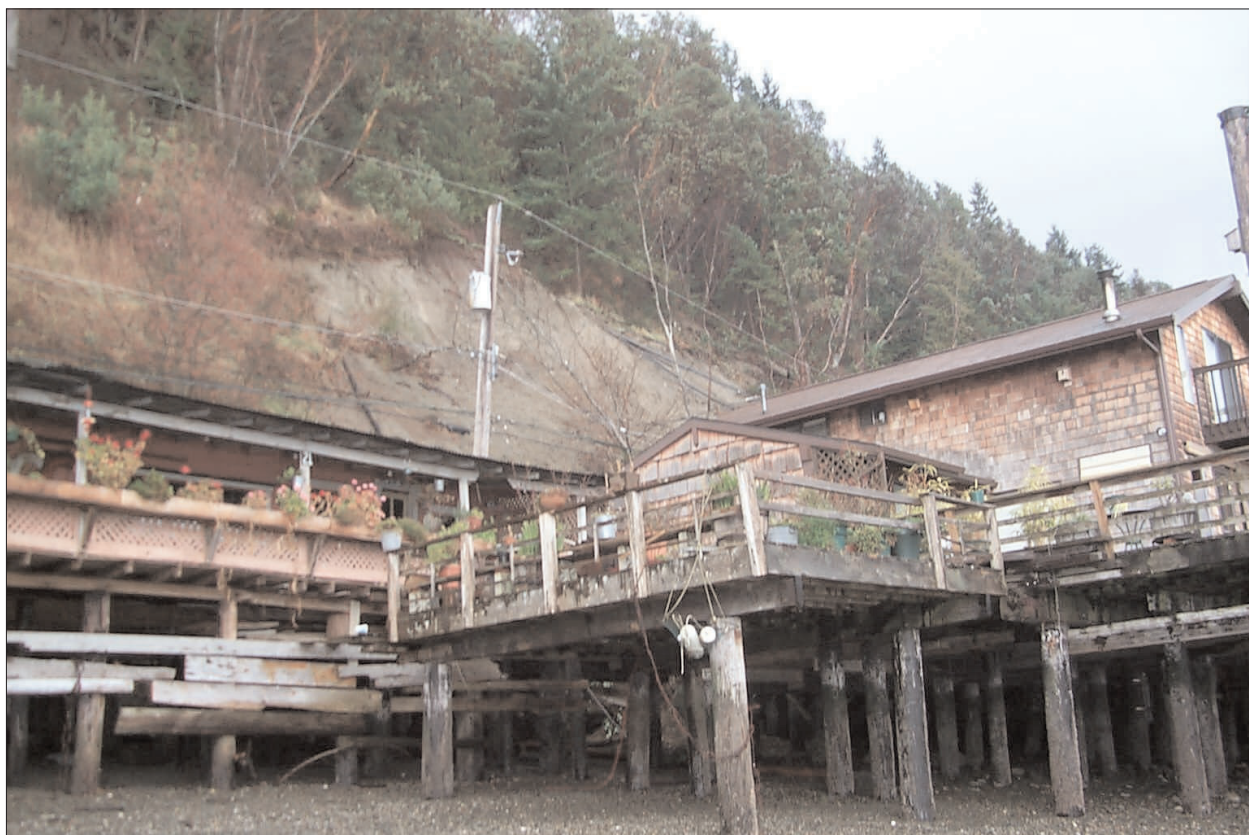
Photo 11. Looking upslope at the lower portion of the Salmon Beach landslide – S of Point Defiance Park in Tacoma.

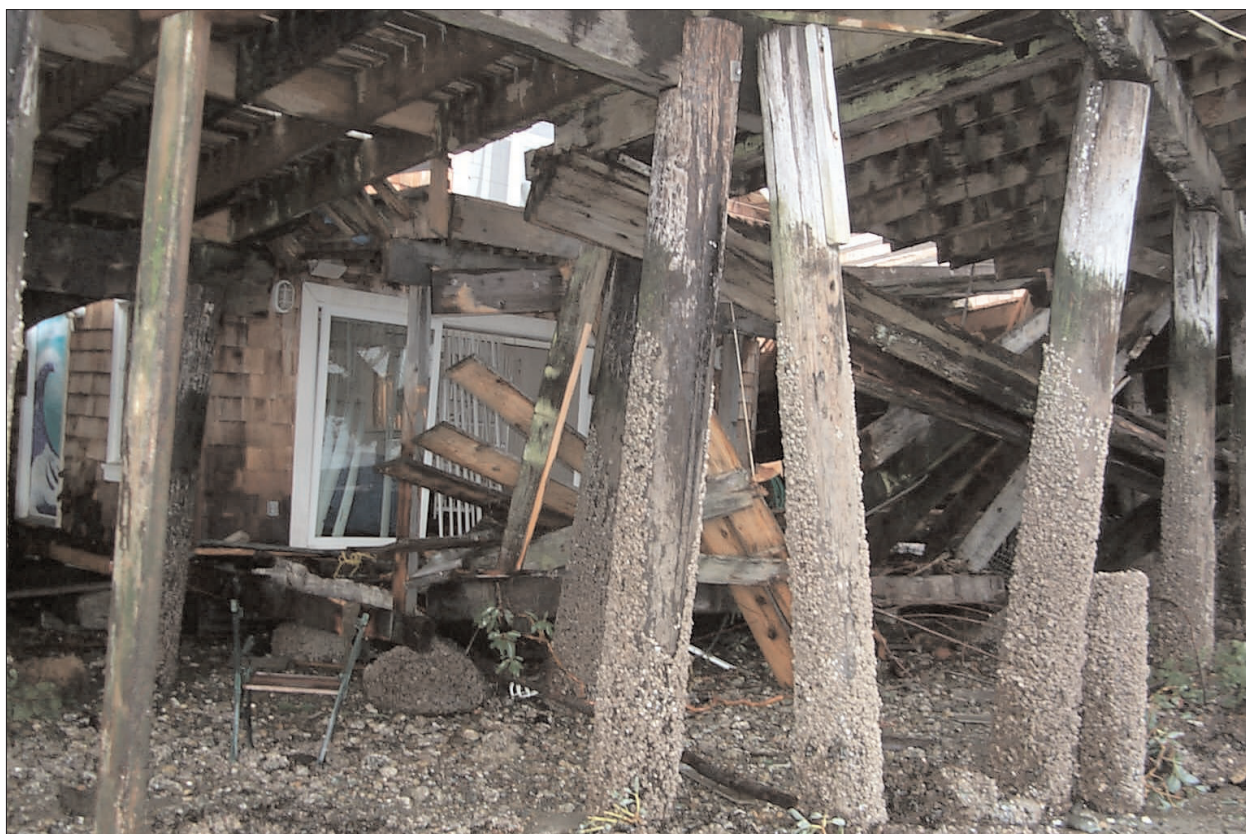
Photo 12. This home's collapse was caused by the Salmon Beach landslide – four houses were substantially affected as of 3-2-01.

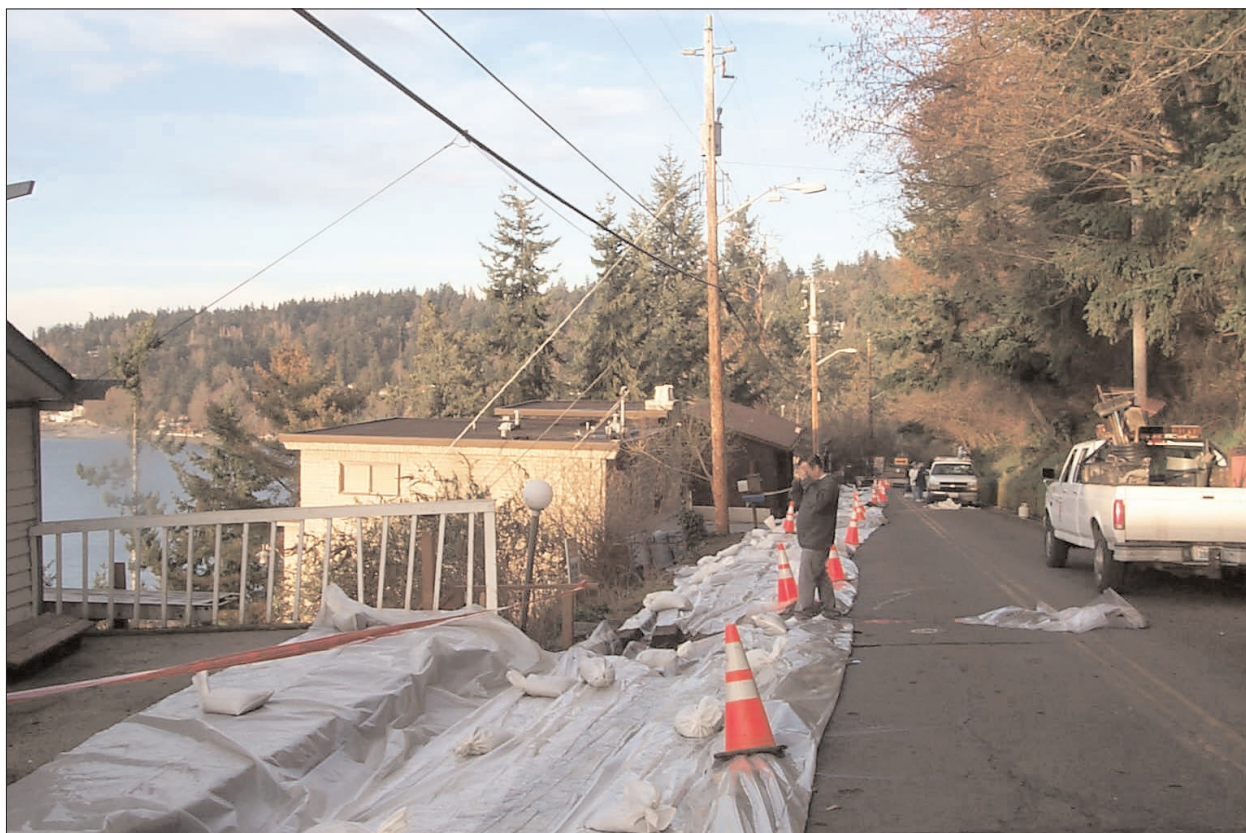
Photo 13. Houses damaged by slope movement in Burien – eight houses were red-tagged as of 3-2-01.

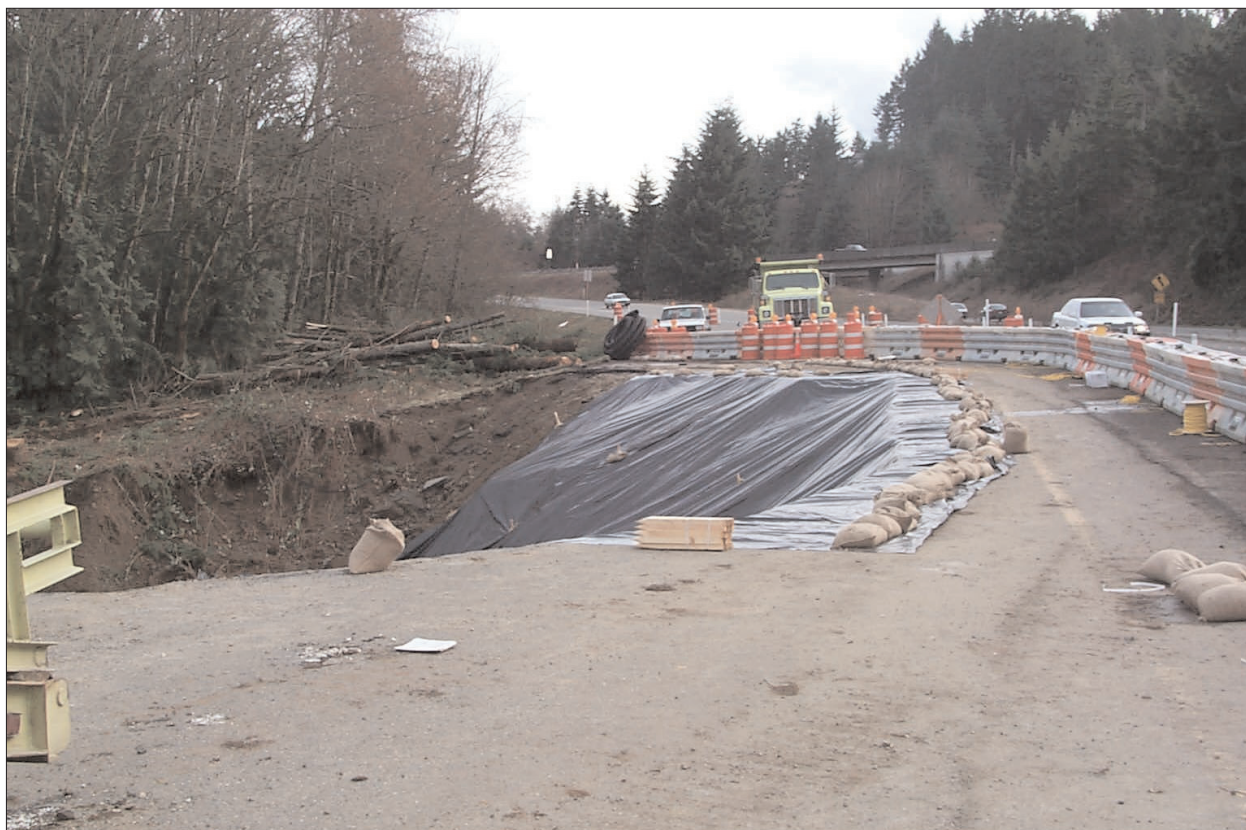
Photo 14. View along scarp of Highway 101 slide NW of Olympia.

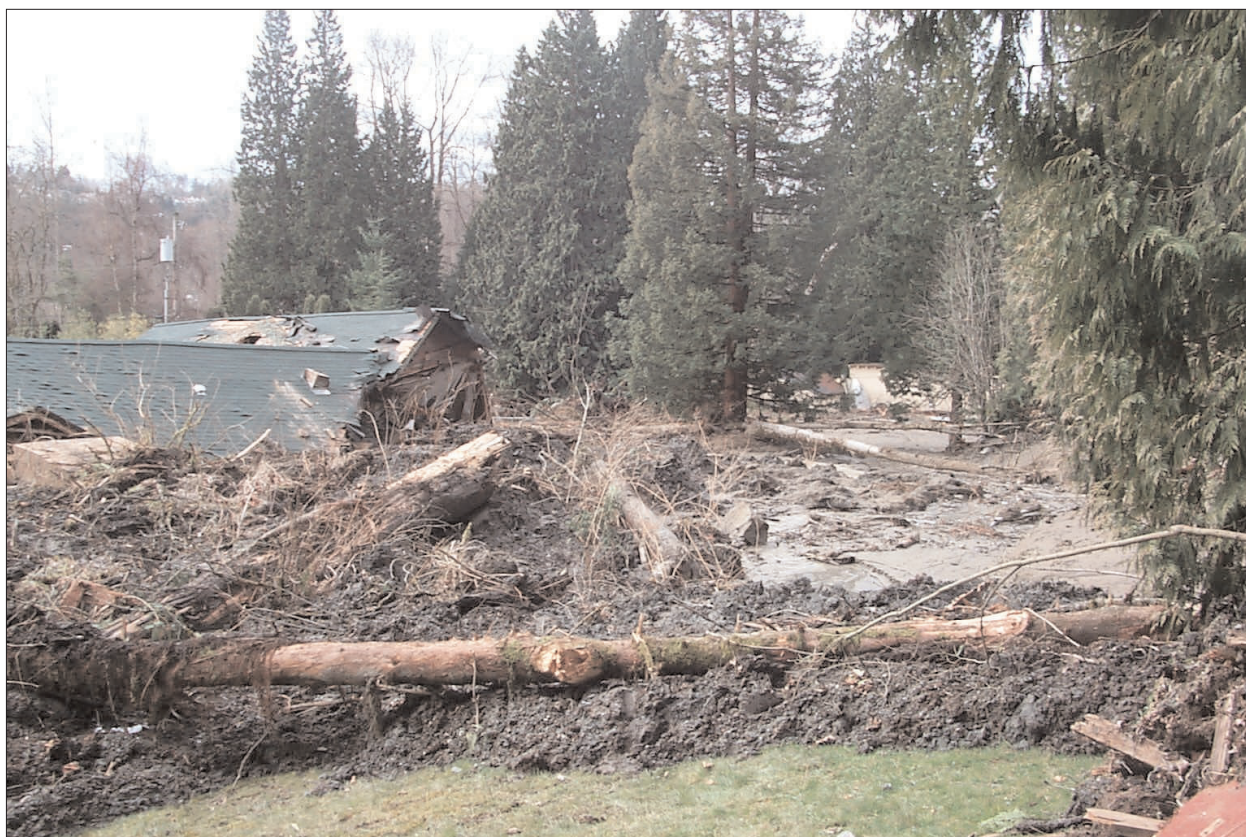
Photo 15. Debris-flow damage in Maplewood near Renton.

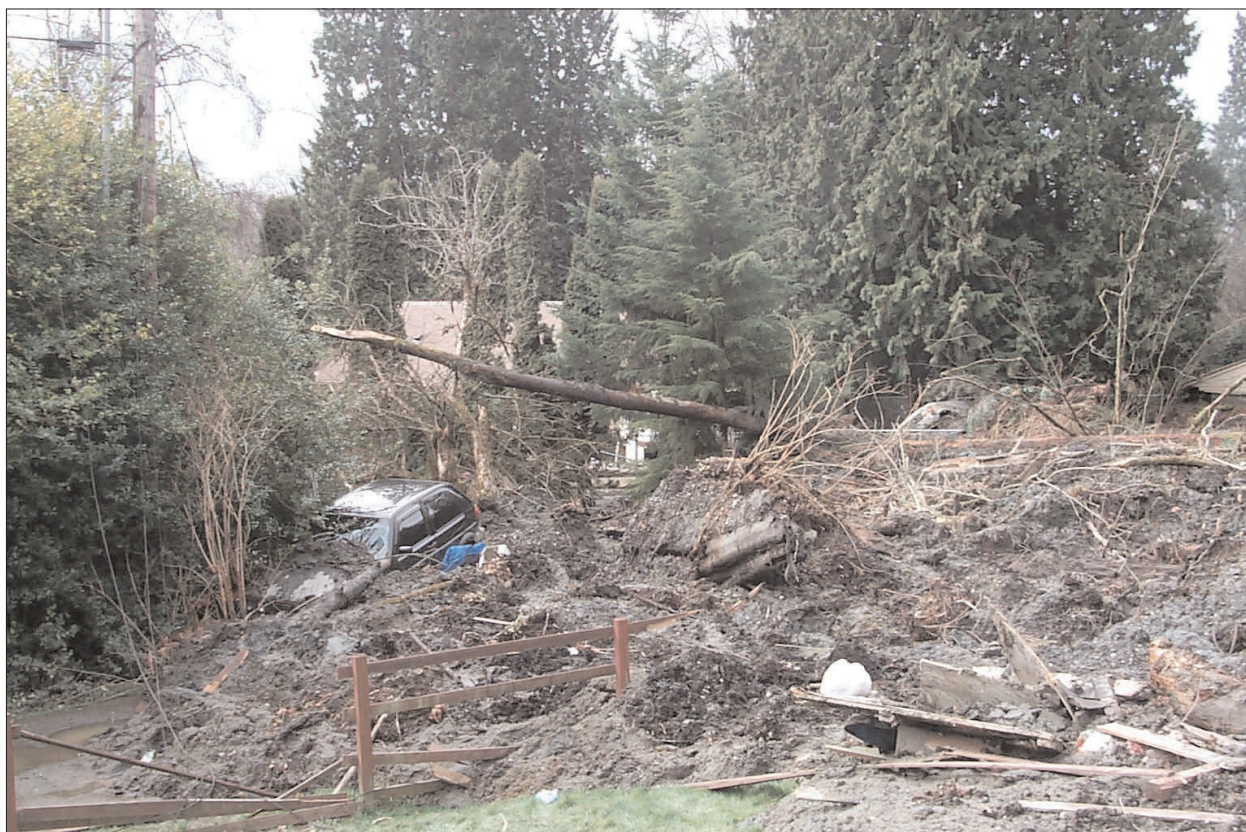
Photo 16. Debris-flow damage in Maplewood near Renton.

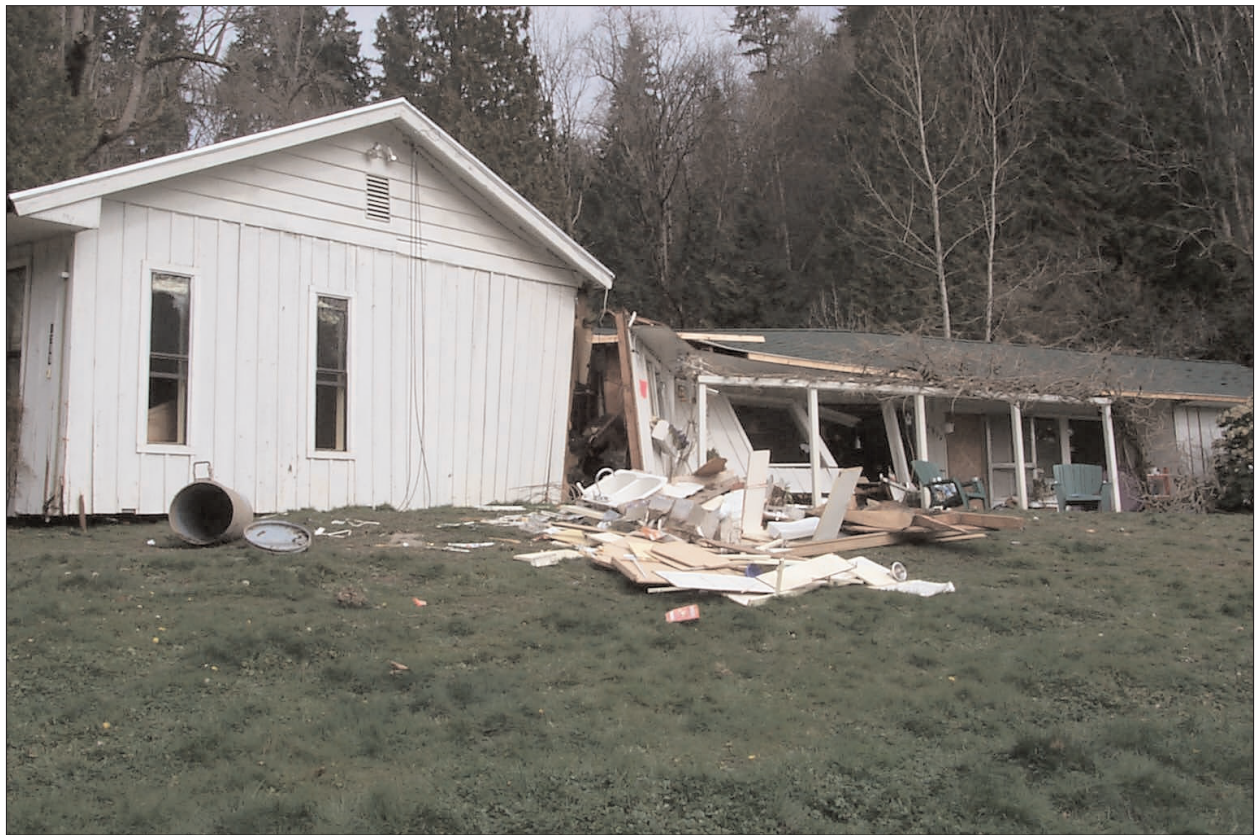
Photo 17. Damage at the Vanderossen residence in Maplewood from a debris flow that struck the back of the building seconds after the onset of shaking.
