**OPEN-FILE REPORT O-23-09**

# **CAPE KIWANDA SINKHOLES AND THEIR FORMATION, TILLAMOOK COUNTY, OREGON**

By Jonathan C. Allan and Laura Gabel

This report evaluates the formation of two sinkholes during 2023 at Cape Kiwanda, Tillamook County, Oregon. The goal is to provide guidance to the Oregon State Parks and Recreation Department (OPRD) on recent and historical coastal changes as well as potential future impacts taking place at Cape Kiwanda.

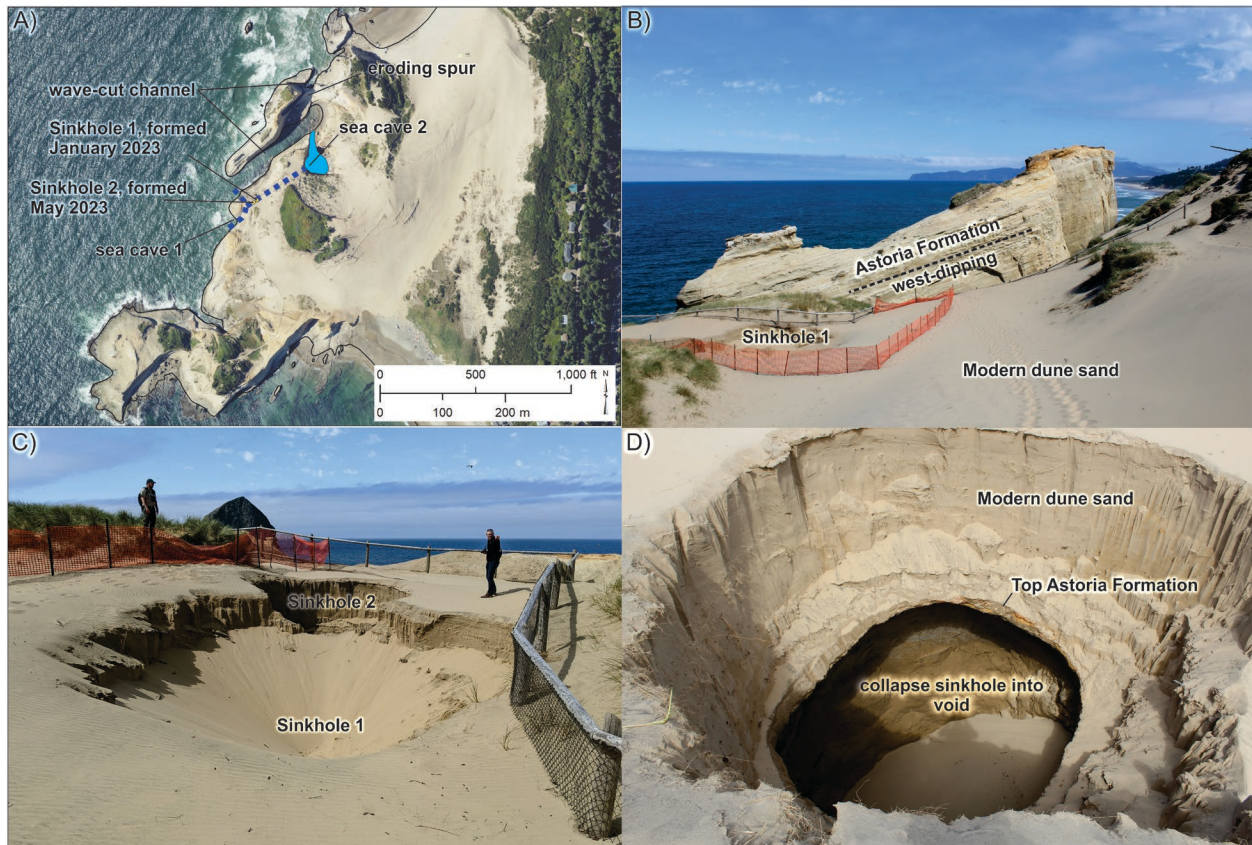
Figure 2. Sinkholes at Cape Kiwanda. A) Map of Cape Kiwanda showing the locations of the two sinkholes and related features; B) View looking north toward Cape Lookout and westward dipping ( $\sim 15^\circ$ ) Astoria Formation, with sinkholes located in the orange fenced area; C) View looking west over the sinkholes toward Haystack Rock; and D) View looking into the most recently developed sinkhole (sinkhole 2). The upper layer consists of approximately 2.5 m (8 ft) of modern dune sand (evident by the freshness of the sand color and presence of dune grass roots), overlying a weathered crust (iron-oxide staining) that likely reflects the top of the Astoria Formation at this location. Below the crust one can differentiate alternating bands of weathered sand, characterized by thin iron-oxide stains. Note also the dark brown sand that comprises the interior of the sinkhole, which appears saturated with water. Iron-oxide staining of the sand is indicative of water movement within the various sedimentary layers.

Sinkholes are defined as depressions in the ground that have no natural external surface drainage (e.g., a creek outlet) and they occur when a subsurface cavity becomes too large to support the overlying rock (**Figure 2C and 2D**). Their development may be gradual, occurring slowly over many years to decades, or sudden. In the latter case, the sinkhole forms rapidly such that the land surface remains intact until support from below fails and the hole opens up. These are termed “collapse sinkholes.”

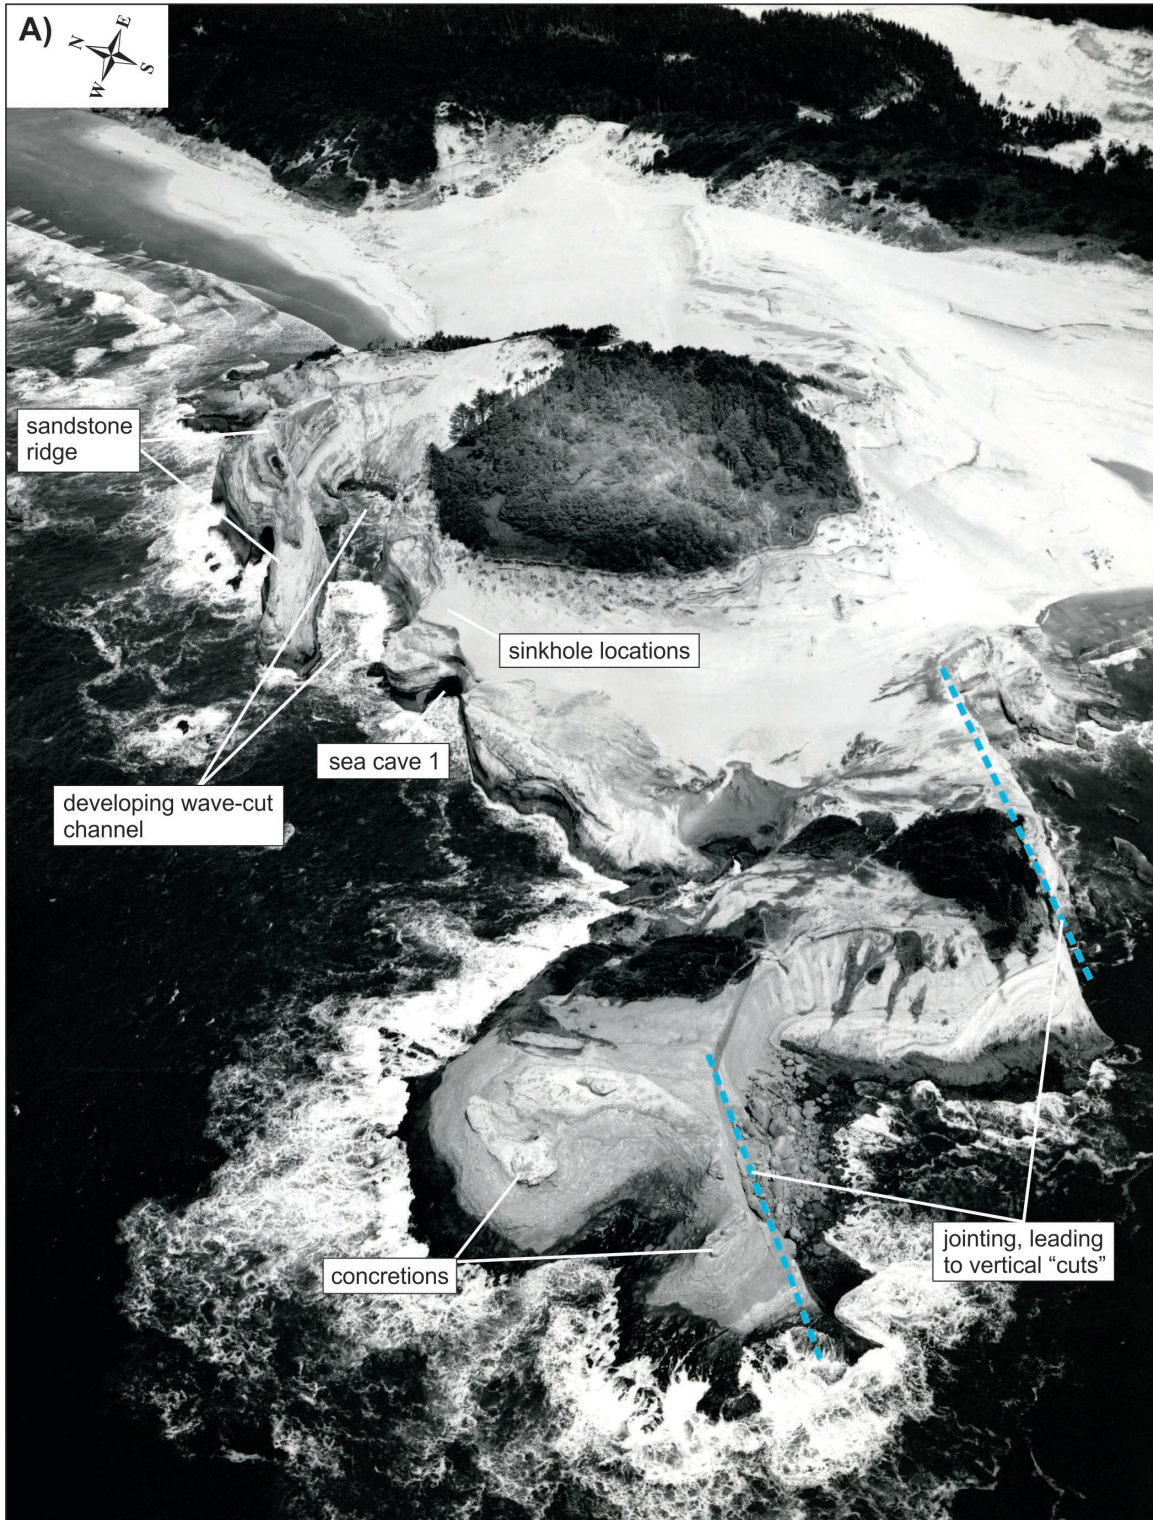
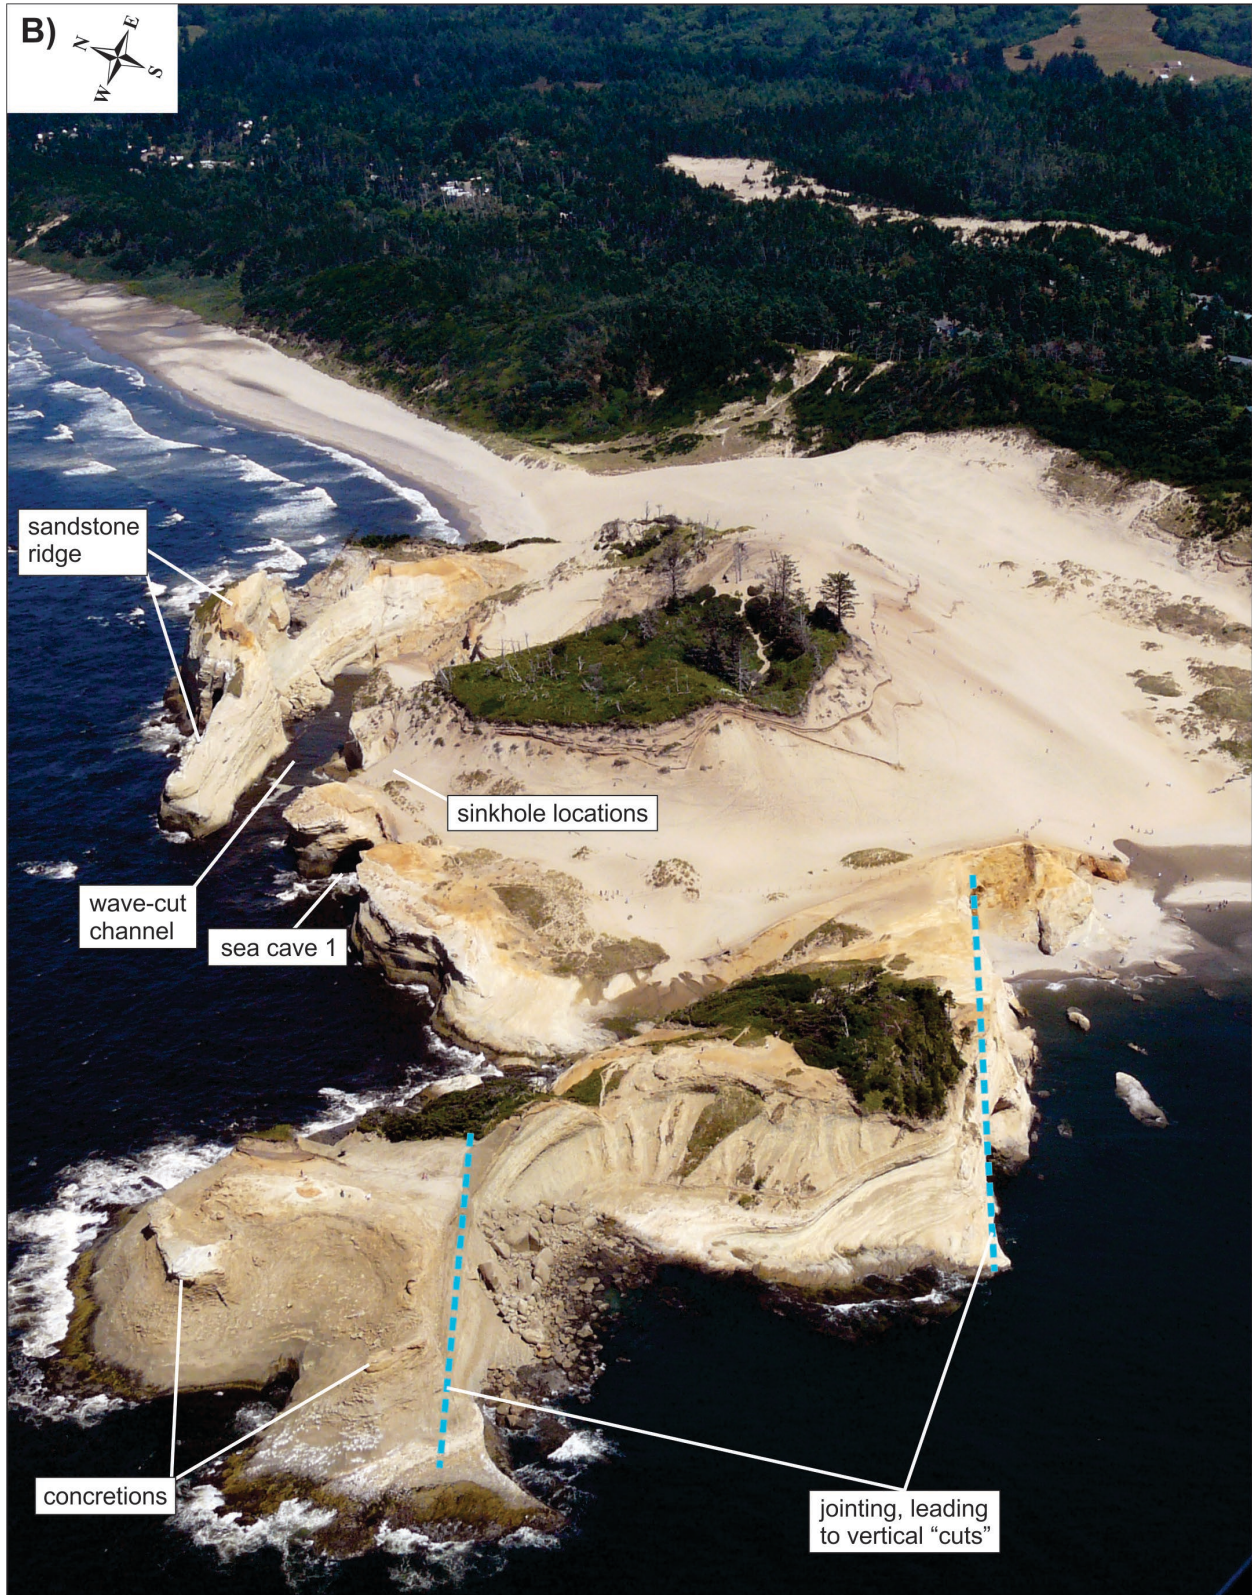
Figure 4. Oblique aerial views of Cape Kiwanda taken in A) November 1974 (Photo credit: Kinney, State Highway Division) and B) in August 2011 (Photo credit: L. Gabel, DOGAMI).

A second notable feature identified in **Figure 5** and in the oblique photos (**Figure 4**) are structural controls within the sandstone, including the wave-cut channel and sandstone ridge to the north of the vegetation strand. The wave-cut channel probably developed in response to wave erosion into a joint, fissure or other vertical sedimentary weakness in the sandstone. Over time, waves would have worked away at these lines of weakness, perhaps initially forming a sea cave that progressively opened up, elongating in the line of the weakness. Eventually the top of the cave collapsed downward, opening up the channel. North of the main wave-cut channel identified in **Figure 4** and **Figure 5** is a sandstone ridge that has remained intact, possibly because it contains rock that is more resistant to wave erosion. Nevertheless, part of the eastern end of this sandstone ridge has eroded over the past two decades as a new, smaller channel develops (**Figure 2A**). Erosion there has occurred rapidly over the past decade and is a testament to the varied characteristics of the local geology and its responses to wave erosion. Finally, linear-like vertical “cuts” in the sandstone on the south side of the headland (**Figure 4**) can similarly be attributed to structural controls within the Astoria Formation. It is noteworthy that these features are orientated in a manner that is very similar to the wave-cut channels to the north (**Figure 2A**). The variation in these types of geologic characteristics, erosion responses, and geomorphology demonstrate the heterogeneity of the sandstone that makes up the headland, which has ultimately guided its evolution.

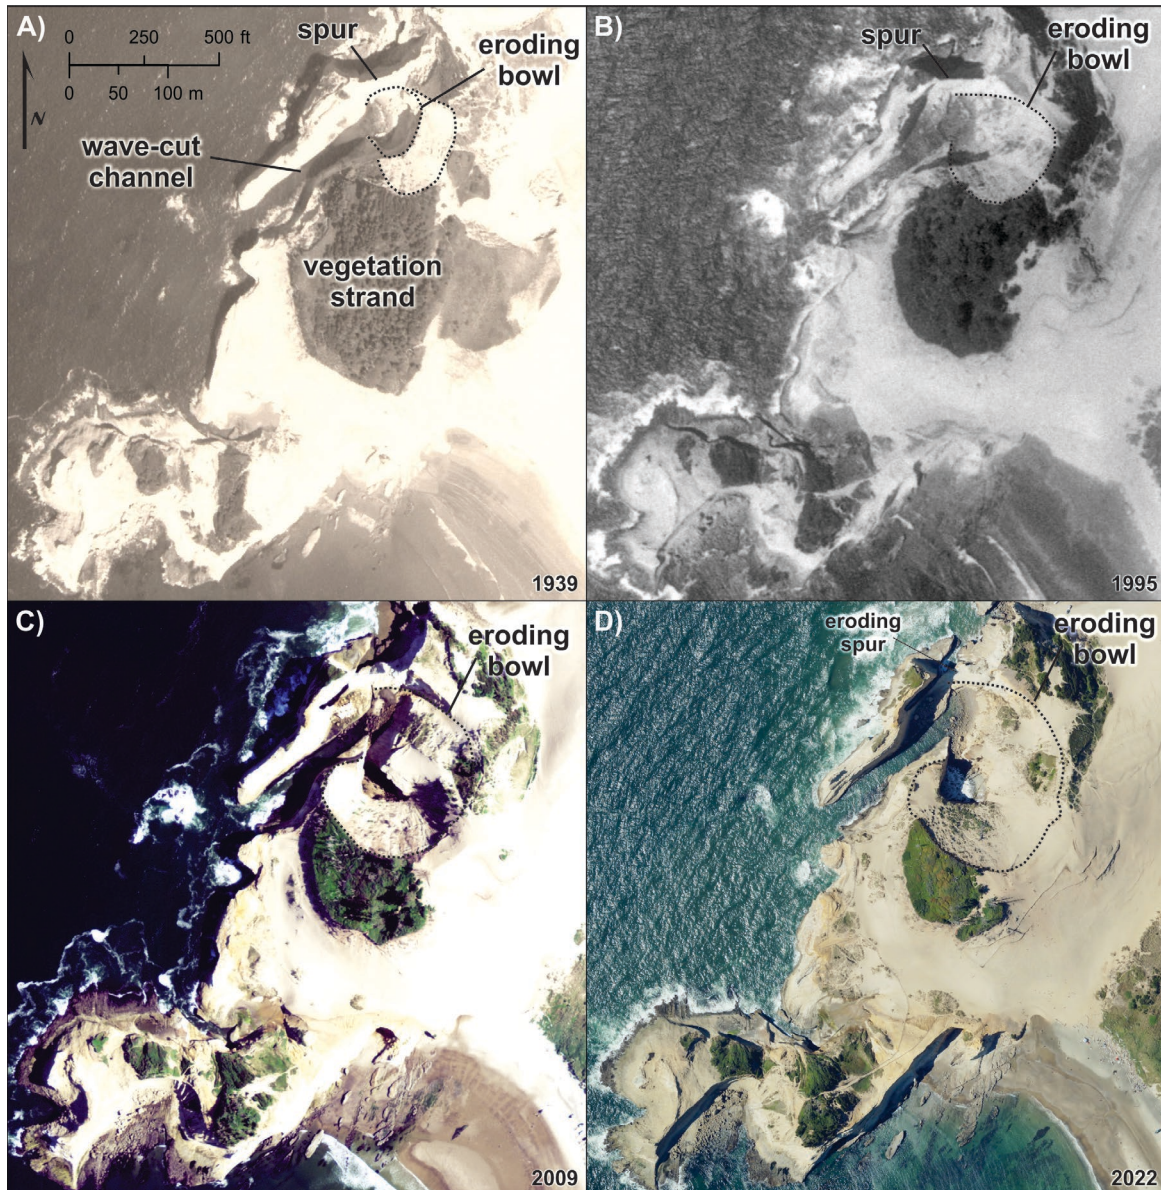
**Figure 5** presents a sequence of digitally orthorectified aerial images (1:5,000 scale) of Cape Kiwanda, from 1939 to 2022, demonstrating the powerful role ocean waves have played in eroding and shaping the sandstone headland over the past 84 years. **Figure 6** provides an interpretation of recent geomorphic changes that can be identified from the various images.

One of the most notable changes that has taken place on the headland is the considerable loss in vegetation coverage over time, from a peak in 1939 to the present coverage in 2022 (compare **Figure 5** to **Figure 6A**). The bulk of this loss can be attributed to the developing “erosion bowl” on the north side of the headland (compare **Figure 5A** and **5D**), which has consumed massive volumes of sand, rock, and vegetation over time. Removal of these sediments has been aided by wave and current processes operating within the wave-cut channel, and from within a cave that has developed parallel to the wave-cut channel. Since 1939, vegetation around central Cape Kiwanda decreased by ~66% from 4.6 to 1.6 hectares (11.5 to 3.9 acres). Conversely, vegetation at the far western end of Cape Kiwanda does not appear to have changed significantly over time (Compare **Figure 5**, 1939 to 2022).

Figure 5. Sequence of aerial images taken of Cape Kiwanda showing geomorphic changes over time. The 1939 image was flown by the USACE, while the 1995, 2009, and 2022 images were collected by the NAIP.

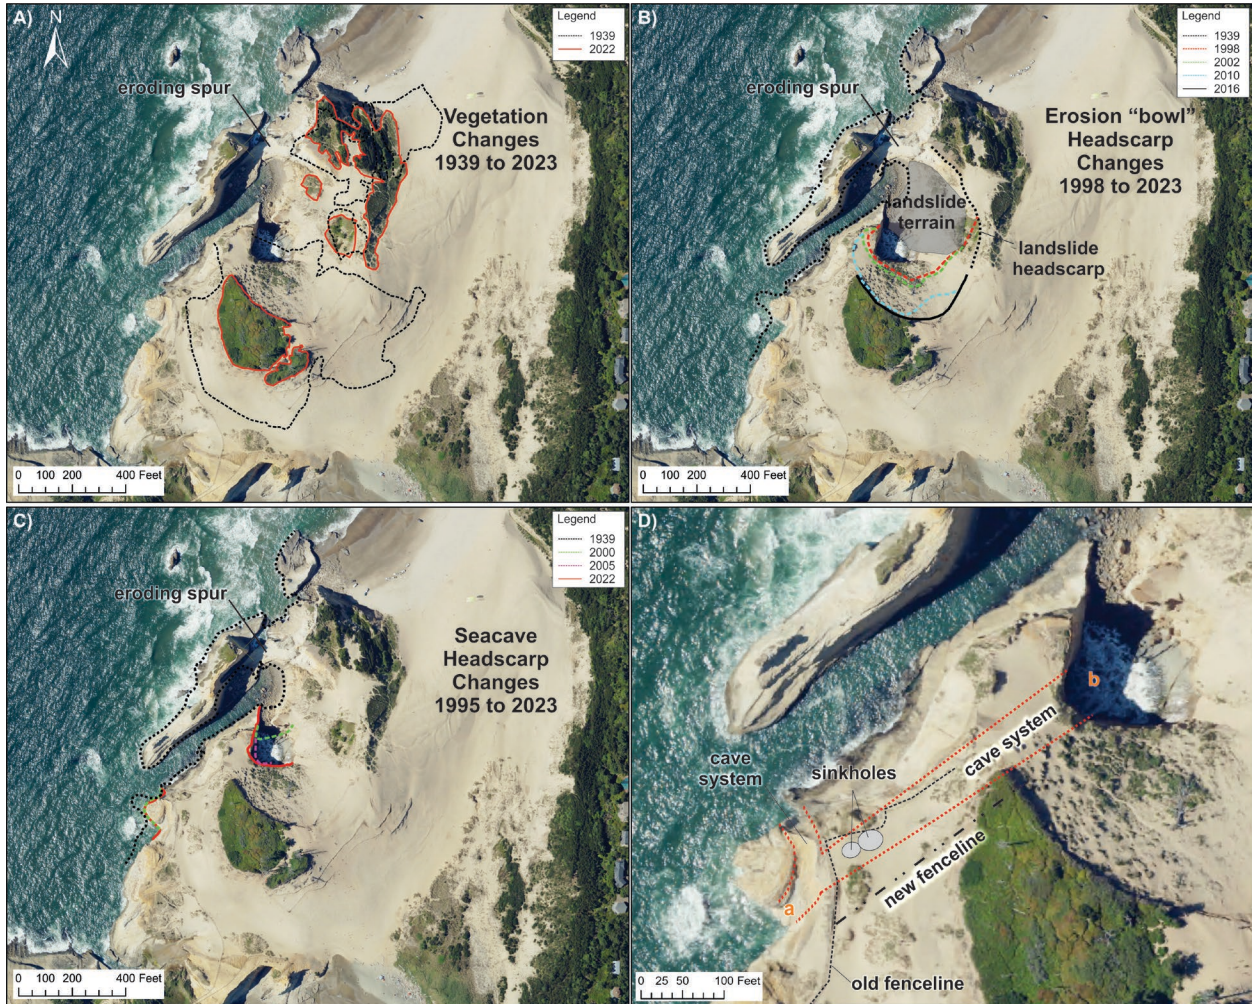
**Figure 6B** and **6C** shows the evolution of the erosion “bowl” since 1939. As can be seen in **Figure 6C** and **Figure 5A**, the area of the “bowl” in 1939 had a more limited extent, being confined to the landward end of the wave-cut channel and was no more than about 50 m (165 ft) in width. Using lidar and aerial photos, we can see that the “bowl” broadened significantly over time with the largest change occurring sometime between 2002 and 2010; as of 2022 the “bowl” had reached a diameter of ~150 m (500 ft). From 2010 to 2022 the erosion “bowl” did not change markedly. The authors were able to access the “bowl” as part of our field reconnaissance and observed that much of this area is highly active, characterized by evidence of landsliding (slope instabilities), including rockfalls (along the bluffs just east of “b” in **Figure 6D**) and slumping above it (**Figure 6B**). We consider the contemporary headscarp of the “bowl” to be unstable, particularly along its northeastern flank, and recommend the OPRD consider fencing this area.

Figure 6. Geomorphic changes around central Cape Kiwanda.

**Figure 6C** shows changes to the entrance of the two sea caves over time. At location “a” it can be seen that the coastline has not changed significantly over time. In contrast, we can track the general broadening of the erosion “bowl” between 1939 and 2000, and development of a cave entrance near “b”. Importantly, it appears the erosion accelerated ~2000 to 2005, with the cave entrance having assumed its current general configuration by ~2005. This would imply that the cave was likely closed at its eastern end prior to 2005. With the eastern end having fully opened up, erosion of the “bowl” accelerated, directly contributing to the landslide failures taking place east of the cave entrance. Since 2005, it appears the rate of erosion around the cave entrance near “b” has slowed, while undermining within the erosion “bowl” continues to make this area highly unstable. Finally, **Figure 6D** provides a schematic of the overall layout of the sea cave and location of sinkholes.

In the absence of any obvious vertical shaft having formed within the sea cave system between “a-b” in **Figure 6D** (meaning ocean water is not visible from the sinkhole), we hypothesize that these are collapse-type sinkholes, in which water may have preferentially dissolved a void within the sandstone, possibly along the same plane as the joint shown in **Figure 8**, which subsequently collapsed downward. The characteristic shape of the sinkhole and internal structure appears to support this idea. The ability to form a void within the sandstone also implies some unique geologic characteristics about the chemical disposition of the sediments below the collapse sinkhole. Hence, the formation of the sinkhole cannot be solely a function of a joint/fissure, but may also have resulted from chemical dissolution. A weakness in the underlying sediment, perhaps within its mineral structure, could have allowed water to preferentially dissolve the mineral, eventually leading to the formation of a void and its eventual collapse. Finally, we cannot rule out entirely mechanical action from the waves below, though this seems highly unlikely when compared with dissolution weathering of the rock strata. For example, the top of the sinkholes is located at an elevation of ~23 m (~75 ft). We can measure the approximate top of the wave runup zone from geomorphic features and erosion cuts near the water line, located at ~8 m (~26 ft) elevation near the caves. If we assume this is the approximate height of the top of the cave, this indicates ~15 m (48 ft) of rock above the cave system, which is a large amount of rock to erode from below.

This study evaluated two sinkholes at Cape Kiwanda, which formed in January (sinkhole 1) and May (sinkhole 2) 2023. Fieldwork confirmed the presence of a large cave system that extends beneath the two sinkholes. However, we saw no evidence for vertical connectivity between the sinkholes and the cave below. We hypothesize that the sinkholes preferentially formed along a joint and within a saddle (low point in the ground surface) that may have allowed water runoff from higher up to preferentially pond within the saddle. This likely allowed water to progressively dissolve the underlying rock structure, leading to a collapse sinkhole. Given the observed erosion and rapid transformation of this part of Cape Kiwanda over the past 84 years and especially in the last two decades, we recommend that the entire area overlying the cave system be avoided entirely. At a minimum, we recommend establishing a new fence line approximately 15 m (50 ft) south of the existing sinkholes, which should provide sufficient setback to allow for future catastrophic failure of the cave system. In time, we suspect that this part of Cape Kiwanda may eventually form a small sea stack as the western sea cave (“sea cave 1” in **Figure 2A**) collapses, while a wave-cut channel could eventually form along the main east-west cave system (“sea cave 2” in **Figure 2A**), similar to the existing wave-cut channel located immediately north of the developing cave system. Finally, our fieldwork within the erosion “bowl” indicated the presence of active slope instabilities, including rockfalls near “b” in **Figure 6D** and slumping (**Figure 6B**). We recommend building a new fence

line (dashed black line in **Figure 6B**) in the northeast to keep people out of the erosion “bowl” as this part of the Cape remains unstable, while maintaining a view overlooking the area.

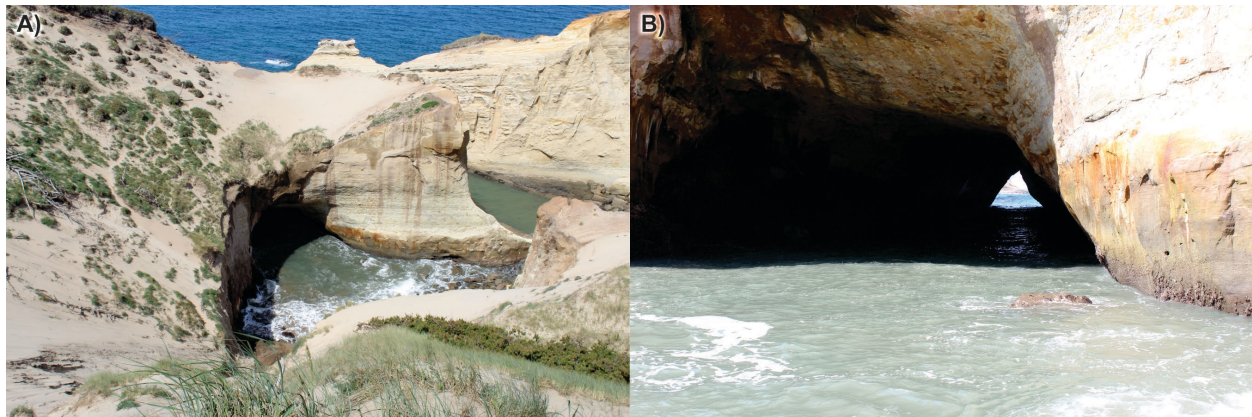
From within the bowl, we identified a large sea cave (**Figure 7**), which connects to a smaller sea cave (“1”) identified in **Figure 2A** and (“b”) in **Figure 6D**. We estimate that the sea cave (2) is approximately 117 m (384 ft) in length and is ~15 m (50 ft) wide at the base of the “bowl” near “b” (**Figure 6D**). Due to its orientation and length, we believe this cave system extends directly under the two sinkholes. However, we could see no evidence for a vertical shaft inside the cave that would identify connectivity with the sinkholes above; similarly, one cannot see the sea surface through the sinkholes. Further study of the sea cave (i.e., size, extent, and internal structure) and the overlying bedrock (i.e., identifying areas of weakness such as jointing and studying groundwater movement) could provide a better understanding of the cave system and predict future sinkhole locations.

Figure 7. A) Looking down into the developing erosion "bowl"; B) Sea cave that connects to the western end of the headland; view is from location "b" in Figure 6D, looking west (Photo credit: J. Allan, 2023).

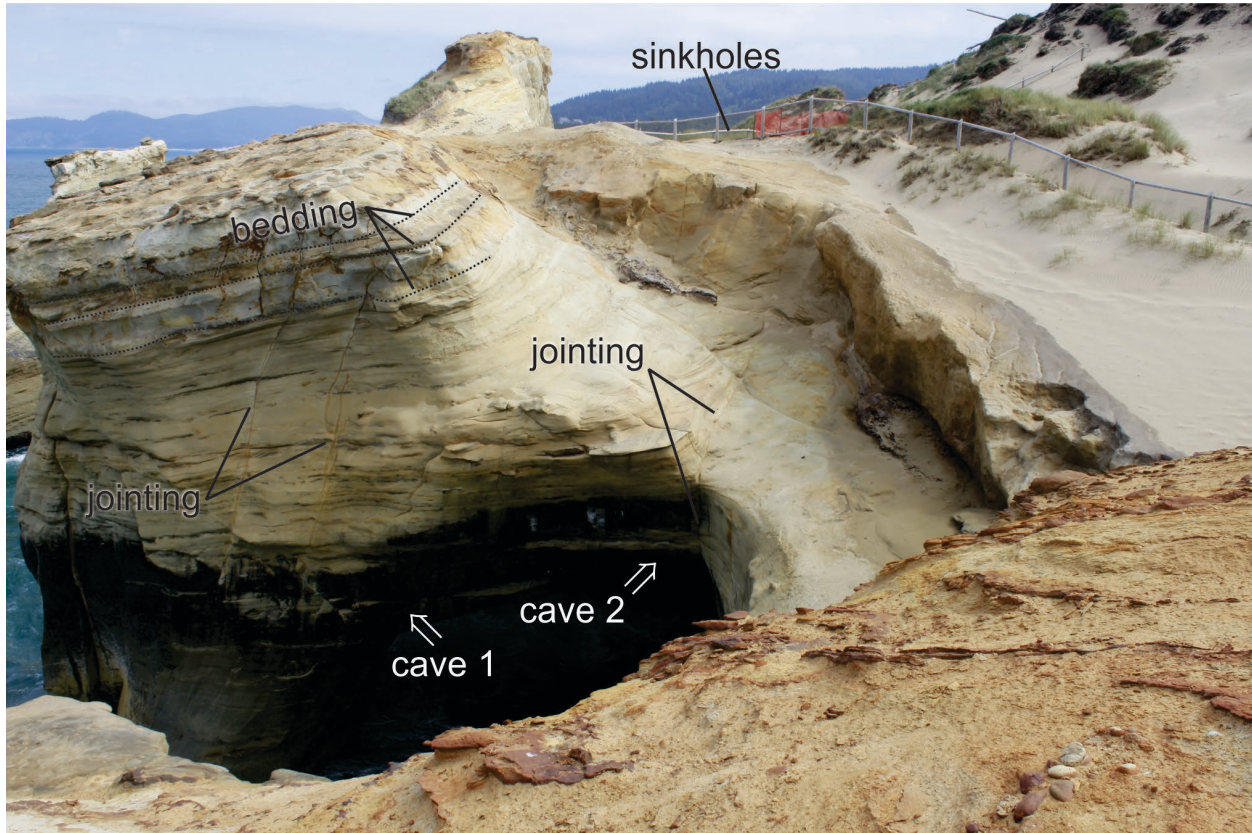
**Figure 8.** View from near “a” in Figure 6D looking in a northeasterly direction into the western end of the cave system. Note the vertical jointing in the Astoria Formation sandstone above and to the right of the cave entrance (as well as in several other locations seen to the left), along with weathering (iron-oxide staining) and concentrations in the various sand layers (Photo credit: J. Allan, 2023).
