Special Paper 38

**PORTLAND STATE UNIVERSITY ONDINE RESIDENCE HALL
SEISMIC REHABILITATION DEMONSTRATION PROJECT**

By
Yumei Wang¹ and Christopher J. Heathman²

2007

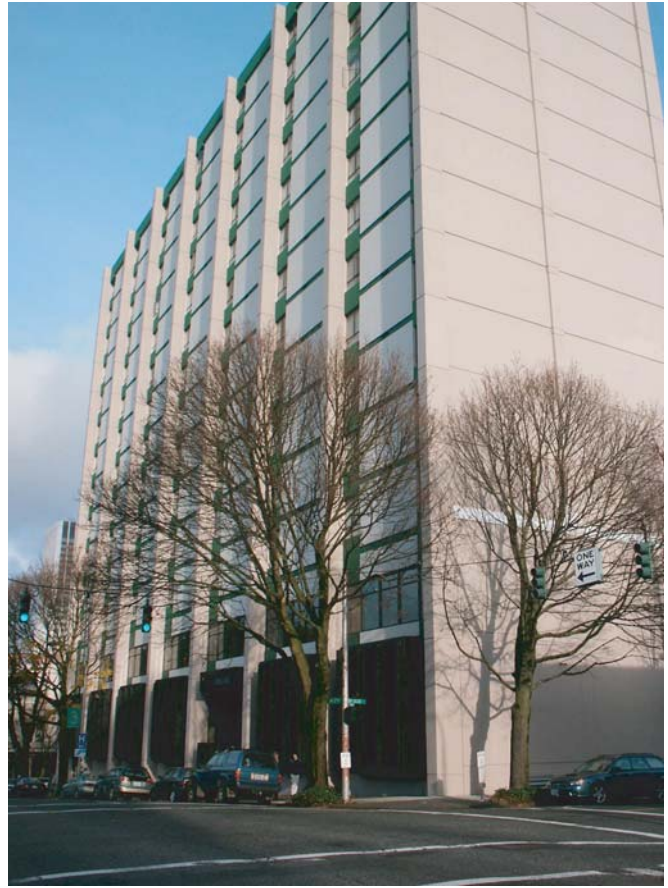
Figure 1. Ondine Residence Hall, Portland State University. This view from the southwest shows the lower, soft stories that are vulnerable to collapse prior to mitigation.

KPFF also determined that the lack of shear walls on the second floor along the west face of the building should be considered a vertical irregularity. At this floor, forces resisted by the shear wall above the second floor must be transferred through the floor diaphragm to other shear walls. This severely degrades the building's performance. It increases the load on the diaphragm and on other shear walls within the building by causing the building to twist and rotate during earthquake shaking.

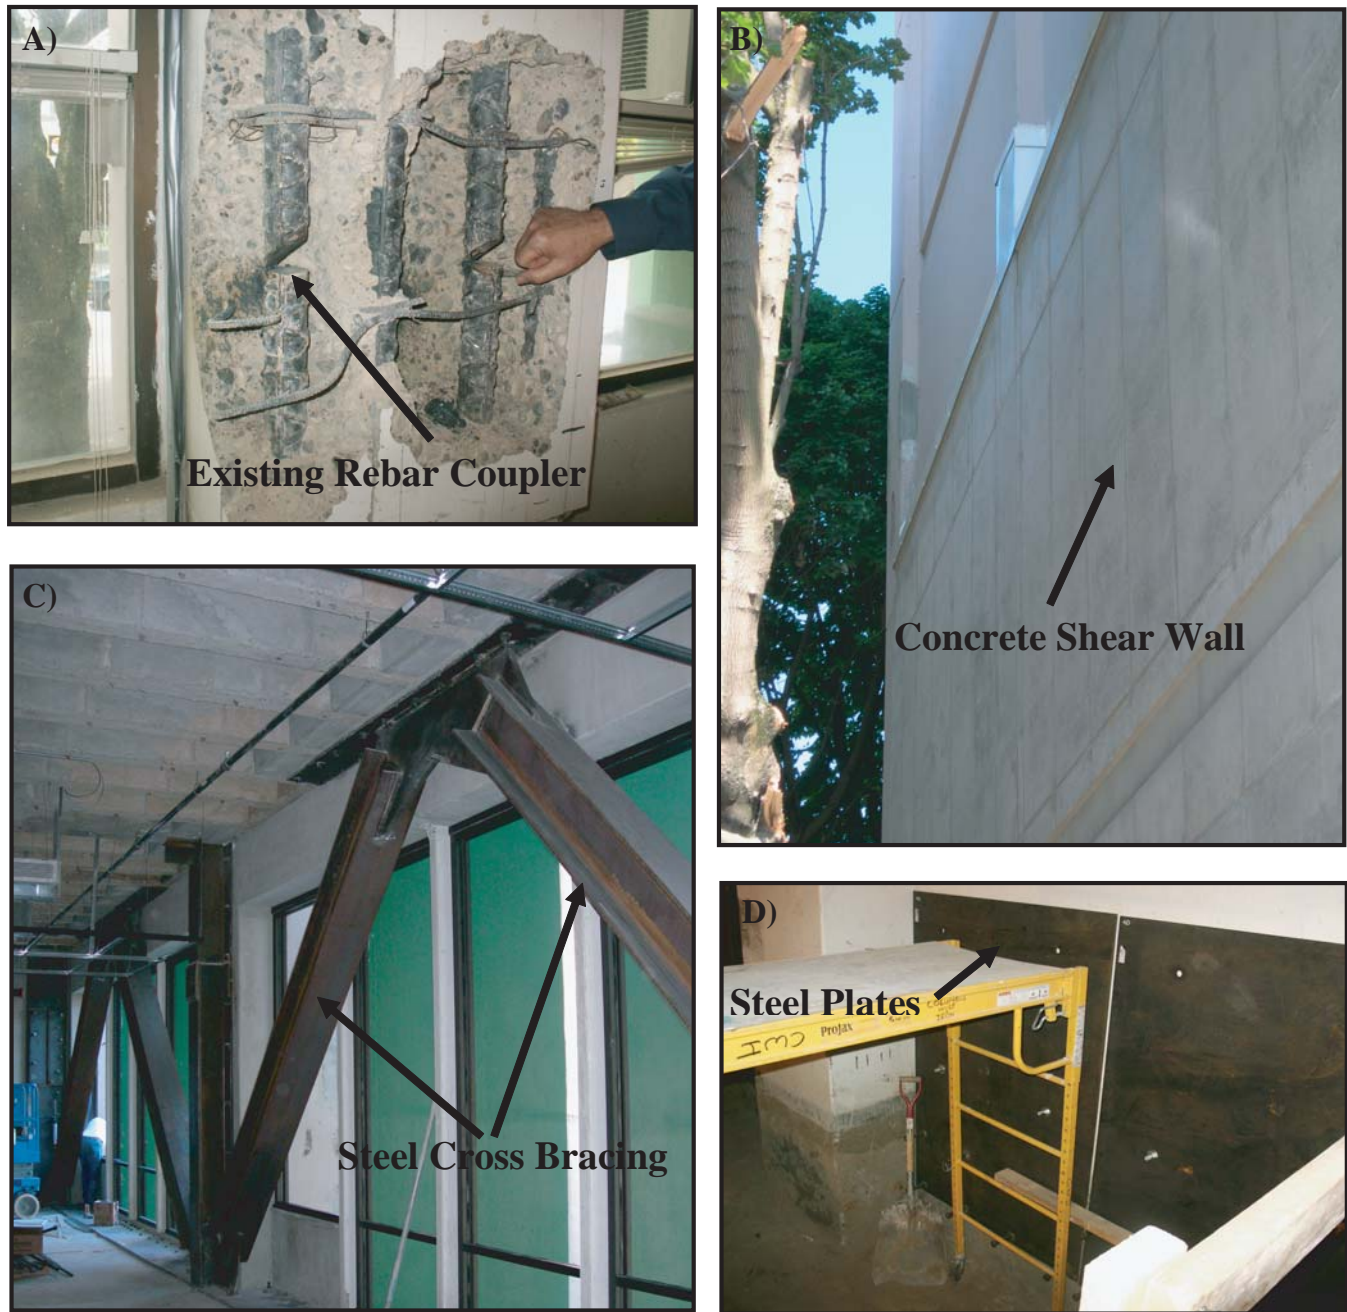
The rehabilitation design mitigated the inadequate shear wall thickness, the inadequate bracing on the first and second floors (which are considered to be soft stories), and the lack of vertical continuity in the rebar located in the concrete columns. These upgrades are intended to improve the building to a life-safety performance level and to minimize potential for a soft story collapse of the first and second floors.

Figure 5. Solutions recommended by structural engineers for seismic improvement: (A) existing rebar joint, which was mitigated by welding rebar together, (B) new concrete shear wall on the south side of the building, (C) new steel cross bracing, and (D) steel plate installation in progress.

reinforcing at existing concrete shear walls, (3) addition of 3/8-inch steel plates to the interior wall along the north and south elevations, and (4) new cross-bracing along the west elevation. Each part of the seismic mitigation design is shown in Figure 5 and is discussed in this report. The proposed upgrade would allow the building to remain close to elastic in the BSE-1 event. The existing building systems that would not be upgraded would benefit due to reduced building drifts and improved lateral load path (KPFF, 2004).

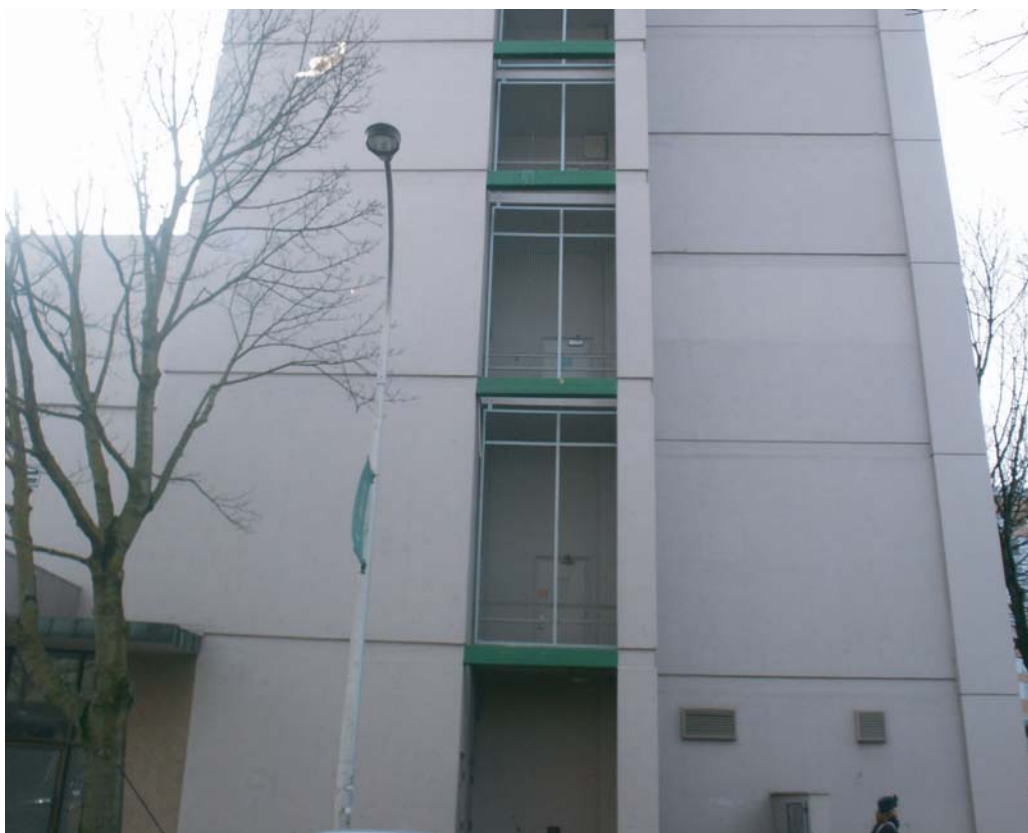
Figure 6. Obstacles such as the exterior stairwell prevented use of additional exterior concrete shear walls.

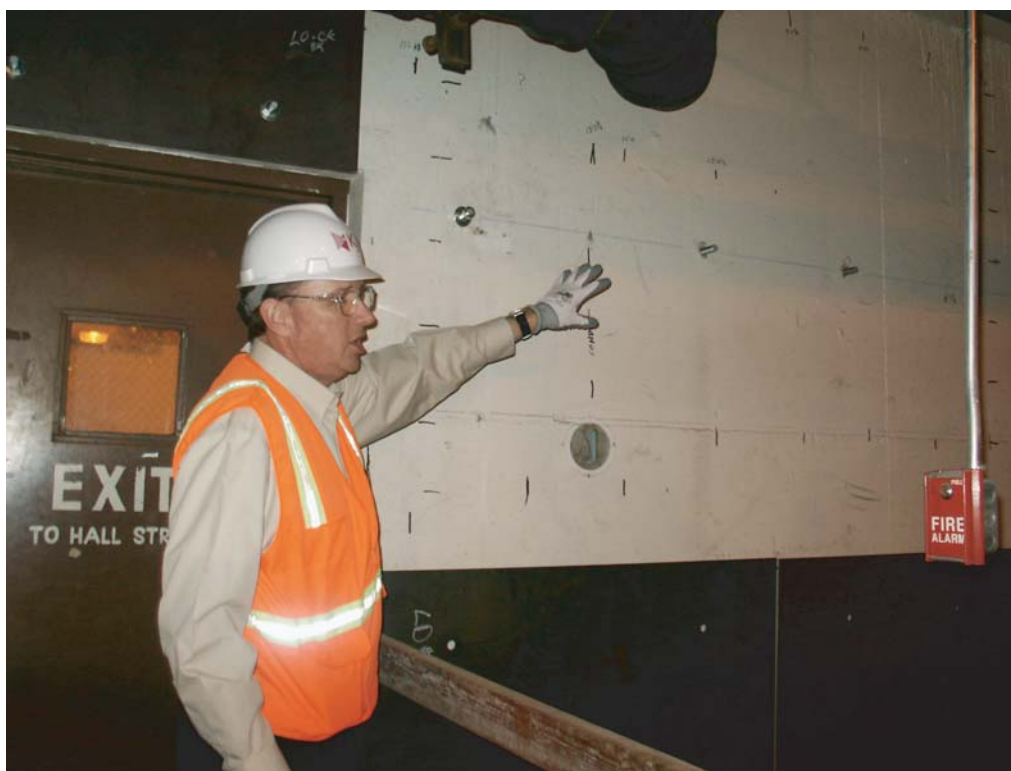
Epoxy-coated anchor bolts were to be used to attach the steel plates to the existing concrete walls. Two main criteria involving the location of the anchor bolts affected the approach to attaching the plates: (1) the architect wanted consistent spacing of the bolts for aesthetic reasons, and (2) KPFF would not permit damage to in-situ rebar in the existing concrete walls.

Figure 7. Map of existing rebar to determine locations for drill hole anchors needed for steel plate mitigation.

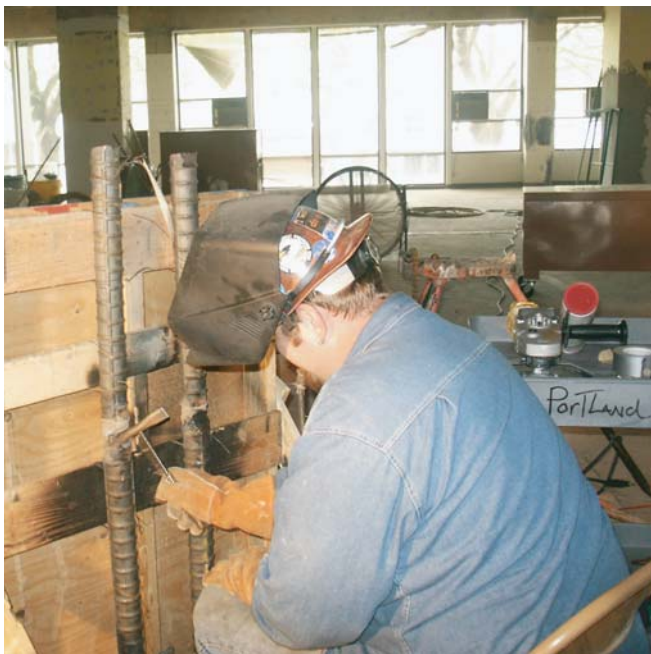
Figure 8. Testing rebar coupler weld.

KPFF then designed a splice that put a heavy splice plate behind the rebar and was vertically welded to the rebar. This design necessitated the removal of a good portion of the column concrete. Also, this design added excessive heat to the rebar over such a large area that there was concern about damaging the remaining concrete above and below the repair.

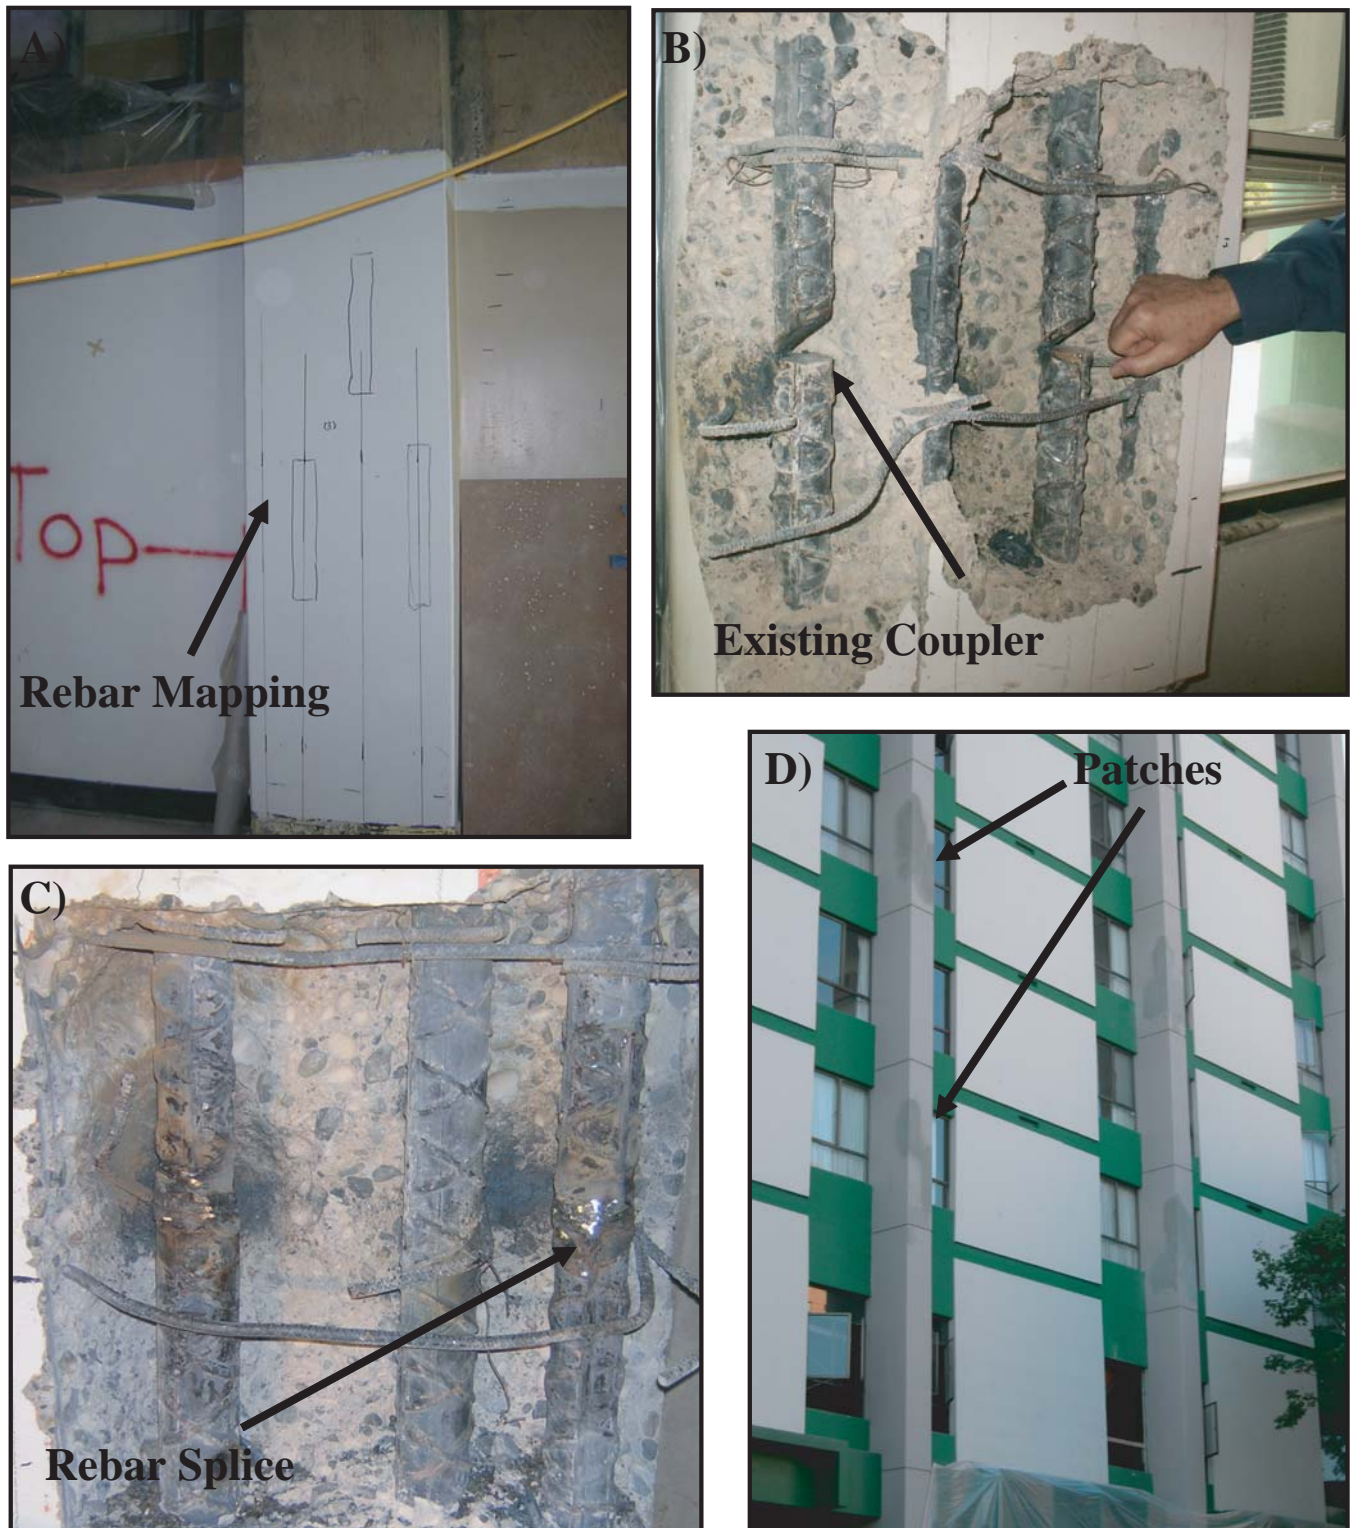
A major problem discovered during the investigation phase of design was that the concrete columns were not positively connected to each other with vertical rebar. At this point, several options were considered. Because the upper floors of the building were to remain occupied during construction, safety of occupants was a major concern when the columns were being reinforced. The first option of adding concrete and reinforcing around the existing column was ruled out due to high cost and loss of interior space. The

Even with the process described above, heat from the welding damaged some concrete areas both above and below the bar splices. In order to repair these locations, all the unsound concrete was removed and the chipped areas were grouted back with concrete. Also, pressure epoxy injection was used around the bar splice repair area to further ensure that the columns remained sound.

Figure 9. Construction process used to connect vertical rebar: (A) rebar mapping destructive tests expose inadequate rebar coupler, (B) existing coupler, (C) close-up of splice used for coupler repair, and (D) cement/concrete patches following coupler repair.

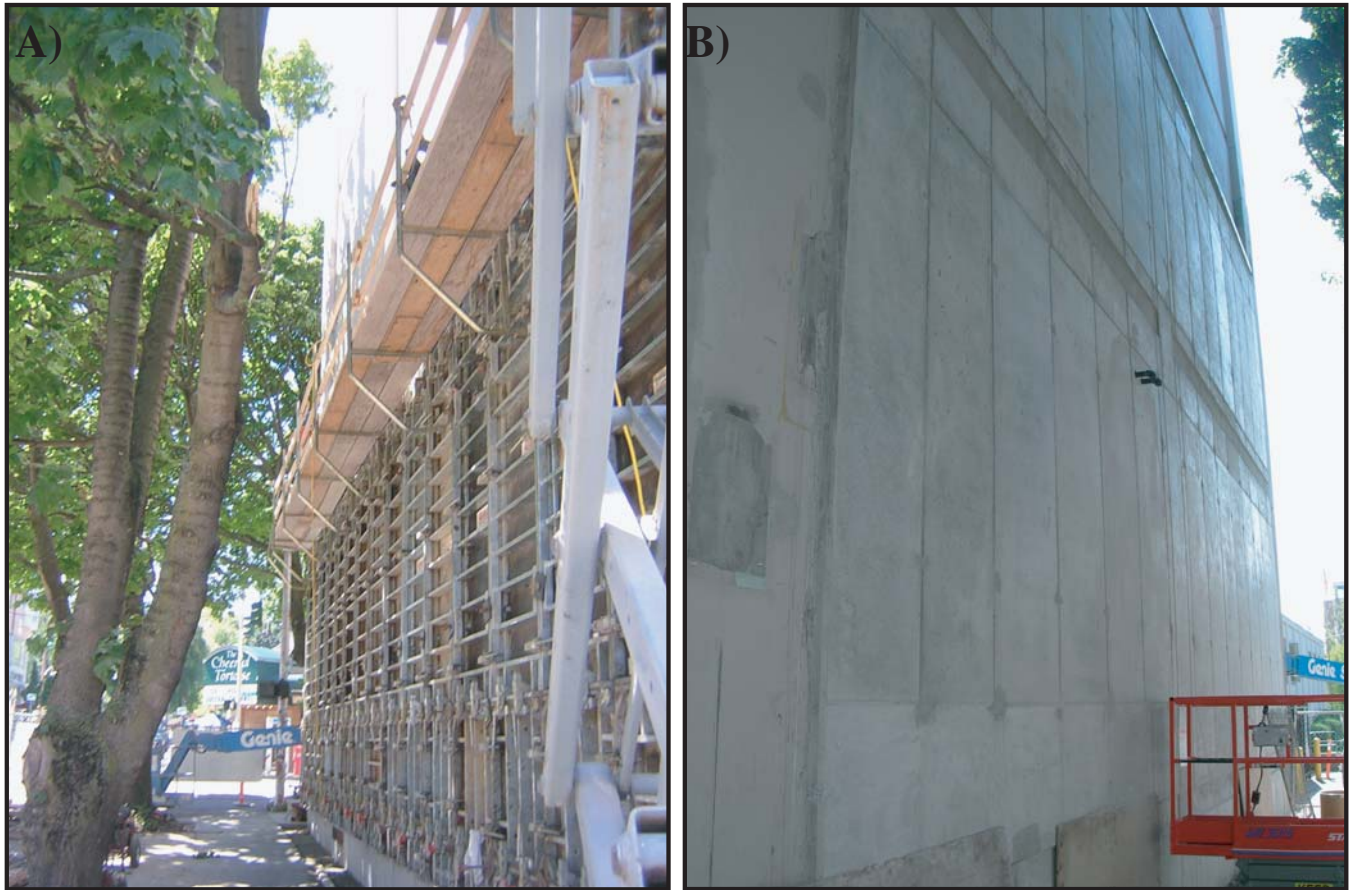
Figure 10. Construction of concrete shear wall along south side of Ondine Hall: (A) preparing new portion of concrete shear wall, and (B) completed shear wall.

Three options were considered to provide additional strength to the inadequate shear walls. The first, and relatively inexpensive, option was to provide additional shear wall thickness by simply adding more concrete shear wall to the existing walls. However, concrete walls would result in a significant increase in load on footings and piles. In this case, the addition of exterior concrete walls was not feasible due to the excavation that would be required for the basement and subbasement stories and associated costs. Also, the use of concrete on interior walls would result in loss of the already limited interior space. Furthermore, adding concrete walls was considered to be unworkable in locations where there were conflicts with obstacles, such as the exterior stairwell shown in Figure 6. A second option of reinforcing with composite fibers was ruled out due to high cost.

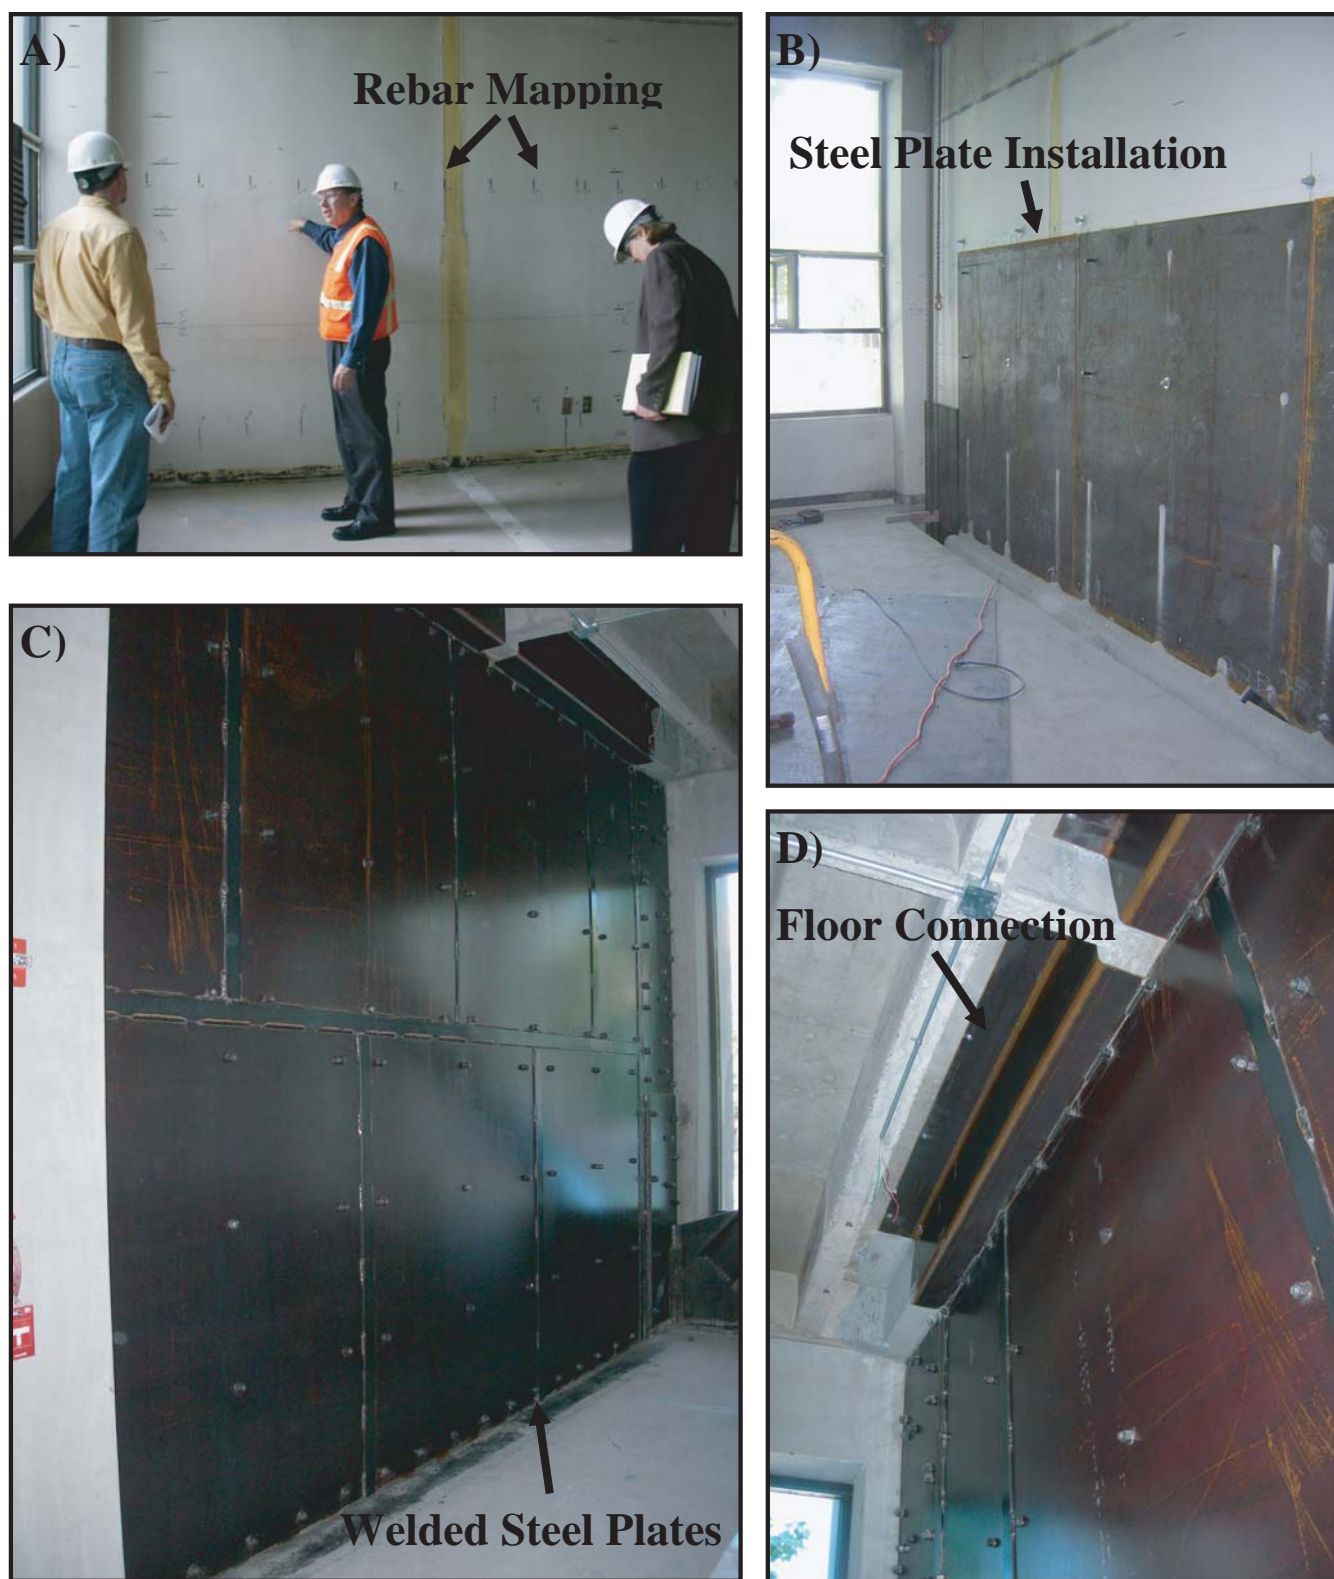
Figure 11. Construction process for steel plates: (A) rebar mapping, (B) installation in progress, (C) completed wall with sheets welded together, and (D) plate connected floor to floor.

Steel plates were added to the interior of the sub-basement, basement, and first floor along the north and south interior walls. The plates were then fabricated as described previously with predrilled holes to receive the threaded anchor bolts. Once the plate was in the proper location on the wall, it was secured to the wall by simply tightening a nut. None of the existing rebar was impacted during drilling and installation of the steel plates. Once installed, the plates were welded together and joined one floor to the next. Figure 11 shows the installation of steel plates.

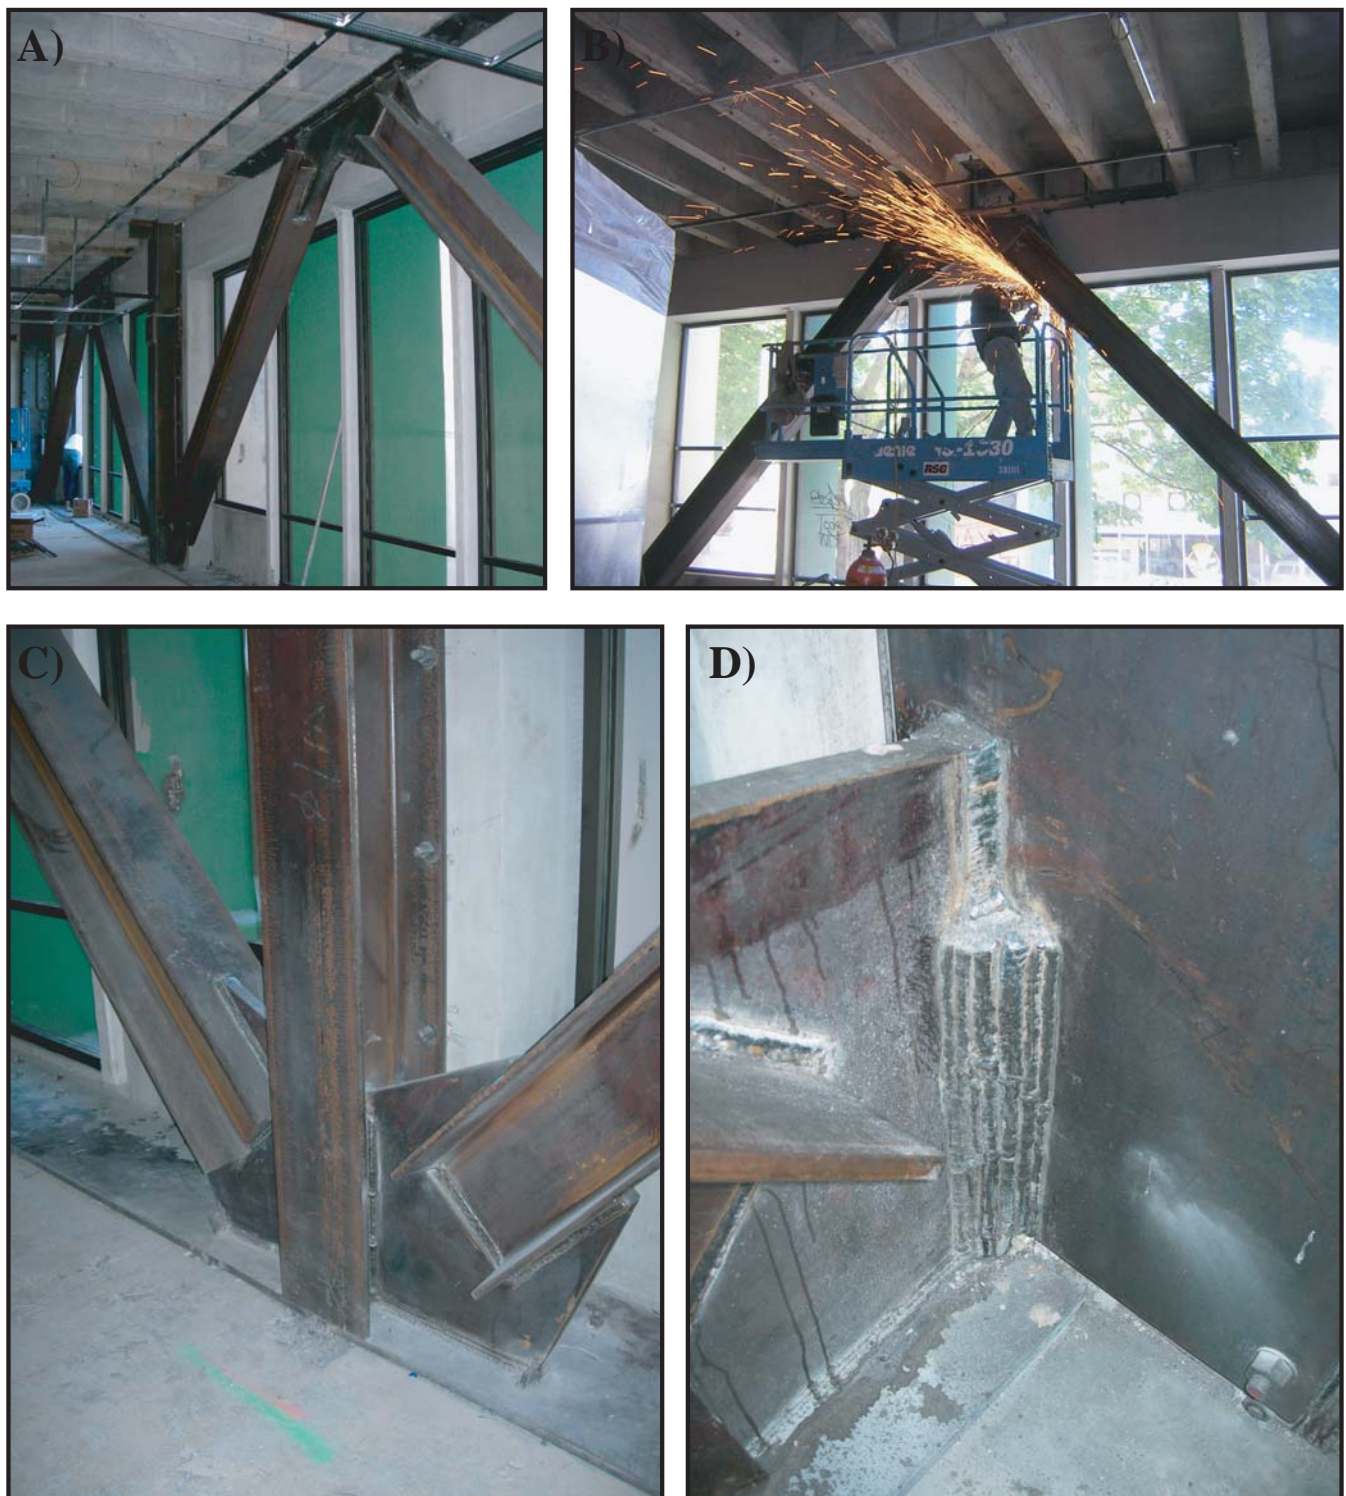
Figure 12. Construction of cross-bracing on first and second stories along west elevation: (A) Installed cross-bracing, (B) cross-bracing installation in progress, (C) close up of welded plate at floor level, and (D) close-up of weld used to connect new cross-bracing to steel plates.

The major west elevation, with its soft stories on the first and second floors, was strengthened using a braced frame, the cross-bracing commonly seen in rehabilitated buildings. Horizontal steel members were bolted at the floor level, and vertical steel members were bolted to the existing shear wall. These steel members were used to tie in the new cross-bracing to the existing structure. Steel plates were used to weld the cross-bracing to the horizontal and vertical steel support members. In the building corners, the cross-bracing members were welded directly to the new steel plates. Construction of the braced frame is shown in Figure 12.

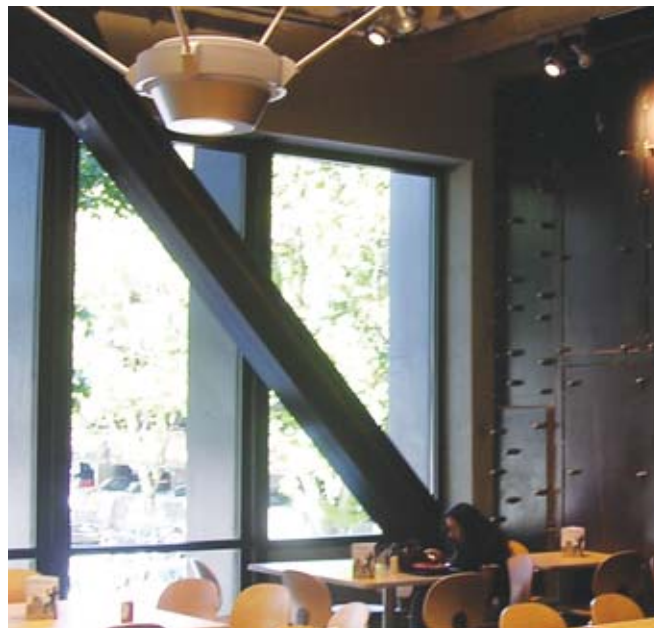
Figure 13. New structural cross-bracing and a wall of steel plates, burnished for aesthetic reasons, are permanently visible in Ondine Hall cafeteria.
