APPENDIX H: EROSION PIN DATA AT THE SEA CLIFF

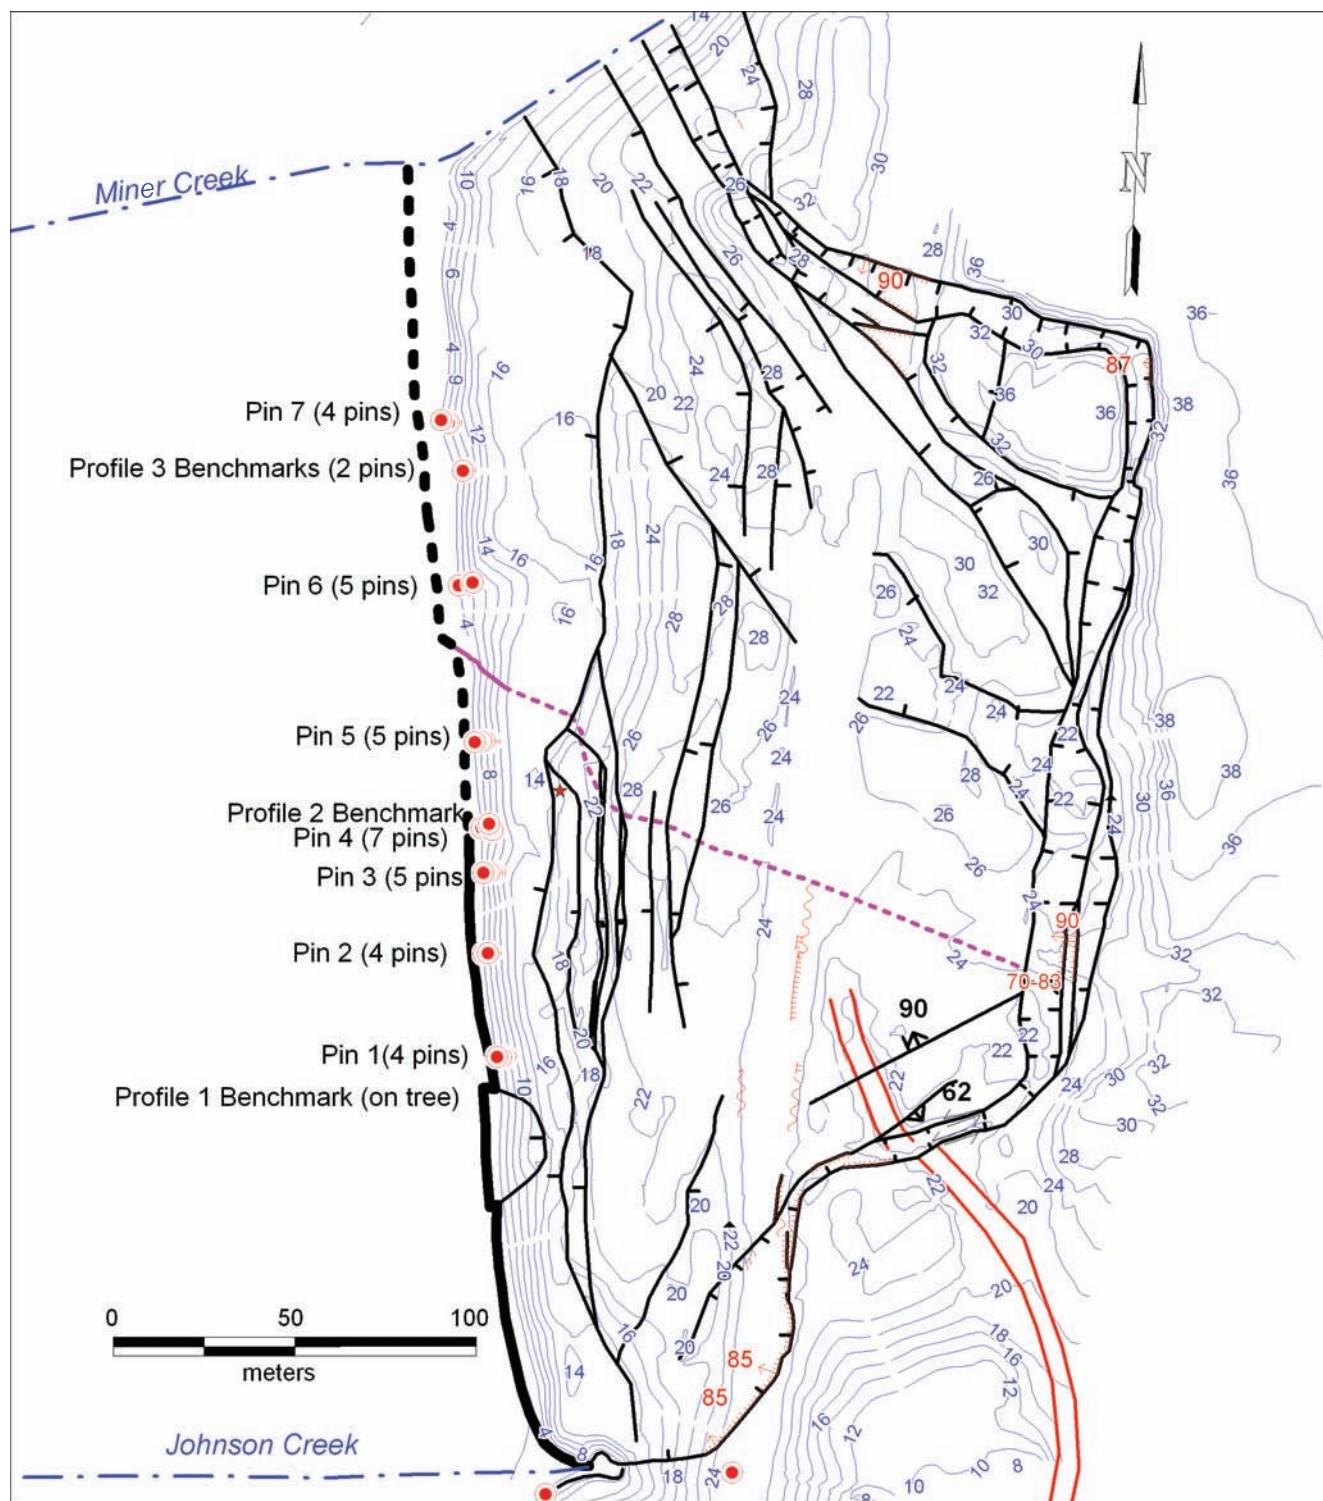
Figure H1. Location of erosion monitoring pins at the toe of the Johnson Creek landslide. Black lines are mapped slide block boundaries. Solid purple line is internal slide structure or fault; dotted purple line is speculative extension of this structure across the slide to match a similar structure inferred from borehole logs. Red numbers are dips on fresh scarps (red hachured lines) where nails were installed in 2003. Blue lines are topographic contours at 2-m intervals.

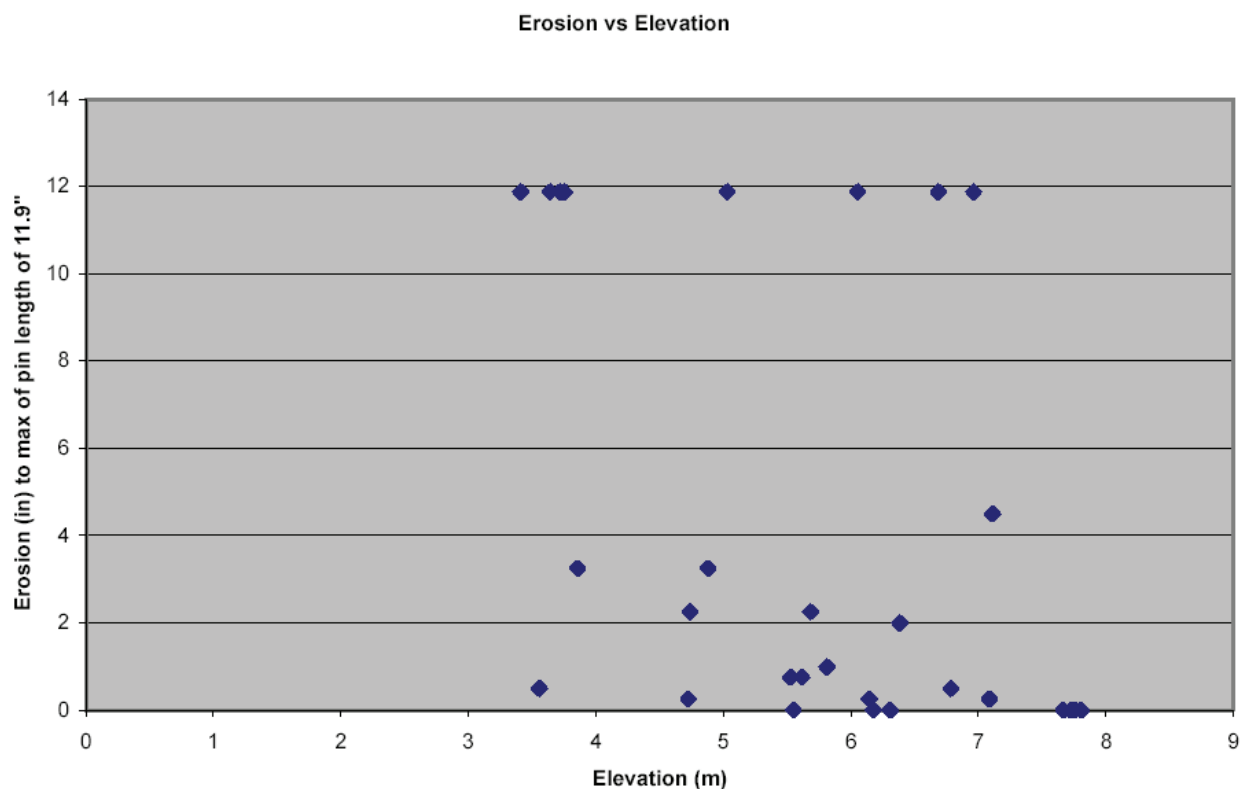
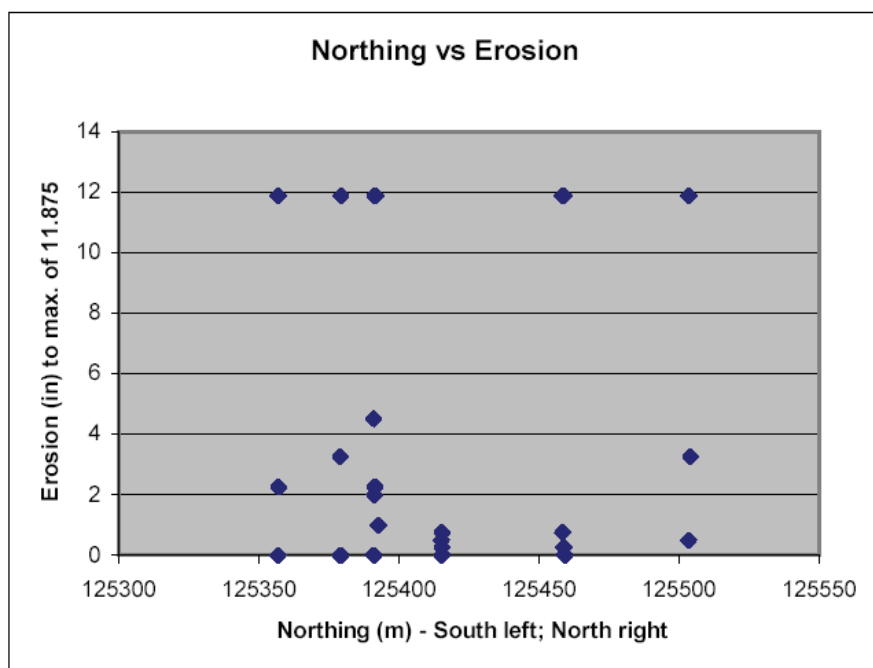
Figure H2. Bluff erosion data for December 9, 2002, to April 10, 2003. Note that there is no obvious correlation of erosion and bluff height or position north-south. The maximum length of pins was 30 cm (11.9 inches), so no larger erosion value could be measured; consequently, there are a number of points at 30 cm (11.9) on the graphs. Pin loss was generally caused by falling blocks of rock similar in size or larger than the pin. To overcome this problem, sharpened steel rods ~76 cm (30 in) long were driven into the bluff in 2004. However, no data have been gathered, owing to low wave conditions prior to compilation of this report.
