#### **BULLETIN 82**

# GEOLOGIC HAZARDS OF THE BULL RUN WATERSHED, MULTNOMAH AND CLACKAMAS COUNTIES, OREGON

John D. Beaulieu
Oregon Department of Geology and Mineral Industries

1974

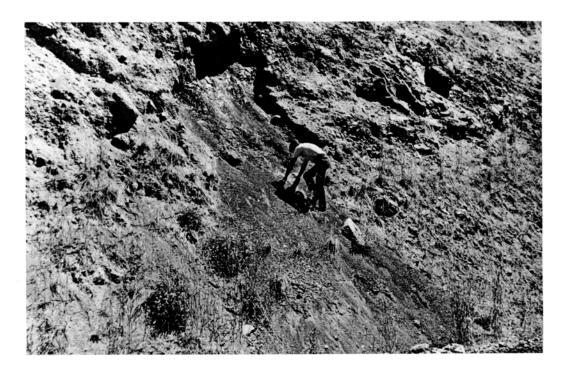
Figure 13. Pods of red colloidal clay in the Rhododendron Formation are particularly hazardous in terms of turbidity (near Fir Creek, sec. 13, T. 1 S., R. 6 E.).

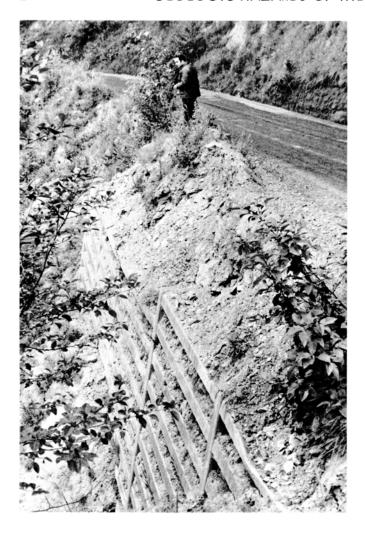
Figure 31. Cribbing supports the access road in steeply sloping Rhododendron terrain near the west gate (sec. 5, T. 1 S., R. 5 E.).

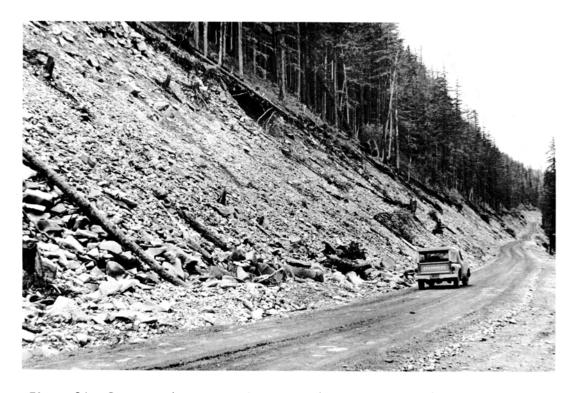
Figure 34. Care must be exercised to assure that roadcuts in talus are not too steep. Note that the thick forest cover probably obscured the talus prior to road construction.

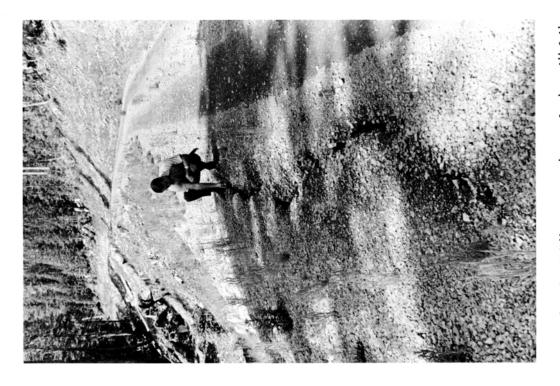
Figure 36. Road fills on steep slopes of talus will fail if the slope is overloaded (sec. 27, T. 1 S., R. 7 E.).

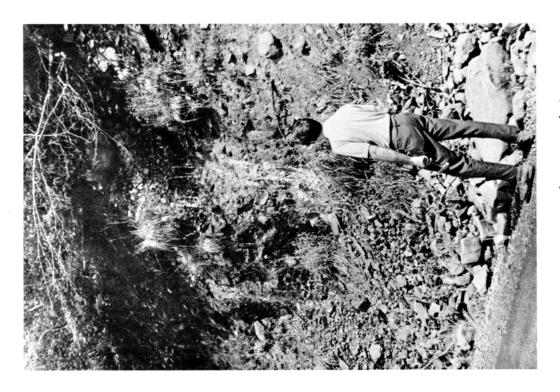
Much runoff occurs a few feet beneath the ground surface in the talus and must be properly accommodated in roadcuts and other excavations (Figure 35). Large cuts in the talus may tend to work their way upslope as the hillside returns to stable conditions. Oversteepening and overloading must be avoided (Figure 36). Some large operations in well-packed talus, however, appear stable. A notable example is the quarry operation 2 miles downstream from Bull Run Lake.

Figure 35. Roadcuts in talus commonly intersect subsurface drainage.

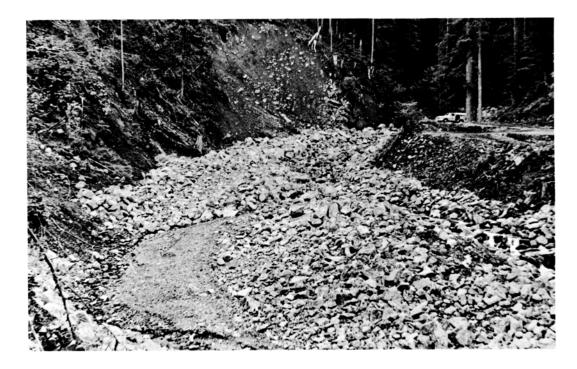
Figure 46. View of part of the North Fork slide looking upstream.

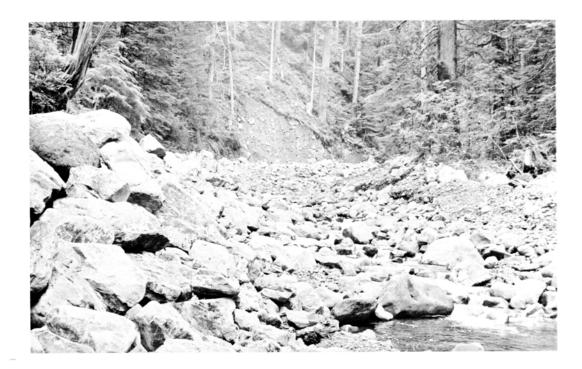
Figure 47. The northernmost part of the North Fork slide area; note that some of the rounded boulders in the creek are as large as much of the riprap.

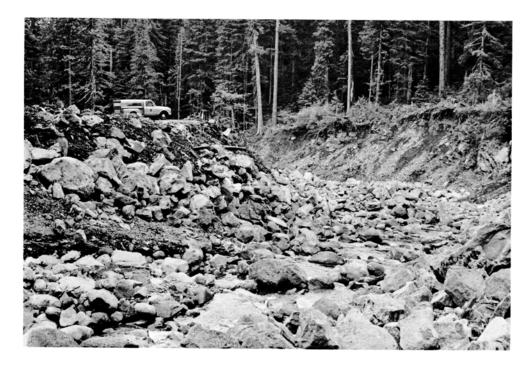
Figure 48. View of part of the North Fork slide area looking downstream; truck is in same position as in Figure 46.

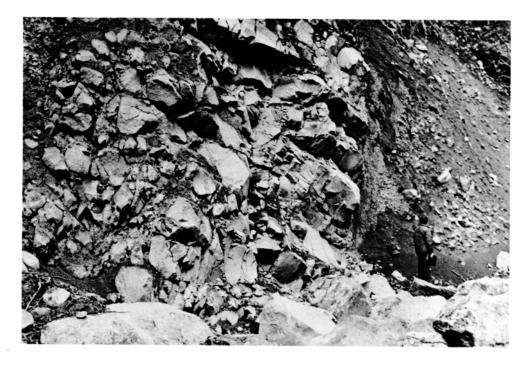
Figure 49. A flow of Pliocene hypersthene andesite, with baked zone to the right and abundant vesicles on the left, has been greatly rotated by massive landsliding at the North Fork slide area.

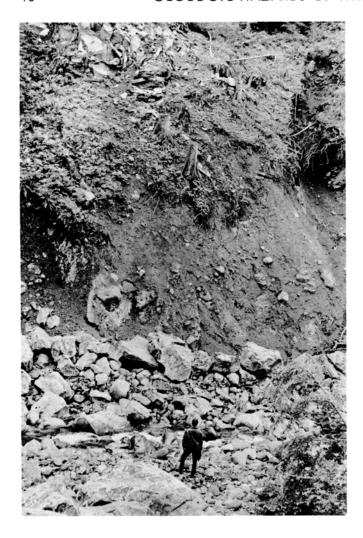
Figure 50. Coarse riprap has been placed along the east bank of the North Fork to prevent stream-bank erosion at the North Fork slide.

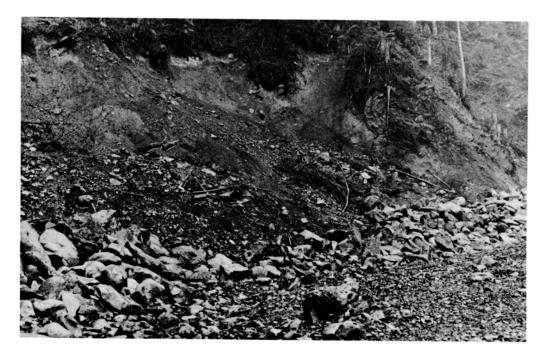
Figure 52. Material sloughing over the riprap into the overflow channel is abundant enough to pose turbidity problems.

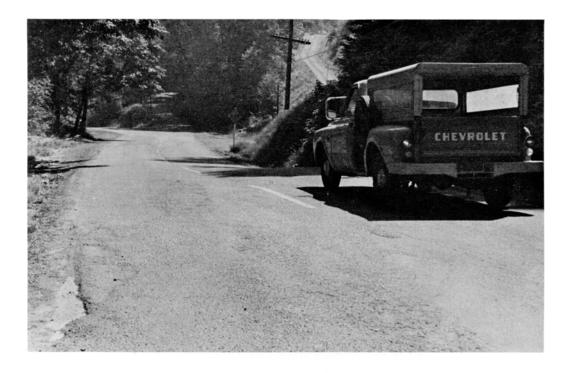
Figure 55. The headscarp of the Ditch Camp slide crosses the main access road.

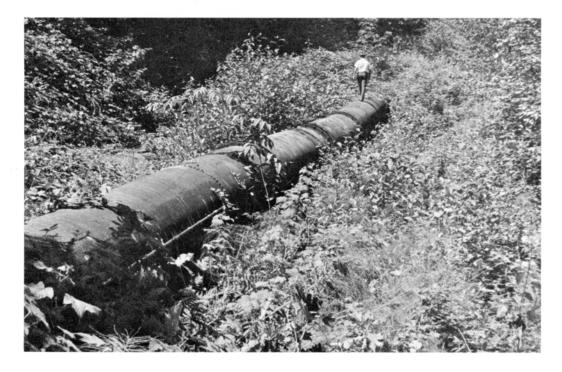
Figure 56. Continued settling or movement at the Ditch Camp slide has bowed conduit No. 4.

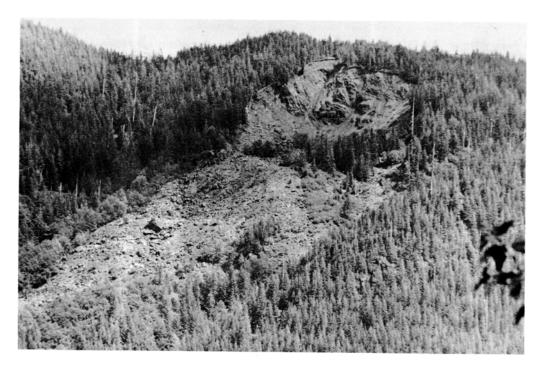
Figure 58. Massive rock failure near Sugar Loaf Mountain near Lolo Pass. Similar sliding, now obscured by timber, has occurred along the South Fork.

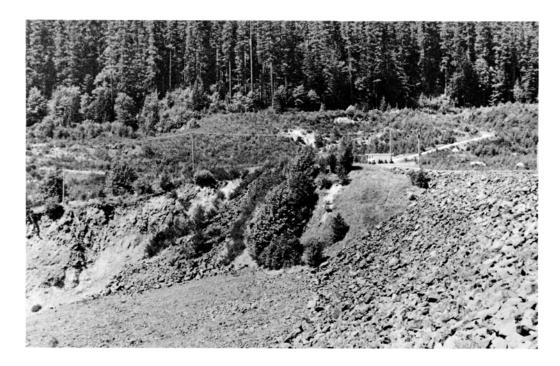
Figure 60. View from Bull Run Dam No. 2 looking north at irregular terrain of the Headworks landslide; note the poorly sorted, unbedded rubble in the cut to the left.

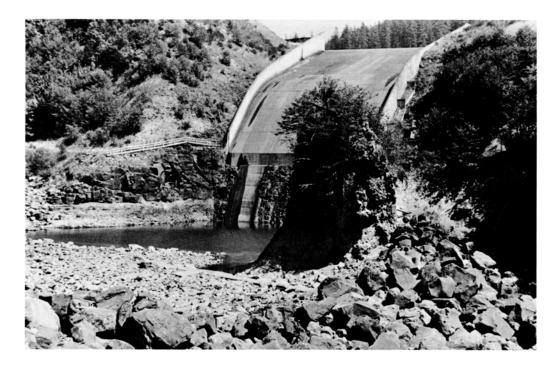
Figure 61. The plunge pool for the Headworks spillway is cut into flows of Columbia River Basalt. Large block of Rhododendron breccia probably slid to its present location.

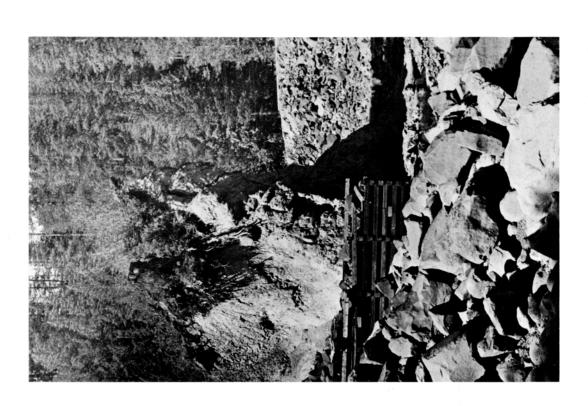
Figure 62. Riprap and cribbing protect displaced block of Rhododendron breccia from high winter runoff.

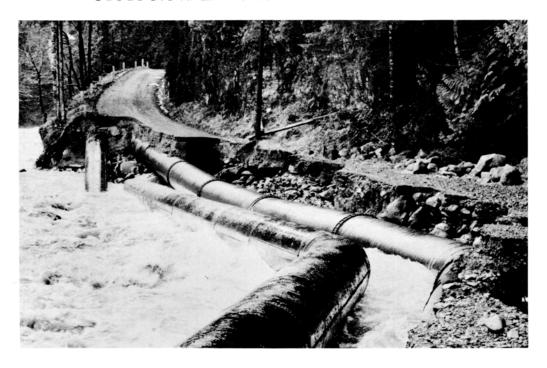
Figure 70. Stream-bank erosion on December 22, 1964 destroyed part of one conduit and threatened two others (same  $1\infty$  ation as Figures 68 and 69).

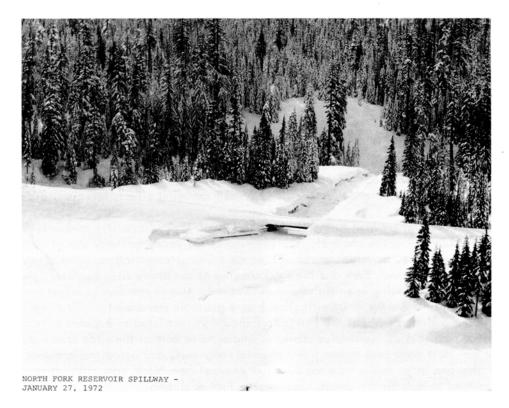
Figure 71. Sagging ice at the North Fork (Boody) Reservoir immediately after the North Fork flood suggests rapid drawdown.

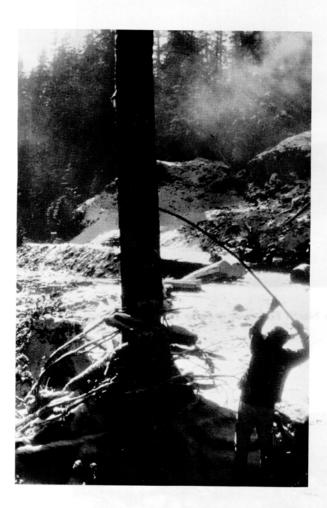
Figure 72. Geologist points to boulder scars on a tree at the mouth of the North Fork.

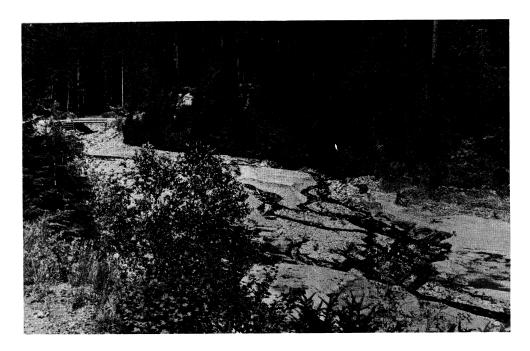
Figure 73. The delta at the mouth of the North Fork was greatly enlarged during the flood of January 20, 1972.

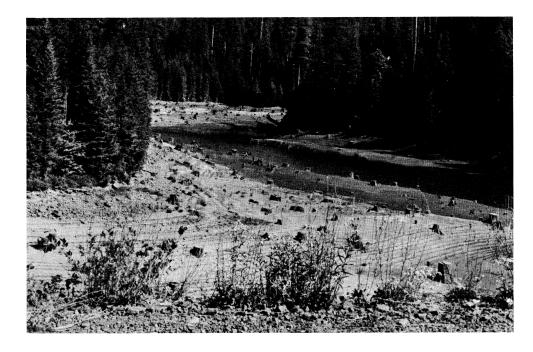
Figure 80. Late summer drawdown exposes large areas to wind, water, and wave erosion and can be a significant factor in reservoir turbidity.
