Probability of Damaging Shaking

2021

By Ian P. Madin¹, Jon J. Franczyk¹, John M. Bauer², and Carlie J. M. Azzopardi¹
¹Oregon Department of Geology and Mineral Industries, Portland Office, 800 NE Oregon Street, Suite 965, Portland, OR 97232
²Principal, Bauer GIS Solutions
Funding for OSHD, Release 1.0 was provided by the Oregon Geospatial Enterprise Office,
Framework Data Development Program award DASPS-3350-19

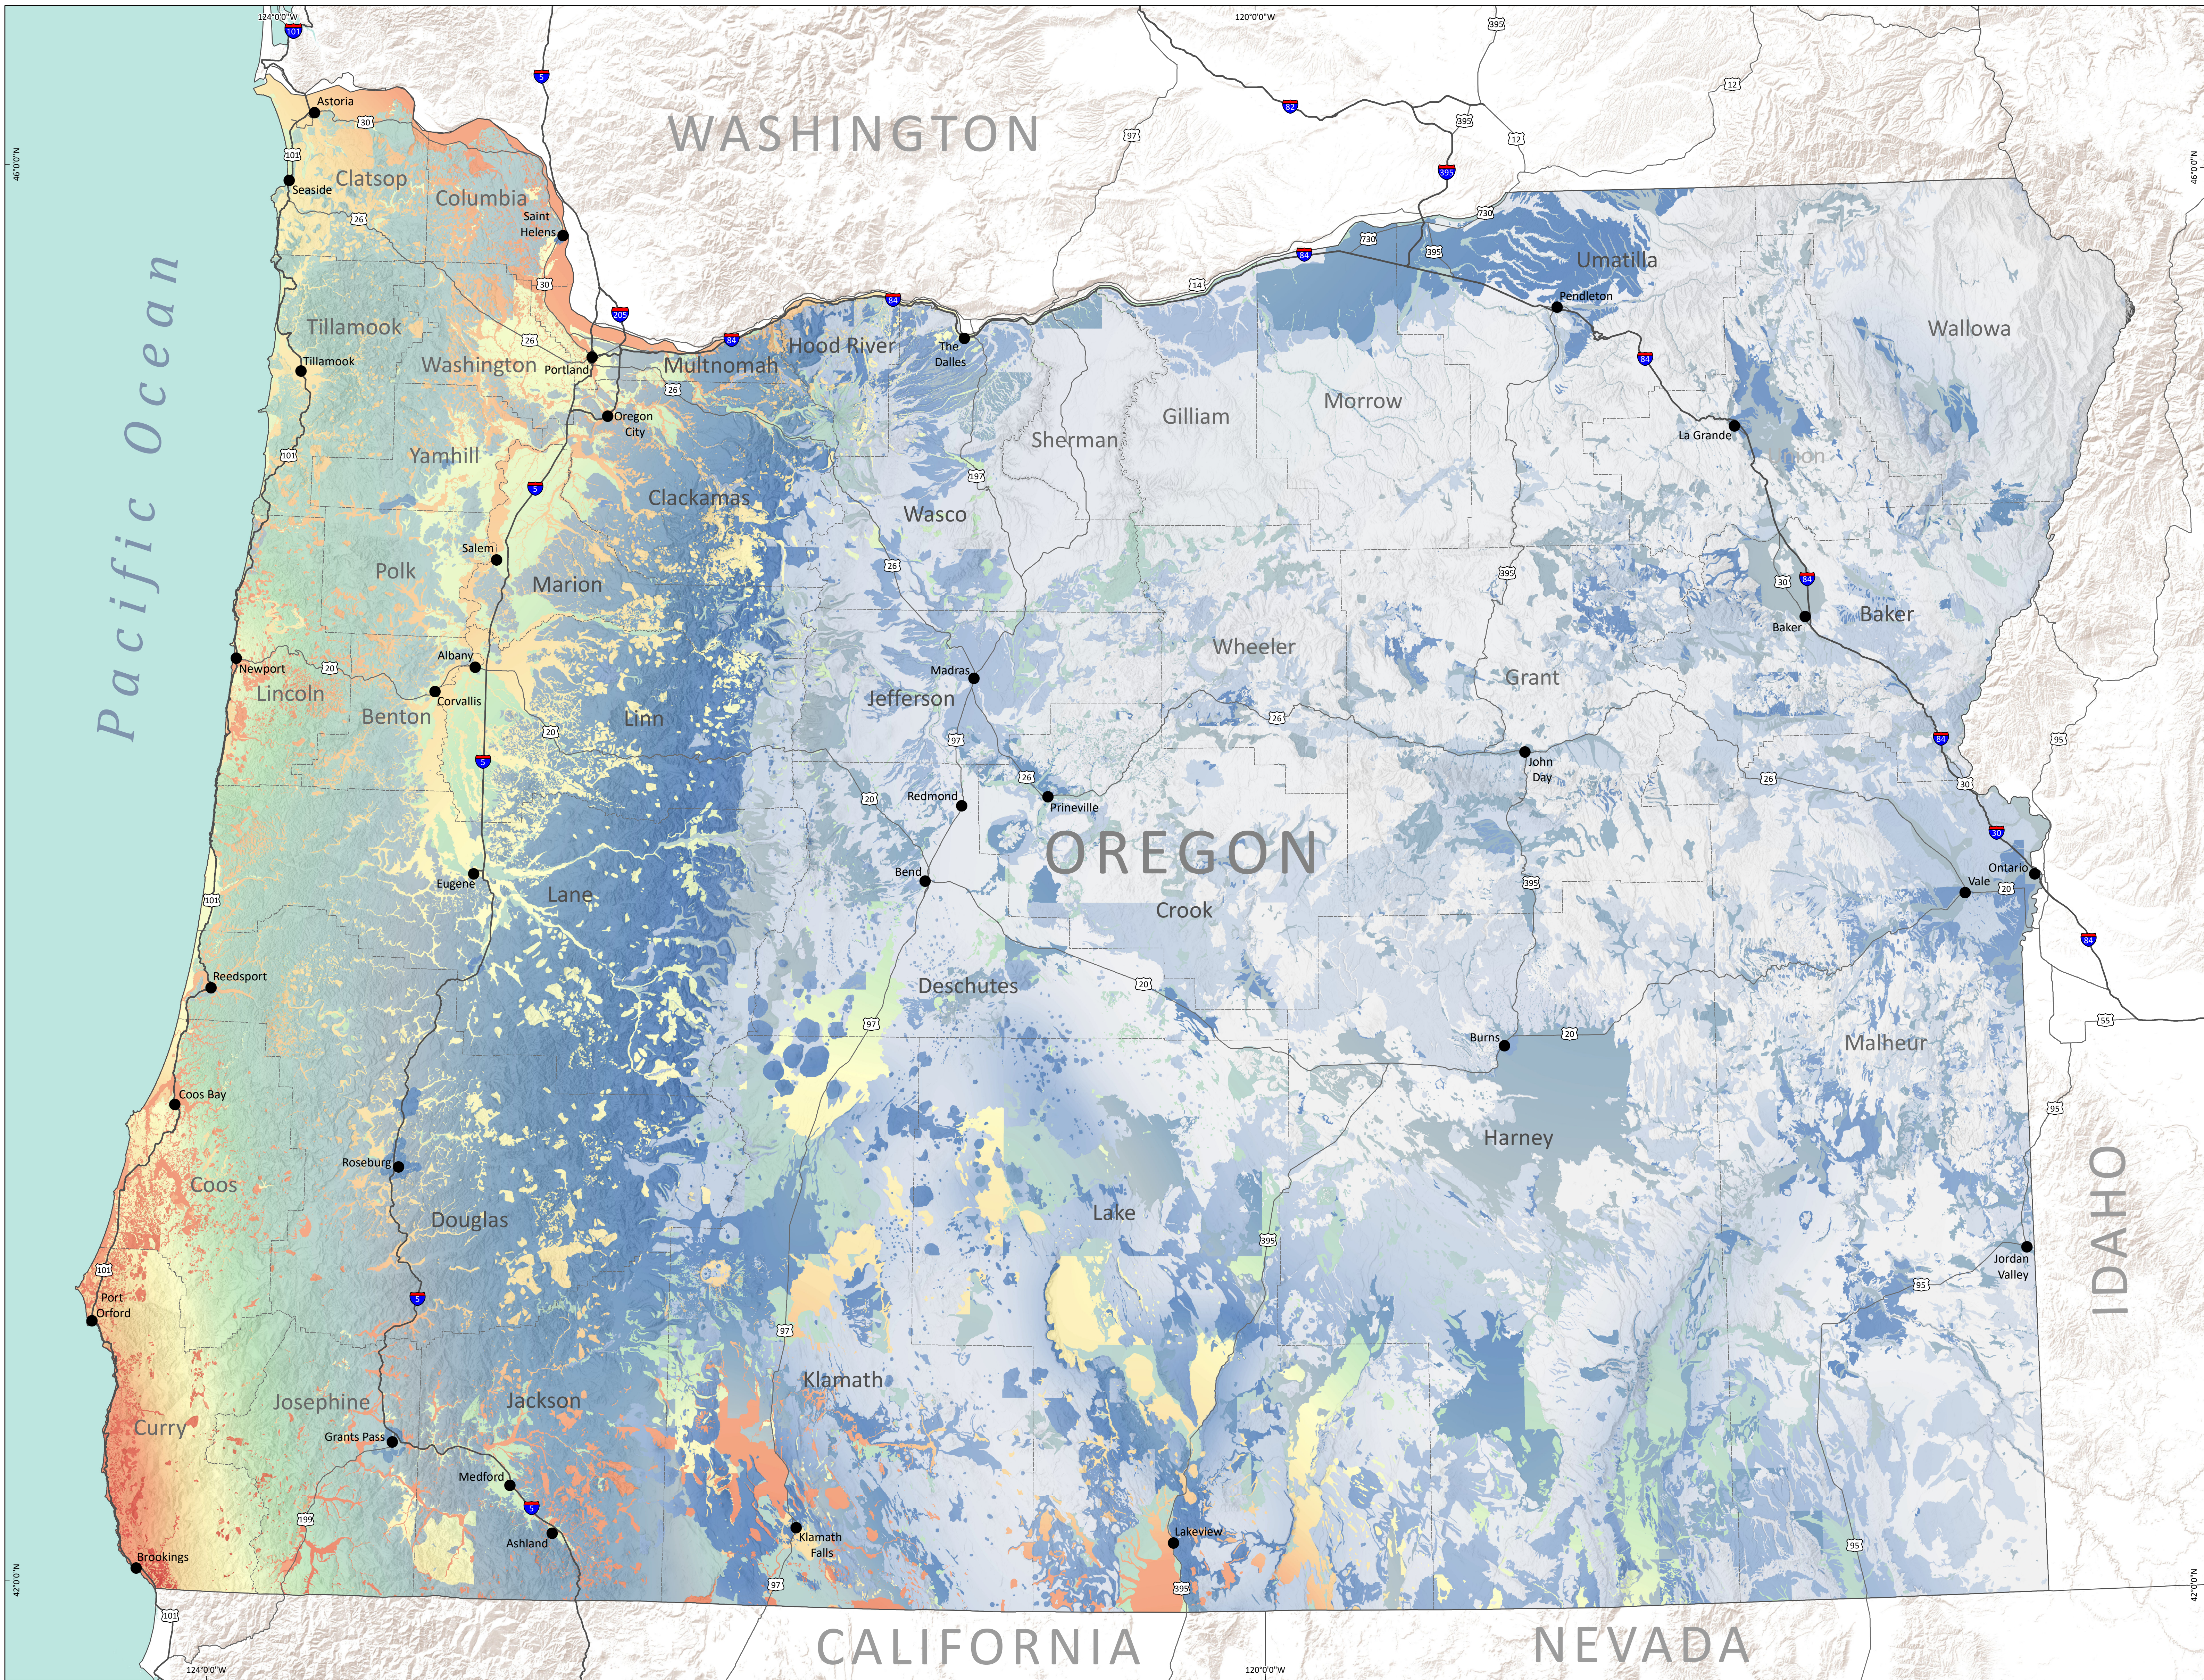
Background

Source Data
