Department of Geology & Mineral Industries  
800 NE Oregon St, Suite 965  
Portland, OR 97232

*North Coast LIDAR Project, 2009 – Delivery 4 QC Analysis*  
**LIDAR QC Report – November 30<sup>th</sup>, 2009**

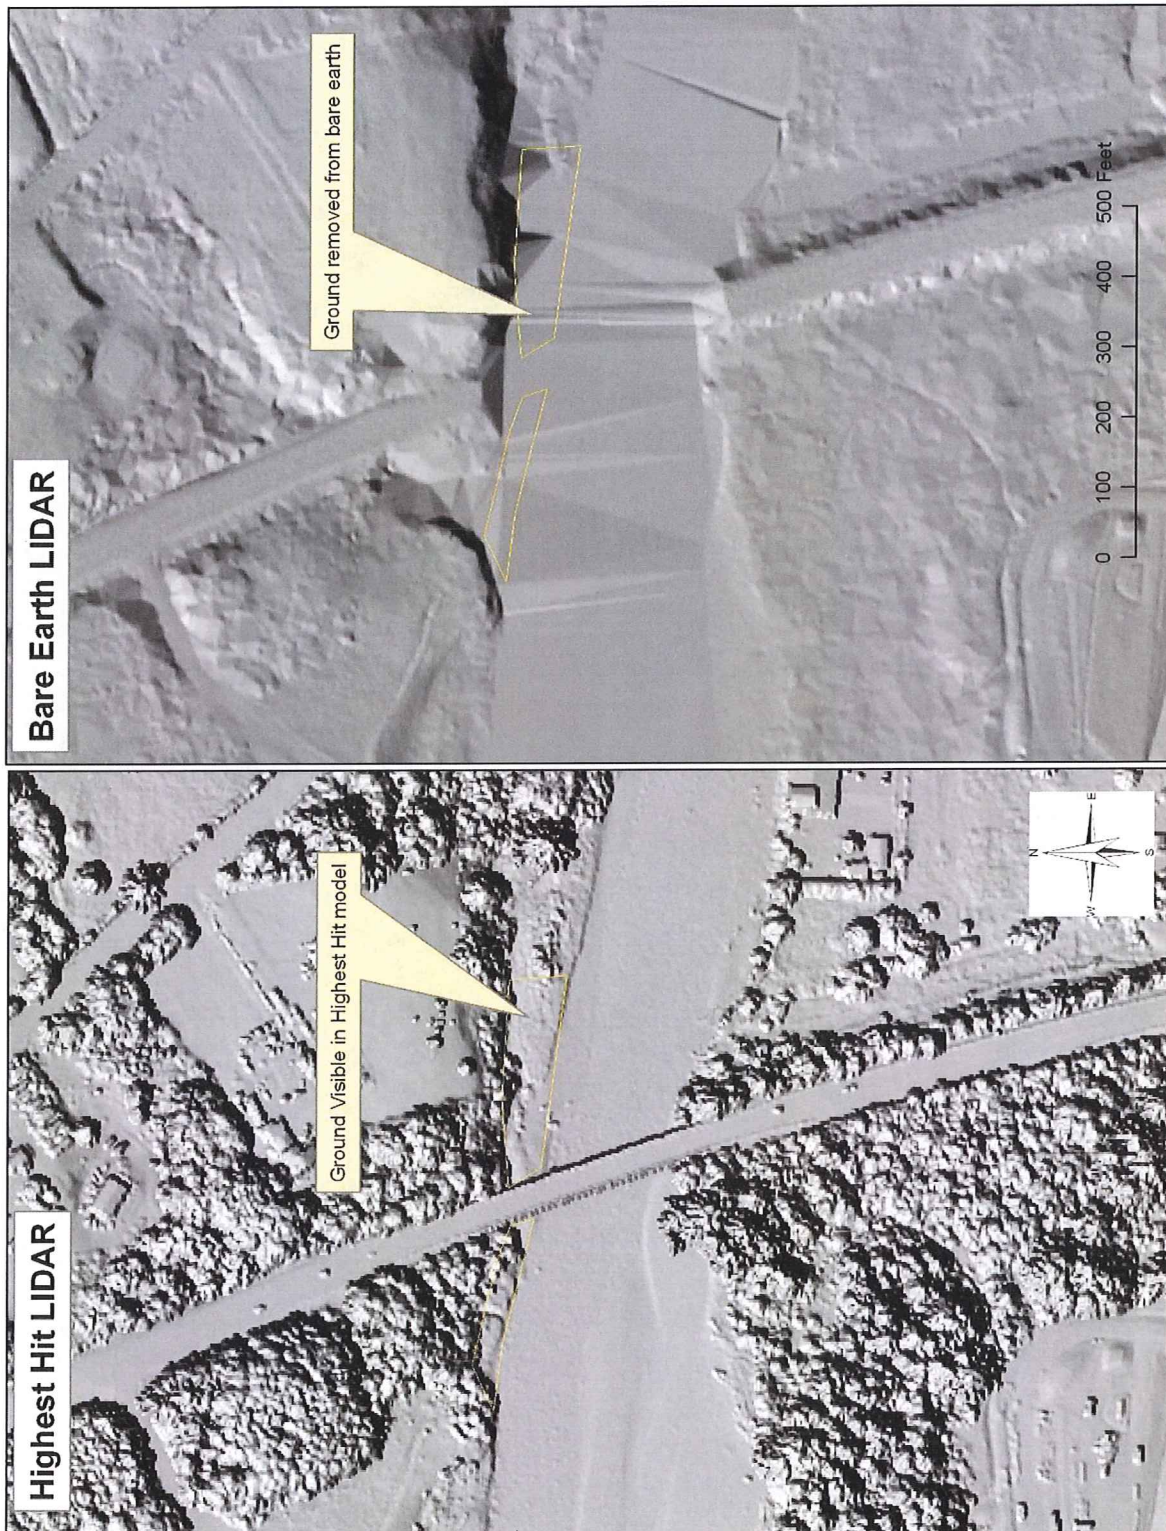
**Figure 3.** Example of missing ground in lidar bare earth data. Ground is clearly visible in highest hit model, but has been removed from the bare earth model. This type of classification error is common near water body features.

Lidar 3ft grids were loaded into ArcGIS software for visual analysis. Data were examined through slope and hillshade models of bare earth returns. Hillshades of the highest hit models were used to identify areas of missing ground (Figure 3). Both bare earth and highest hit models were examined for calibration offsets, tiling artifacts (Figure 4), seam line offsets, pits (Figure 5), and birds.

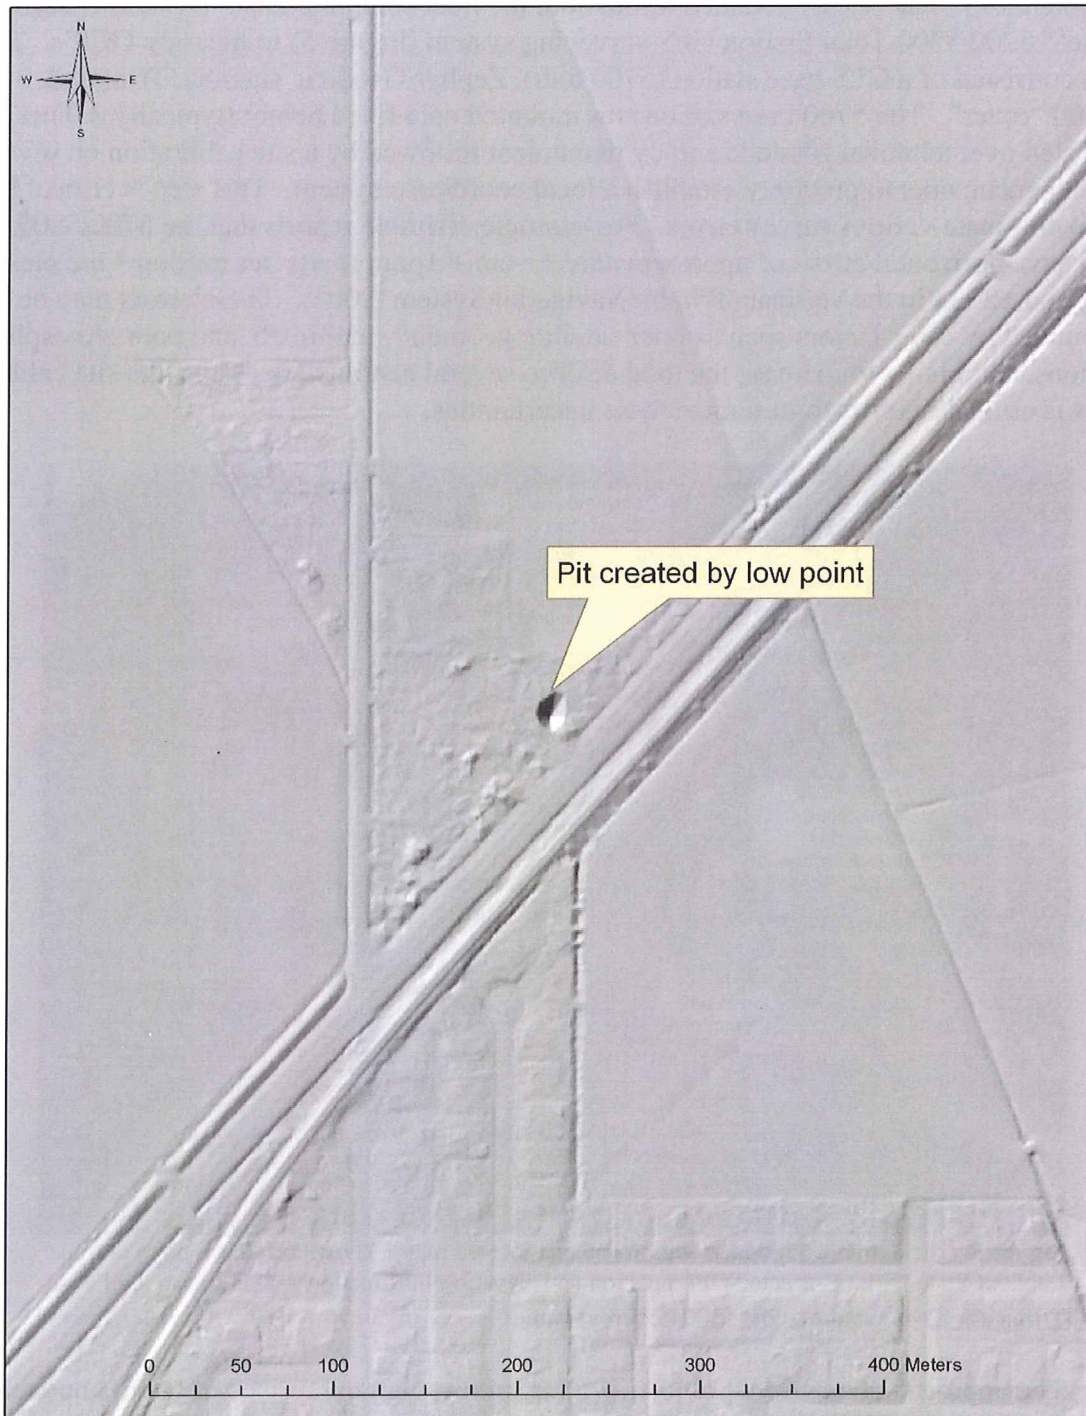
**Figure 5.** Example of “Pit” caused by low point in ground model. Pits are caused when standing water absorbs the lidar pulse. Pits are evident in ground model as the lowest point elevation is assigned to the grid cell value. Inversely the pit is not observable in the highest hit model as the highest point elevation is assigned to the grid value

are typically visualized as a linear stair step running along the edge of connecting flight lines. Pits and birds refer to uncommonly high or low points that are the result of atmospheric and sensor noise. Pits (low points) typically occur where the laser comes in contact with water on the ground (Figure 5). Birds (high points) typically occur where the laser comes into contact with atmospherics<sup>1</sup>.
