## OPEN-FILE REPORT O-01-03

# **EVALUATION OF COASTAL EROSION HAZARD ZONES ALONG DUNE AND BLUFF BACKED SHORELINES IN TILLAMOOK COUNTY, OREGON: CASCADE HEAD TO CAPE FALCON**

**PRELIMINARY**  
**TECHNICAL REPORT TO TILLAMOOK COUNTY**  
**2001**

**By**  
**JONATHAN C. ALLAN AND GEORGE R. PRIEST**  
Oregon Department of Geology and Mineral Industries  
Coastal Field Office, 313 SW 2<sup>nd</sup> St, Suite D  
Newport, OR 97365

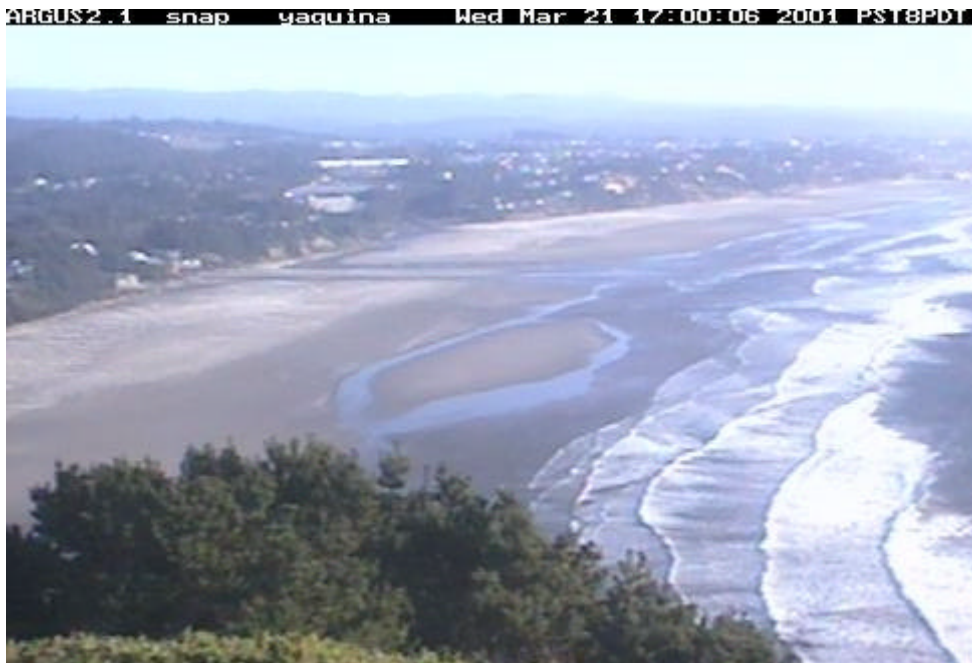
**Figure 5** Example of a swash-bar system at Agate Beach, Newport, on March 21, 2001 (Photo is courtesy of the Coastal Imaging Lab, College of Oceanic & Atmospheric Sciences, Oregon State University).

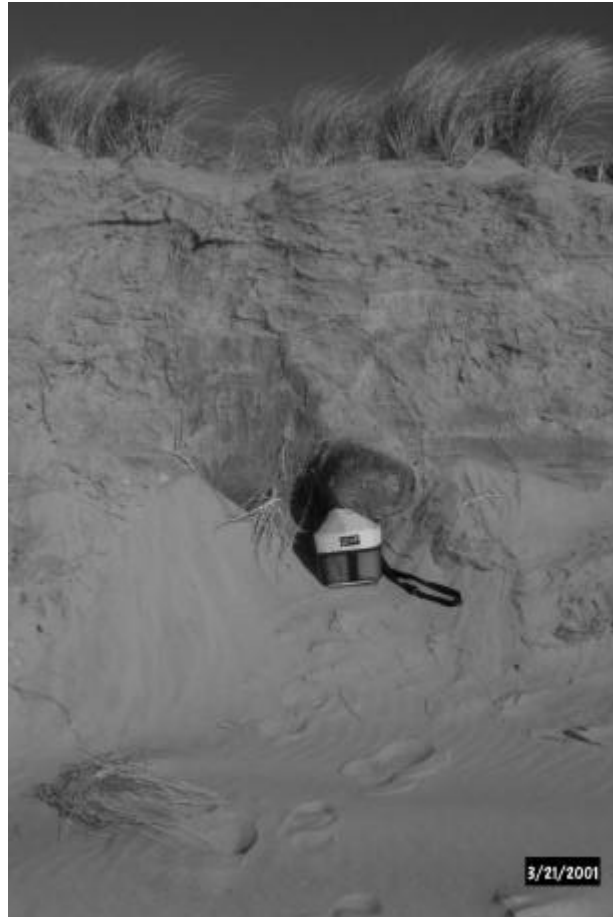
**Figure 11** Example of a sawed log located *in situ* in the foredune at Nedonna Beach. The log was exposed due to the presence of a large rip embayment that had formed, enabling wave processes to erode the beach.

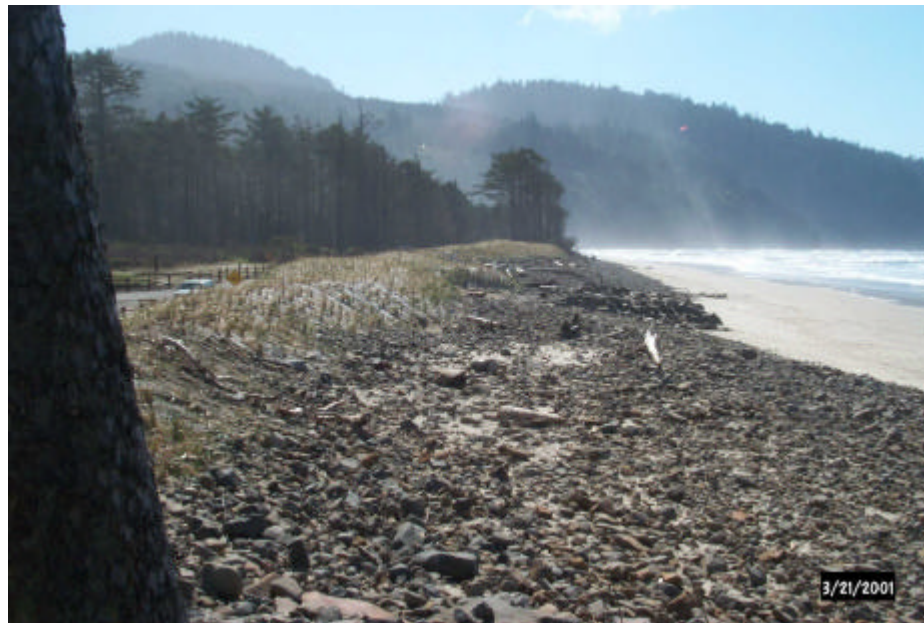
**Figure 15** A dynamic revetment structure constructed at Cape Lookout State Park, utilizing materials found at the site.

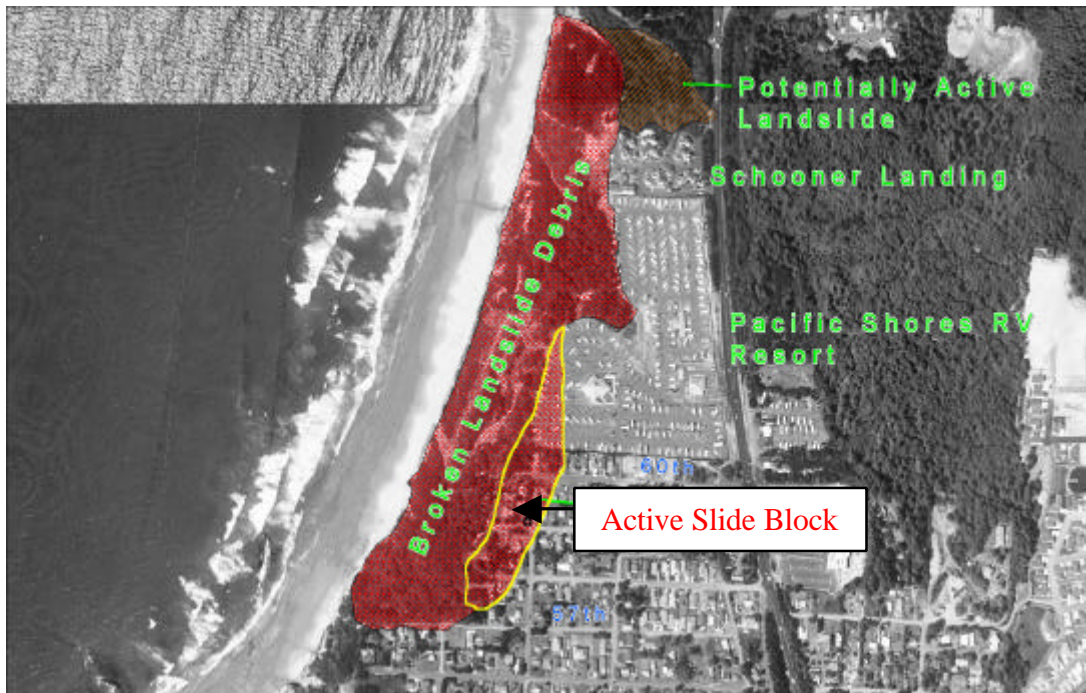
**Figure A 1** Schooner Creek landslide of Newport, Oregon showing an active slide block that has begun to displace city streets over the last few decades but has only a few feet of lateral and vertical displacement. Meanwhile, the broken landslide debris in front of this block continues to move seaward in response to wave erosion and high groundwater, opening up fissures in front of the block. Movement on the active block has apparently ceased from about May of 2000 to present (June, 2001). This period has been characterized by unusually low rainfall on the Oregon coast.

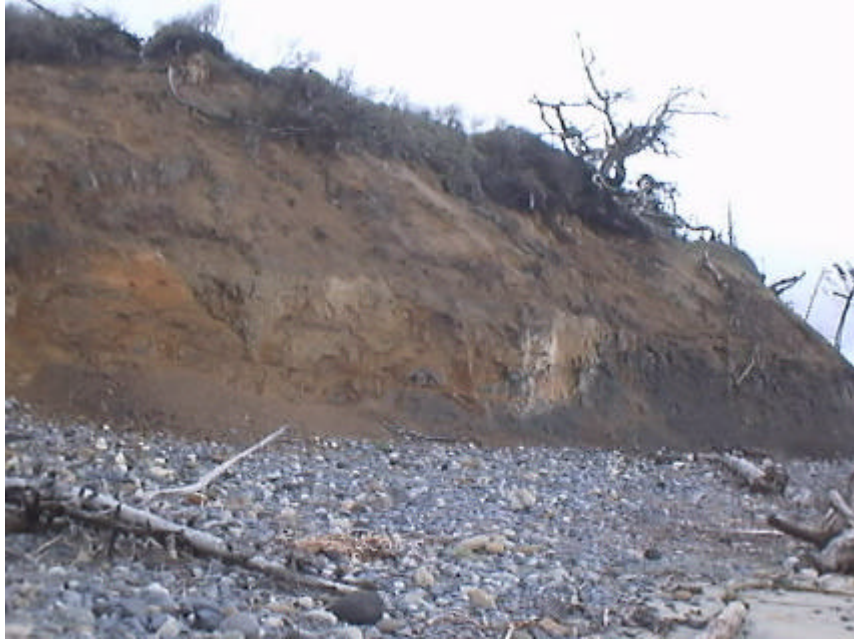
**Figure D 3** Landslide toe at Schooner landing. Toe material is totally disaggregated slide debris and the slide plane lies several feet above the beach.

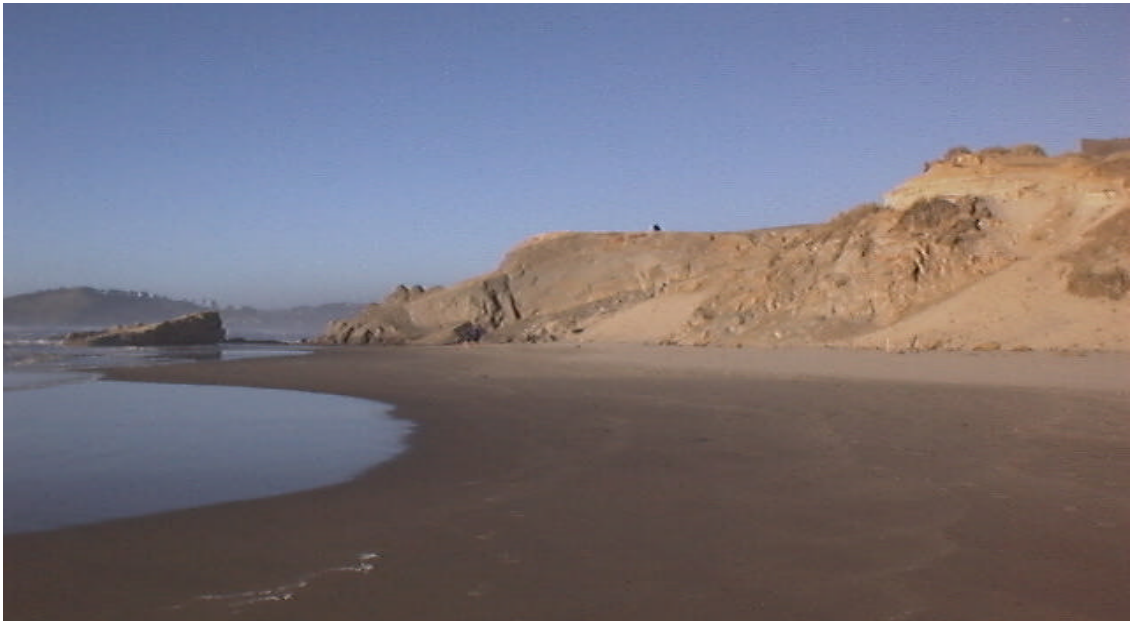
**Figure D 4** Geologic structure of the Jumpoff Joe bluff illustrating 14° dip of Tertiary sandstone of the Astoria Formation (sea stack and resistant material on end of the headland). The dark unit below the sandstone is the weaker Nye Mudstone, which fails as large landslides. About 34 feet of yellowish colored Pleistocene marine terrace deposits sit on the nearly horizontal wave cut platform that bevels the Tertiary sequence. Bluff is about 80 feet high at the highest point on the right.

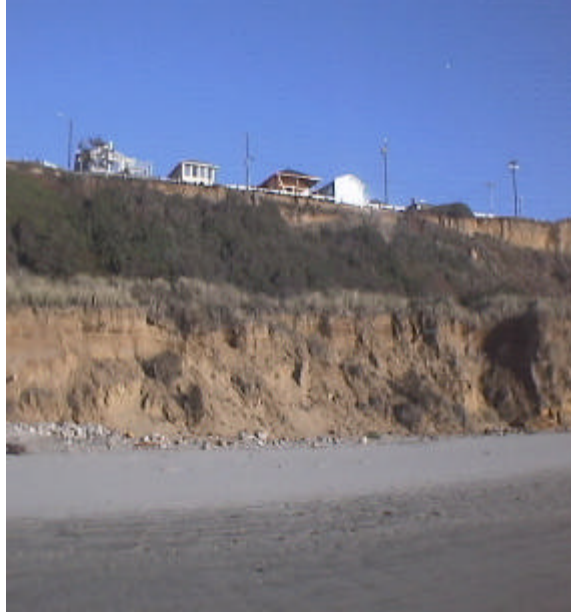
**Figure D 5** Southern slide block of the Jumpoff Joe landslide. This block lies immediately adjacent to the south side of the small headland illustrated in Figure D3. Before erosion, the block was 330 feet wide at its widest point. This block had numerous houses that were destroyed when downward and lateral displacement occurred in the 1940's.

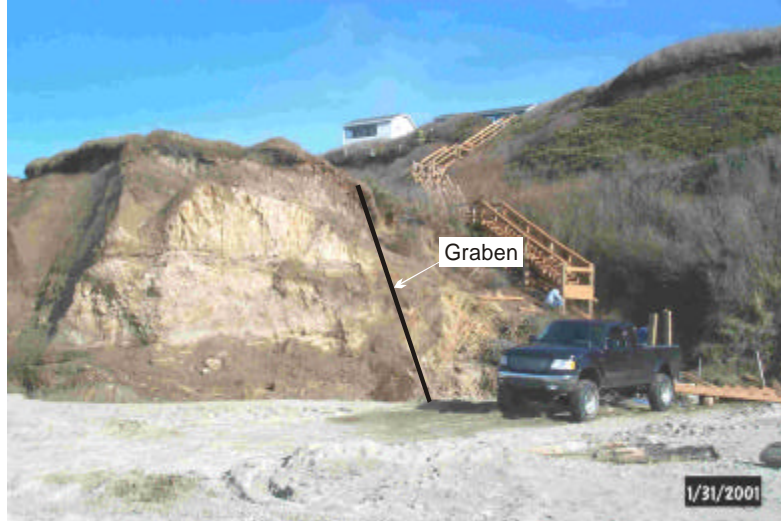
**Figure D 6.** Nearly east-west cross section across the south end of the Jumpoff Joe slide block shown in Figure D4. Slide plane is at a very low, almost flat inclination in this exposure. A graben cuts the east side of the block at the black line, dropping overlying marine terrace deposits downward behind the laterally moving slide. Little or no backward rotation of the slide has occurred, so motion is mostly translation. Some of the basal Nye Mudstone (gray rock at base) has been cut out of the section by a combination of Pleistocene subaerial (low-stand) erosion and possibly basal shearing at the slide plane. Tan colored material forming much of the outcrop is Pleistocene low-stand soil; capping the upper few feet of the outcrop is marine terrace sand from a high sea stand.

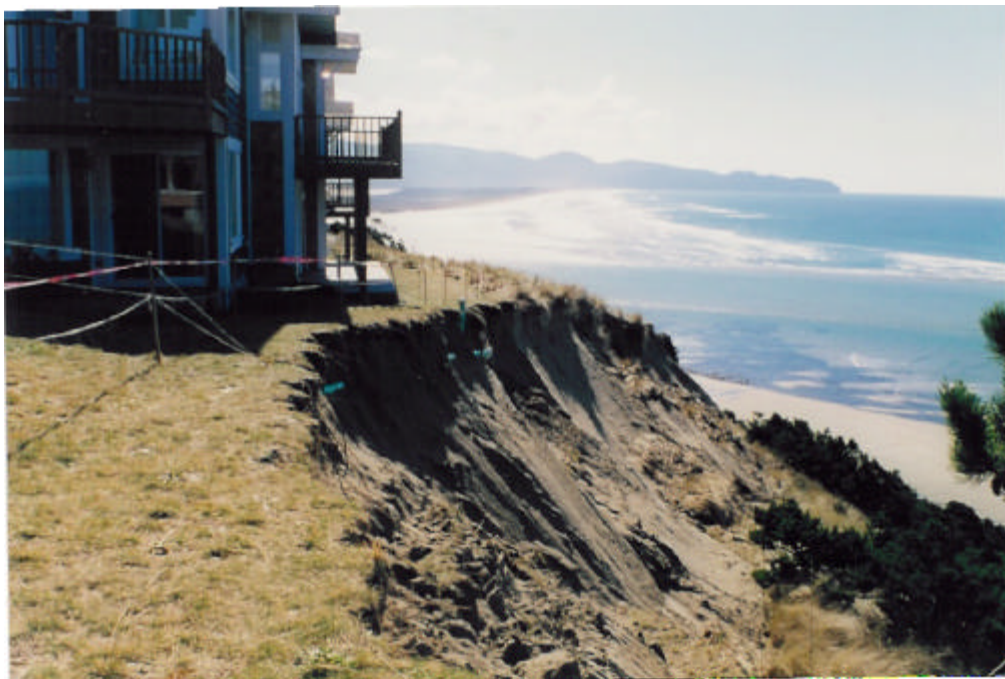
**Figure D 9** Headwall of The Capes landslide taken in summer of 1998. Holocene to Pleistocene dune sand has sloughed away, threatening the condominium at left.
