OFR-03-08

**Review of Geologic Report
for Surfrider Resort Proposal,
Lincoln County, Oregon
OPRD Permit #BA-555-03**

April 11, 2003

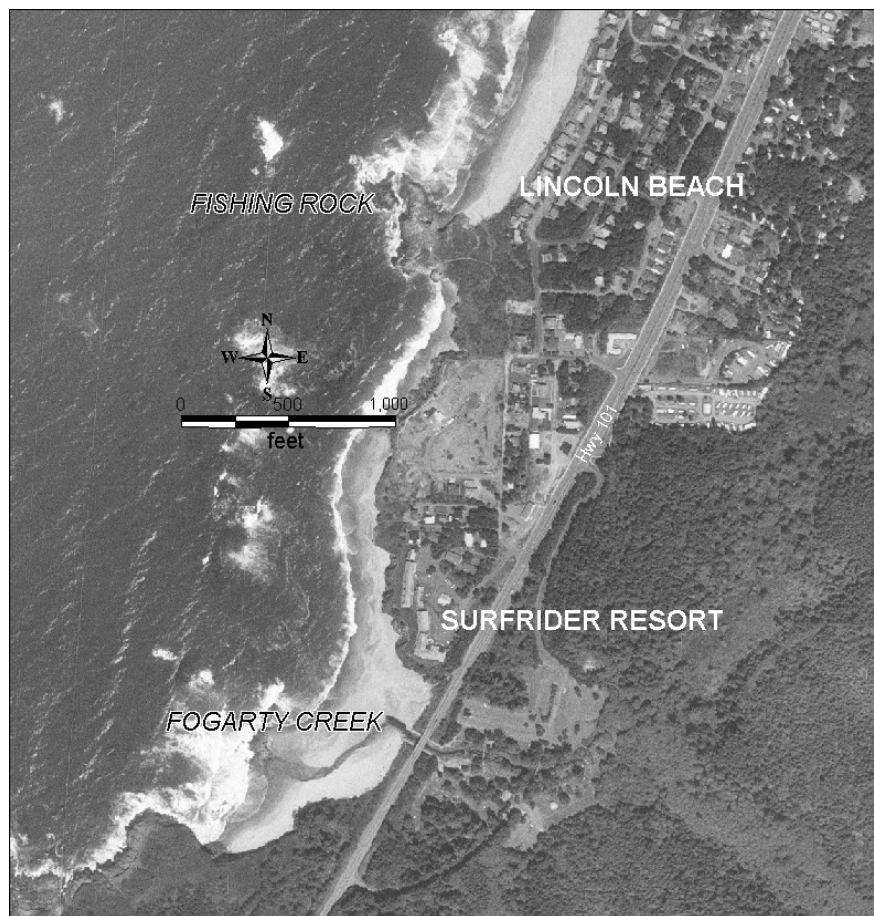
Figure 1 Location of Surfrider Resort. North-south trending portion of sea cliff is area of concern. Note the gap in offshore rocks immediately west of the resort that allow waves to break much closer to the beach.

The area in question is shown on Figure 1 and consists of a sea cliff composed of about 24 feet of dark gray Astoria Formation overlain by approximately 30 feet of Quaternary marine terrace sand. The Astoria is composed of pelecypod-bearing silty clayey fine grained sandstone with minor interbeds of medium grained sandstone. In hand specimen, most of the Astoria at this locality appears to be a mudstone but actually has a high enough fine sand content to be classified as sandstone, according to Dr. Alan Niem (personal communication, 2003). One thin (~ 1 foot wide) north-south trending vertical diatreme dike filled with fragments of Astoria Formation and devitrified basaltic glass cuts through the Astoria. The terrace sand is horizontally bedded coarse pebbly sand in the lower 10 feet and appears to be medium to coarse sand in the upper part. A dark Holocene soil caps the sequence. The contact between the Astoria Formation and the Quaternary deposits consists of a near horizontal surface. The Astoria is inclined seaward, striking N43°E and dipping 21°NW, and is characterized by significant jointing and zones of weakness. The local bluff trend is north-south with numerous reentrants on the cliff face.

1. A dramatic increase in wave heights over the past several winters; the largest storm waves occurred during the 1997-98 El Niño and 1998-99 La Niña winters (Allan and Komar, 2002). These storms produced significant wave heights that reached 46 ft. Furthermore, these events were also characterized by increases in mean sea level due to the 1997-98 El Niño climate phenomena and as a result of storm surges along the coast; surges locally raised mean sea level by 1.6 to 3.3 ft;
2. Greater access of waves to the sea cliff as the buffering beach sand was removed;
3. Change of rock resistance to erosion in the interior of the sea cliff;
4. Channeling of wave energy into northeast-trending fissures in the Astoria;
5. Channeling of wave energy through offshore breaks in rock reefs (Figure 1); and,
6. Some combination of the above factors.

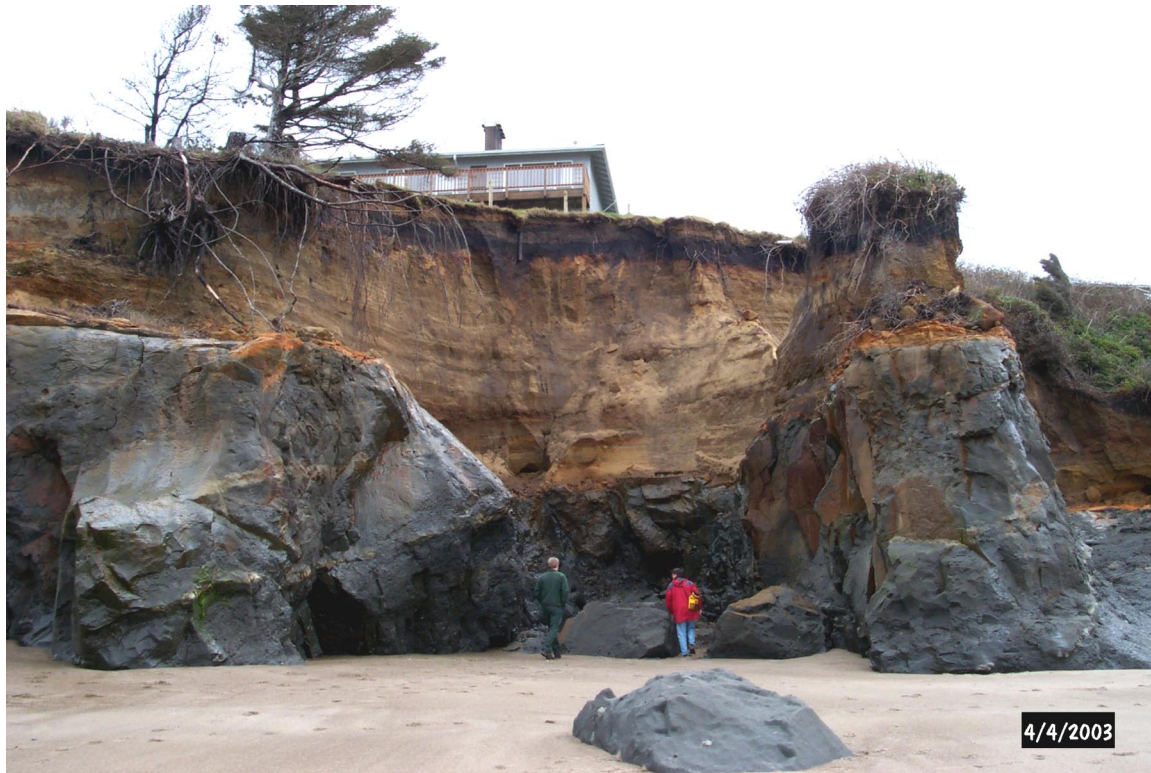
Figure 2 Looking east at reentrants in dark gray Astoria Formation; reentrants have reached to within 30 feet of the Surftrider Resort building at the top of the bluff. Orange to tan unit is overlying Quaternary Marine Terrace deposits. Steve Williams of OPRD is on the right; Jonathan Allan of DOGAMI is on the right.

The beach seaward of the bluff face consists of coarse sand and therefore is steep (slope (S) = 0.07 (1 on 14)) and reflective to intermediate in the classification of Wright and Short (1983). Such beaches are highly dynamic such that they respond rapidly to changes in the offshore wave energy. Furthermore, because of the steep nature of the beaches, wave runup is able to reach much higher elevations on the backshore, allowing the hydrostatic and hydrodynamic pressures generated by the wave swash to erode the rock surface. Hydrostatic pressures result from the mass of water and air impacting a surface, while the hydrodynamic pressures result from turbulence and the compression of entrained air against the rock. As a result, if a rock surface is characterized by a narrow fronting beach (i.e. has limited buffering potential), reentrants, extensive jointing and zones of weakness, the hydrostatic and hydrodynamic properties associated with wave swash can be further concentrated along the reentrants, where they may rapidly erode the Astoria (Figures 2 and 3).

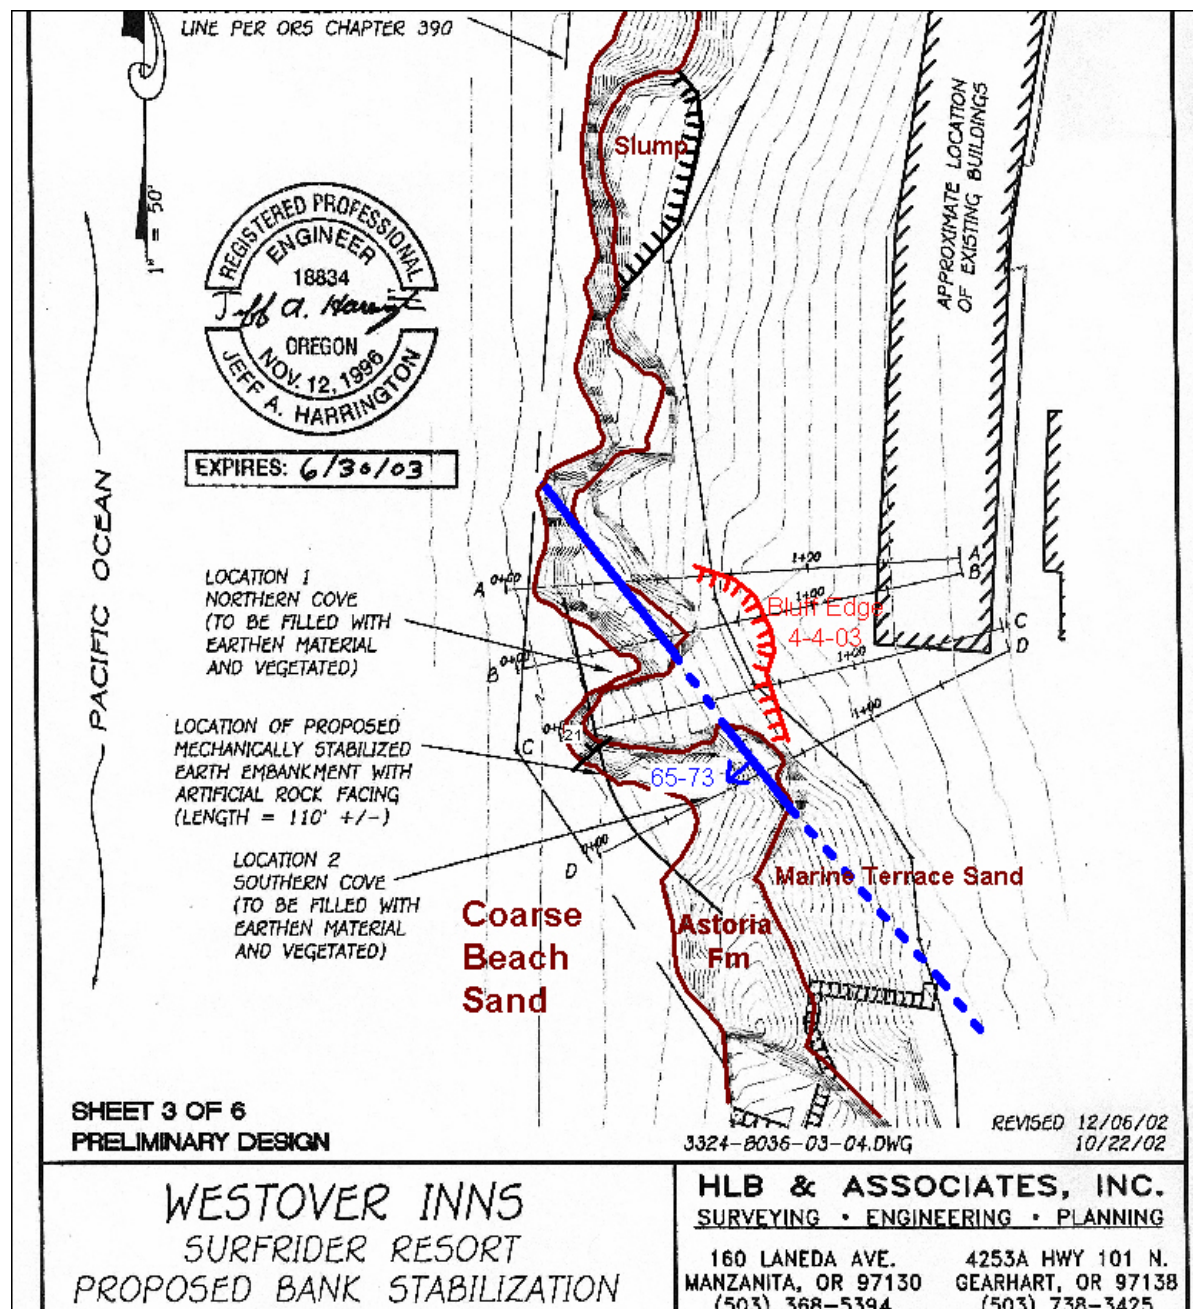
Figure 3 Geologic map with prominent fault or sheared joint system shown in blue with inclination of in degrees in direction of blue arrow. The structure is dashed where covered by Quaternary marine terrace sand. Geologic contacts are brown lines; geologic units are labeled with brown lettering. Strike and dip of a thin sandstone bed in the Astoria Formation (see Figure 6) is shown with strike and dip symbol. All black and white graphics (topographic map and illustration of engineering features) are from HLB & Associates, Inc. Note April 4, 2003 location of the bluff edge (shown in red hachures) compared to the bluff edge on the December of 2002 topographic map. The corner of the building is now only 30 feet from the sea cliff.

What appeared to be a slump or translational slide was also identified at the north end of the site. It had a few feet of vertical offset. There was no time to do a detailed investigation of its cause, but a sketch of the approximate location is given in Figure 3.

The report does not address the apparent slump feature noted in the north part of the study area north of the proposed SPS (Figure 3). Propagation of further slope failures of this kind may threaten the northern part of the resort in the future. If this is a translational failure, it may have implications for translational failures that could affect the SPS.

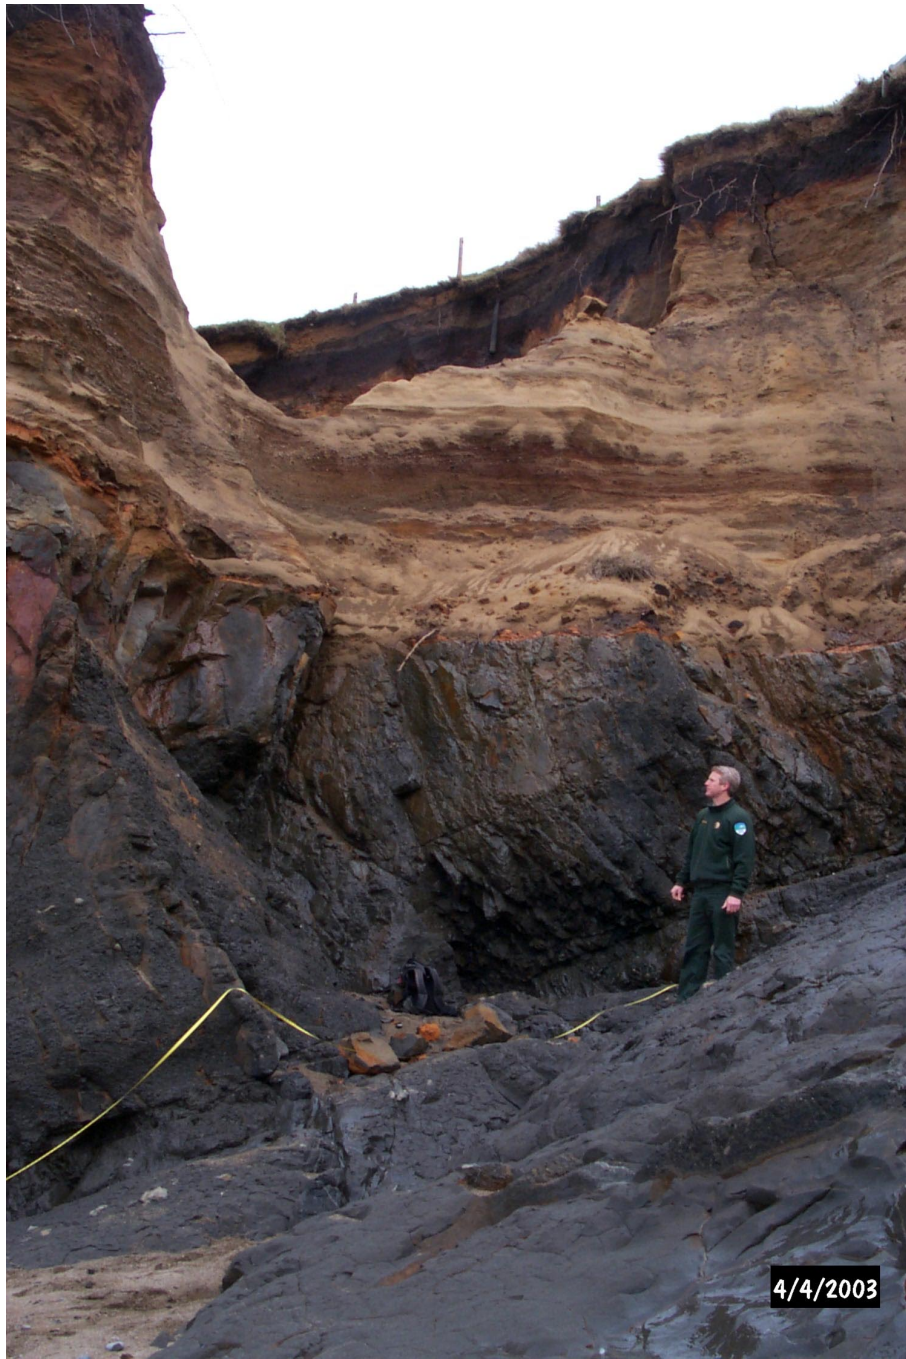
Figure 4 View looking northeast. Steve Williams is standing on prominent bedding plane shear in silty clayey fine-grained sandstone of the Astoria Formation. Shattered Astoria overlies the bedding plane shear in upper right part of picture. A northwest trending fault or sheared joint system terminates the shattered Astoria in the left center of the picture. Note how erosion in the shattered Astoria has nearly removed the septum of rock and terrace sand. Iron stain at horizontal contact of highly permeable marine terrace sand with the nearly impermeable Astoria is probably indicative of lateral groundwater movement along the contact. Similar stains on high angle fractures in the Astoria are probably indicative of vertical flow of oxygenated groundwater into the fracture system. Such flow was observed during the field visit. Note the dark Holocene soil exposed at top of bluff.

Groundwater also moves freely through the poorly indurated Quaternary marine terrace deposits. Some spring water was observed weeping from the contact of these deposits with underlying Astoria. Heavy iron oxide stain on Astoria Formation at this contact may be evidence for lateral and vertical movement of oxygenated groundwater that changes reduced iron in the iron smectite clay to a higher oxidation state (Alan Niem, 2003, personal communication; Figure 4). The stain may also be from conversion of FeO carried in solution by groundwater to more oxidized, less soluble forms of iron. Another possibility is that this iron-stained zone is a palaeosol, but this seems less likely since the contact is a wave-cut platform that would not have been amenable to soil-forming processes. Groundwater saturation of friable marine terrace deposits probably decreases their strength, making them more susceptible to failure from stress-release fracturing and cantilevered block falls (see Hampton, 2002 for explanation of the cantilevered block fall process). The cantilevered block fall process keeps the upper part of the sea cliff at a near vertical slope (Figure 4).

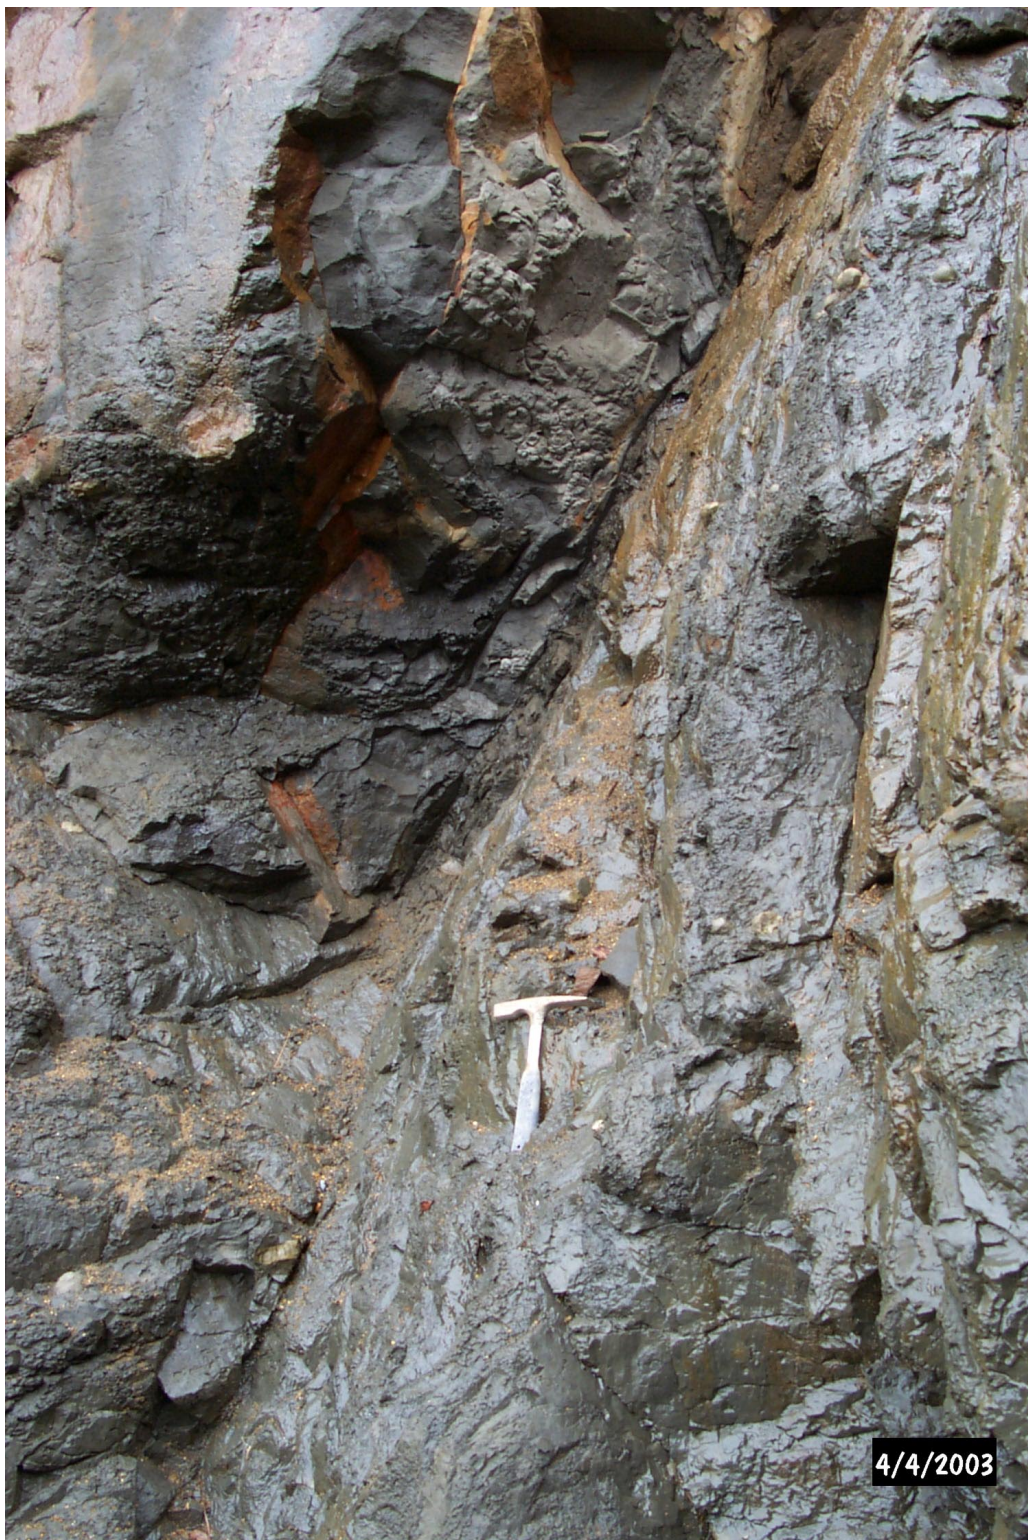
Figure 5 Close up view to northwest at the prominent N35W trending, west-dipping sheared joint or fault in Astoria Formation. Location is in left central part of the photograph of Figure 4. Trace of structure is shown in blue on Figure 3.

Regarding erosion around the sides of the SPS, the report does not address likely erosion along the extension of the N35°W shear zone immediately north of the proposed north end of the SPS. This zone of weakness could provide early breaching to the side of the SPS, which may lead to destabilization of the structure.

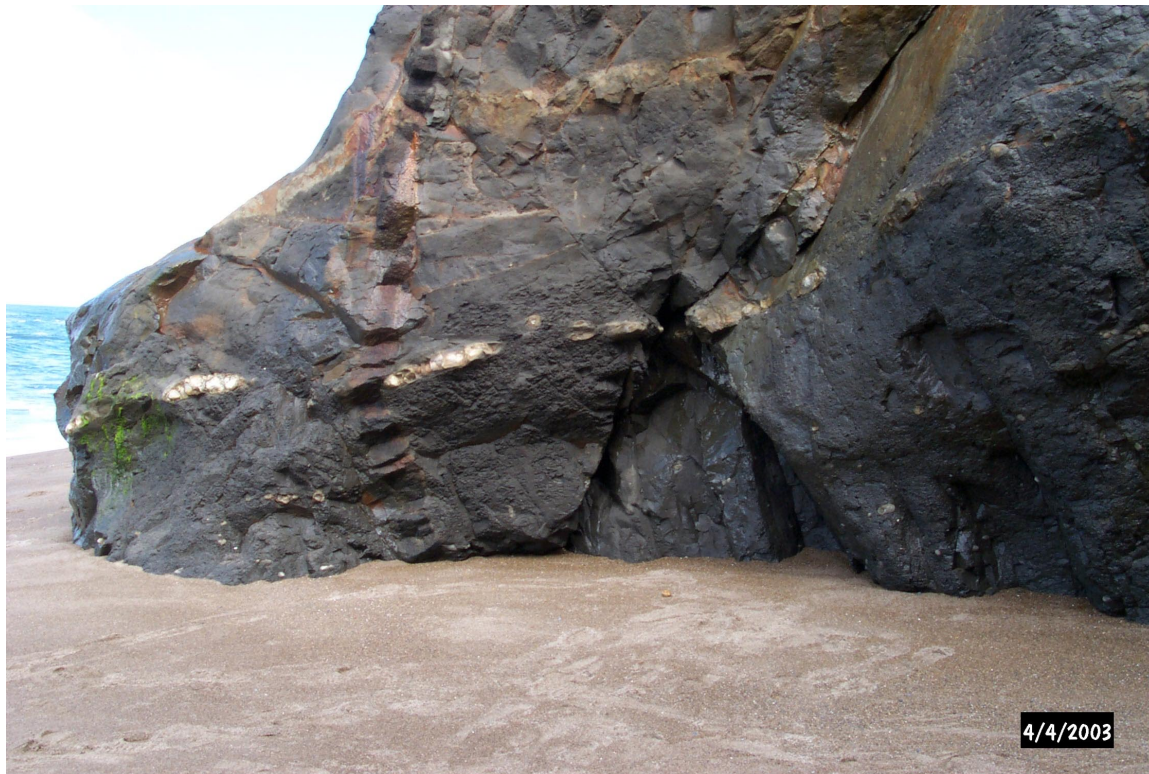
One prominent joint does cut through the outer (western) part of the cliff face trending N27°W and dipping 75°W. This joint creates a separate block of Astoria Formation at the nose of the small promontories that project out from the bluff (Figure 6). This joint is a zone of weakness with respect to wave erosion.

Figure 6 View to the north at northwest-trending joint in Astoria Formation at nose of small promontory. Note the northwest-dipping thin sandstone bed. This open fracture system is a significant zone of weakness for wave erosion.

Should the shotcrete wall fail, the mechanically stabilized fill behind the wall would probably not survive for very long under sustained winter wave attack. For this reason, the performance and construction of the wall should be explained in some detail. For example, it is not clear that the shotcrete would be reinforced with steel mesh or some other means. Detailing may be quite important with respect to wave erosion resistance. That said, the report does do a good job of explaining how the wall will be recessed into the bedrock at the bottom and sides of the structure. Erosion around the sides is probably mitigated by recessing the wall 5-10 feet inland; however, erosion along major joints like the one in Figure 6 could be a problem and should be treated in the report.
