**OPEN-FILE REPORT  
OFR O-06-02**

**INTERIM REPORT:  
JOHNSON CREEK LANDSLIDE PROJECT,  
LINCOLN COUNTY, OREGON**

By  
George R. Priest<sup>1</sup>, Jonathan Allan<sup>1</sup>, Alan Niem<sup>1</sup>, Samuel R. Christie<sup>2</sup>, and Stephen E. Dickenson<sup>2</sup>

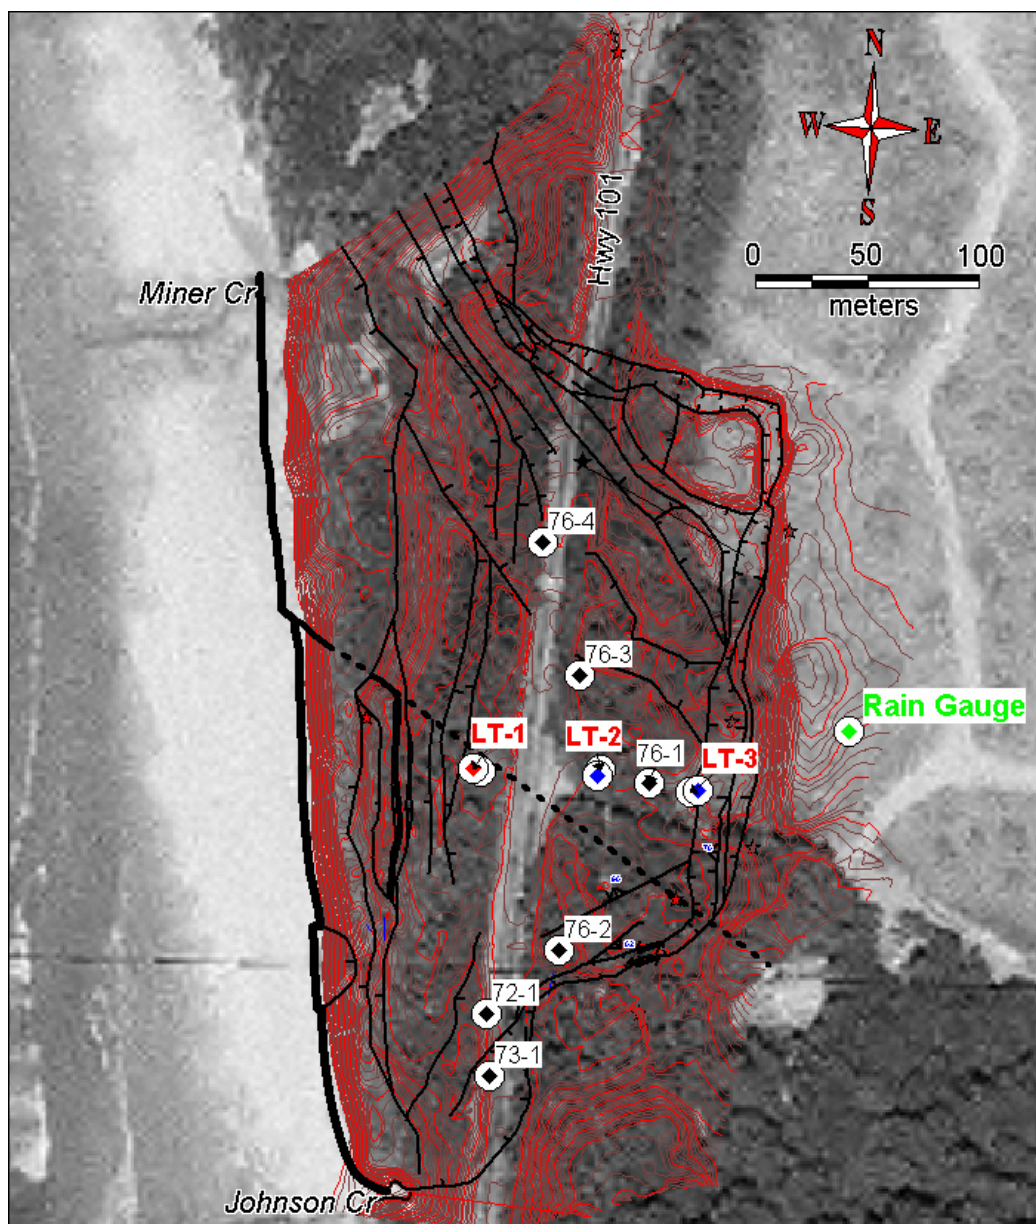
**Figure 2.** Site map of the Johnson Creek Landslide showing the drill sites, LT-1, 2, and 3 (red labels) plus location of 1970's boreholes (black diamonds with circles) and the rain gauge. Base map is a 2002 US Geological Survey digital orthophoto quadrangle (DOQ). Red lines are topographic contours at 2 m intervals; muted brown lines are contours at 0.5 m intervals; black lines are major slide block boundaries. Black teeth on slide boundaries point toward the down thrown side.

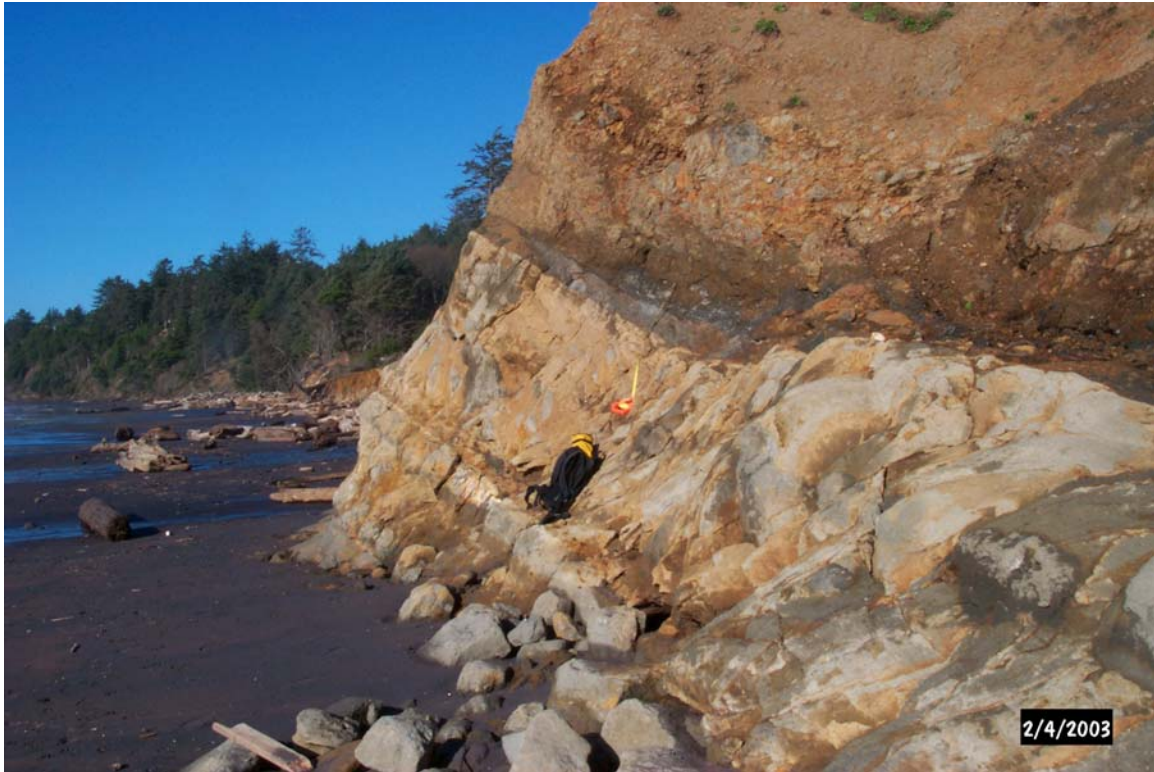
**Figure 3.** Looking north at Tertiary Astoria Formation sandstone (smooth light tan unit) and sandy siltstone (overlying dark orange gray unit) at the toe of the Johnson Creek Landslide. Dark gray unit exposed in small patch below the sandstone is highly sheared sandy siltstone from the basal shear zone of the slide. Black 0.8 m long back pack is shown for scale.

**Toe**. The toe of the landslide is at the base of the shoreline bluff (Figure 3). At the south where Johnson Creek flows onto the beach, in-place bedrock is exposed in the creek ravine. Sheared bedrock is exposed at the base of the cliff to the north during winter beach conditions (Figure 4).

**Sea Cliff.** Exposures of landslide debris in the sea cliff above the toe include bedding that is tilted, fractured and sheared. Bedding that is relatively intact tends to dip between 15 and 45 degrees to the east (Figure 3). This “back-rotation” is likely due to upward movement of slide blocks and local slumping of the sea cliff. If the basal slide zone of a translational slide rises to the surface at its toe, a passive wedge is formed where material can rotate relative to the main slide mass. Local slumps can also result in back-rotation of slide blocks. Westward movement of the main slide mass oversteepens the bluff, which can locally slump over the low strength gouge. The scarp bounding the passive wedge on the east trends north-south consistent with westward movement.

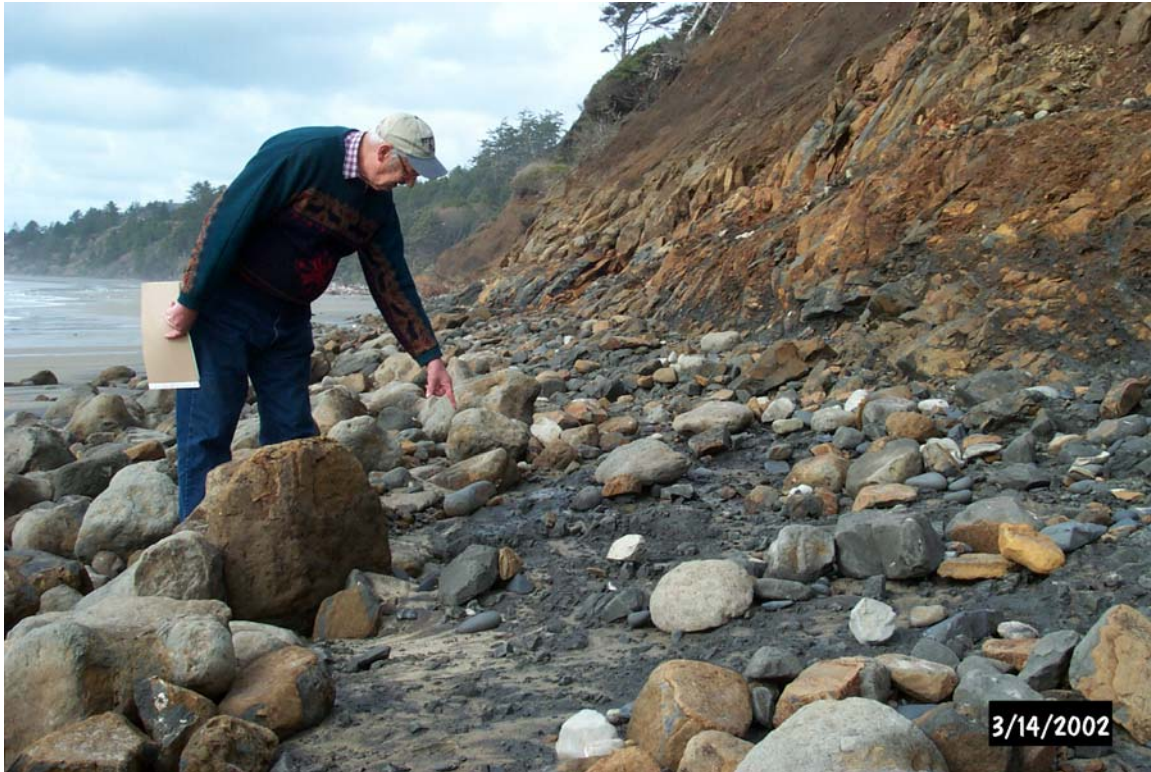
**Figure 4. Highly sheared dark gray sandy siltstone unit at the toe of the Johnson Creek Landslide. Chuck Dennison of Dennison Surveying is pointing at the soft, highly deformed material.**

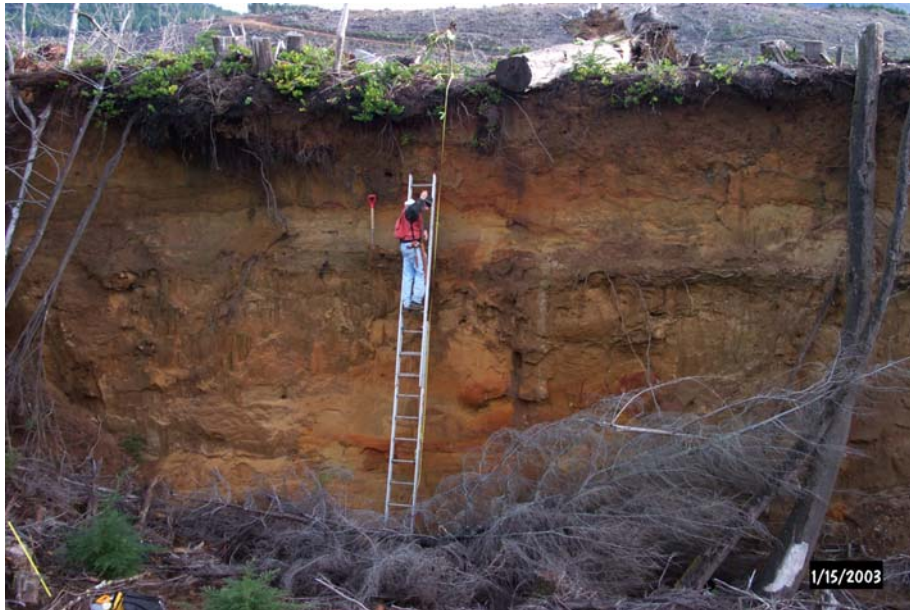
**Figure 5.** Pleistocene marine terrace sand exposed in the northeast headwall of the landslide. Jonathan Allan of DOGAMI is measuring the thickness of the unit. Note the nearly flat surface of the sand sheet. The contact with underlying Tertiary Astoria Formation is ~1 m below the base of the ladder.

The slide also cuts Pleistocene marine terrace sand deposits that lie on a nearly flat-lying Pleistocene wave cut terrace (Figures 4-8). These deposits are 3 to 6 meters (10 to 20 feet) thick and are comprised of well-sorted fine- to medium-grained quartz-feldspathic sand underlain by a basal cobble layer. In some places post-depositional erosion has removed or redistributed the original deposits. The deposits have much higher permeability than the finer grained, cemented and poorly sorted sedimentary rock of the underlying Astoria Formation. The Pleistocene sand is slightly cemented by thin films of poorly crystalline goethite (Johnson, 2003; <http://web.pdx.edu/~grathog/StudentWork/Catrina%20Johnson%20UG%20honors%20thesis%20SP03.pdf>) and/or allophane with some larger voids locally filled with gibbsite (Grathoff and others, 2001; Grathoff, 2005; [http://web.pdx.edu/%7Egrathog/CMS2003\\_files/frame.htm](http://web.pdx.edu/%7Egrathog/CMS2003_files/frame.htm); Johnson, 2003), but overall porosity is still quite high. As allophane dehydrates and shrinks, it loses its cementing qualities, causing the terrace sand to become highly friable where exposed (Grathoff, 2005), hence, most exposures of the terrace sand quickly become covered in talus unless the exposure is recent or talus is continuously removed by erosion. The best exposures are at the recently exposed portion of the northeast headscarp (cover page picture and Figure 5) and at the top of the sea cliff.

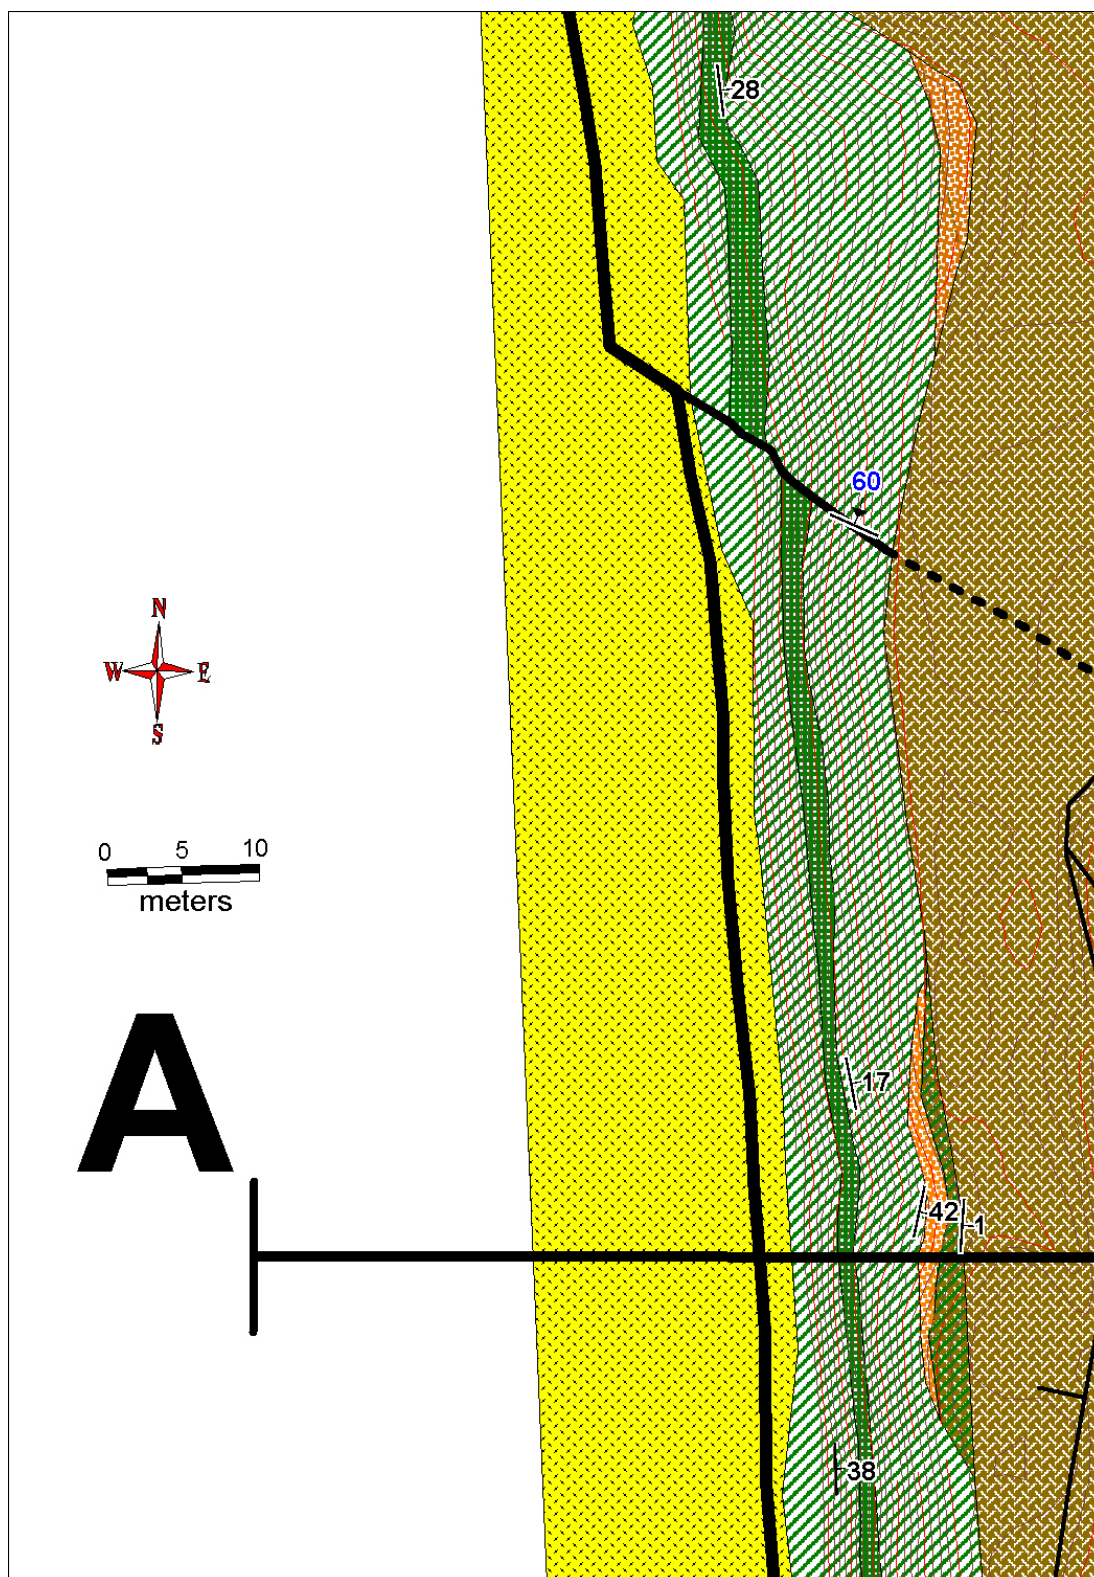
**Figure 9. Geologic map illustrating general continuity of bedding along the large block at the toe of the landslide. Note the cross cutting structure. This may be a tectonic fault now offset and possibly reactivated within the landslide (see discussion in the text).**

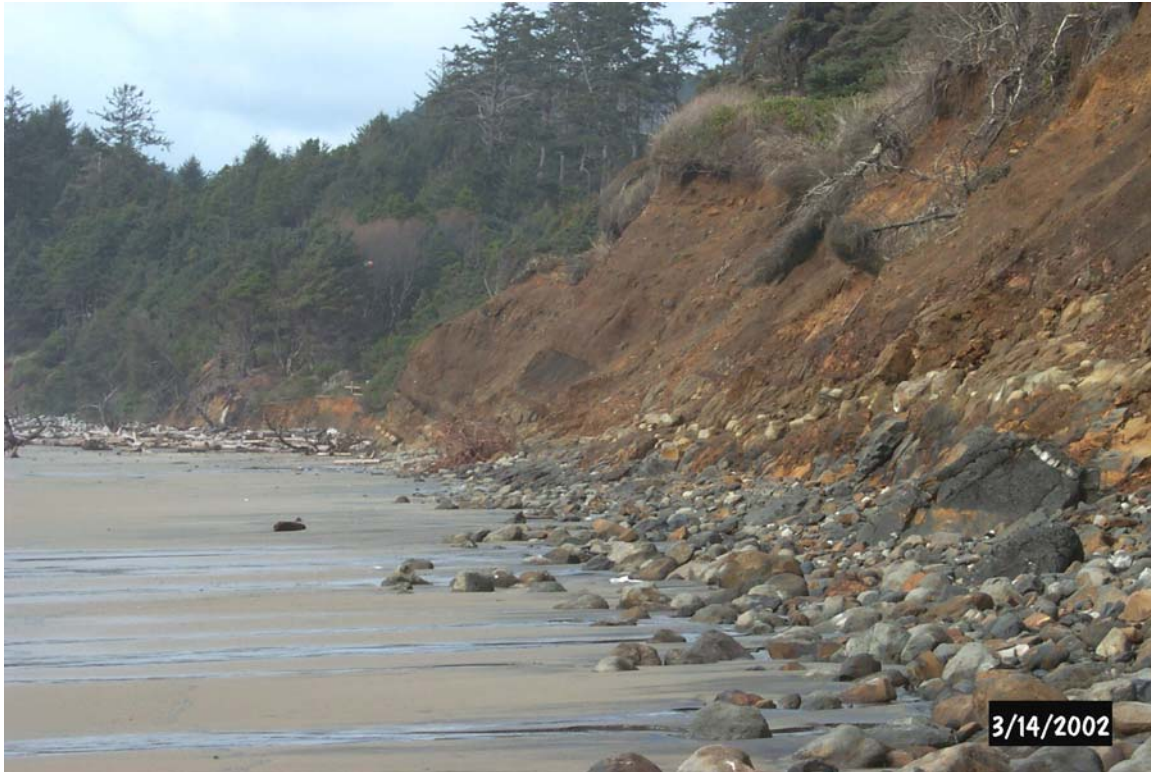
**Figure 10. View north at white marker bed that is easily traced for hundreds of feet along the toe of the Johnson Creek Landslide. This is the same general area as in Figure 9 above. The sandstone unit in green in Figure 9 is the cliff forming unit with the white marker bed at the lower contact.**

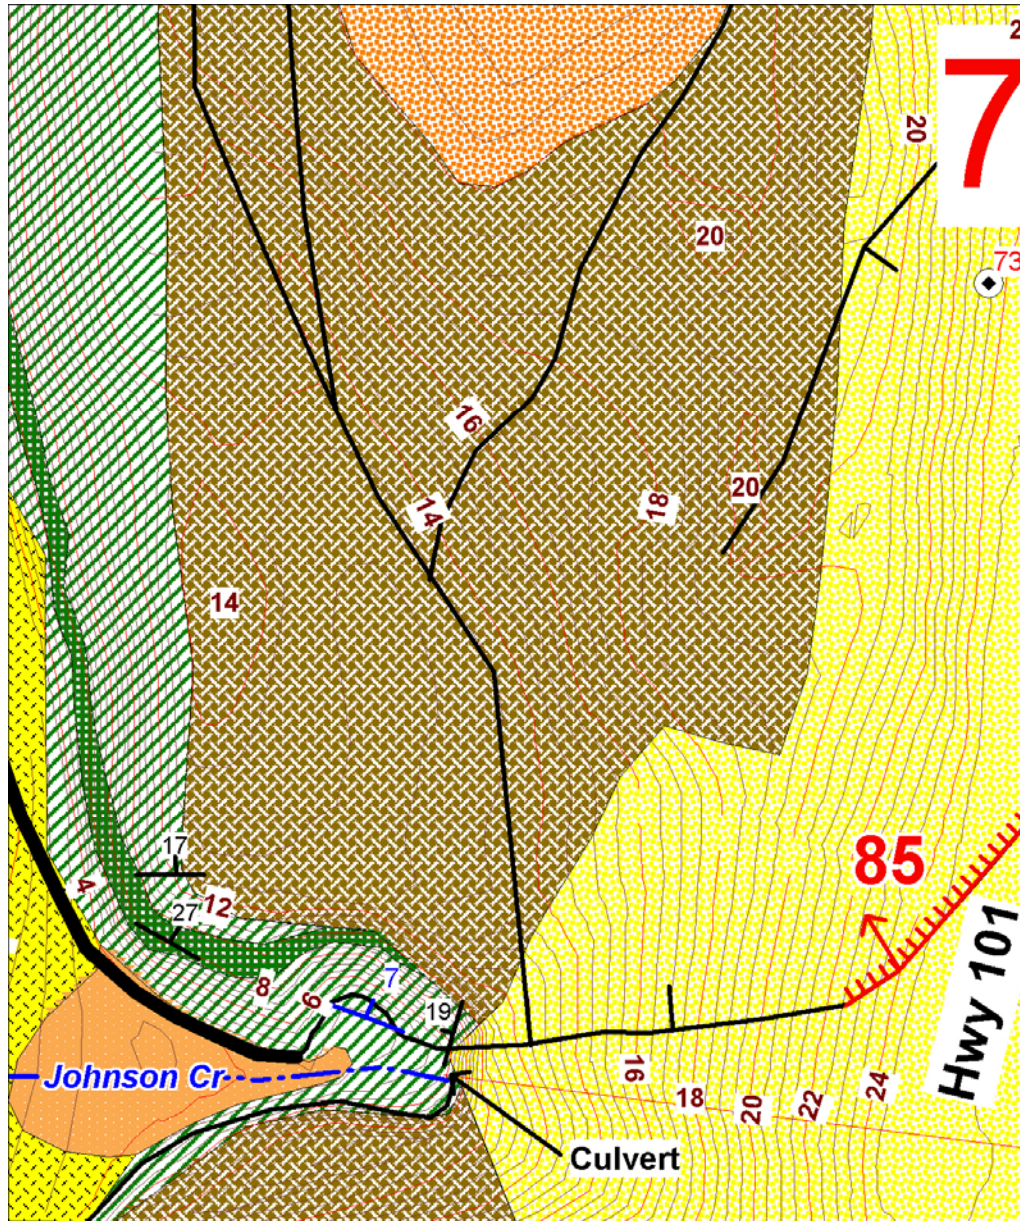
Figure 12. Detailed geologic map of the southwest end of the Johnson Creek Landslide. Brown numbers are elevations in meters above geodetic mean sea level (NAVD88); black numbers are bedding dip in Astoria Formation; red number is dip of recently active shear plane cutting highway fill, and the blue number is the dip of basal slide plane at Johnson Creek. Note that the prominent sandstone marker bed (green unit) has dips to the north and northeast at the sea cliff but crops out at similar or higher elevation to the east on the north side of Johnson Creek. The dip must therefore change to lower dip in the interior of the westernmost slide block, probably subparallel to the slide plane dip. The west dip of 19° on the east side of this exposure illustrates complete reversal of dip from that at the toe of the slide. These observations are consistent with a synclinal structure in this exposure.

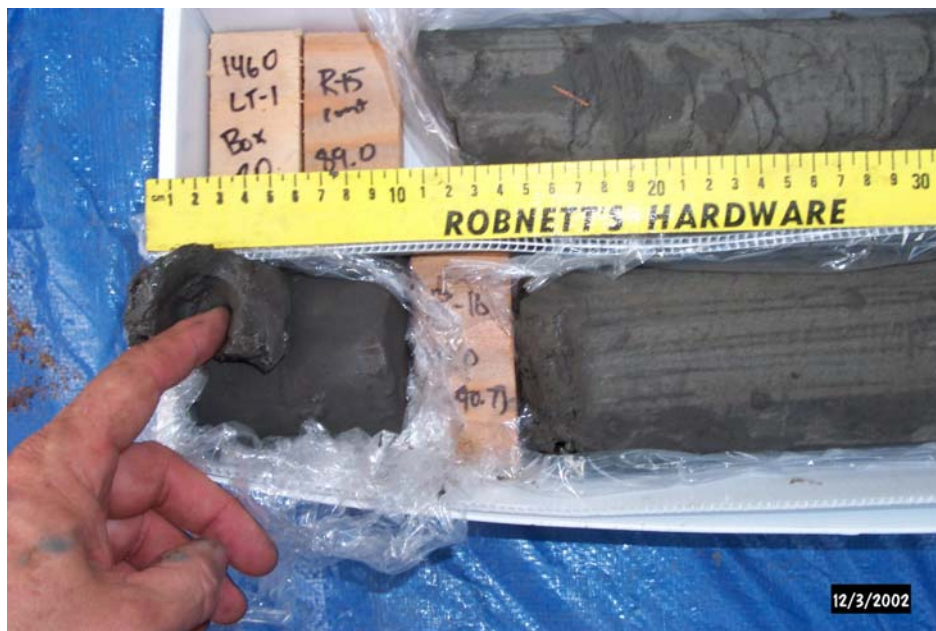
Figure 14. Soft wet silty gouge at slide plane in borehole LT-1 at 27.4 m (90 ft) depth.

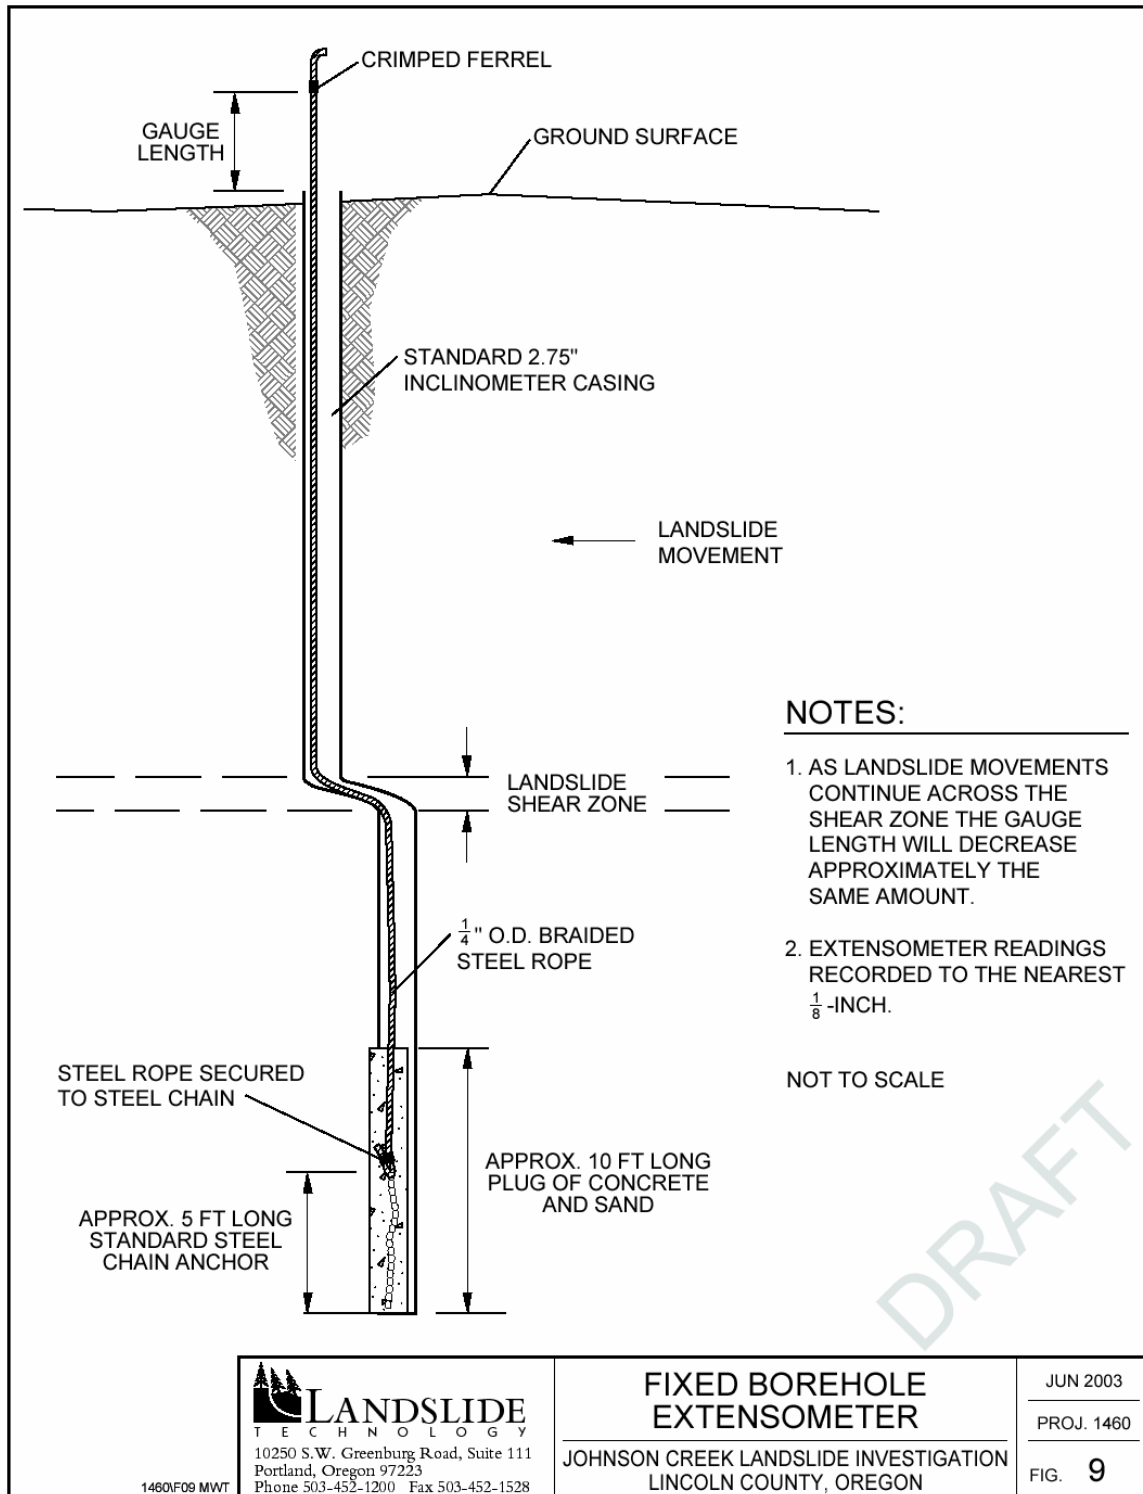
**Figure 15. Schematic diagram of extensometer construction in boreholes LT-1, LT-2, and LT-3. Taken from Landslide Technology (2004).**

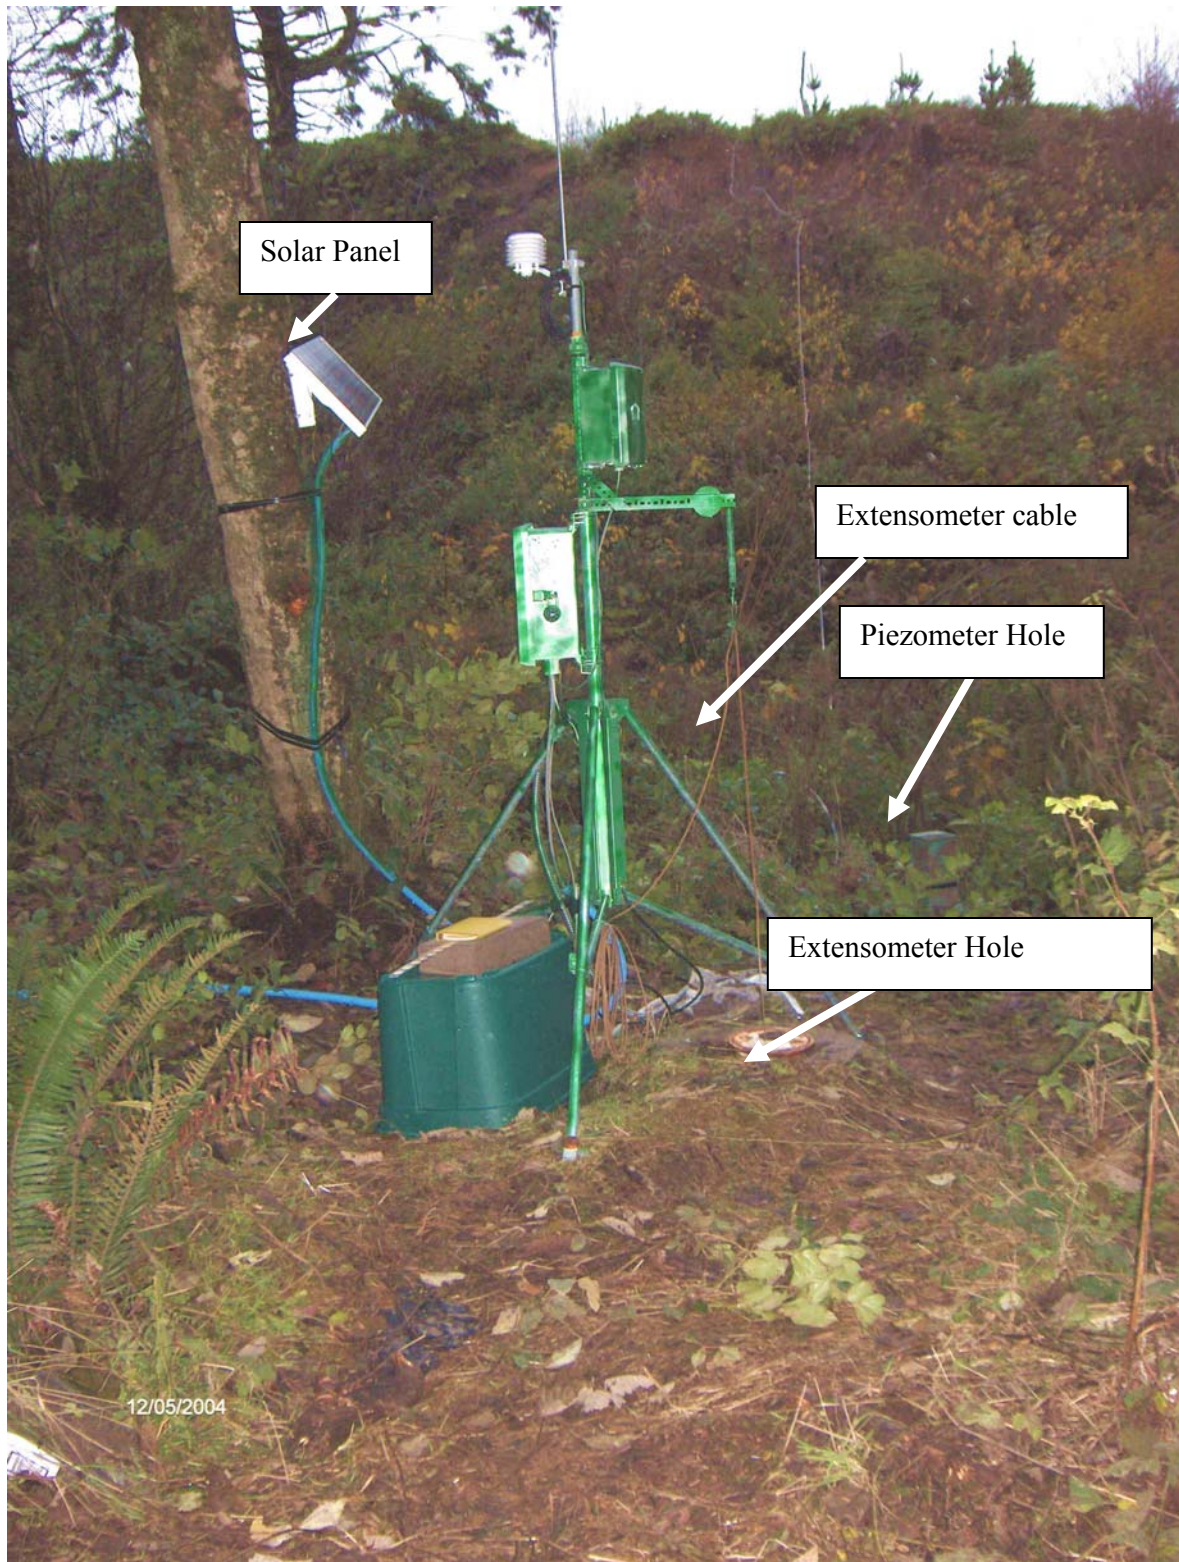
**Figure 16. Automated data collection system installed November 20, 2004. Photo is looking east at the site of the LT-3 borehole showing the cable and pulley system for the extensometer (center) and solar panel (left on tree) that recharges the batteries in the data logger (left mounted on tripod). Headwall of slide is in the background.**

The U.S. Geological Survey (USGS) on November 20, 2004 set up PsiTronix extension transducers (80-inch range) attached with a pulley and reel assembly to the braided wire in each of the three extensometer holes (Figure 16). They replaced the three GEOKON dataloggers with two Campbell Scientific CR10X dataloggers, one at the LT-1 site and one at the LT-3 site. Piezometer and extensometer data from LT-2 and LT-3 installations flow through wire to the datalogger at the LT-3 site. LT-1 piezometer and extensometer data flow to the logger at the LT-1 site. Both loggers are powered by rechargeable gel cell batteries that are hooked to solar panels. All data are recorded hourly. Extensometer data from this new system will thus be recorded hourly with rainfall and water pressure and will be much more accurate, since constant, equal tension is on the cables at all times. Even slight (mm) movements of the cable into the boreholes should be detectable. No data from this new set up will be reported in this paper, owing to time limitations and some minor inconsistencies between calibrations of the piezometer data in the old and new systems. These inconsistencies will be removed when the final report is produced in 2007. Movement has been negligible since November 20, 2004 in any case.

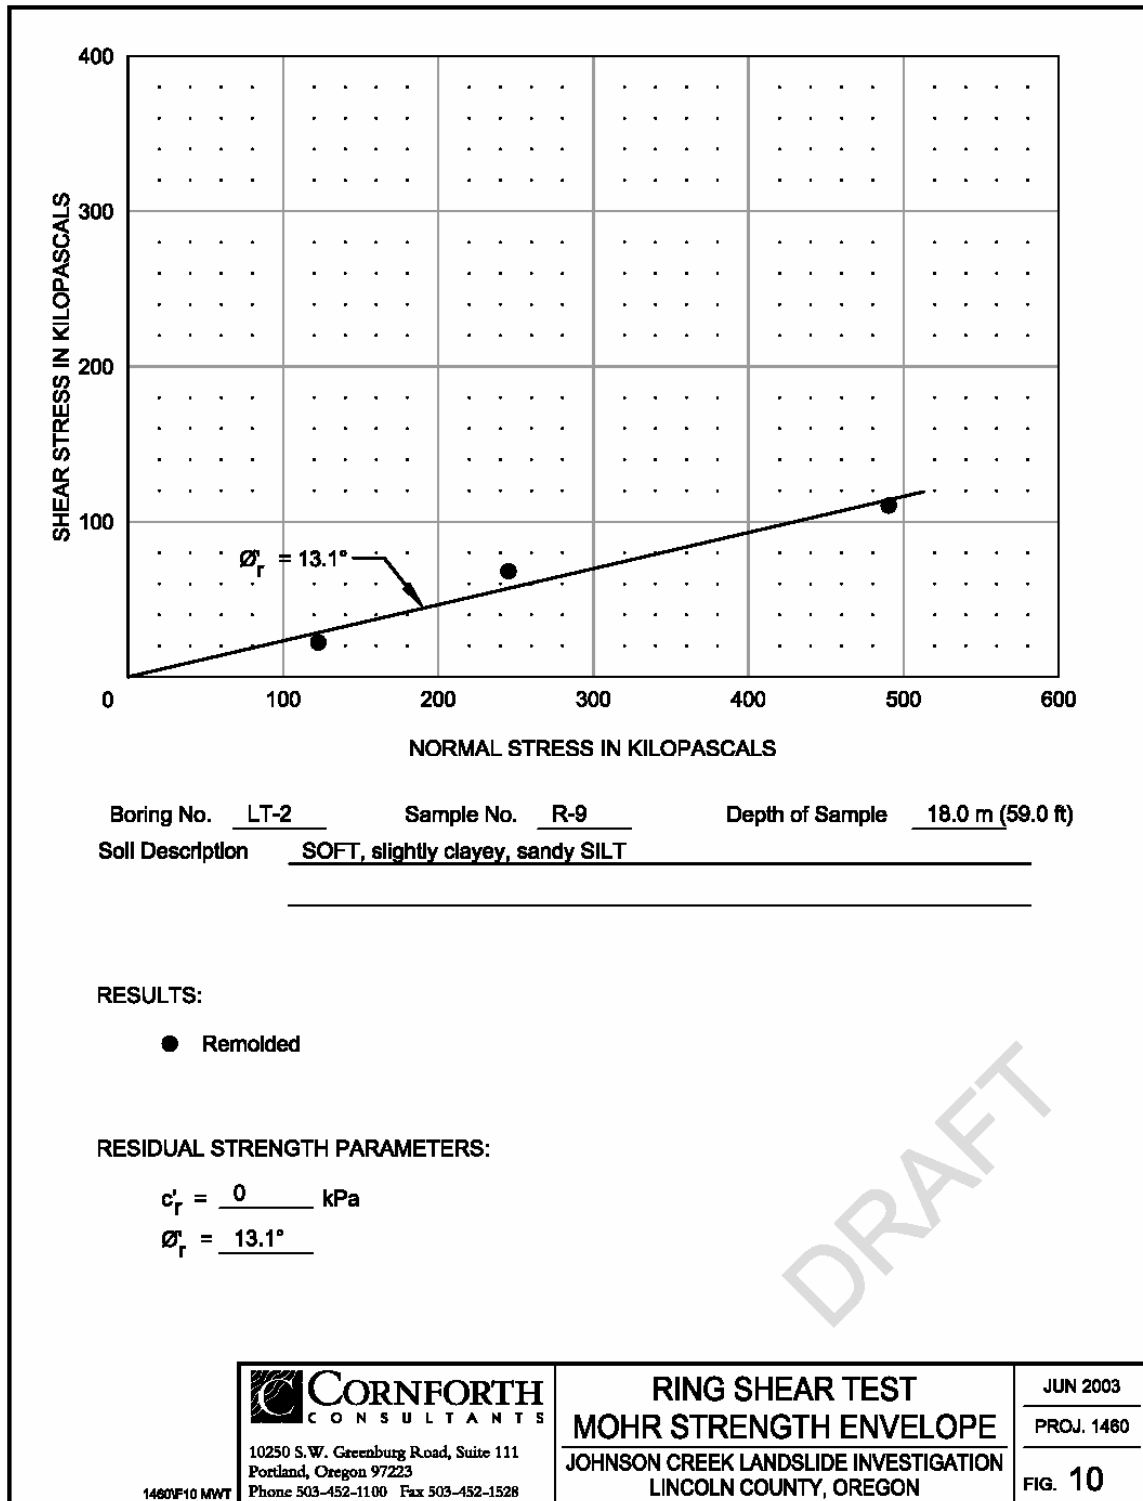
Figure 19. Results of ring shear test on sample from 59 ft depth in borehole LT-2.

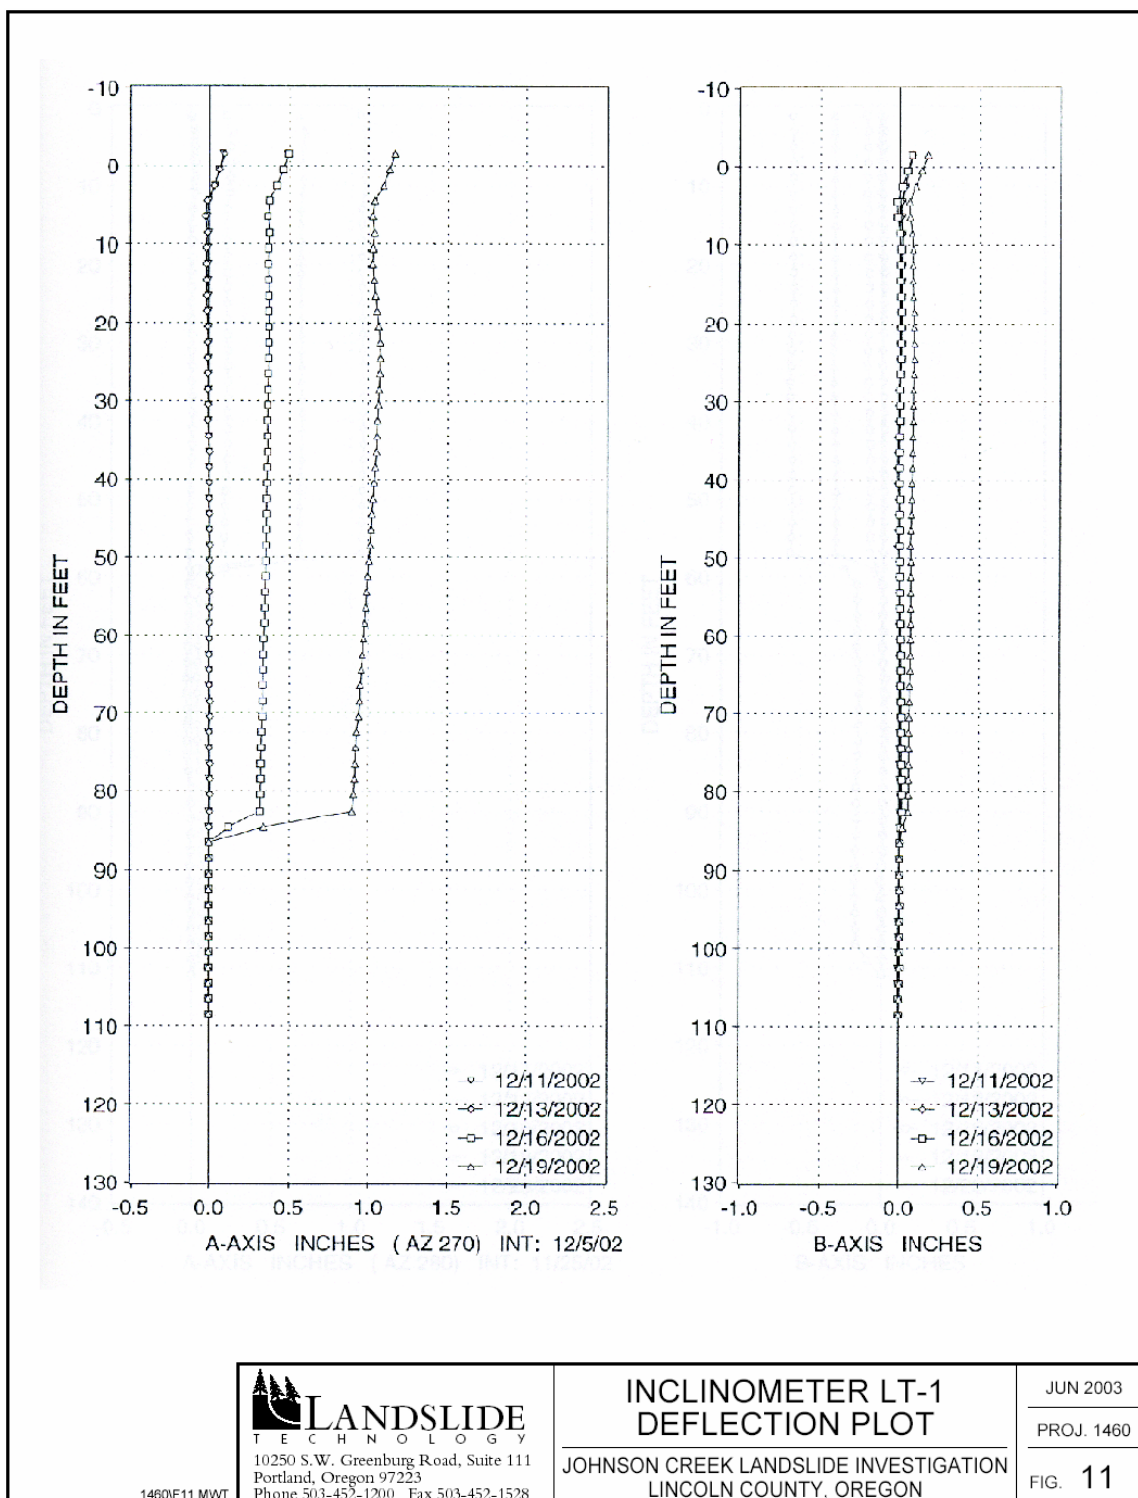
Figure 20. Inclinometer data for borehole LT-1.

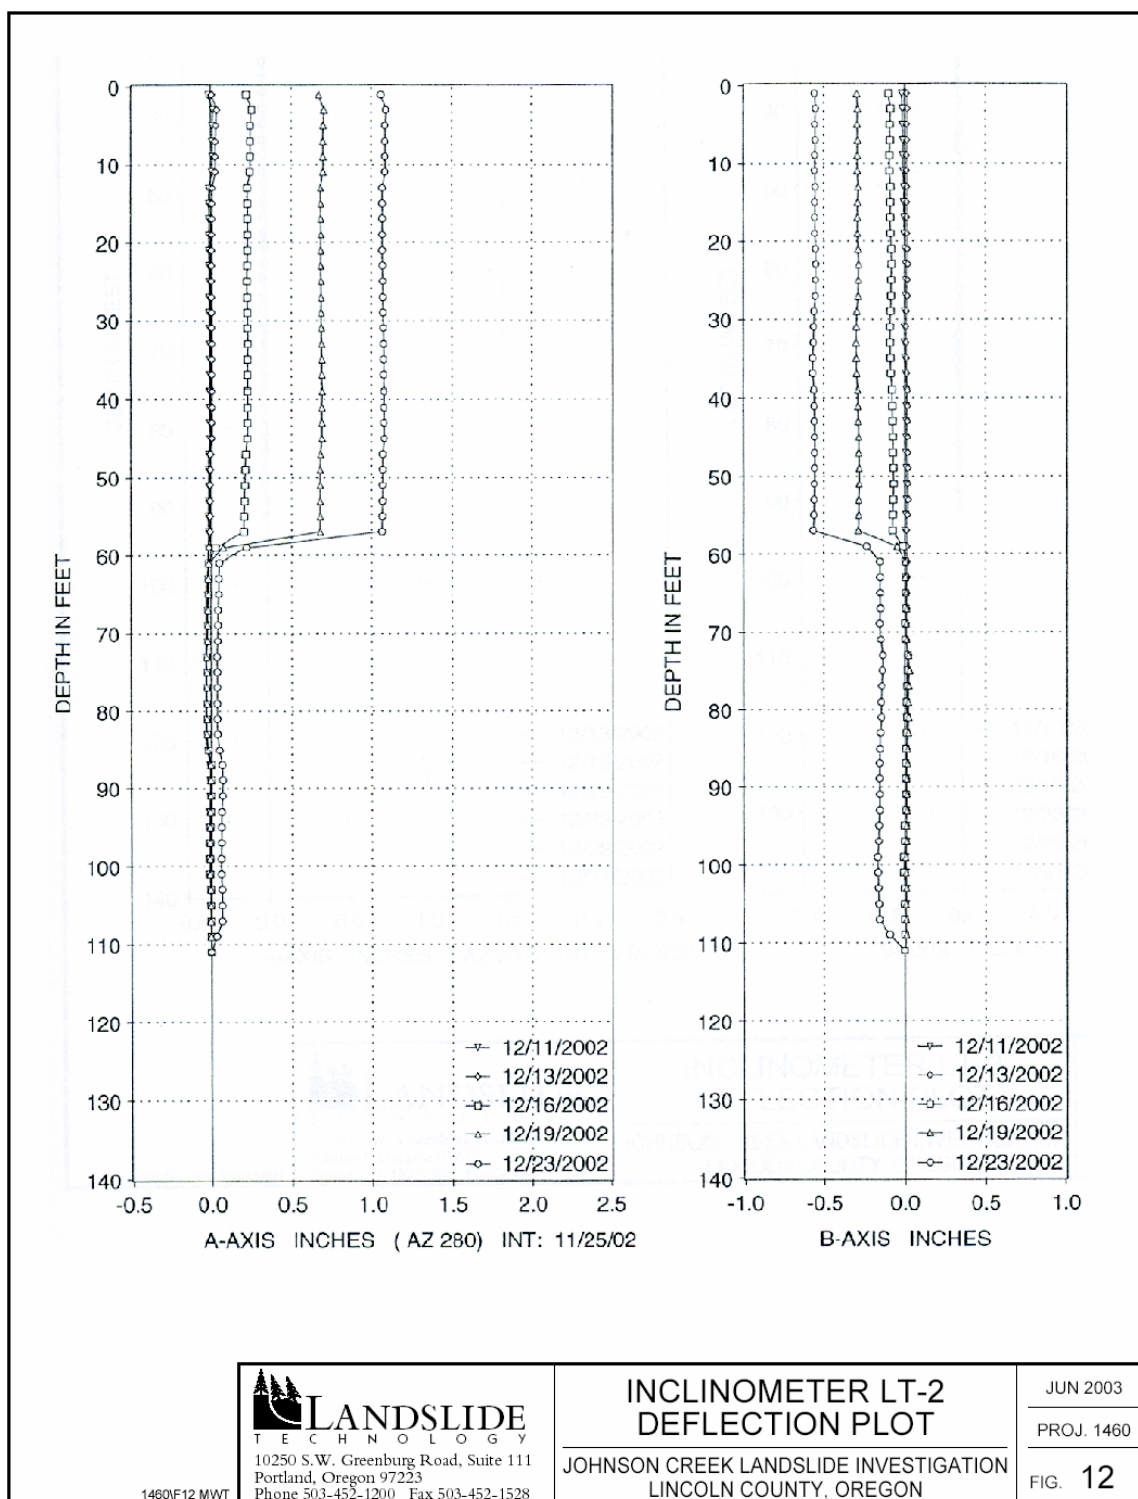
Figure 21. Inclinometer data for borehole LT-2.

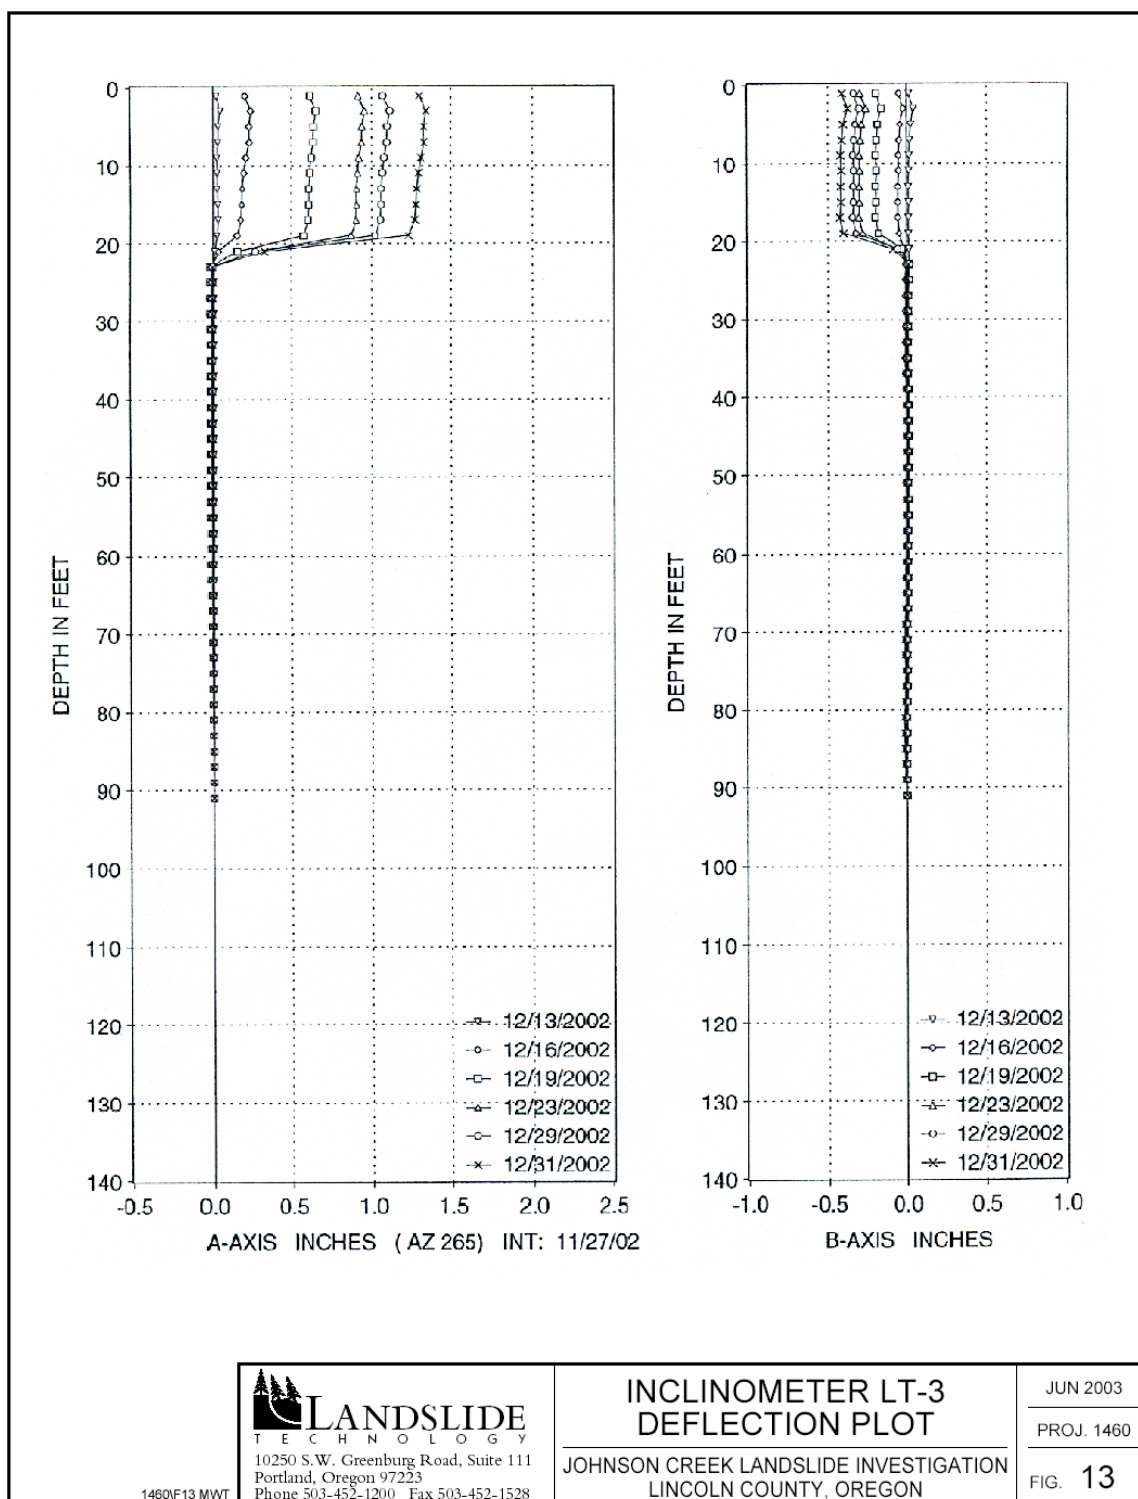
Figure 22. Inclinometer data for borehole LT-3.

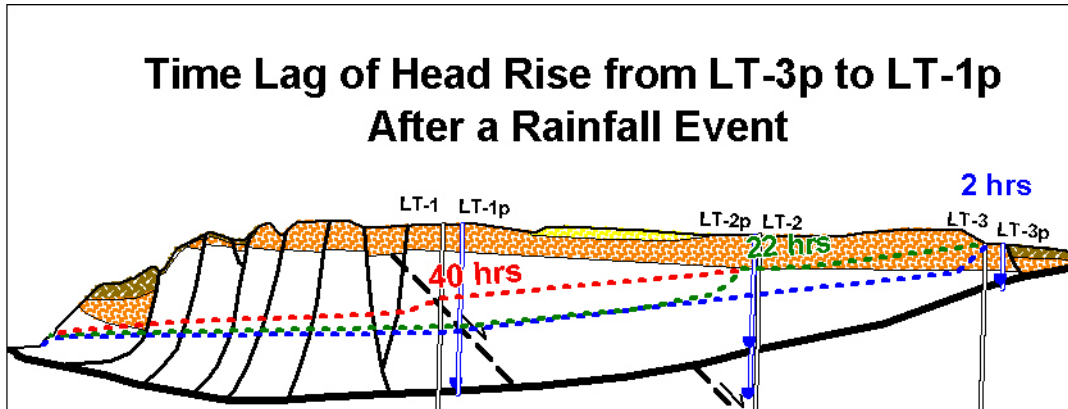
**Figure 38. Schematic illustration of progressive rise in piezometric head from east-to-west after a typical rainfall event. Elevation head is lower to the west, so rainfall must percolate further to reach the water table there. Lateral flow of water from east to west is another possible explanation for the east-to-west wave of pressure head increases that trigger movement at each borehole. Note the steep hydraulic gradient that must be present at the leading edge of the east-to-west wave of piezometric head rise.**

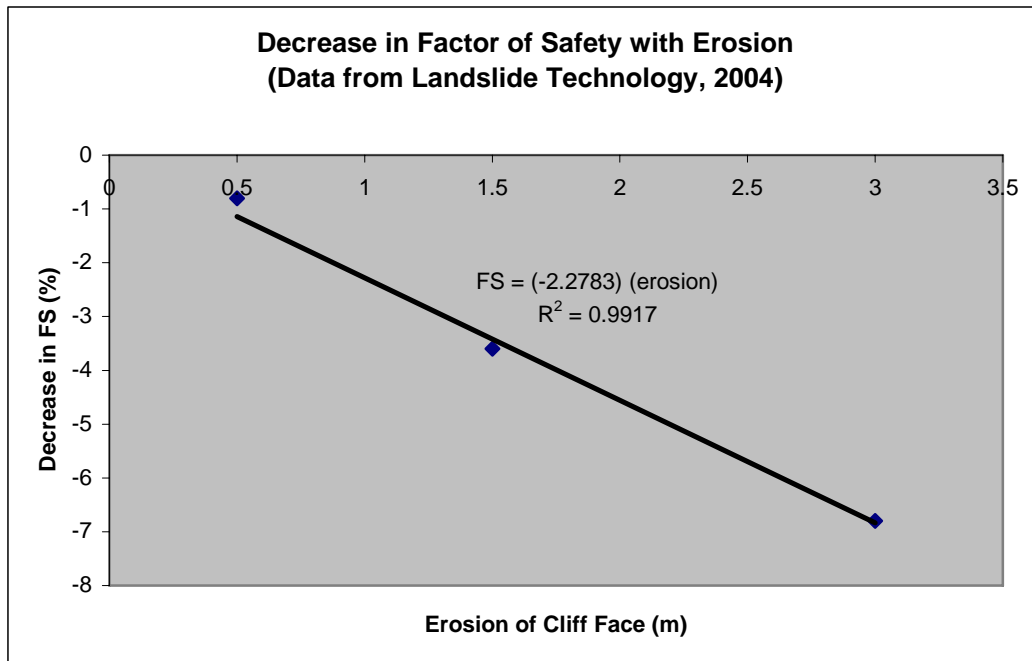
**Figure 41. Decrease of factor of safety at the Johnson Creek Landslide from erosion of the slide toe (sea cliff). Calculations for the three points were done by Landslide Technology (2004), but the present authors produced this figure to illustrate the linear relationship.**

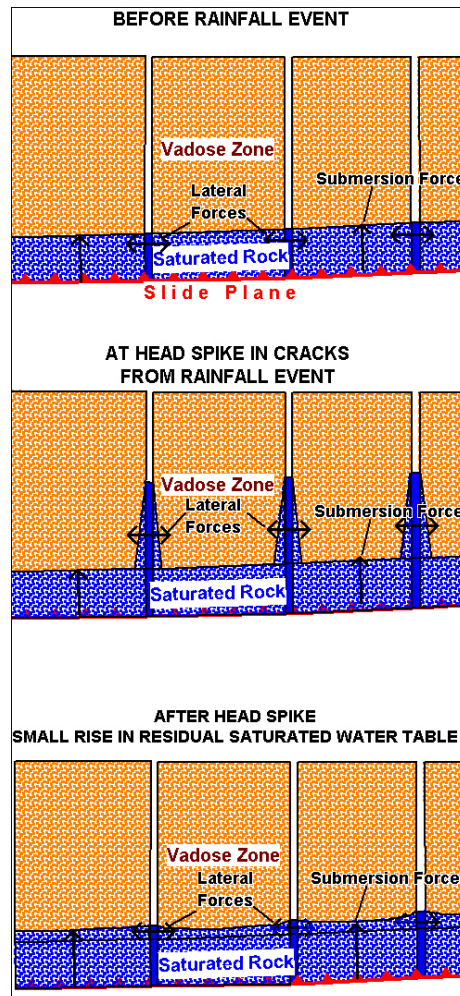
**Figure 45. Schematic illustration of probable water level changes in the landslide fracture system before, at, and after a sharp rise in pressure head from a rainfall event.**
