**OPEN-FILE REPORT  
OFR O-06-02**

**INTERIM REPORT:  
JOHNSON CREEK LANDSLIDE PROJECT,  
LINCOLN COUNTY, OREGON**

By  
George R. Priest<sup>1</sup>, Jonathan Allan<sup>1</sup>, Alan Niem<sup>1</sup>, Samuel R. Christie<sup>2</sup>, and Stephen E. Dickenson<sup>2</sup>

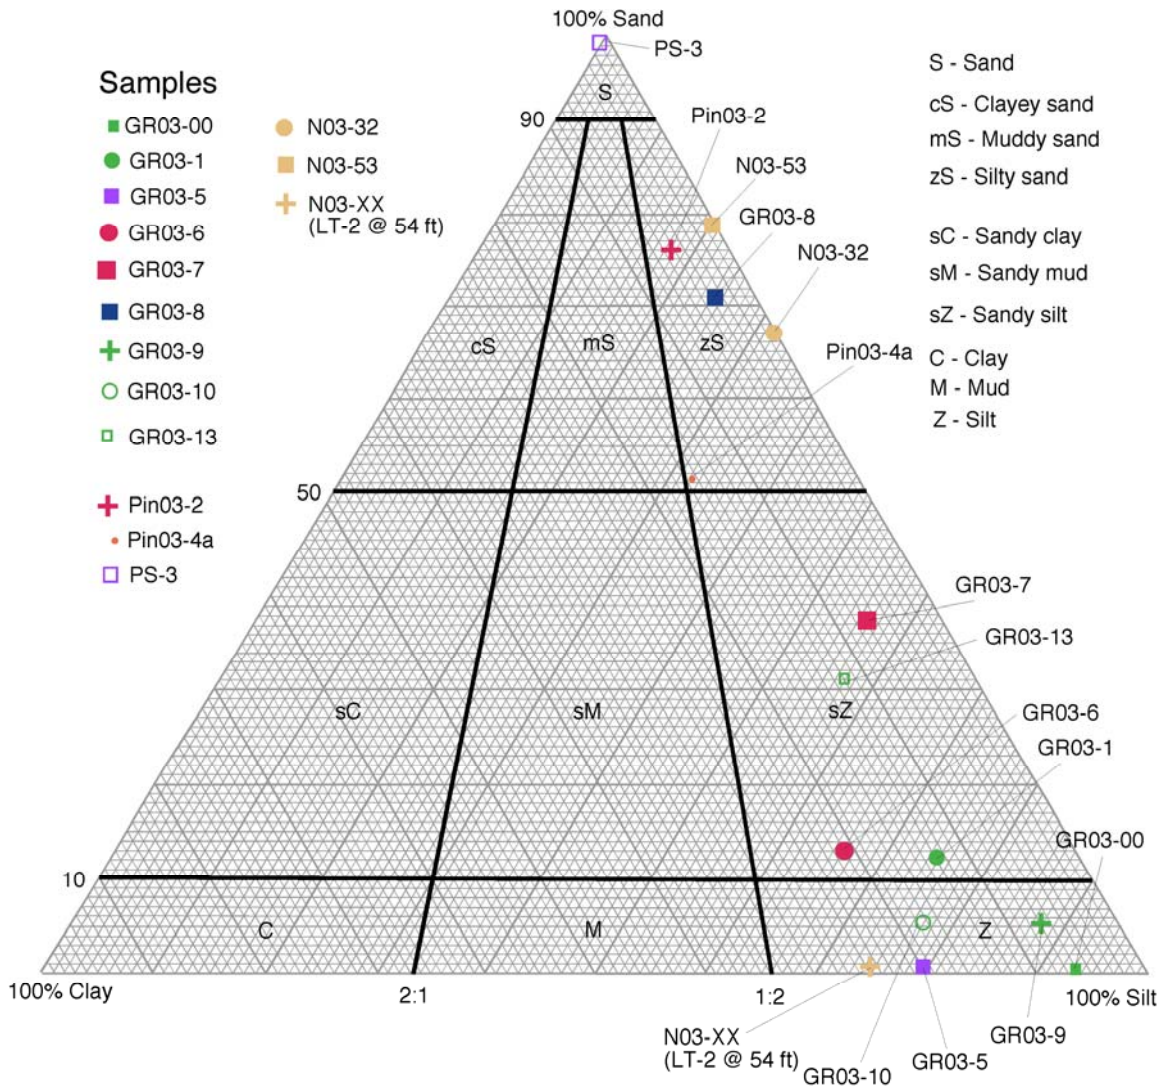
Figure 4. Grain size classification of disaggregated lower and middle Miocene Astoria Formation sandstones and siltstones from sea cliffs at the toe of the Johnson Creek landslide and from cored boreholes LT-1, LT-2, and LT-3. Grain sizes from sieve and hydrometer analysis. Triangular classification diagram of sediments by Folk (1974).

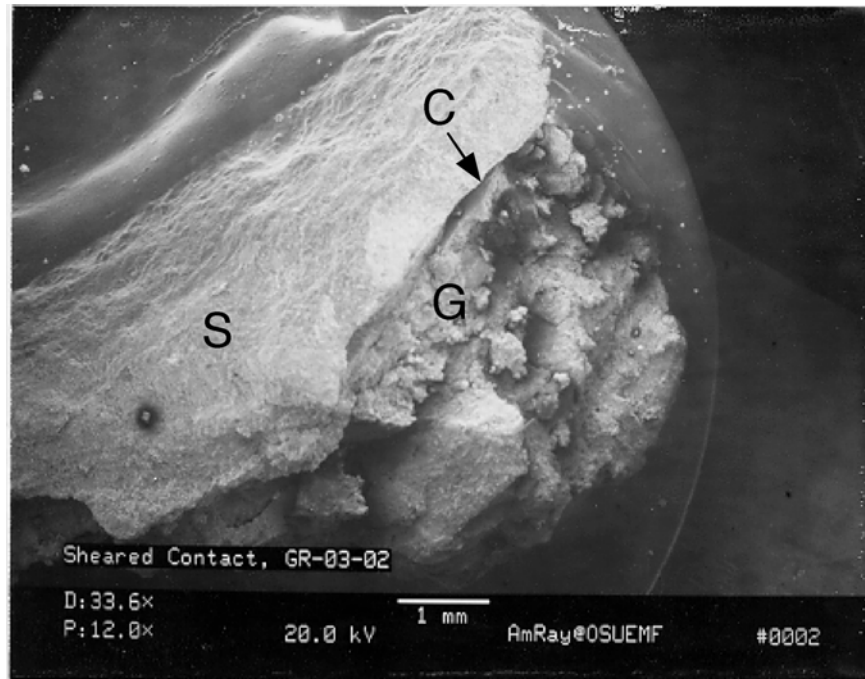
Figure 5A. SEM photomicrograph of sheared contact (Sample GR03-02) shows the contact of the undeformed host siltstone (labeled S) with broken fragmented clay-silt gouge (note angular broken siltstone fragments labeled G). The dark crack (labeled C) is the sharp 2 mm thick contact. Note 1 mm bar scale in bottom margin of photo.

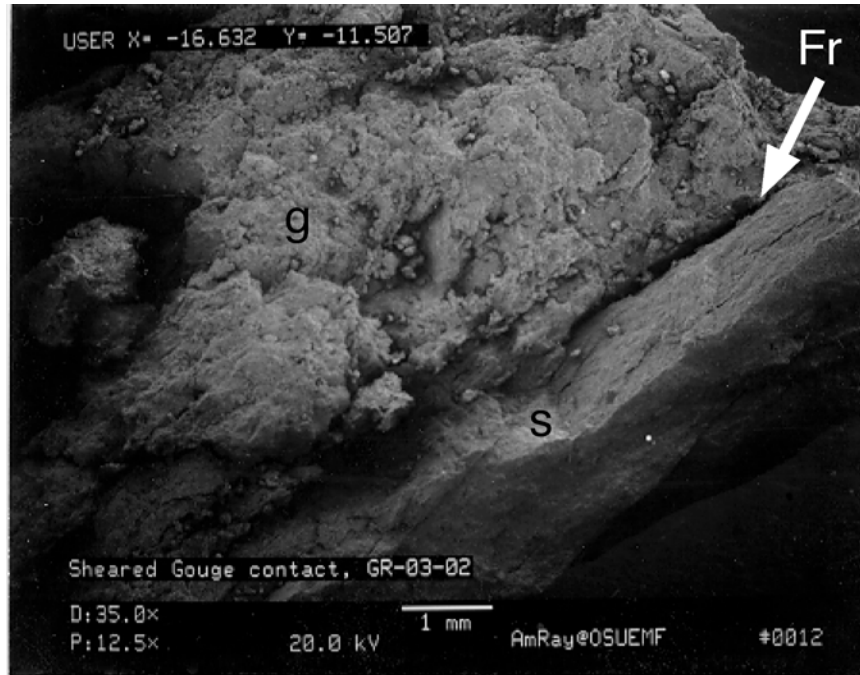
Figure 5B. SEM photomicrograph at low magnification (12.5X) shows a sharp smooth shear plane (labeled Fr) which appears to step across the specimen. The specimen was mounted upside-down which places the shear gouge (g) in the upper NW half of the photograph and the unsheared siltstone (s) in the lower SE half of the photograph. The sheared gouge appears as a jumbled mass of largely subparallel (imbricated) smectite clay particles or packets. In the gouge, multiple fractures (dark lines), along which slippage has occurred, subparallel the main shear boundary.

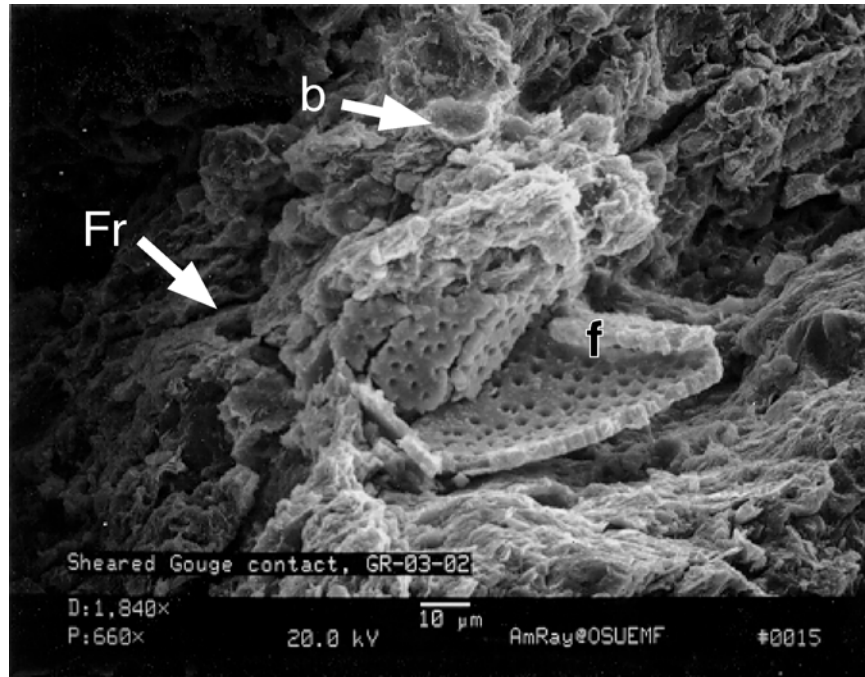
Figure 5C. SEM photomicrograph of bent and broken test (shell) of benthonic foraminifer (f) along a fracture (Fr). Flake of biotite (mica) is labeled b.

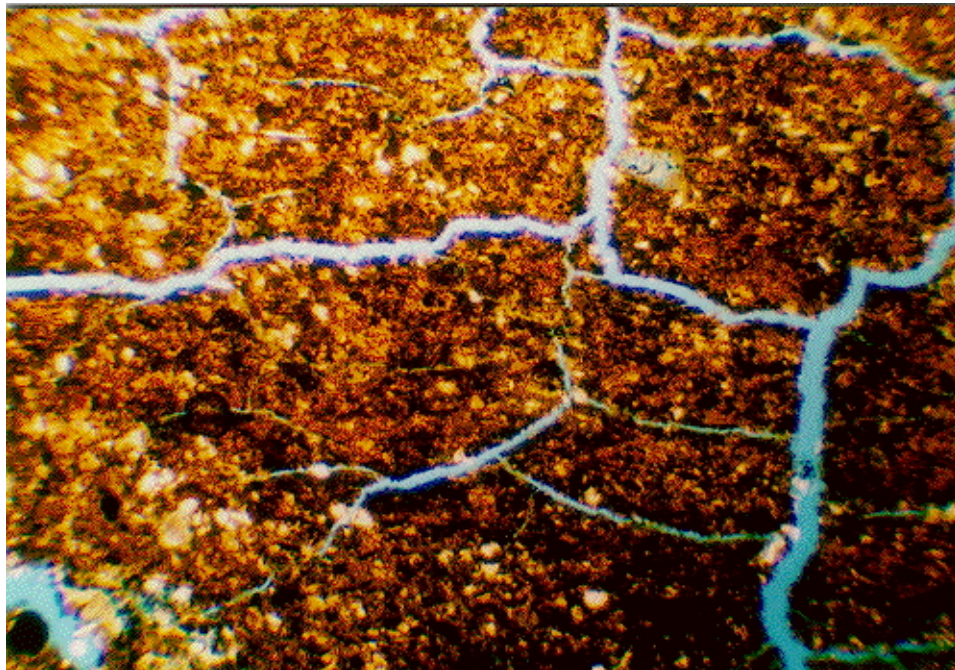
Figure 6. Photomicrograph of dessication microfractures in siltstone sample N03-XX (borehole LT-2 at 54 ft). Microfractures were created as the sample was dried and heated in the process of preparing the thin section. Blue-dyed epoxy fills the microfractures (3.5X, plane-polarized light).

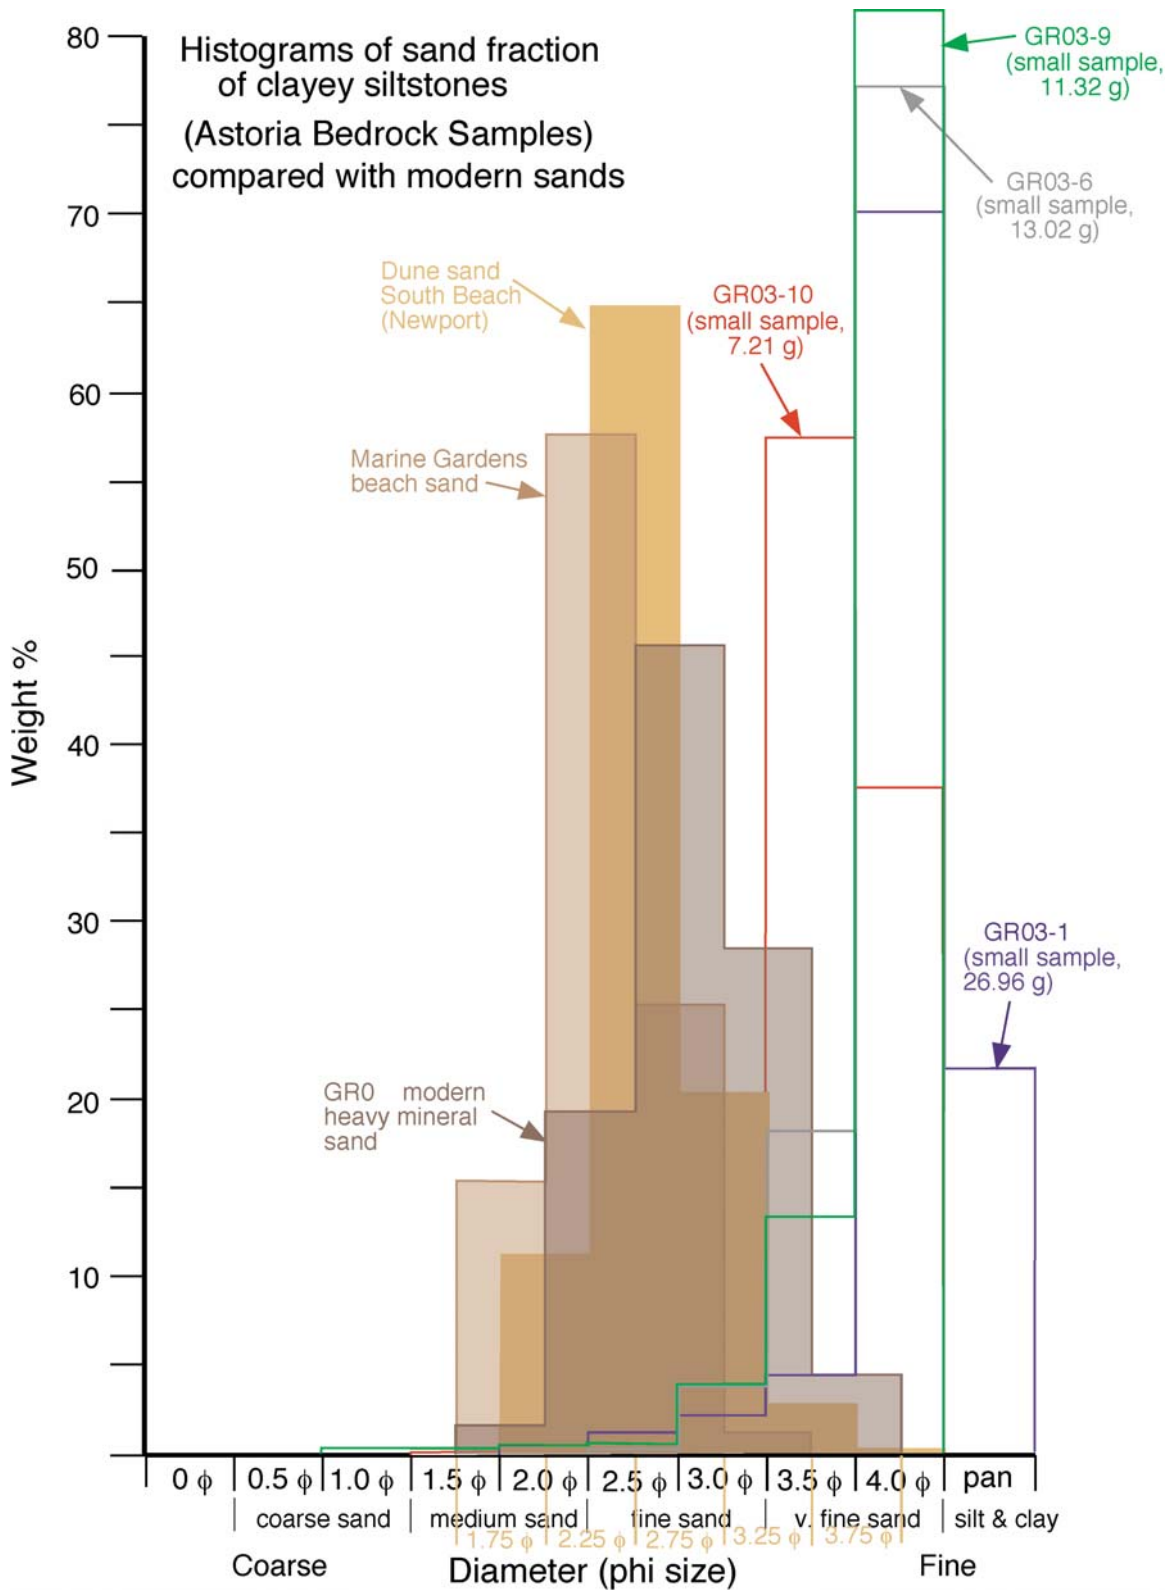
Figure 7. Histograms of sand fraction of Astoria Formation clayey siltstones and siltstones compared with modern sands.

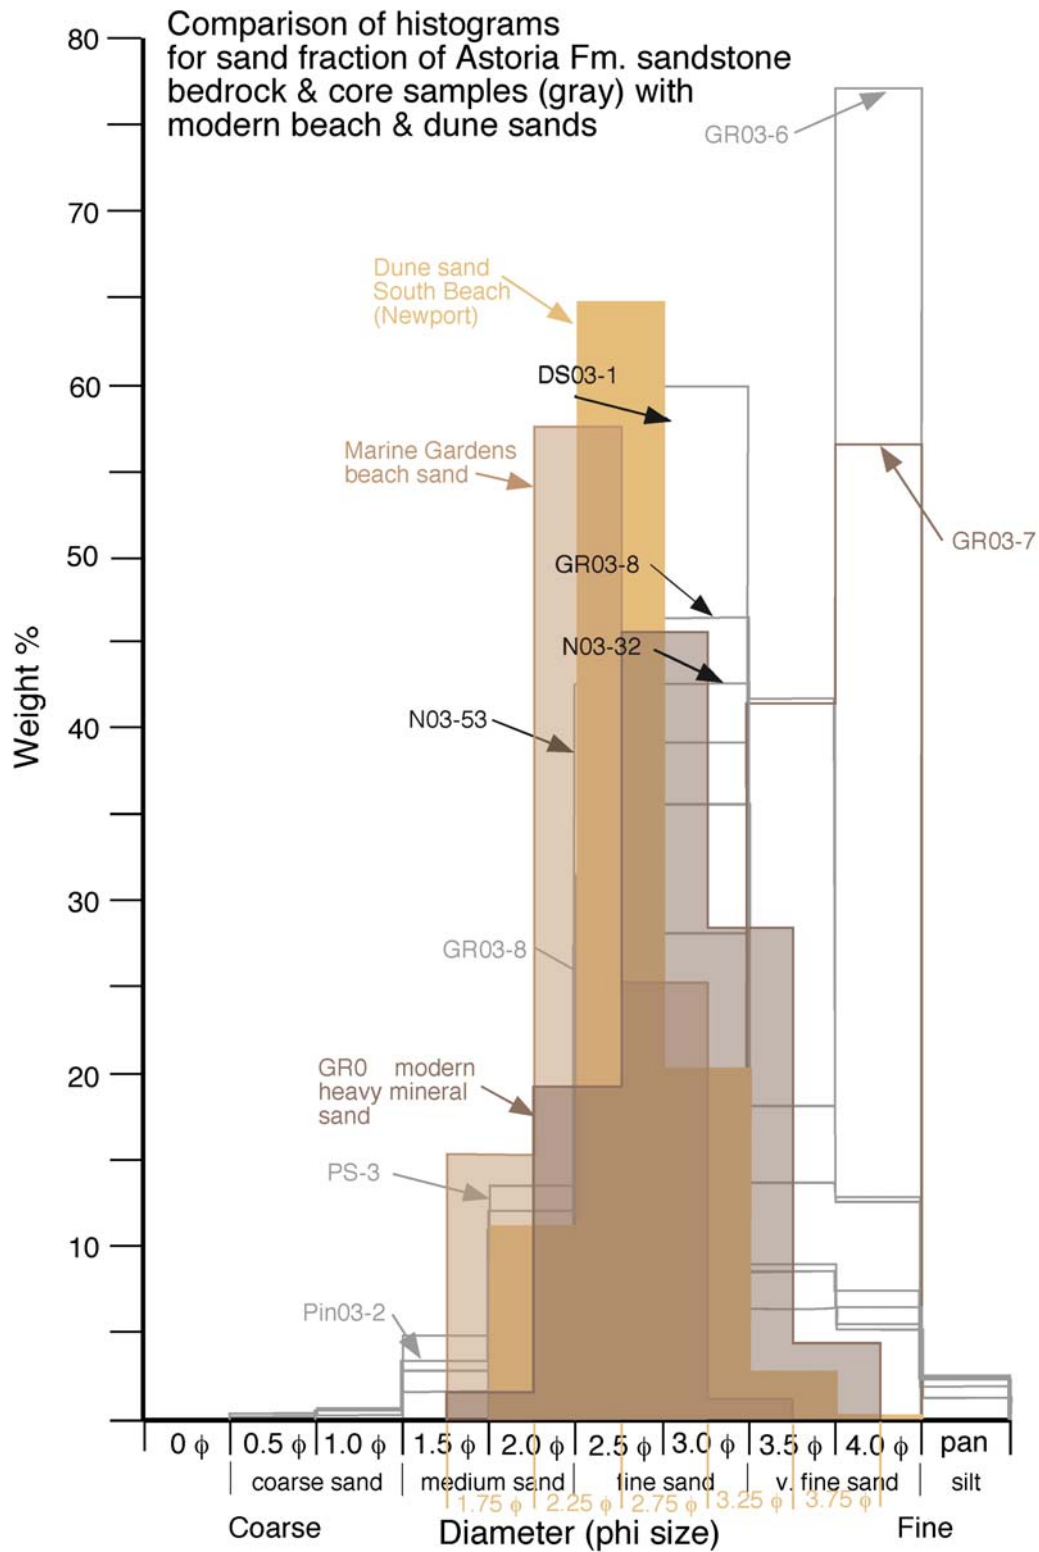
Figure 10. Comparison of histograms for sand fraction of Astoria Formation sandstone bedrock and core samples (gray) with modern beach sands and dune sands. The modern sands are distinctly coarser grained than the sand fraction in the bedrock.

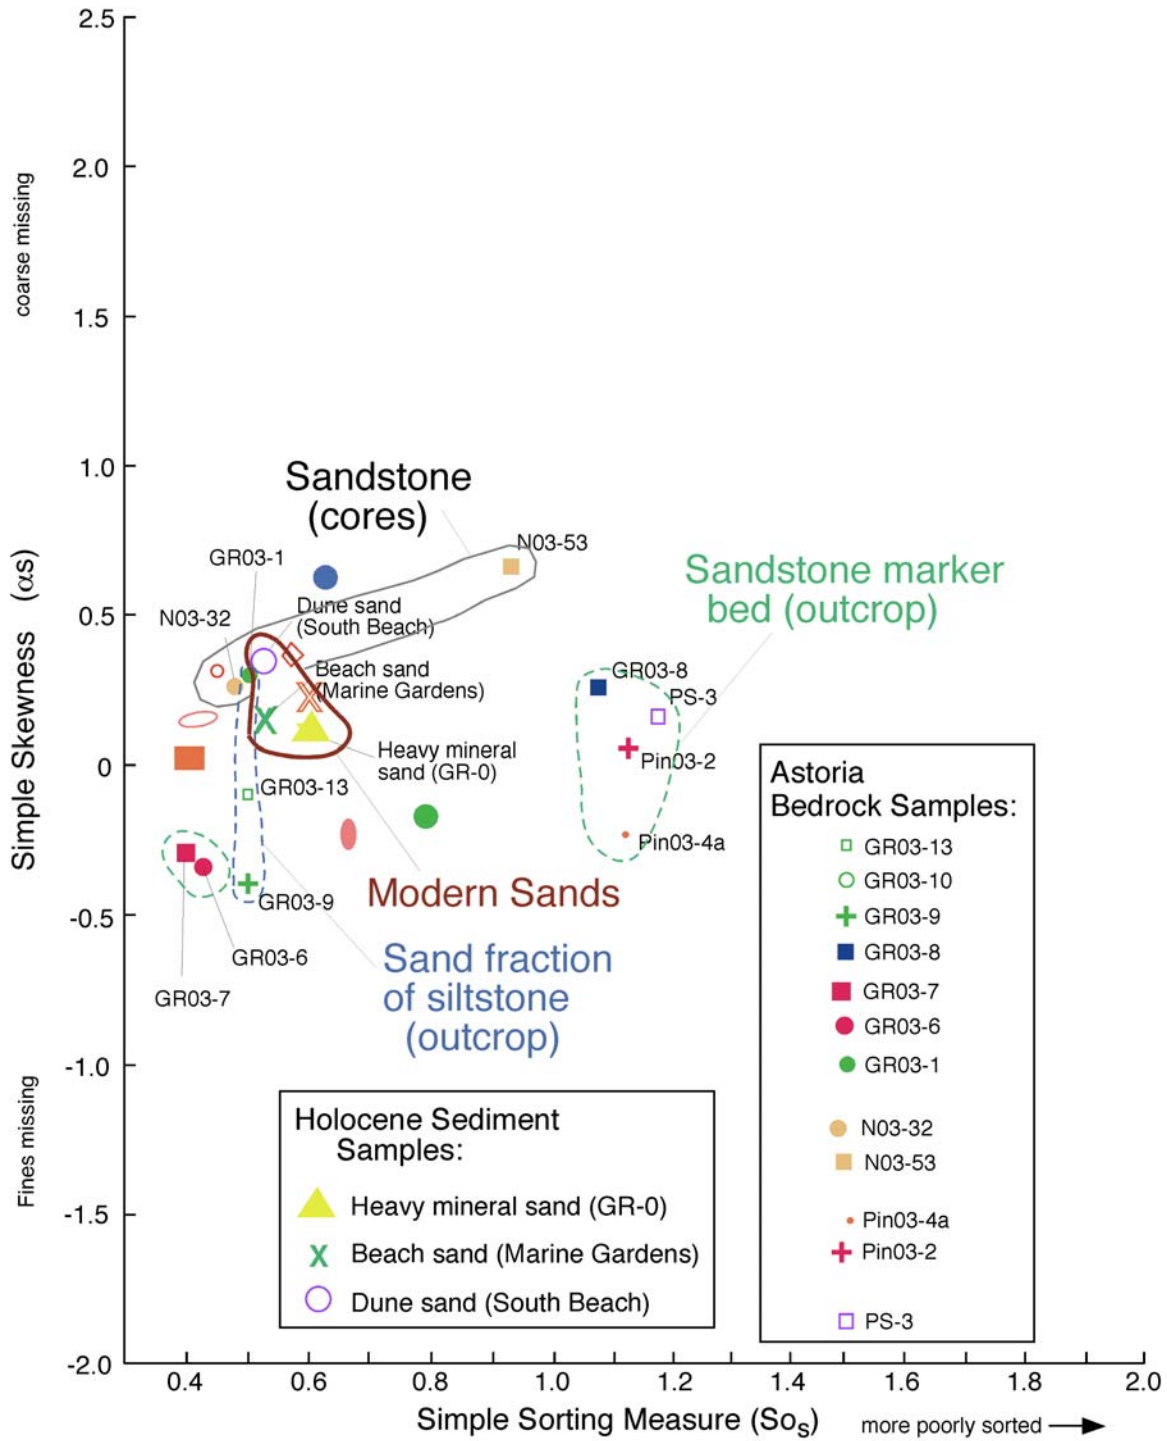
Figure 12. Binary plot of simple skewness versus simple sorting compares sand-sized fraction of Astoria Formation (bedrock) samples with modern sands (beach and dune). After Friedman (1962).

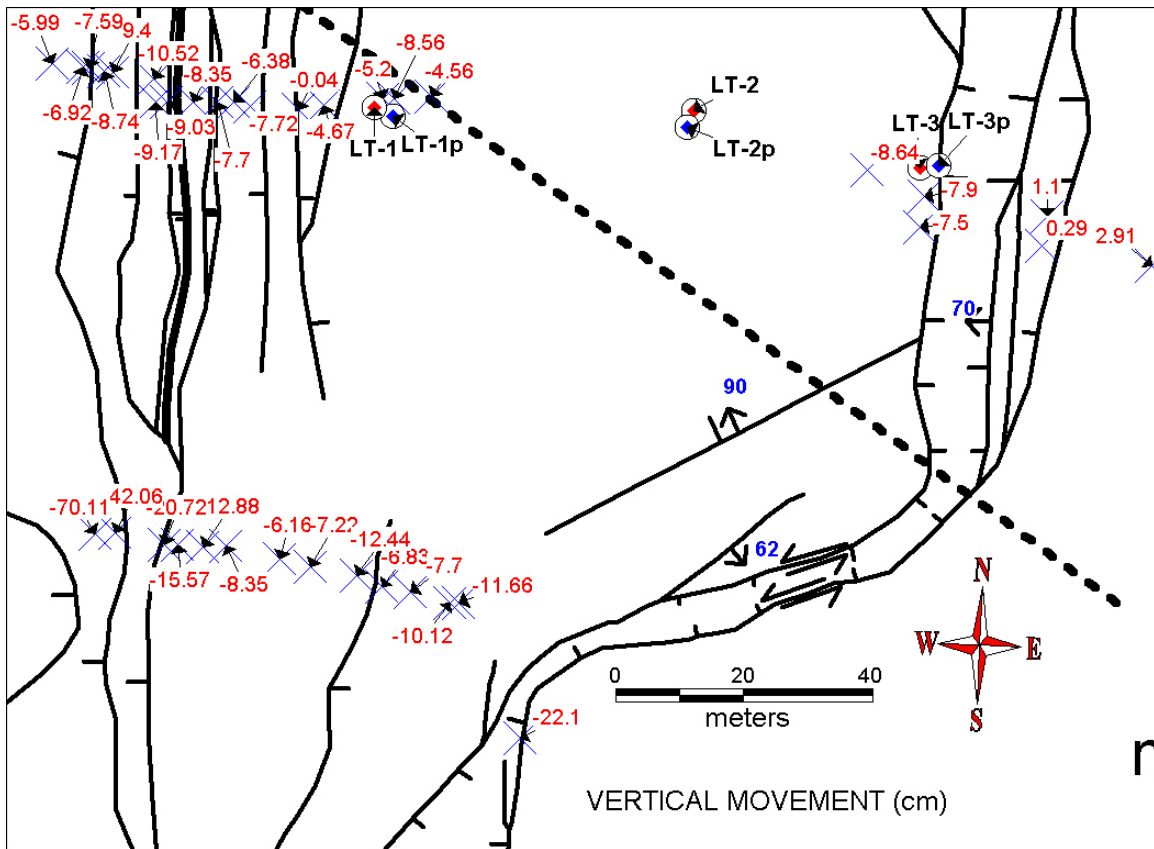
Figure 5. Vertical movement (cm) at steel stakes (blue crosses) in southern part of landslide. Movement east of the headwall of +2.91 to +5.51cm (upward) is survey error, so this is the approximate error of the data. There is one survey stake east of the headwall with an error of -129.88 cm, but this is probably a local anomaly caused by tampering with the steel stake or transcription error by the surveyor.

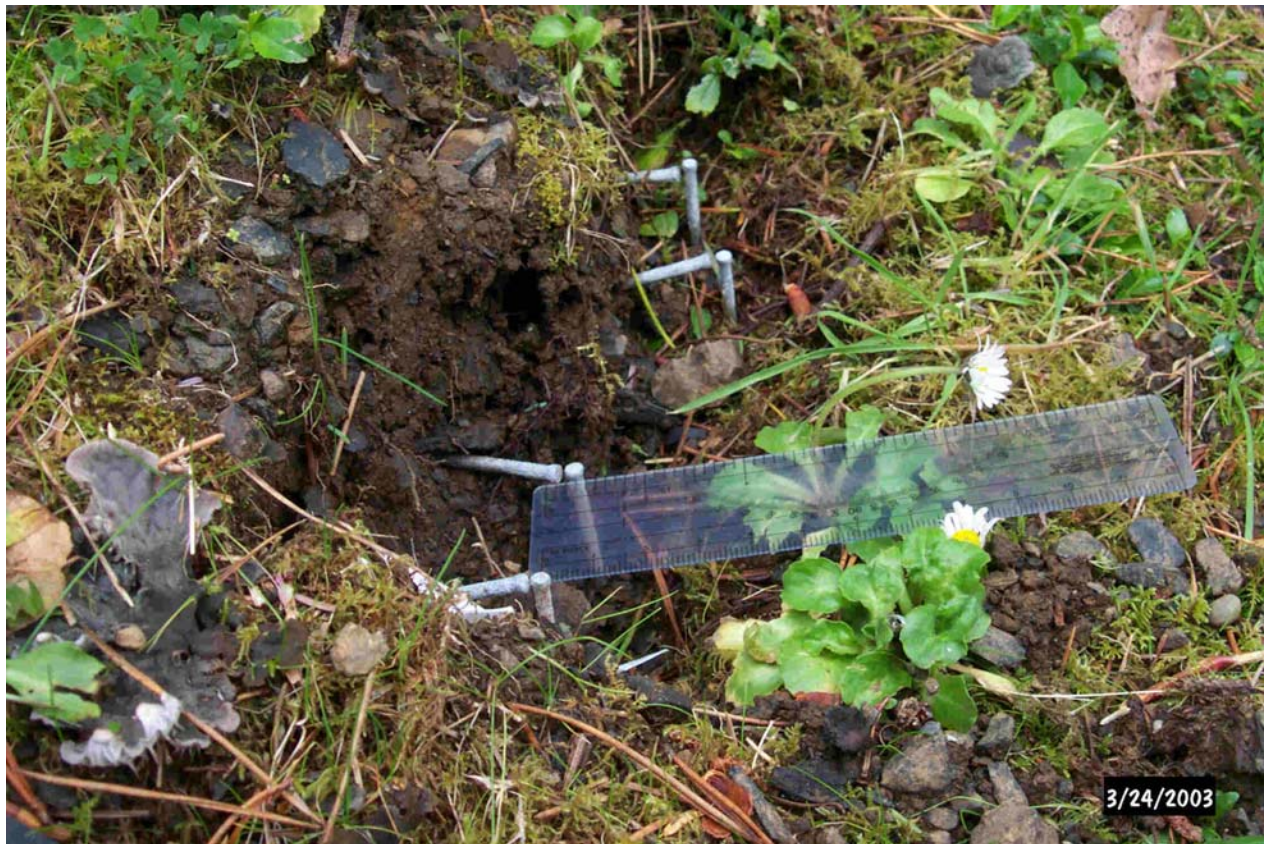
Figure 1. A typical site with 6-inch ruler used for measurements. This is site JC-23.

Measurements were done in the field by first pounding 10 cm galvanized nails and/or galvanized wires into slide scarps around the margins of the slide such that the nail heads on the scarp and on the soil below the scarp touched. Several nails and/or wires were installed at each site. Wires were only used where it was difficult to seat the nails close enough together to get a measurement. Movement was measured using a plastic scale ruled in tenths and 20ths of an inch. Measurement error on the scale is  $\sim \pm 0.05$  inches, although the human eye can detect 0.01 inches of displacement between to linear objects. Thus movement less than 0.05 inches was detected when heads of nails or heavy gauge wires were displaced, but the exact amount below 0.05 inches is unknown. Values for multiple nails were averaged to obtain a representative value of movement. Some data were discarded where nails were obviously disturbed by roadwork, human activity, or instabilities in the soil itself (e.g. nails or wires gradually rotating because of loose soil). Data from the galvanized wires were generally not used because it was very difficult to seat them well enough to prevent shifting of the wires from wind.

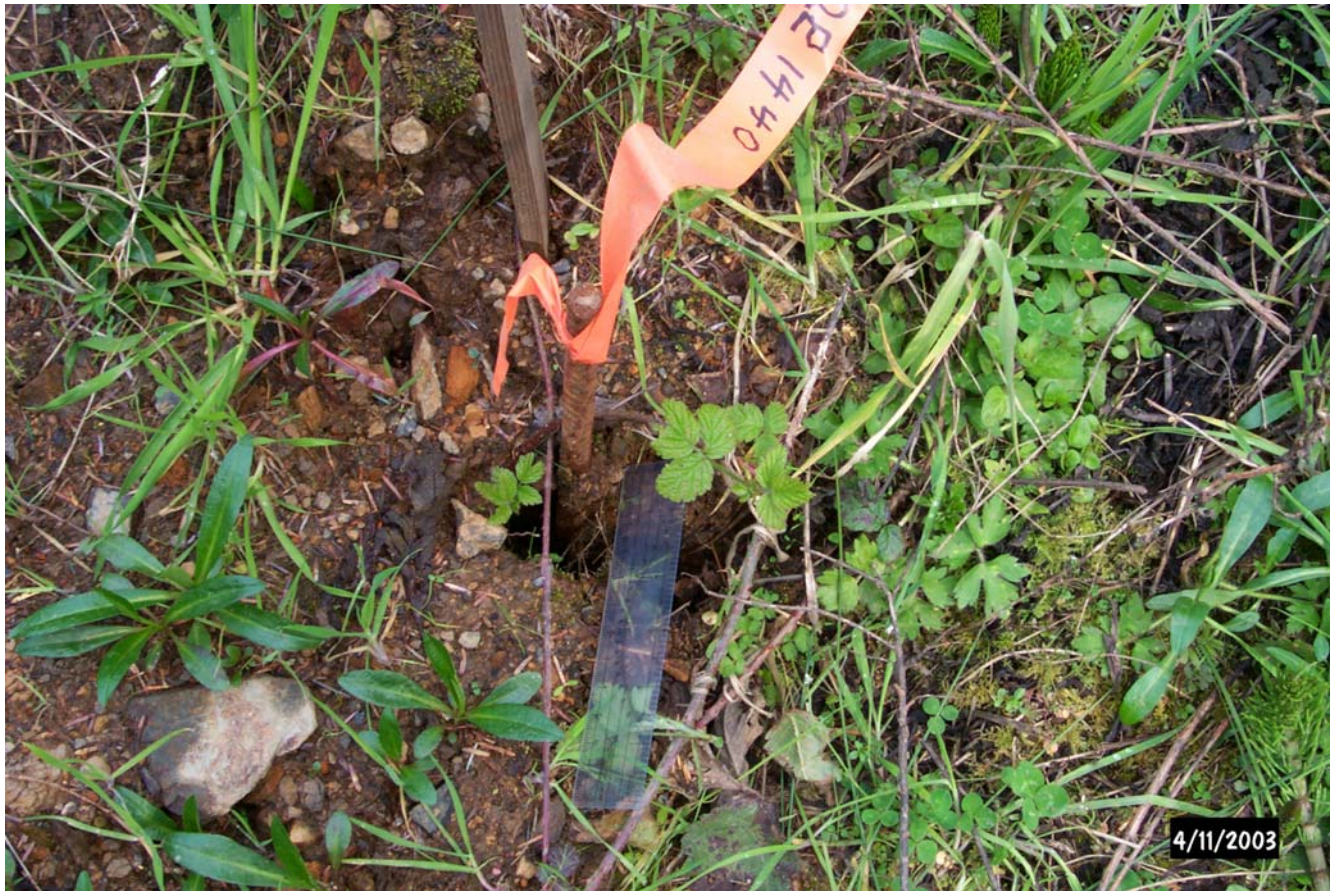
Figure 6. JC-17 site with displaced steel survey marker at headscarp, looking east.  
This stake was not used in the resurvey.

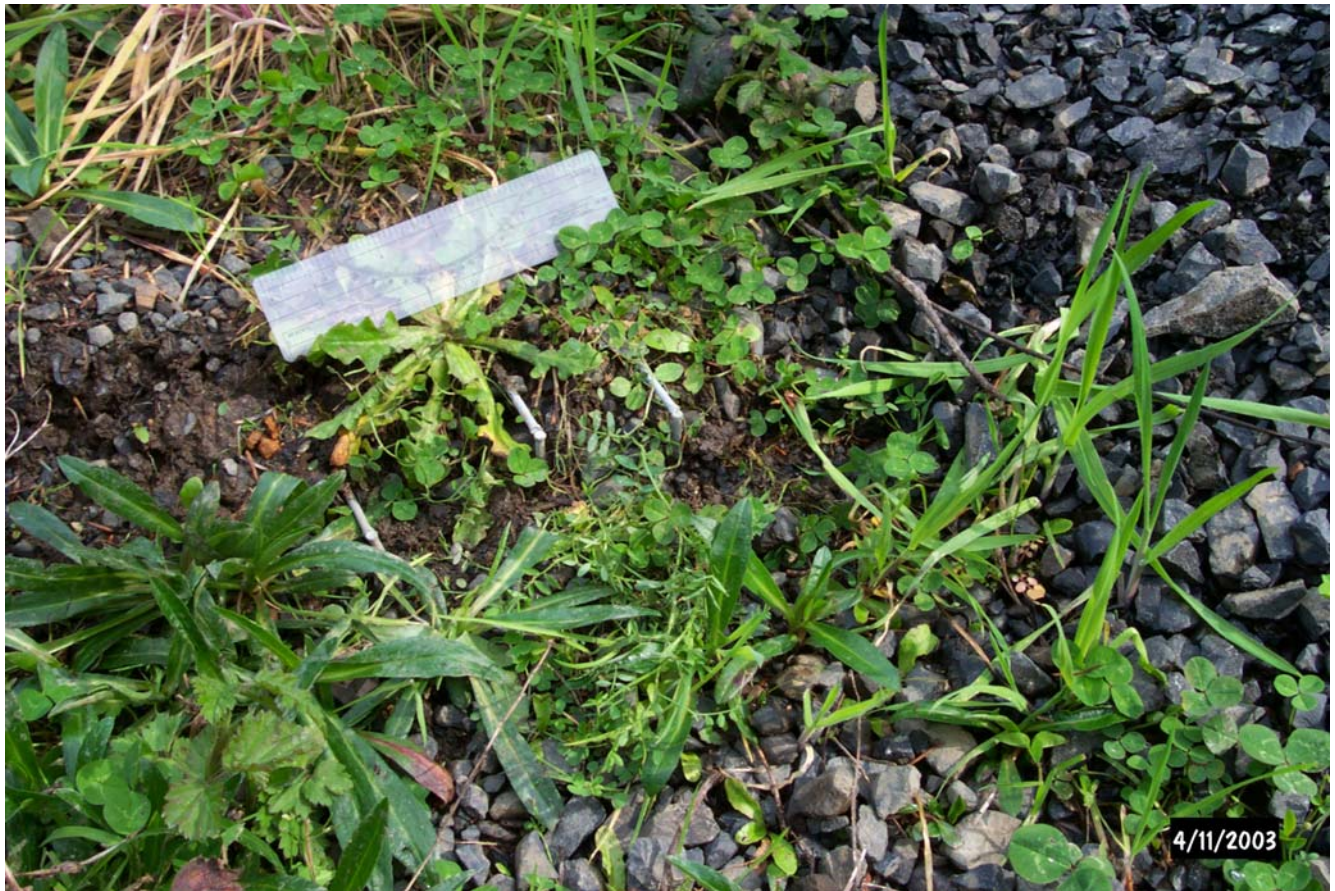
Figure 7. JC-17 site showing nail locations next to forest road, looking east southeast.  
The scarp is in gravel fill from the forest road.

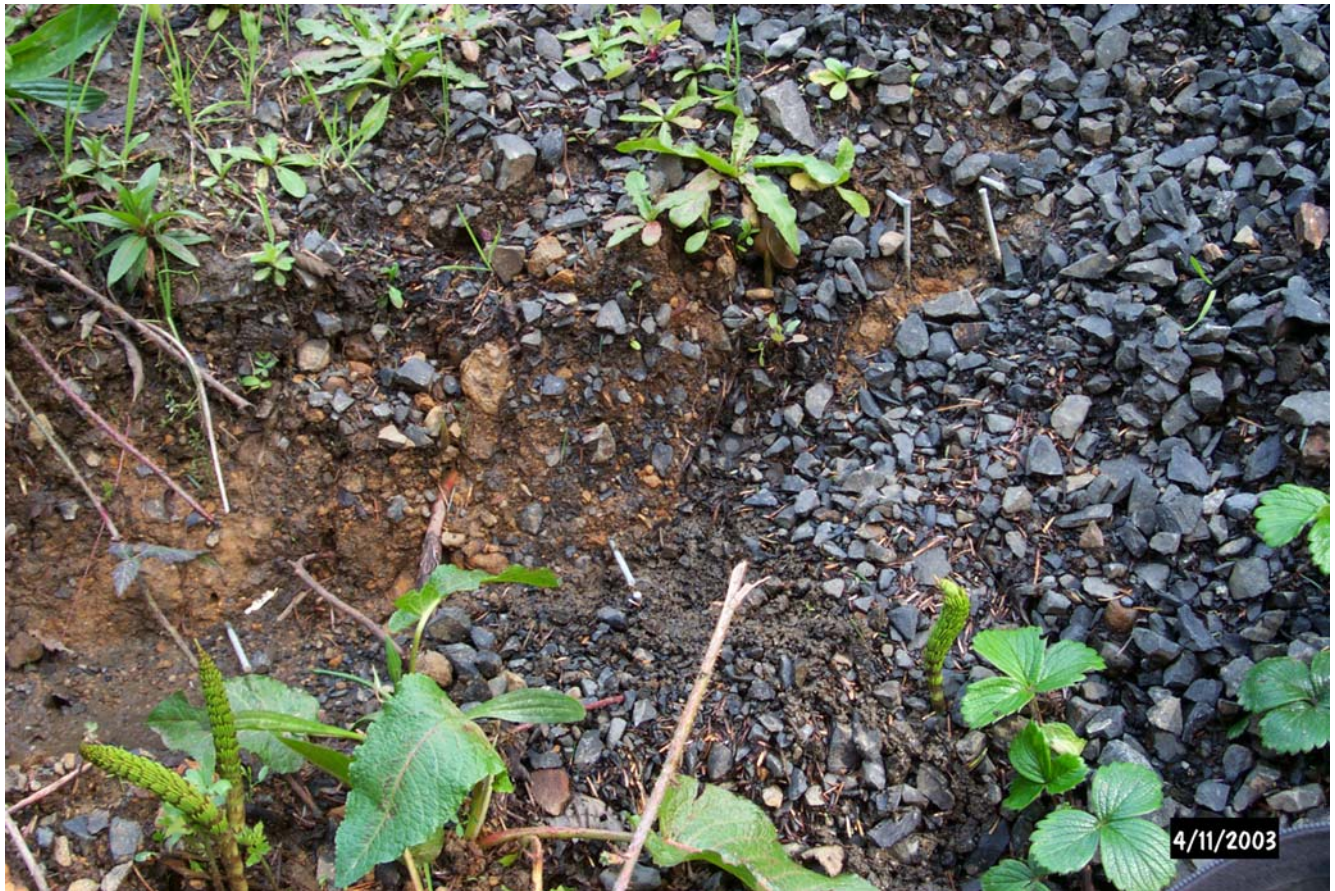
Figure 8. JC-18 site, looking southeast. The scarp is in gravel fill from the forest road. Exposed portions of the two vertical nails is on the right~1.2 cm long. Note that fresh gravel dumped on the road has disturbed the nails on the right, so that measurement was not used.

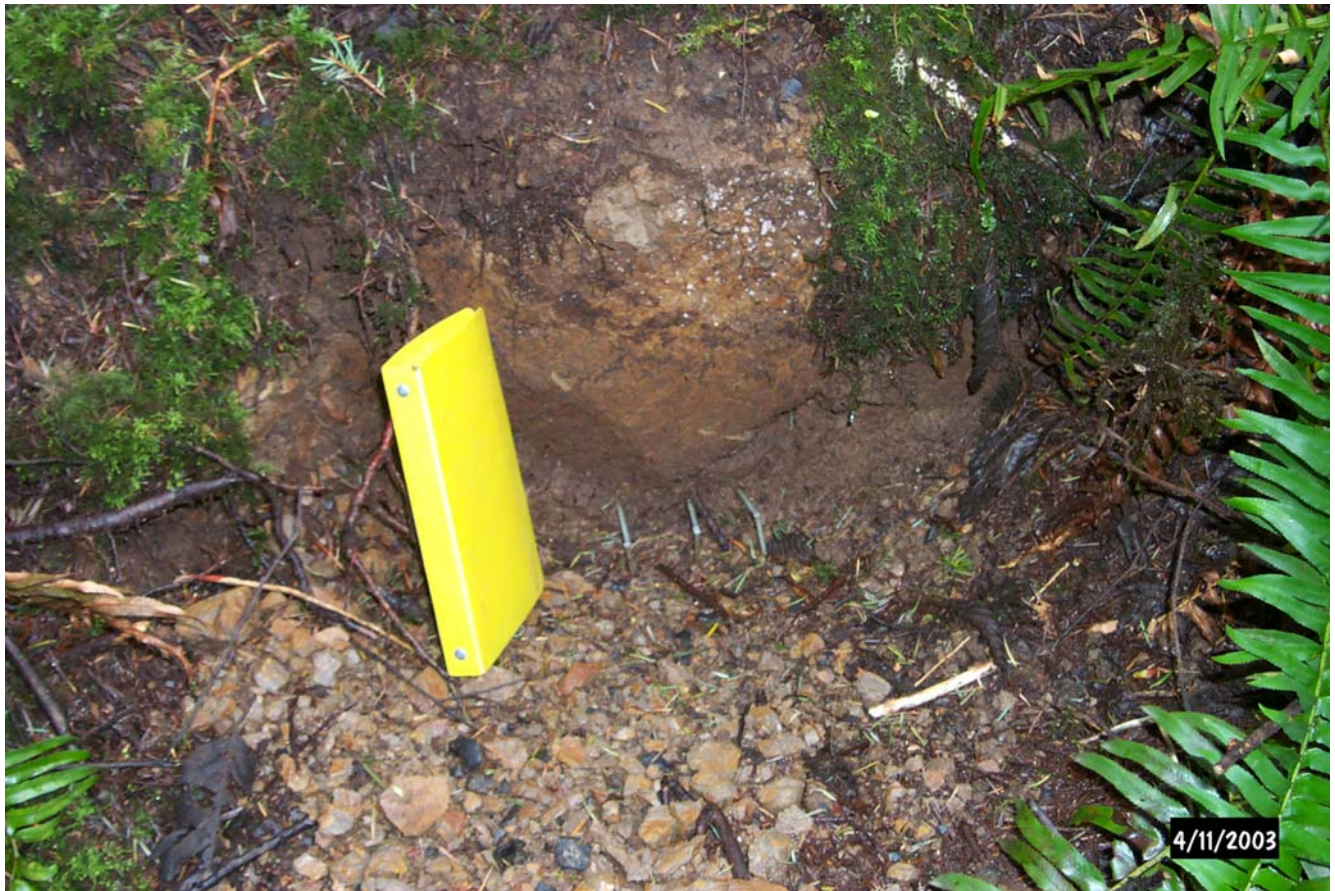
Figure 9. JC-19 location looking south. Yellow field book is ~19 cm long. Note that all nail heads are still touching in this April photograph, so no significant movement occurred. Scarp is in relatively fresh Astoria Formation siltstone and sandstone with a thin covering of gravel from the Old Coast Highway.

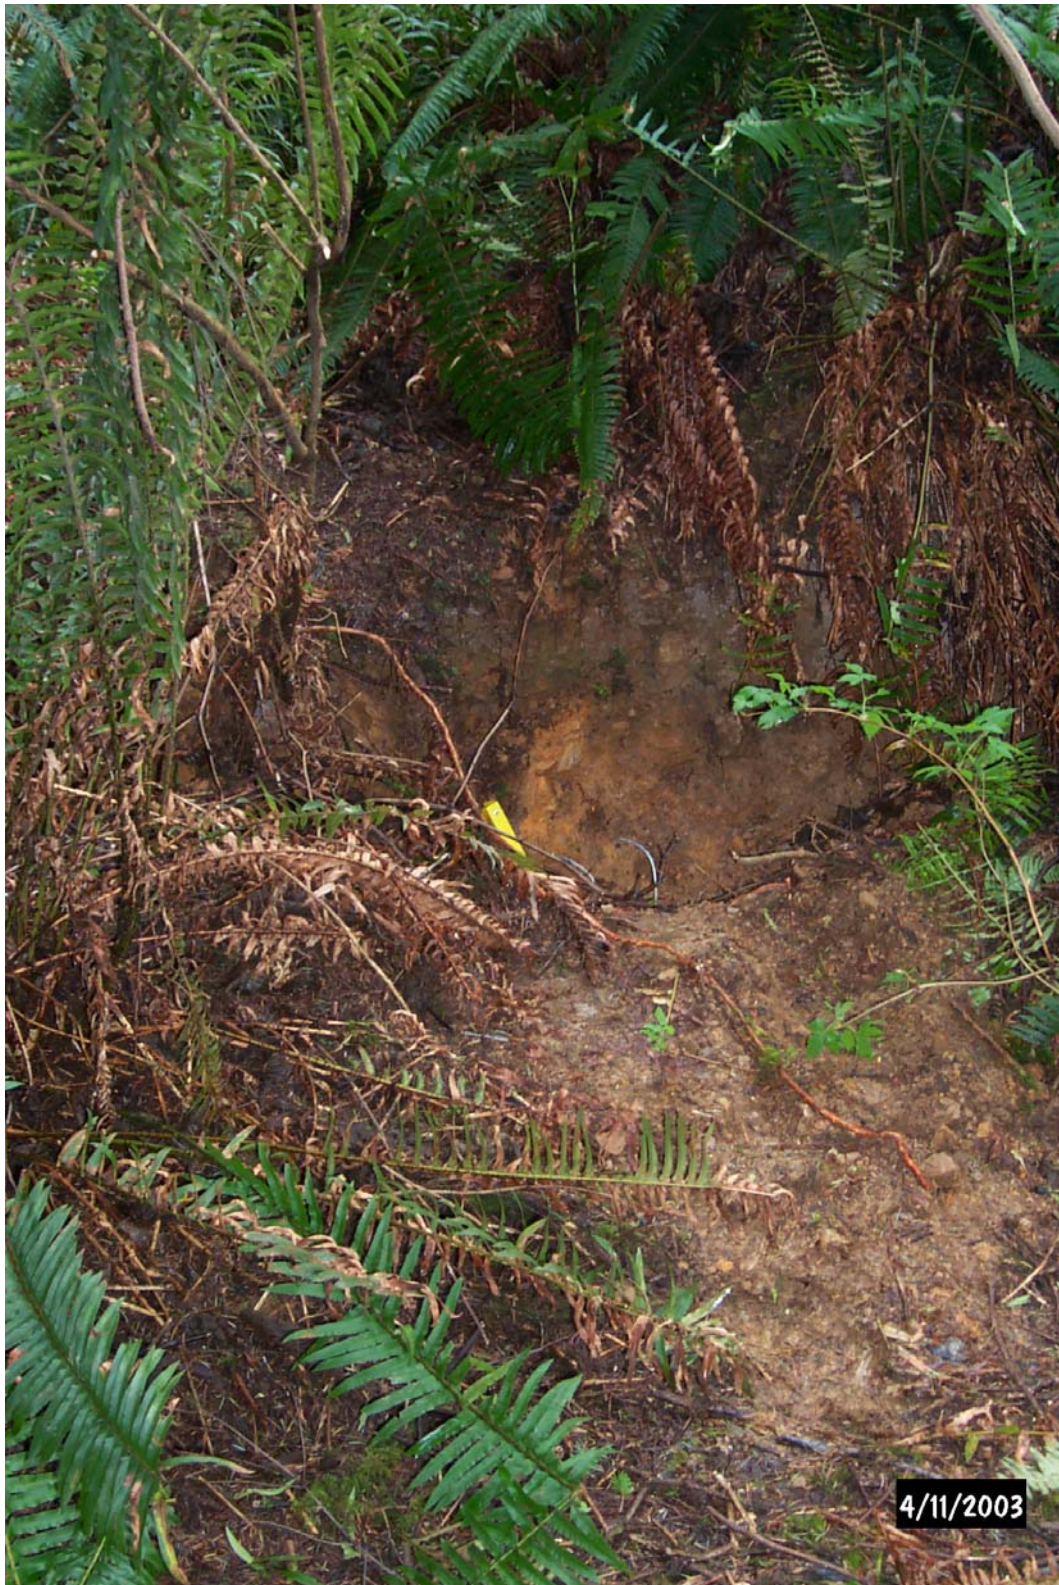
Figure 10. .JC-20 site looking south. Yellow field book is ~19 cm long. Scarp cuts Old Coast Highway. The scarp is in weathered Astoria Formation colluvium below the Old Coast Highway and some gravel fill from the adjacent private driveway.

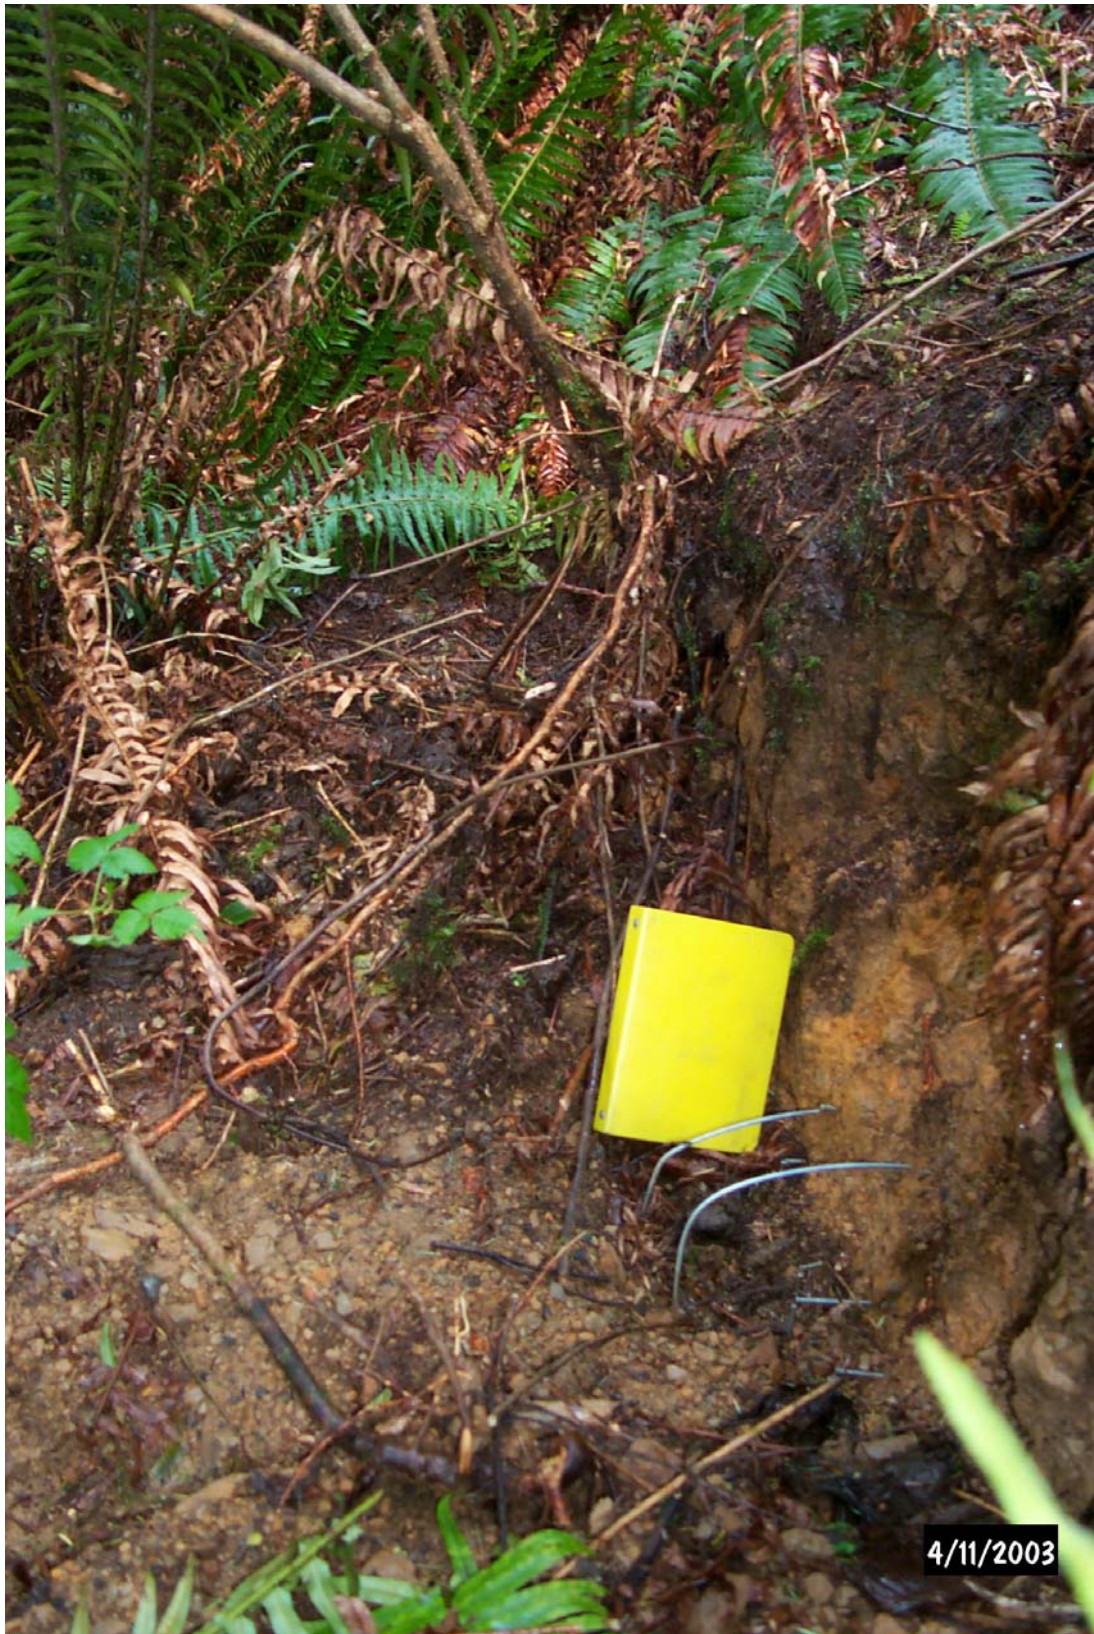
Figure 11. JC-20 site looking south. Yellow field book is ~19 cm long.

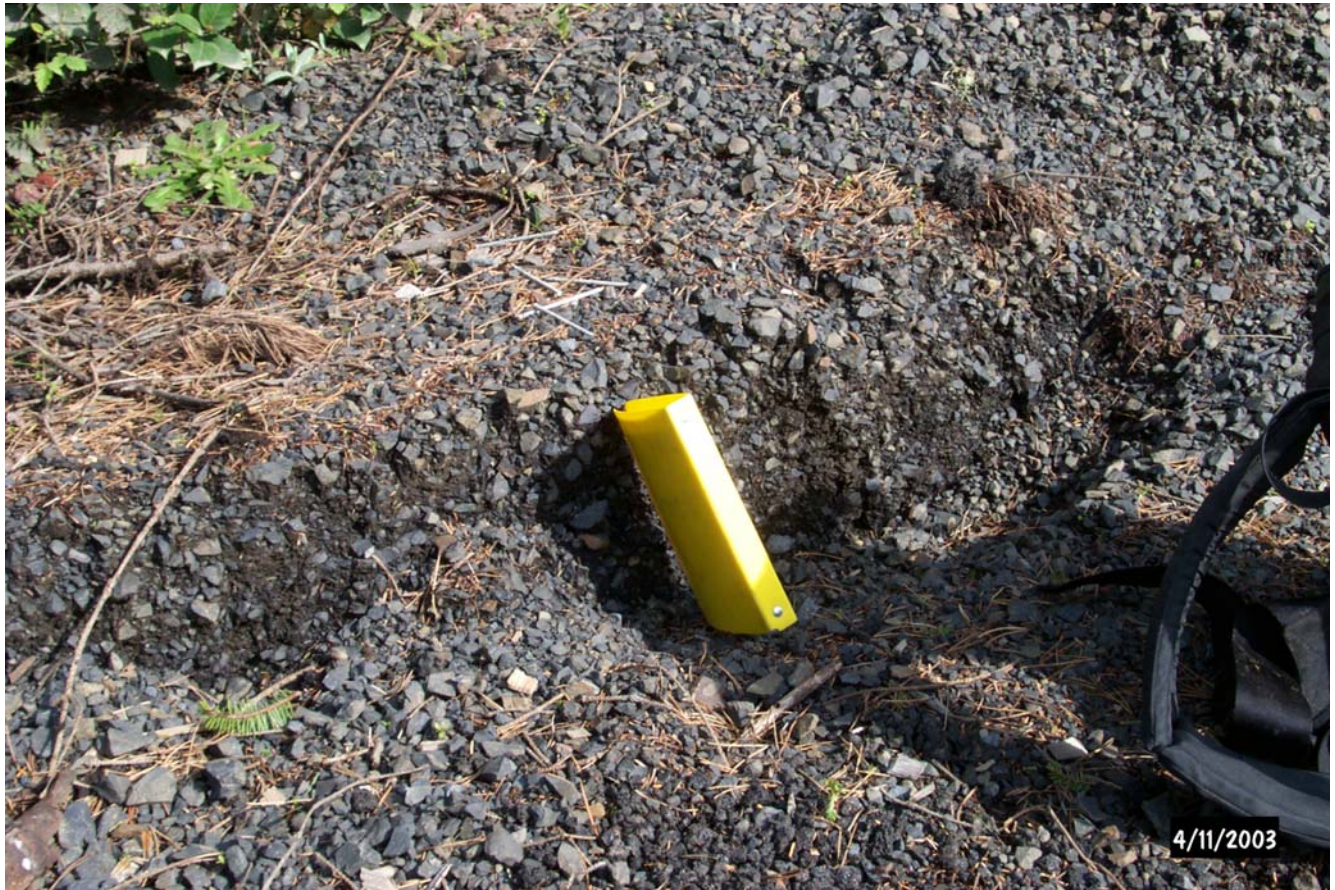
Figure 12. JC-21 site looking southeast. Yellow field book is ~19 cm long.  
The scarp is in gravel fill from the Highway 101.

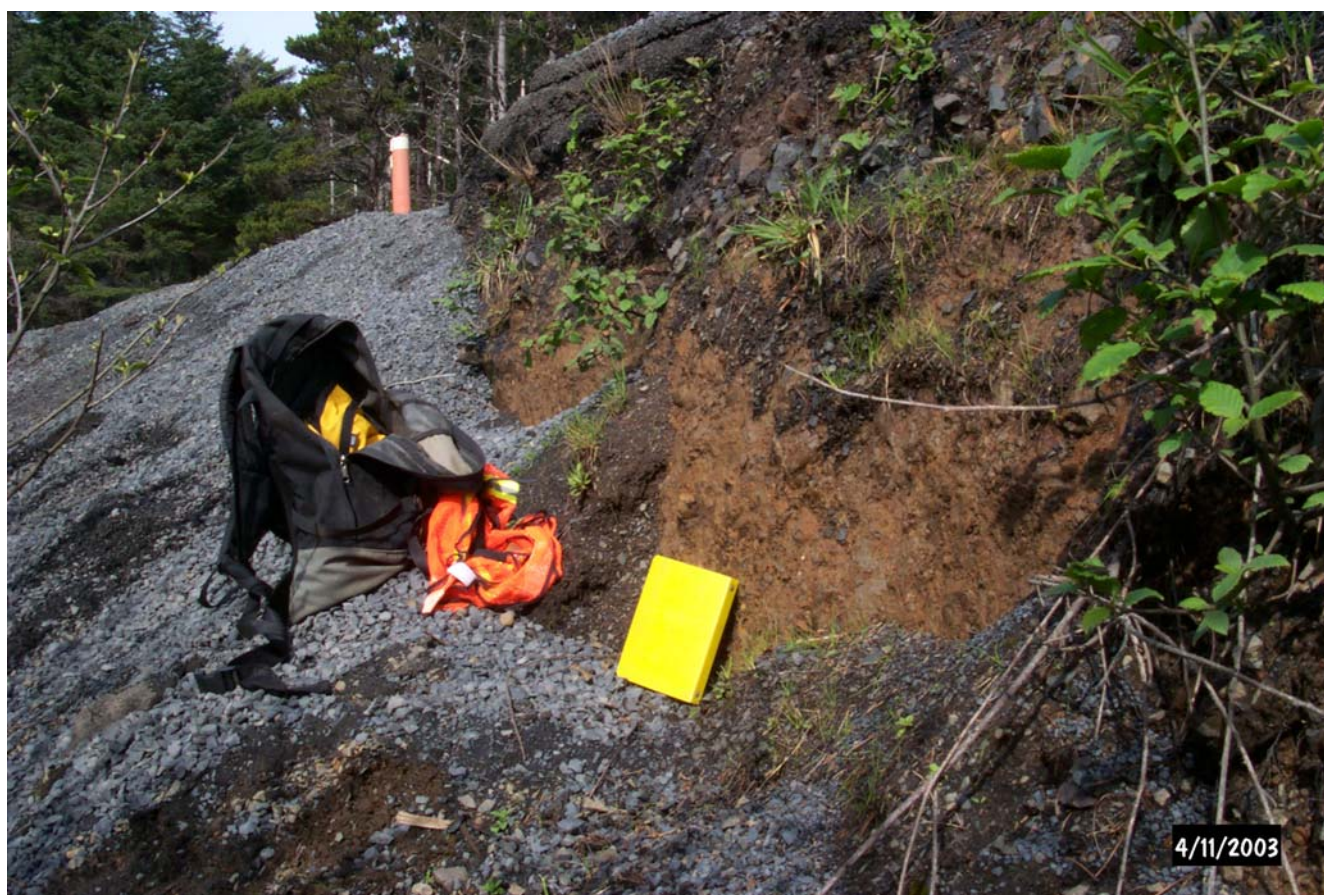
Figure 13. Sites JC-22 (near red highway cone at top of highway embankment) to JC-24 (to the right of the yellow field book) looking northeast parallel to the strike of the fresh headscarp (red orange fill of excavated Astoria Formation). Yellow field book is ~19 cm long. Near vertical portion of scarp is ~1.2 m high.
