**OPEN-FILE REPORT  
OFR O-06-02**

**INTERIM REPORT:  
JOHNSON CREEK LANDSLIDE PROJECT,  
LINCOLN COUNTY, OREGON**

By  
George R. Priest<sup>1</sup>, Jonathan Allan<sup>1</sup>, Alan Niem<sup>1</sup>, Samuel R. Christie<sup>2</sup>, and Stephen E. Dickenson<sup>2</sup>

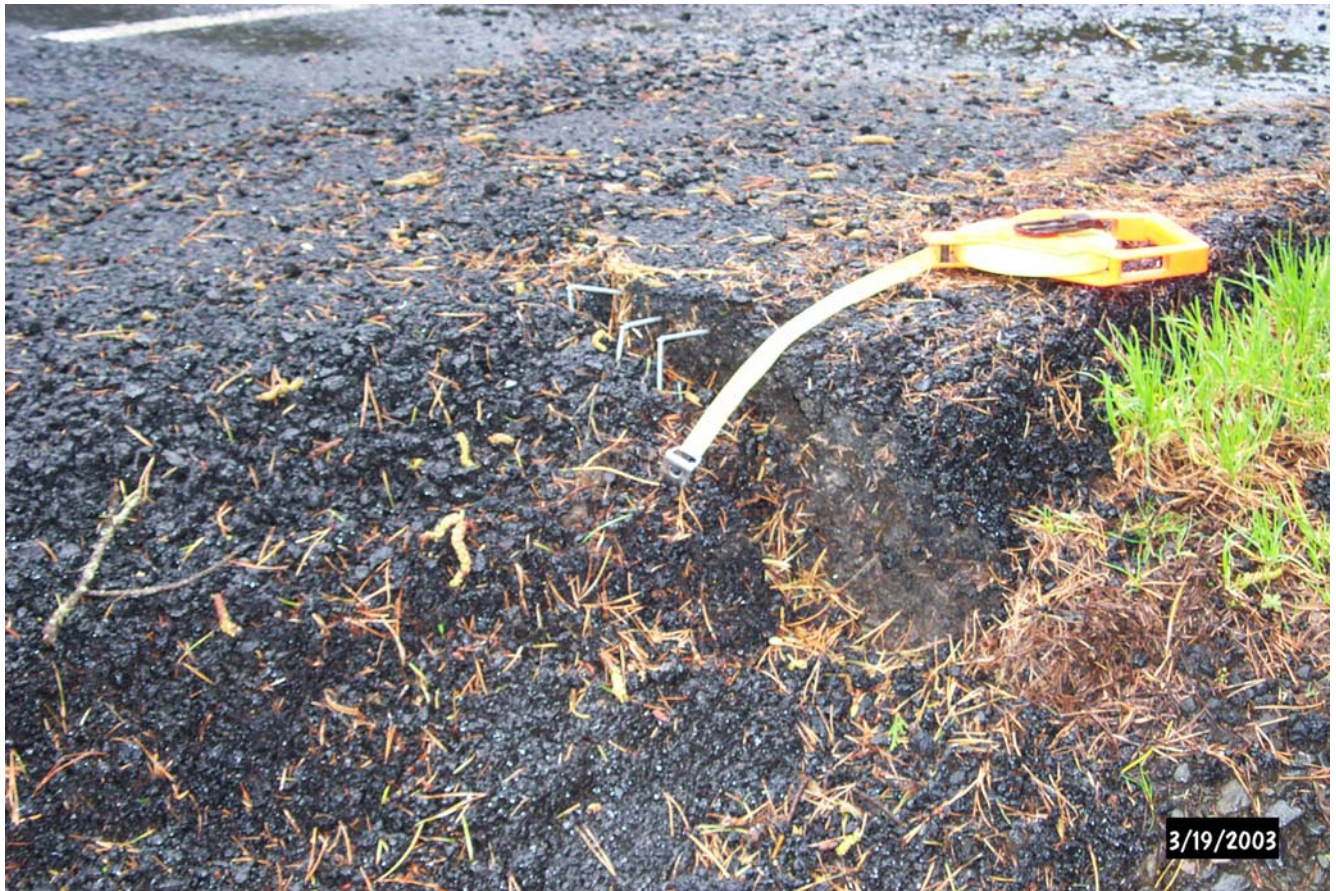
Figure 14. JC-22 site looking southeast on west side of Highway 101. Scarp is asphalt and gravel.

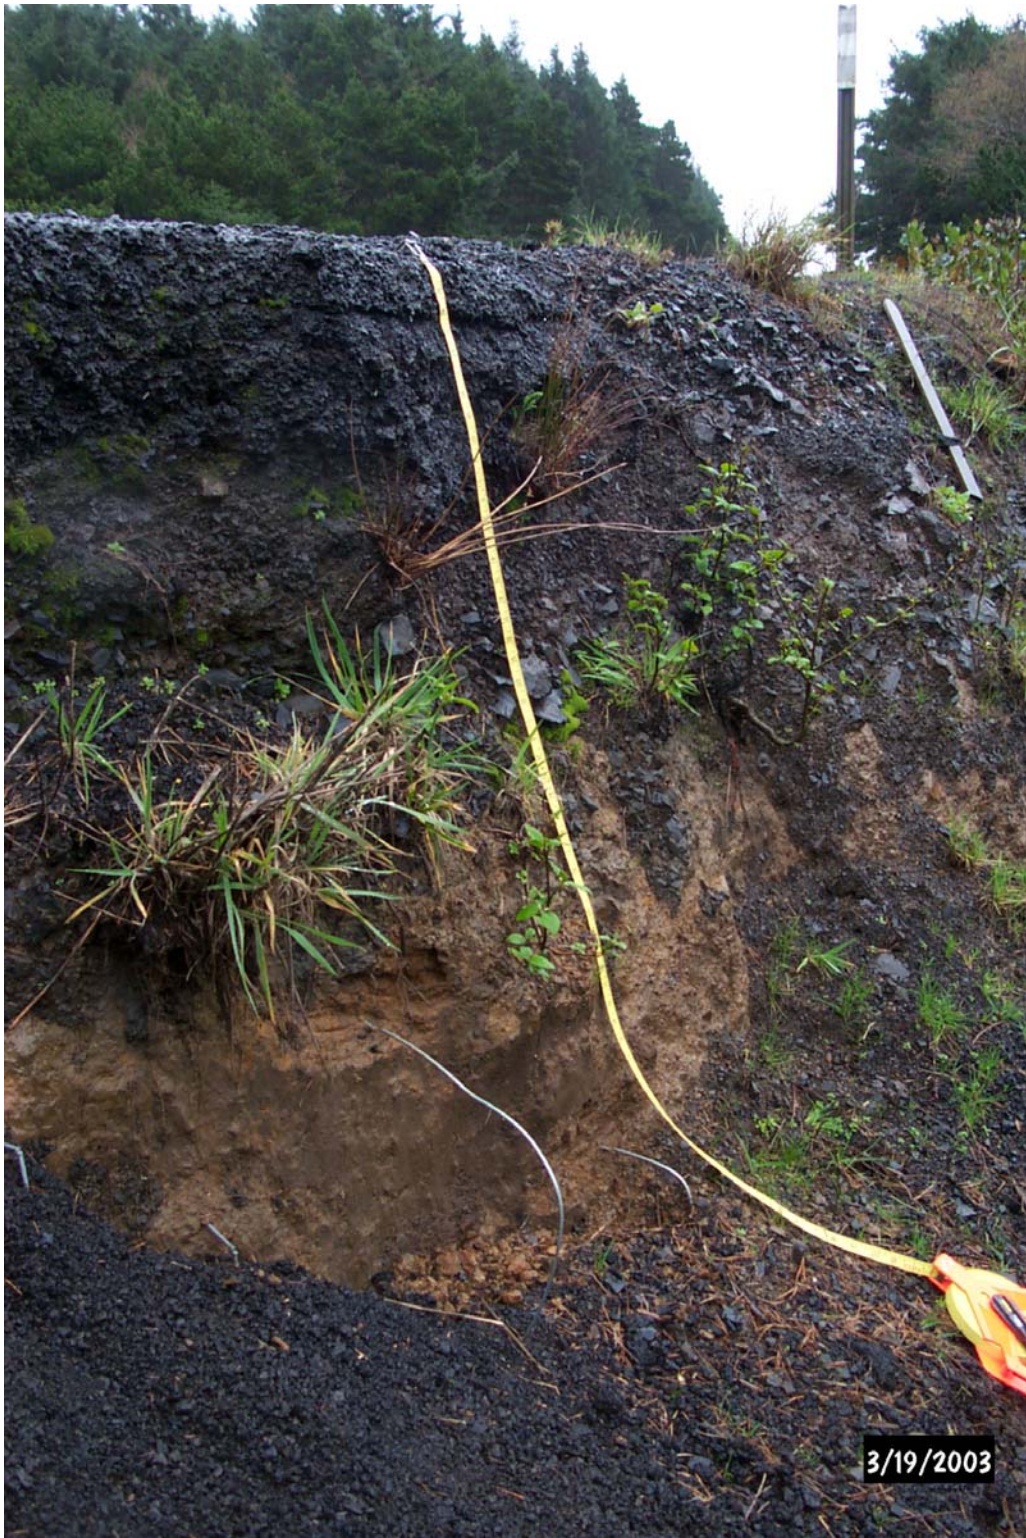
Figure 15. JC-23 site with both wires and nails, looking south southeast. Scarp is in red orange fill of excavated Astoria Formation overlain by gravel and asphalt. Near vertical portion of scarp is ~1.2 m high.

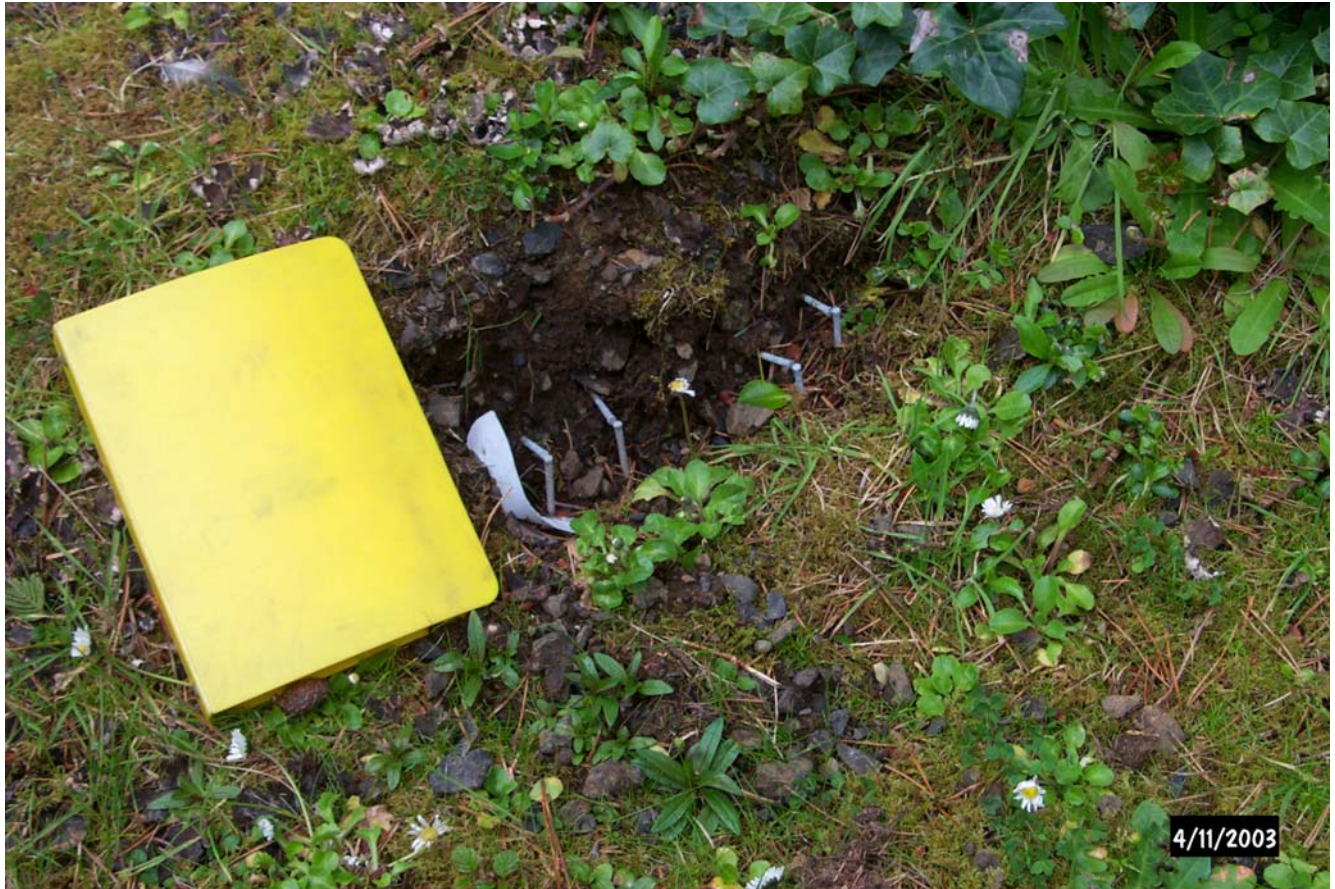
Figure 16. JC-23 site on north margin of the landslide looking east southeast.  
Yellow field book is ~19 cm long.

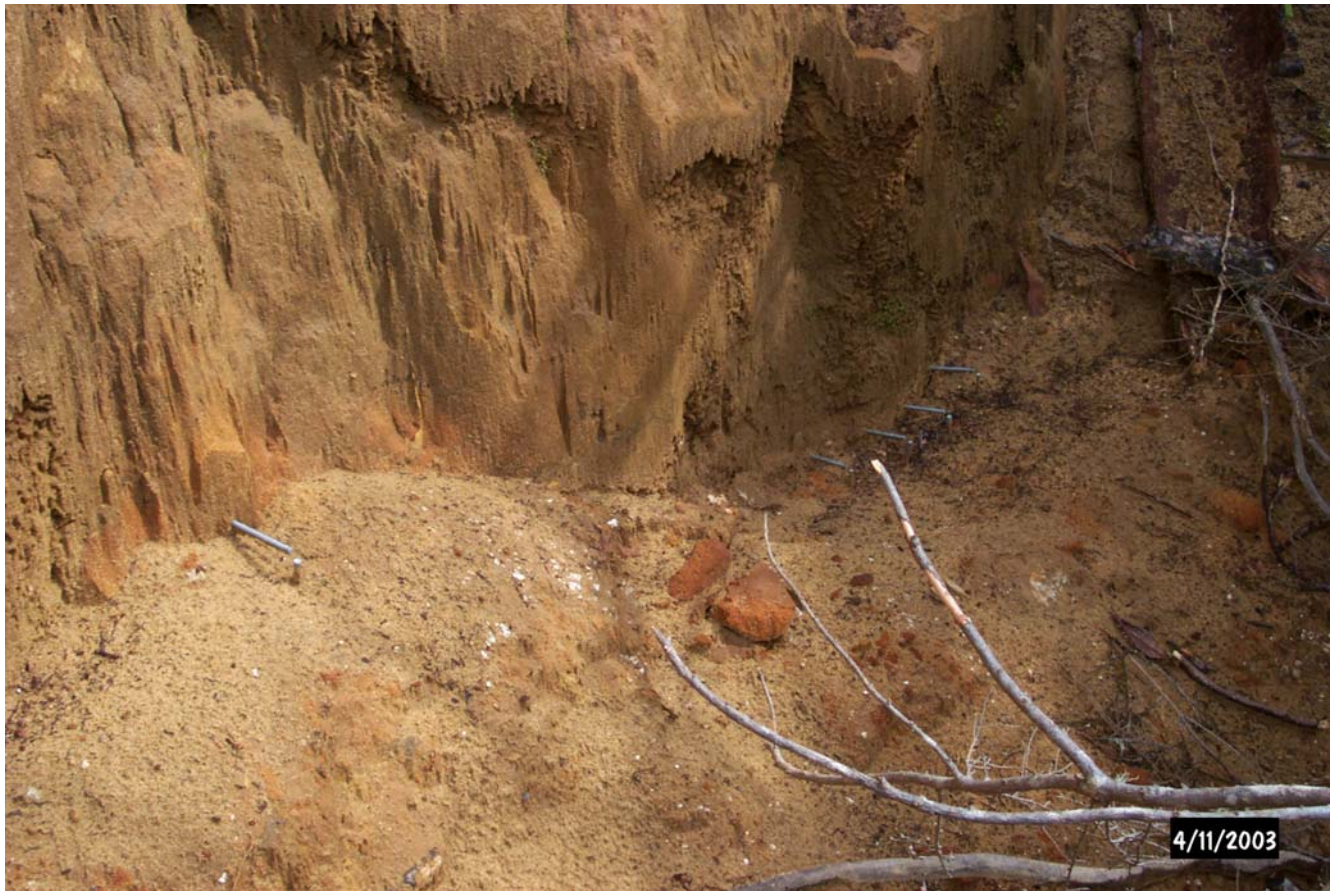
Figure 17. JC-24 site looking southeast. This is the northeast headwall of the landslide. The tan unit in the near vertical escarpment is Pleistocene marine terrace sand.  
Talus lies along the base of the slope.

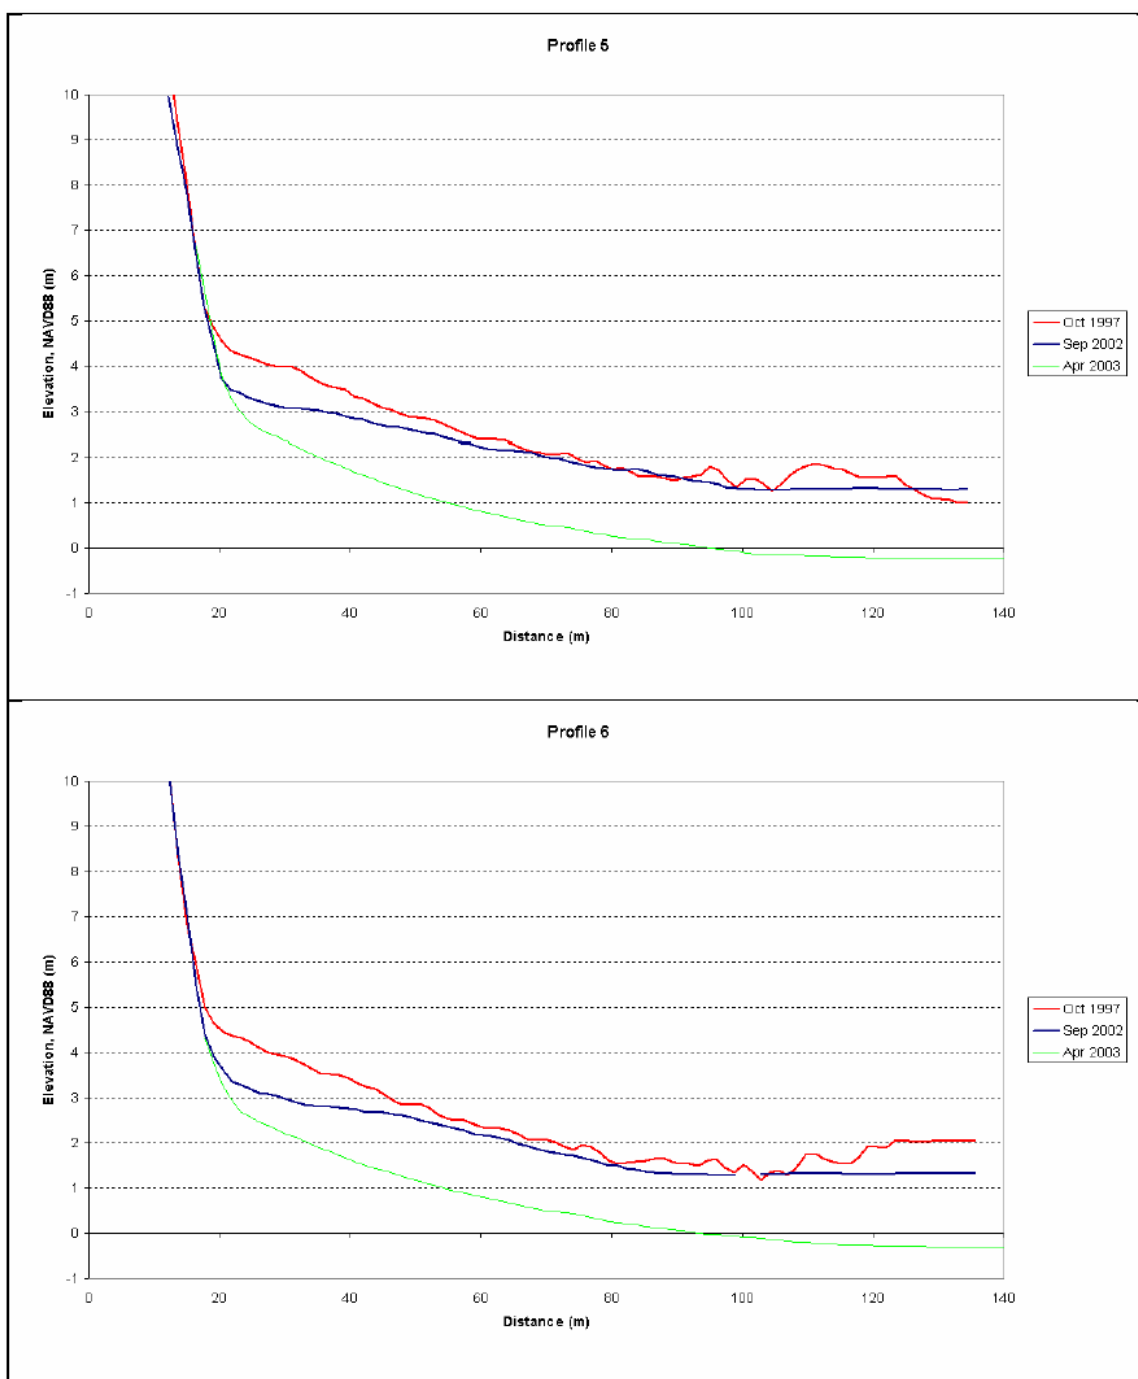
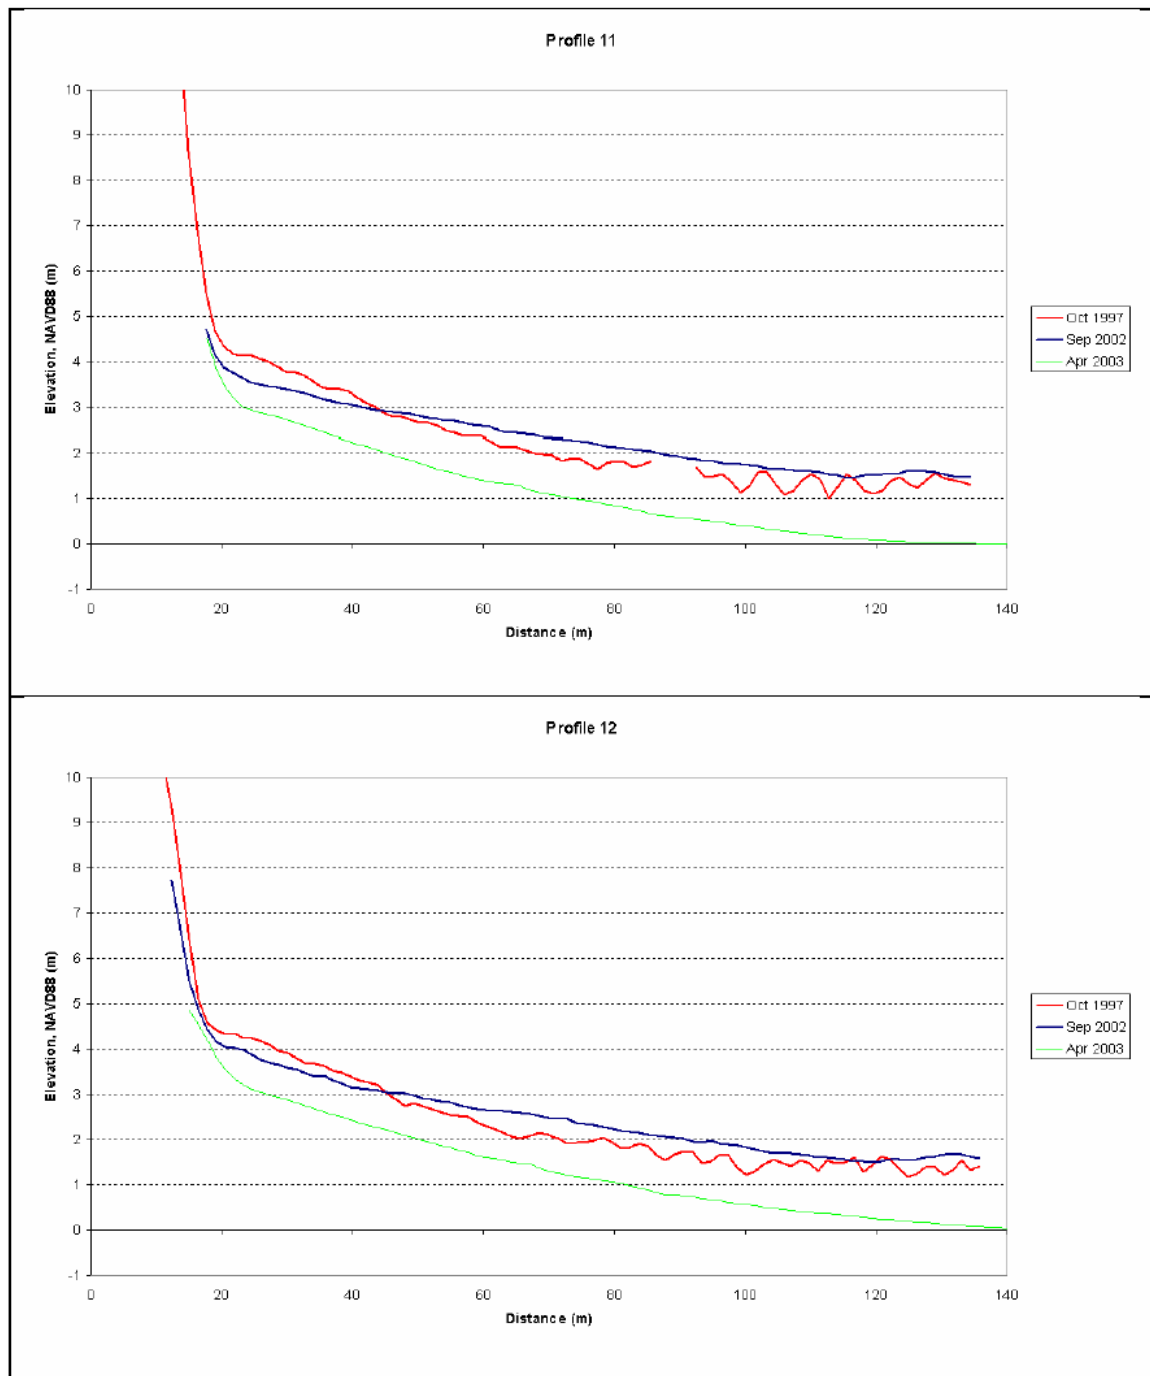
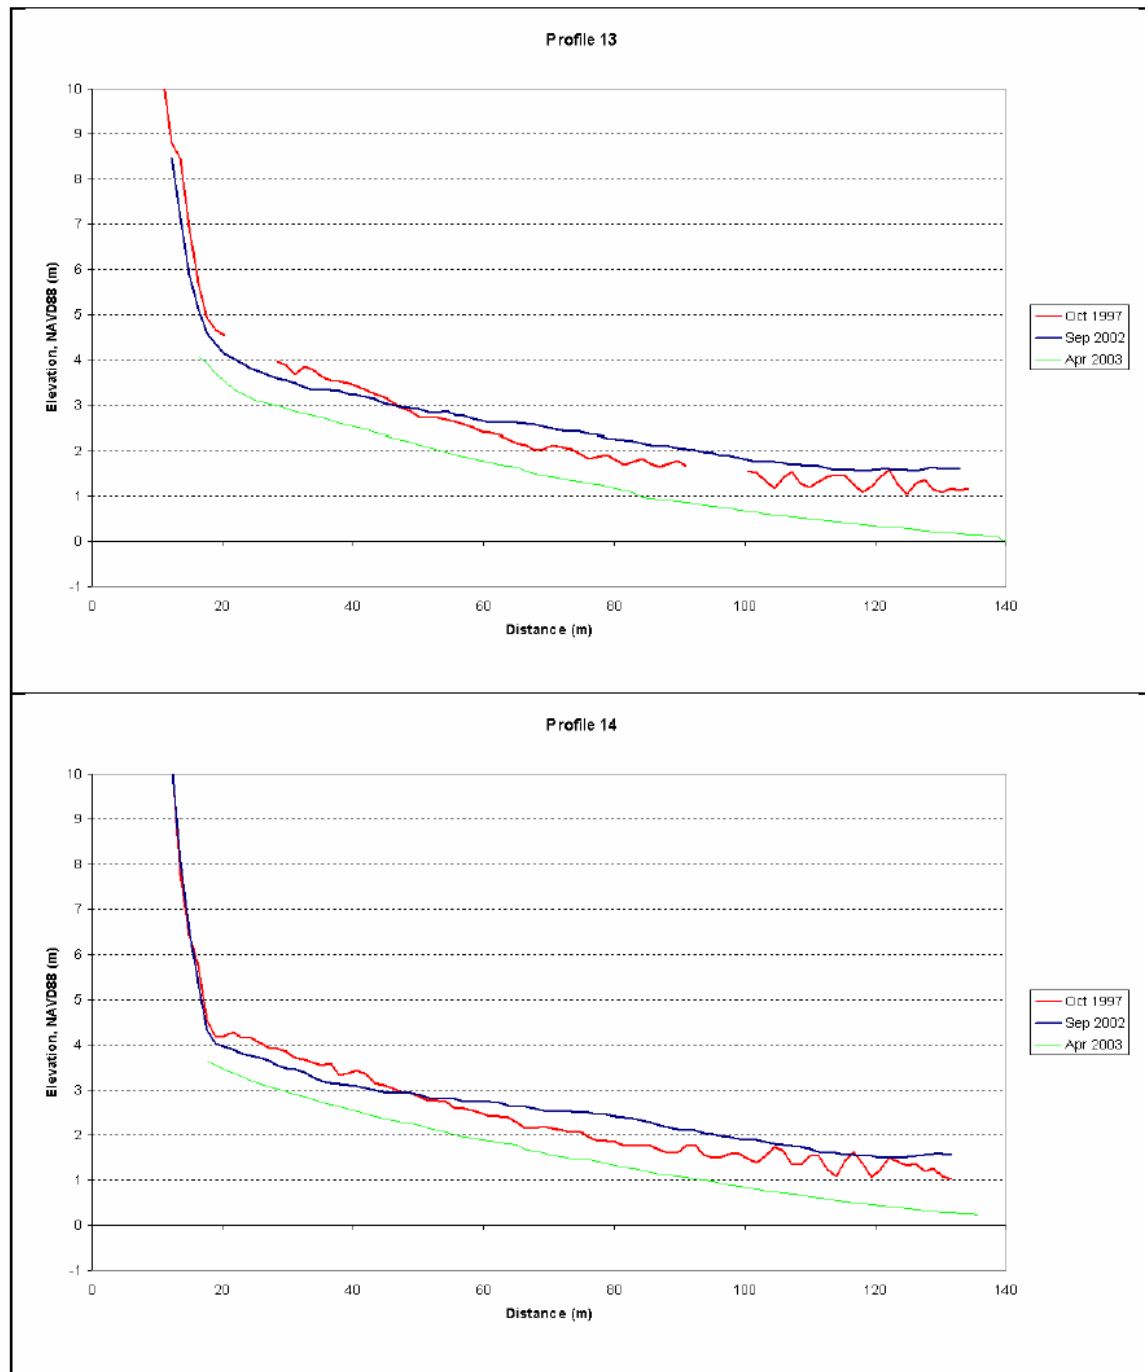
Figure 3A. Beach profile survey derived from LIDAR data and from the April 2003 topographic survey.

Figure 3B. Beach profile survey derived from LIDAR data and from the April 2003 topographic survey.

Figure 3C. Beach profile survey derived from LIDAR data and from the April 2003 topographic survey.

Figure 3D. Beach profile survey derived from LIDAR data and from the April 2003 topographic survey.

Figure 3E. Beach profile survey derived from LIDAR data and from the April 2003 topographic survey.

Figure 3F. Beach profile survey derived from LIDAR data and from the April 2003 topographic survey.

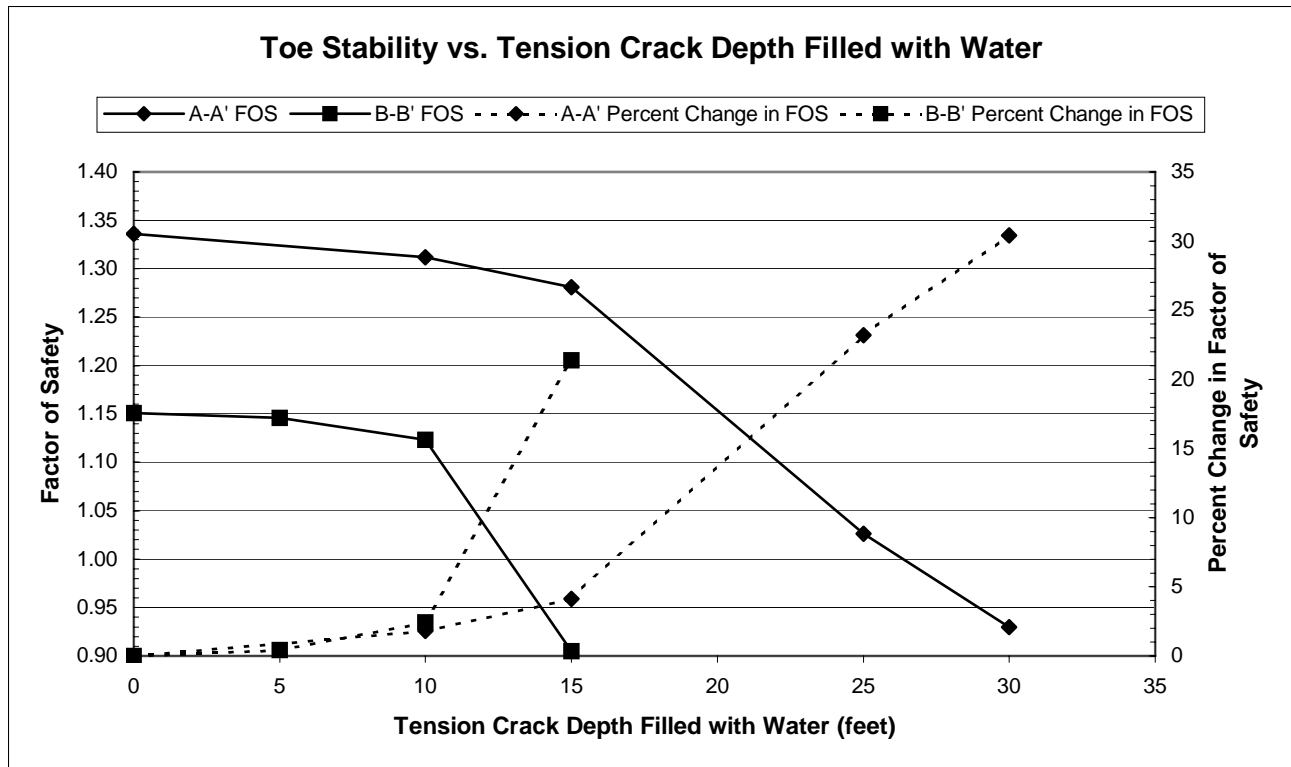
**Figure 7.** Analysis of Toe Stability with Varying Tension Crack Depth Filled with Water.

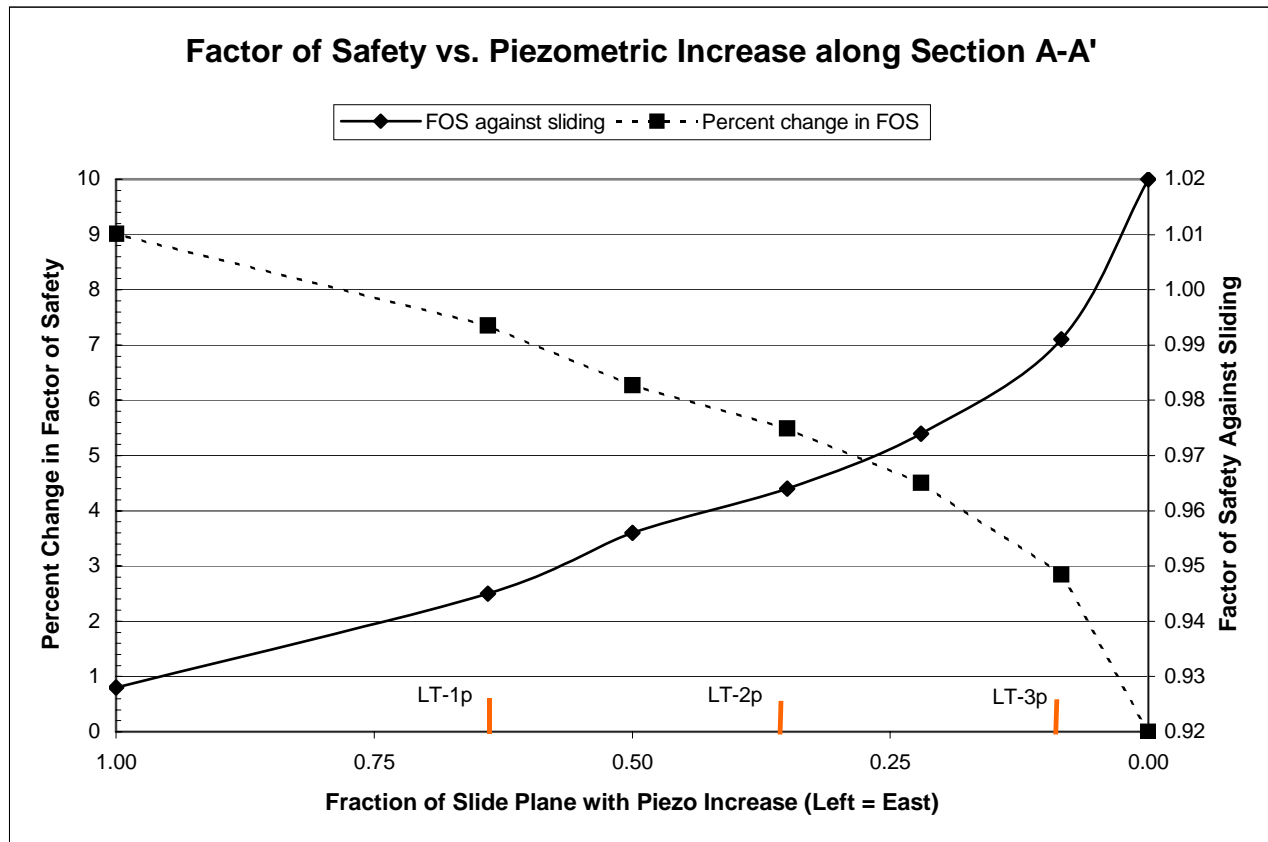
**Figure 9.** Factor of Safety versus Piezometric Increase along Shear Zone A-A'.  
(Note that left is actually west in this diagram).
