Rapid Visual Screening of Buildings for Potential Seismic Hazards

A Handbook

FEMA 154, Edition 2 / March 2002

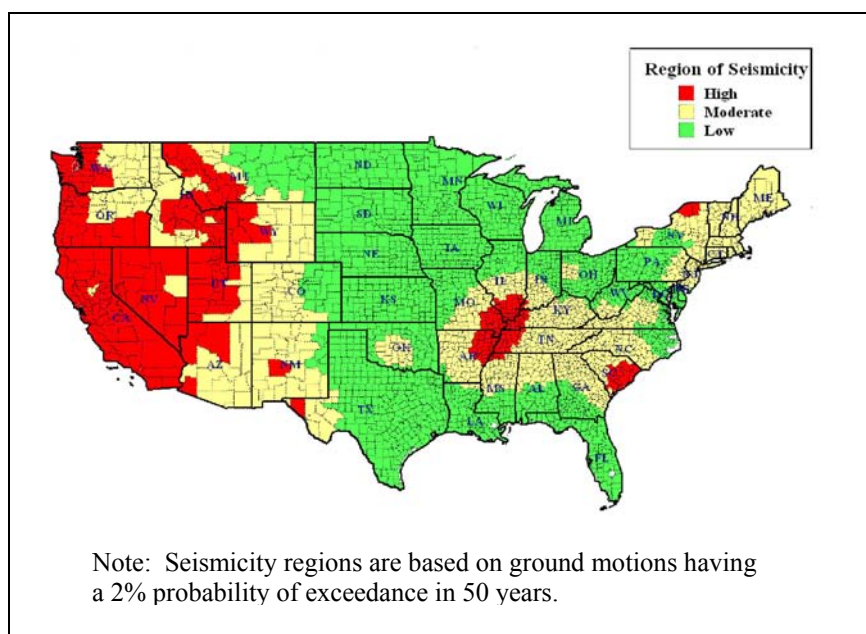
Figure 1-1 High, moderate, and low seismicity regions of the conterminous United States. A different RVS Data Collection Form has been developed for each of these regions. Enlarged maps are available in Appendix A.

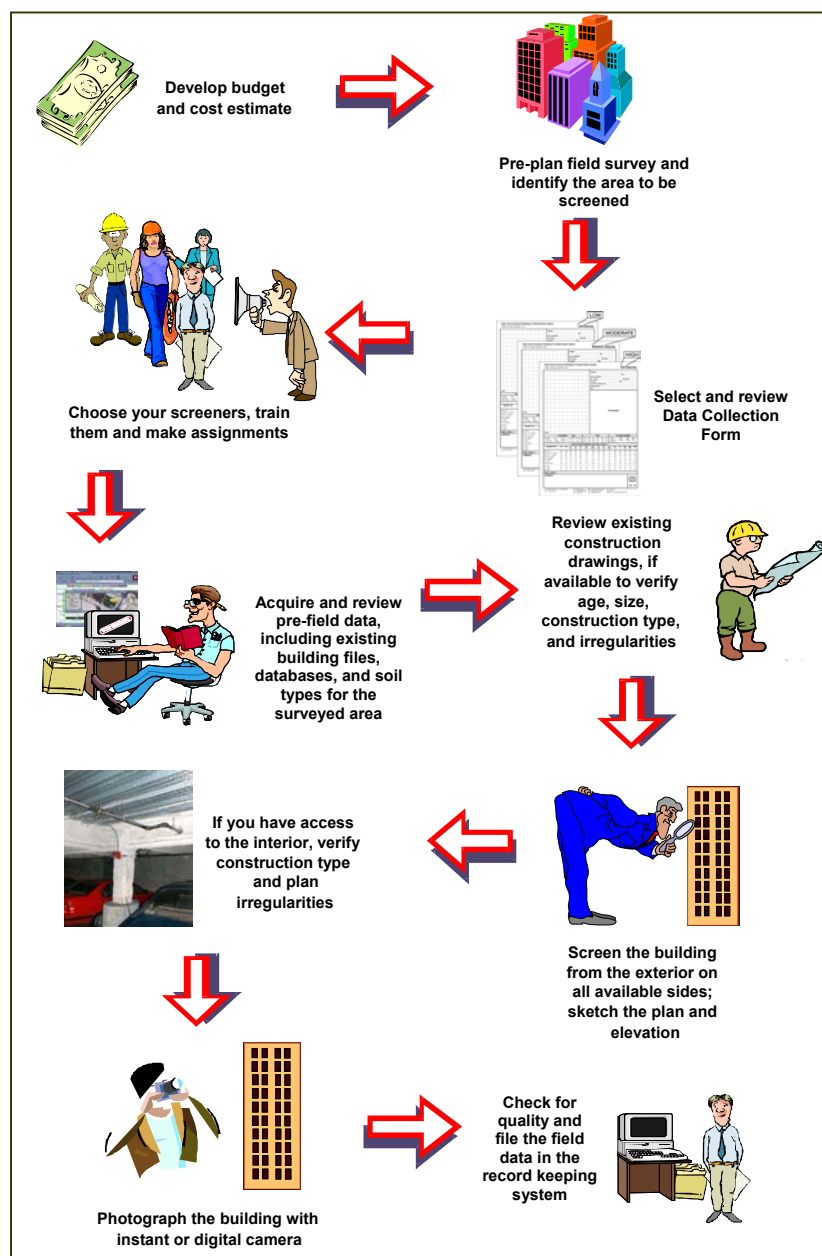
Figure 2-1 Rapid visual screening implementation sequence.

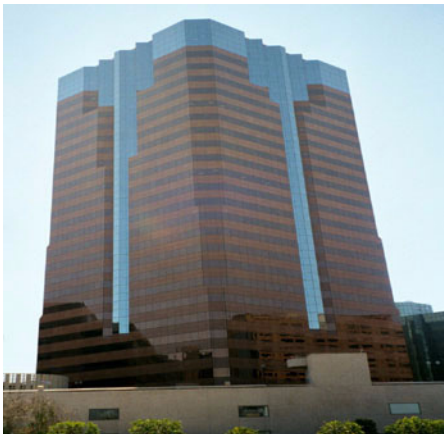
<i>Building Identifier</i>	<i>Photograph</i>	<i>Basic Structural Hazard Score</i>	<i>Characteristics and Performance</i>
S1 Steel moment-resisting frame

H = 2.8 M = 3.6 L = 4.6	<ul style="list-style-type: none"> • Typical steel moment-resisting frame structures usually have similar bay widths in both the transverse and longitudinal directions, around 20-30 ft. • The floor diaphragms are usually concrete, sometimes over steel decking. This structural type is used for commercial, institutional and public buildings. • The 1994 Northridge and 1995 Kobe earthquakes showed that the welds in steel moment-frame buildings were vulnerable to severe damage. The damage took the form of broken connections between the beams and columns.
S2 Braced steel frame

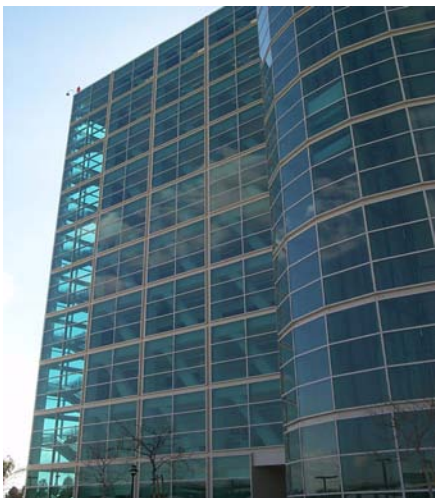
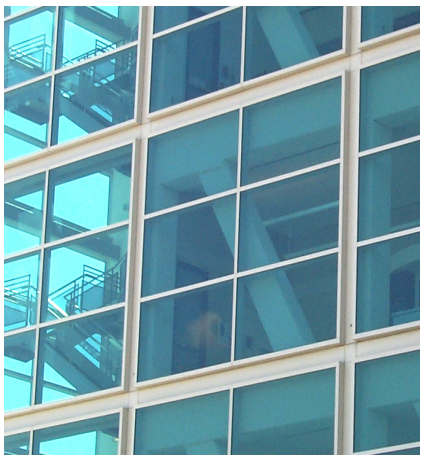
Zoom-in of upper photo	H = 3.0 M = 3.6 L = 4.8	<ul style="list-style-type: none"> • These buildings are braced with diagonal members, which usually cannot be detected from the building exterior. • Braced frames are sometimes used for long and narrow buildings because of their stiffness. • From the building exterior, it is difficult to tell the difference between steel moment frames, steel braced frames, and steel frames with interior concrete shear walls. • In recent earthquakes, braced frames were found to have damage to brace connections, especially at the lower levels.

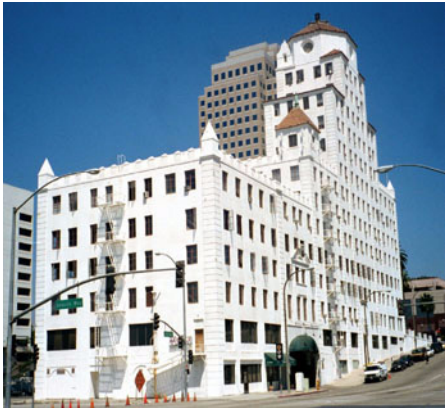
H = 2.8 M = 3.6 L = 4.8	<ul style="list-style-type: none"> • Lateral loads are resisted by shear walls, which usually surround elevator cores and stairwells, and are covered by finish materials. • An interior investigation will permit a wall thickness check. More than six inches in thickness usually indicates a concrete wall. • Shear cracking and distress can occur around openings in concrete shear walls during earthquakes. • Wall construction joints can be weak planes, resulting in wall shear failure below expected capacity.

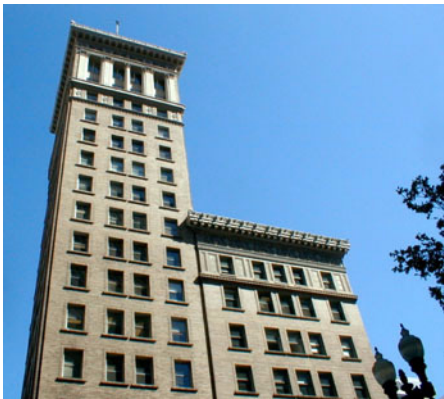
<i>Building Identifier</i>	<i>Photograph</i>	<i>Basic Structural Hazard Score</i>	<i>Characteristics and Performance</i>
S5 Steel frames with unreinforced masonry infill walls

H = 2.0 M = 3.6 L = 5.0	<ul style="list-style-type: none"> Steel columns are relatively thin and may be hidden in walls. Usually masonry is exposed on exterior with narrow piers (less than 4 ft wide) between windows. Portions of solid walls will align vertically. Infill walls are usually two to three wythes thick. Veneer masonry around columns or beams is usually poorly anchored and detaches easily.
C1 Concrete moment-resisting frames

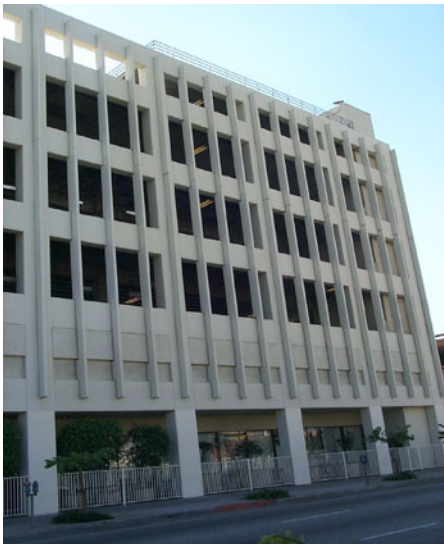
H = 2.5 M = 3.0 L = 4.4	<ul style="list-style-type: none"> All exposed concrete frames are reinforced concrete (not steel frames encased in concrete). A fundamental factor governing the performance of concrete moment-resisting frames is the level of ductile detailing. Large spacing of ties in columns can lead to a lack of concrete confinement and shear failure. Lack of continuous beam reinforcement can result in hinge formation during load reversal. The relatively low stiffness of the frame can lead to substantial nonstructural damage. Column damage due to pounding with adjacent buildings can occur.

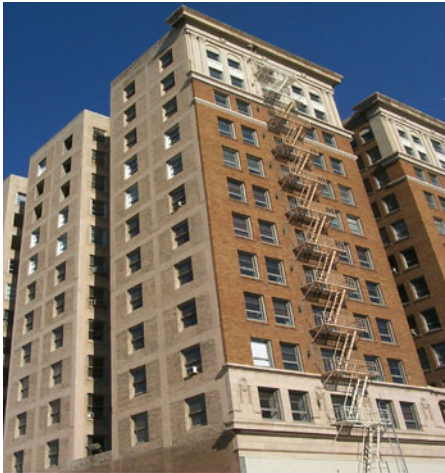
H = 1.6 M = 3.2 L = 4.4	<ul style="list-style-type: none"> Concrete columns and beams may be full wall thickness and may be exposed for viewing on the sides and rear of the building. Usually masonry is exposed on the exterior with narrow piers (less than 4 ft wide) between windows. Portions of solid walls will align vertically. This type of construction was generally built before 1940 in high-seismicity regions but continues to be built in other regions. Infill walls tend to buckle and fall out-of-plane when subjected to strong lateral out-of-plane forces. Veneer masonry around columns or beams is usually poorly anchored and detaches easily.

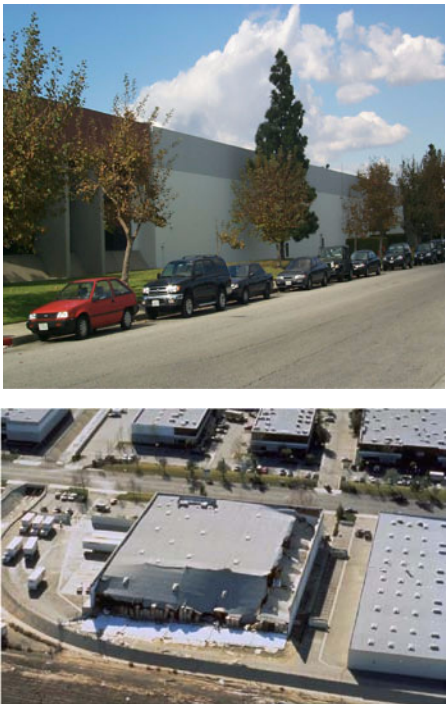
<p>Partial roof collapse due to failed diaphragm-to-wall connection</p>	<p>H = 2.6 M = 3.2 L = 4.4</p>	<ul style="list-style-type: none"> • Tilt-ups are typically one or two stories high and are basically rectangular in plan. • Exterior walls were traditionally formed and cast on the ground adjacent to their final position, and then “tilted-up” and attached to the floor slab. • The roof can be a plywood diaphragm carried on wood purlins and glulam beams or a light steel deck and joist system, supported in the interior of the building on steel pipe columns. • Weak diaphragm-to-wall anchorage results in the wall panels falling and the collapse of the supported diaphragm (or roof).

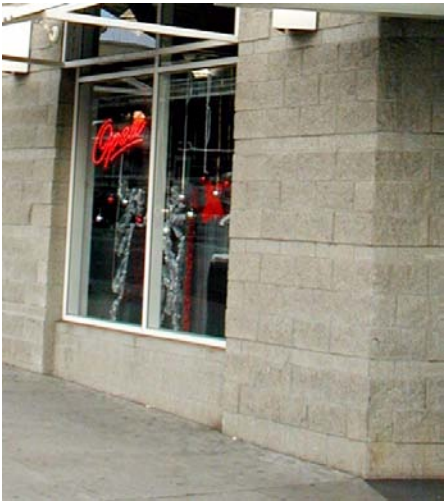
<p>Detail showing reinforced masonry</p>	<p>H = 2.8 M = 3.6 L = 4.8</p>	<ul style="list-style-type: none"> • Walls are either brick or concrete block. • Wall thickness is usually 8 inches to 12 inches. • Interior inspection is required to determine if diaphragms are flexible or rigid. • The most common floor and roof systems are wood, light steel, or precast concrete. • These buildings can perform well in moderate earthquakes if they are adequately reinforced and grouted, with sufficient diaphragm anchorage. • Poor construction practice can result in ungrouted and unreinforced walls, which will fail easily.

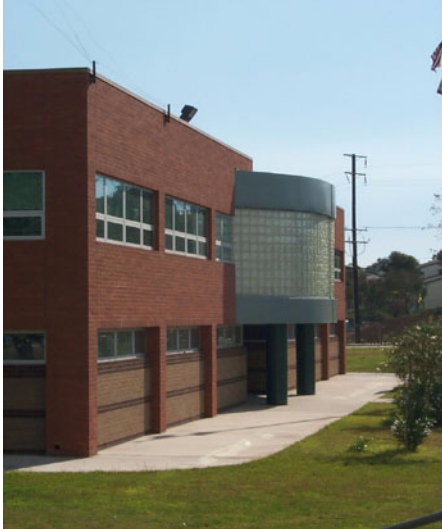
<i>Building Identifier</i>	<i>Photograph</i>	<i>Basic Structural Hazard Score</i>	<i>Characteristics and Performance</i>
RM2 Reinforced masonry buildings with rigid diaphragms

H = 2.8 M = 3.4 L = 4.6	<ul style="list-style-type: none"> Walls are either brick or concrete block. Wall thickness is usually 8 inches to 12 inches. Interior inspection is required to determine if diaphragms are flexible or rigid. The most common floor and roof systems are wood, light steel, or precast concrete. These buildings can perform well in moderate earthquakes if they are adequately reinforced and grouted, with sufficient diaphragm anchorage. Poor construction practice can result in ungrouted and unreinforced walls, which will fail easily.
URM Unreinforced masonry buildings

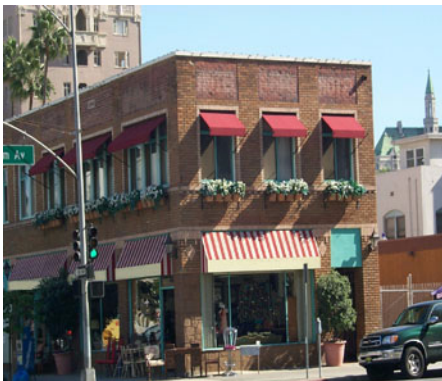
H = 1.8 M = 3.4 L = 4.6	<ul style="list-style-type: none"> These buildings often used weak lime mortar to bond the masonry units together. Arches are often an architectural characteristic of older brick bearing wall buildings. Other methods of spanning are also used, including steel and stone lintels. Unreinforced masonry usually shows header bricks in the wall surface. The performance of this type of construction is poor due to lack of anchorage of walls to floors and roof, soft mortar, and narrow piers between window openings.

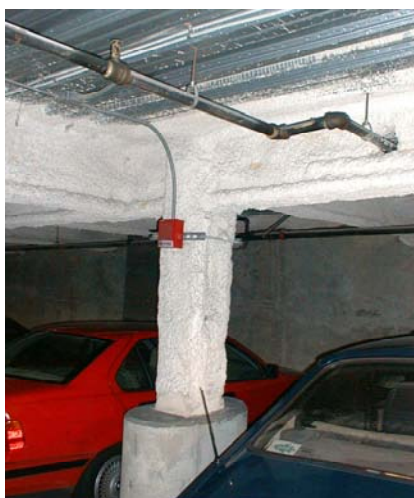
Figure 3-11 Interior view showing fire-proofed columns and beams, which indicate a steel building (S1, S2, or S4).

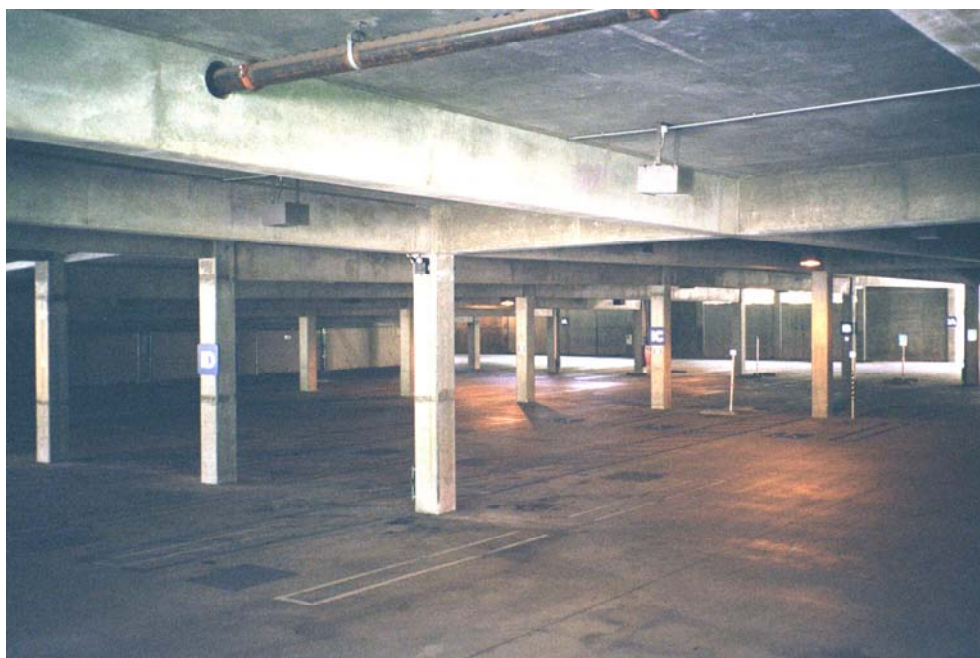
Figure 3-12 Interior view showing concrete columns and girders, which indicate a concrete moment frame (C1).

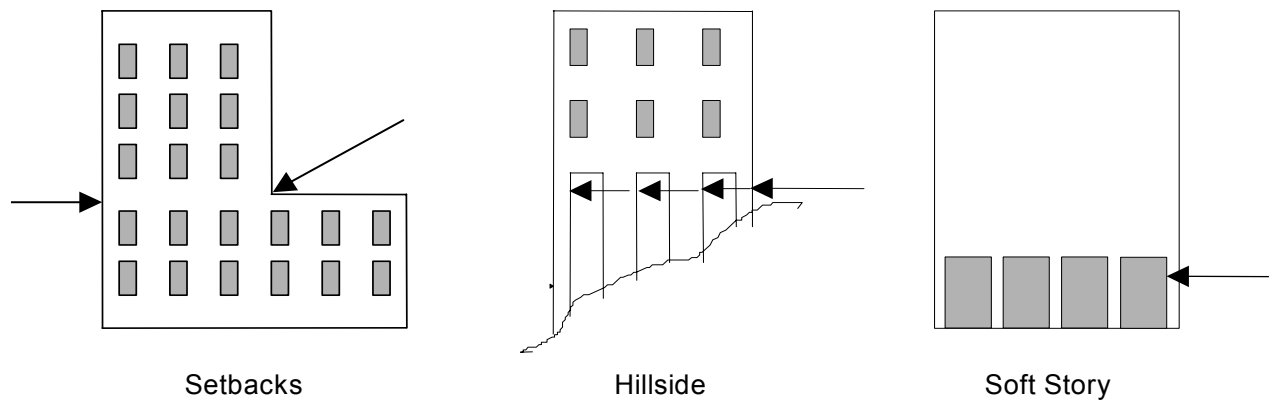
Figure 3-14 Elevation views showing vertical irregularities, with arrows indicating locations of particular concern.

If the building is on a steep hill so that over the up-slope dimension of the building the hill rises at least one story height, a problem may exist because the horizontal stiffness along the lower side may be different from the uphill side. In addition, in the up-slope direction, the stiff short columns attract the seismic shear forces and may fail. In this case the performance modifier is applicable. See Figure 3-14 for an example.

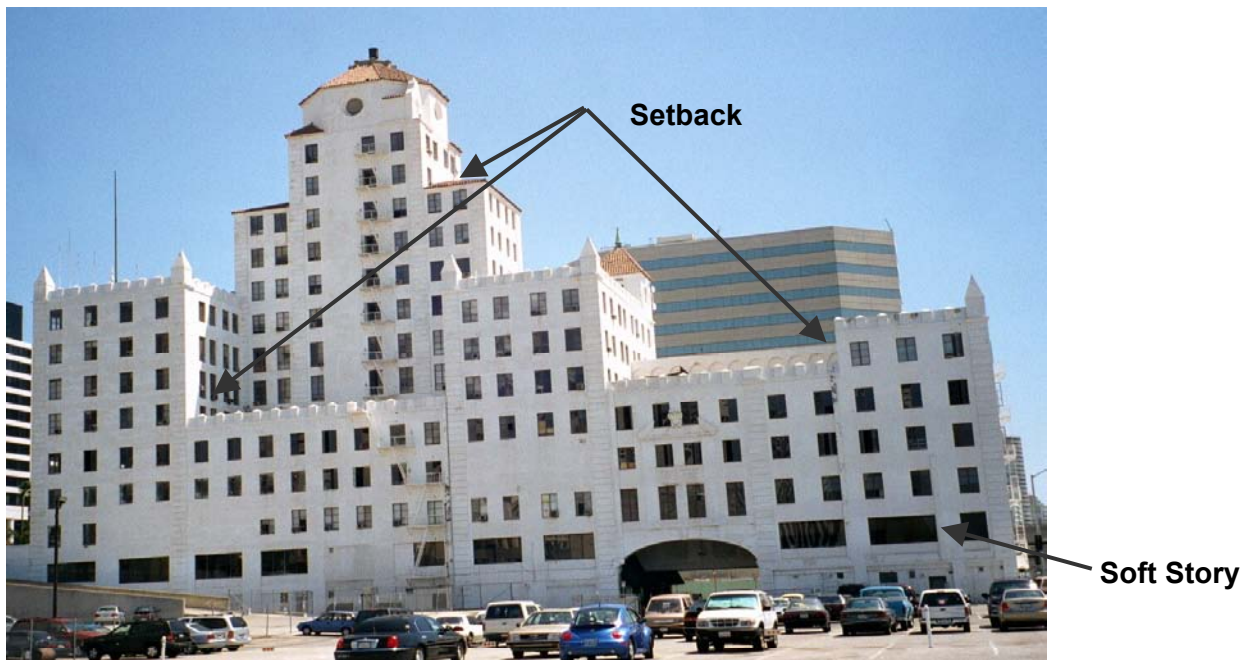
Figure 3-15 Example of setbacks (see Figure 3-14) and a soft first story.

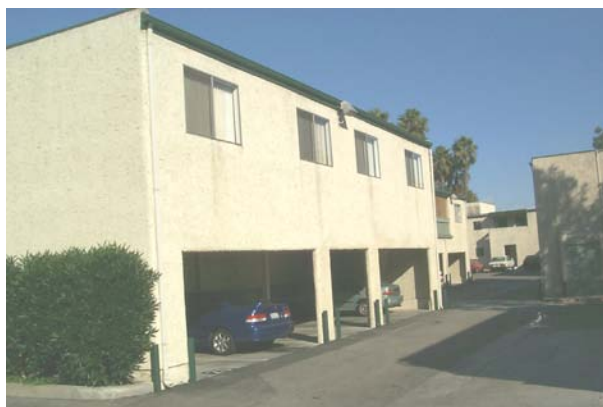
Figure 3-16 Example of soft story conditions, where parking requirements result in large weak openings.

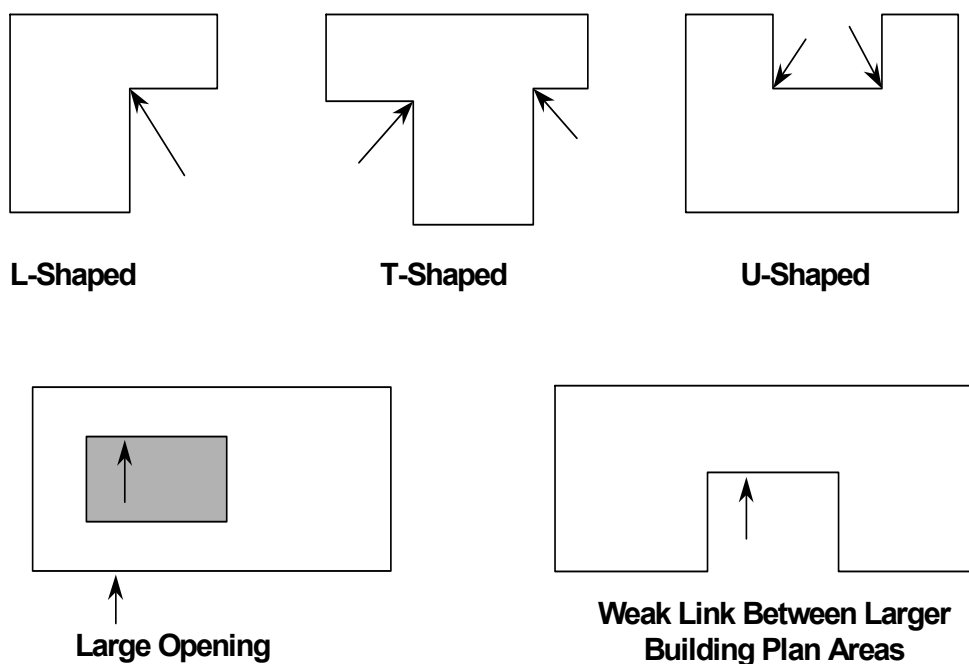
Figure 3-17 Plan views of various building configurations showing plan irregularities; arrows indicate possible areas of damage.

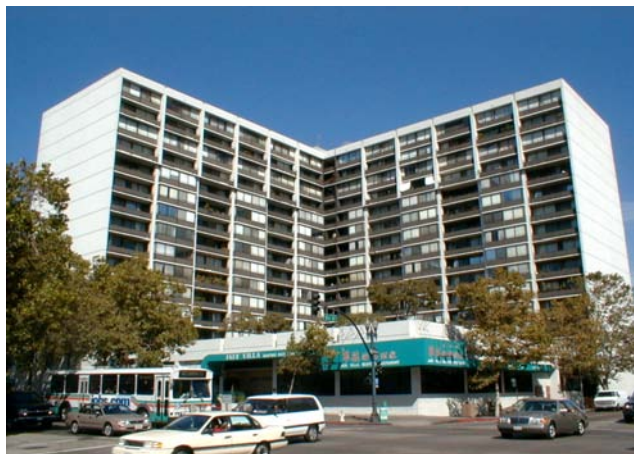
Figure 3-18 Example of a building, with a plan irregularity, with two wings meeting at right angles.

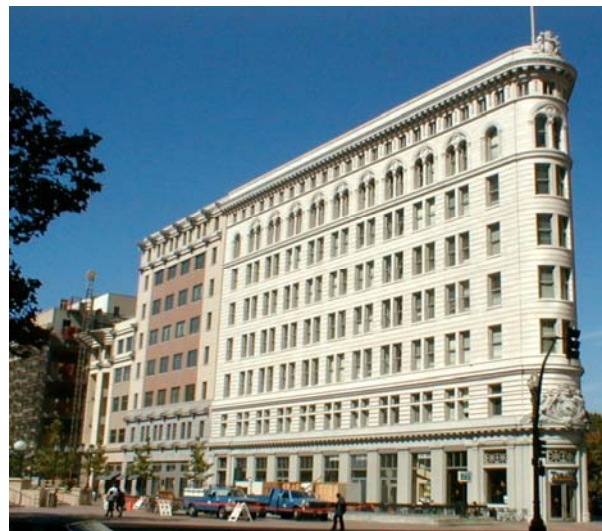
Figure 3-19 Example of a building, triangular in plan, subject to torsion.

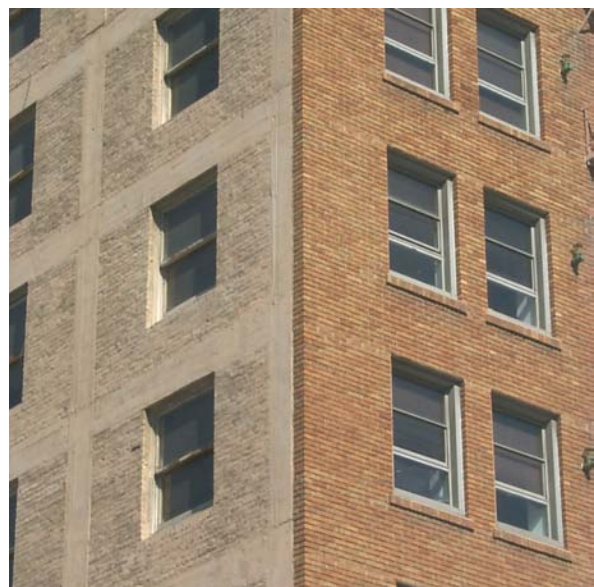
Figure 5-10 Close-up view of 3711 Roxbury Street building exterior showing infill frame construction.

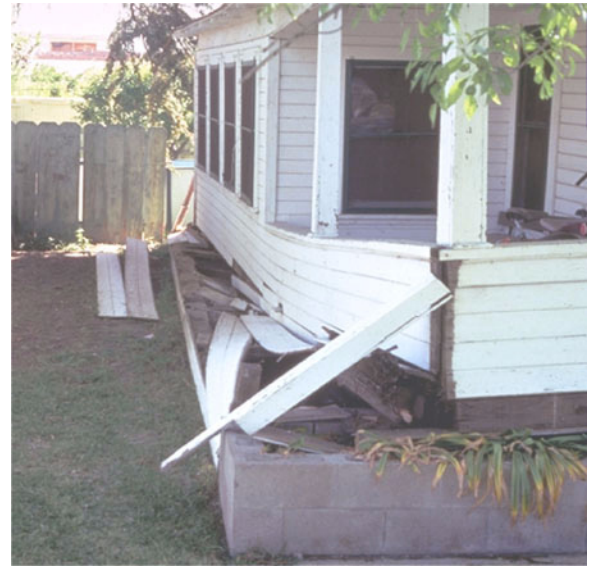
Figure E-7 House off its foundation, 1983 Coalinga earthquake.

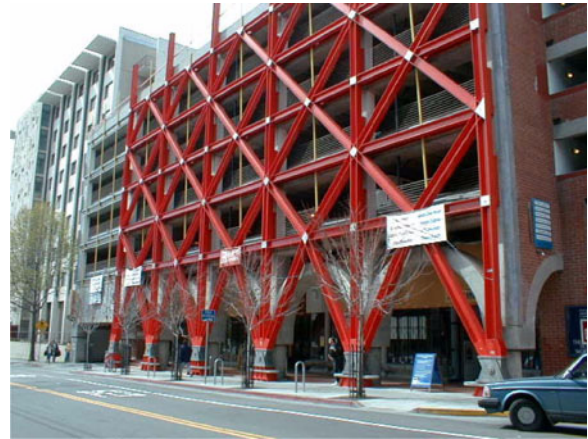
Figure E-15 Rehabilitation of a concrete parking structure using exterior X-braced steel frames.

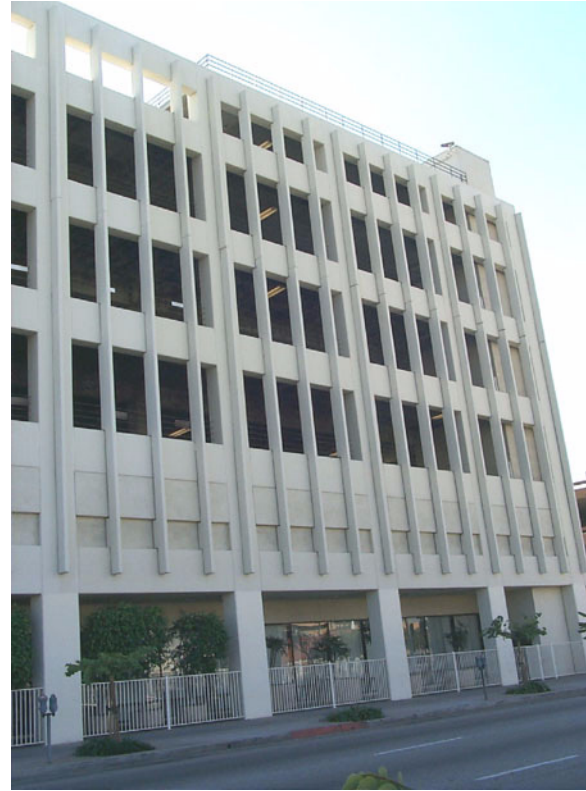
Figure E-28 Concrete moment-resisting frame building (C1) with exposed concrete, deep beams, wide columns (and with architectural window framing).

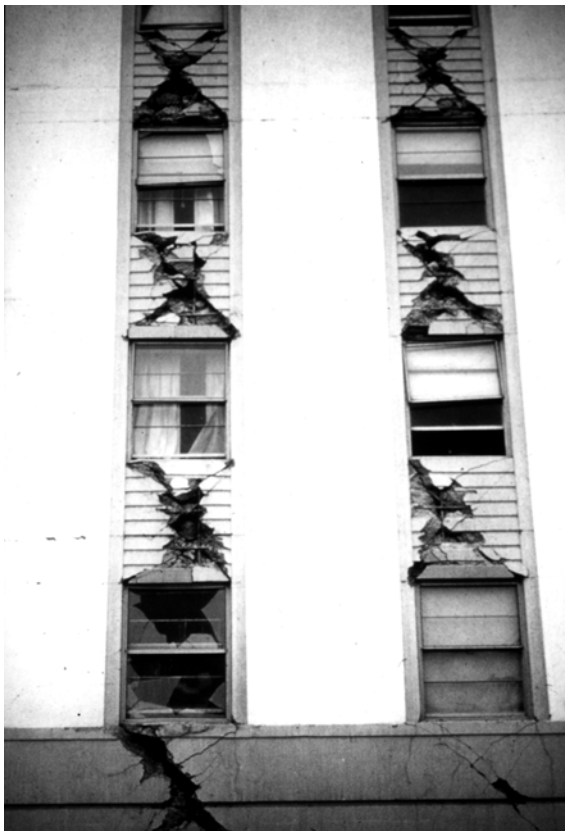
Figure E-31 Tall concrete shear-wall building: walls connected by damaged spandrel beams.

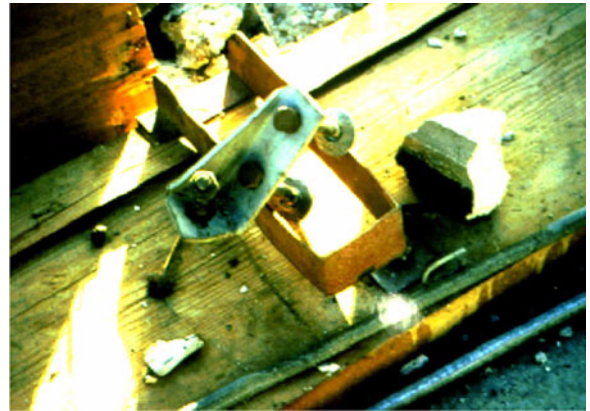
Figure E-38 Tilt-up construction anchorage failure.

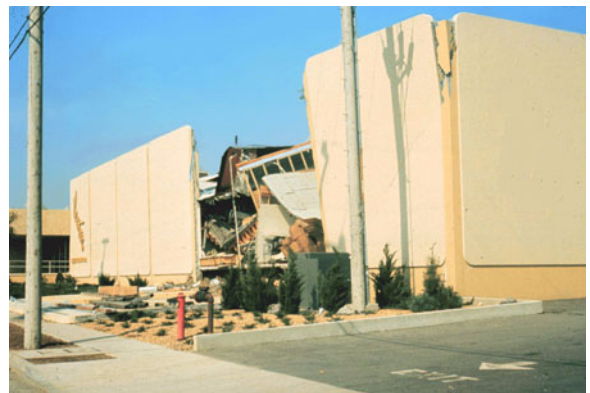
Figure E-39 Result of failure of the roof beam anchorage to the wall in tilt-up building.

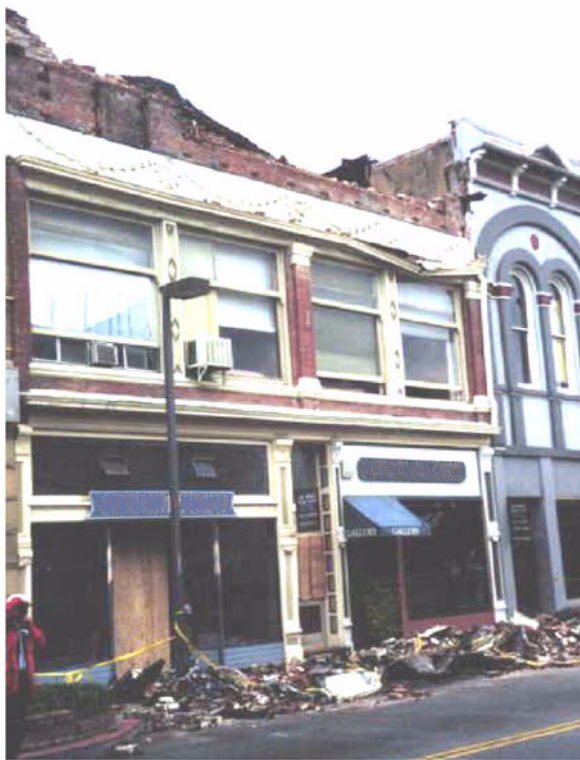
Figure E-53 Parapet failure leaving an uneven roof line, due to inadequate anchorage, 1989 Loma Prieta earthquake.

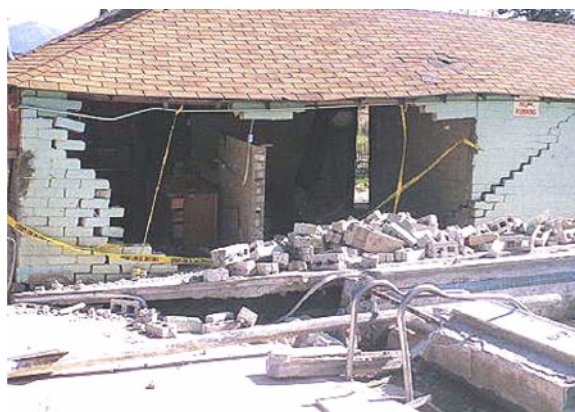
Figure E-54 Damaged URM building, 1992 Big Bear earthquake.

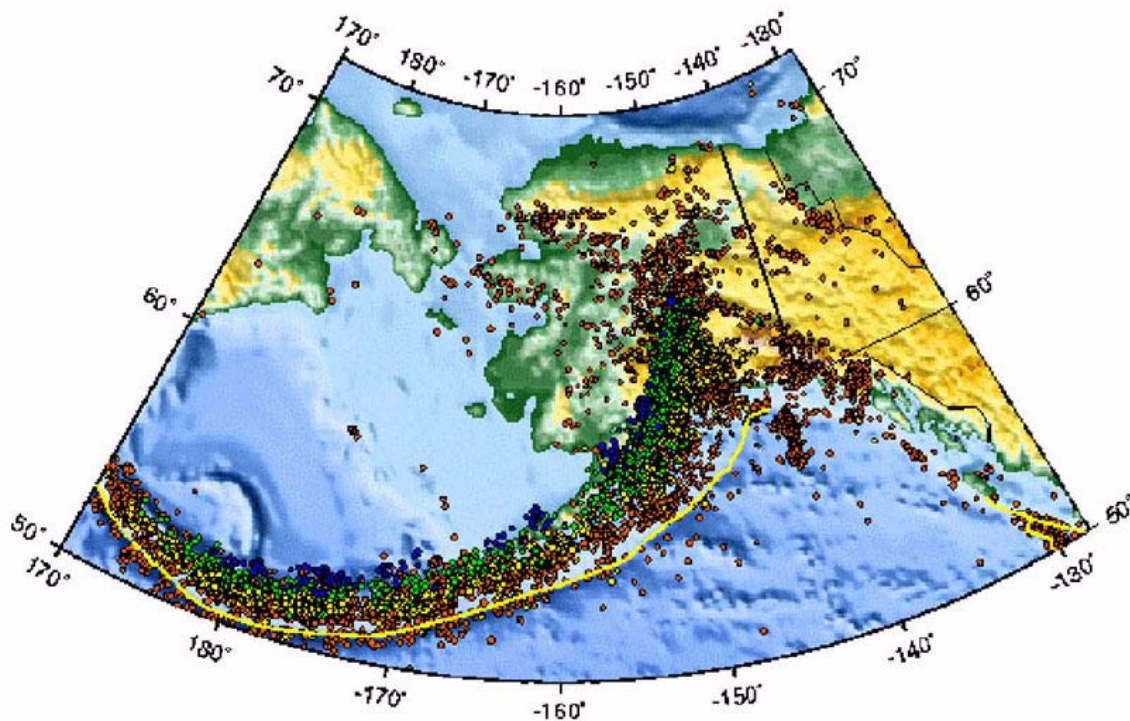
Figure F-3 Seismicity of Alaska 1977 – 1997. The white line close to most of the earthquakes is the plate boundary, on the ocean floor, between the Pacific and North America plates.

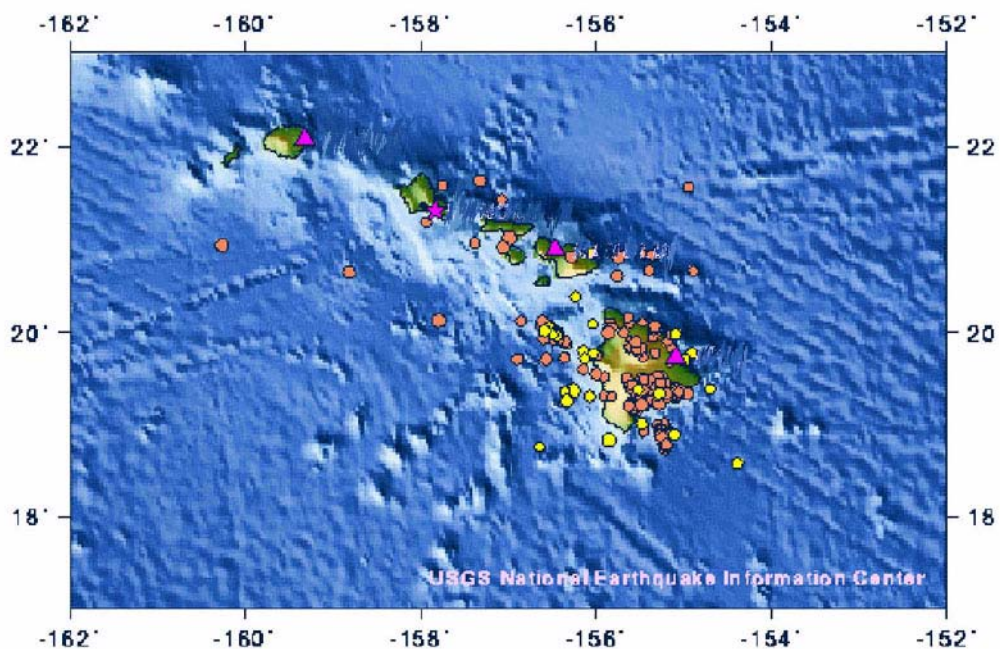
Figure F-4 Seismicity of Hawaii 1977 – 1997. See Figure F-2 caption.

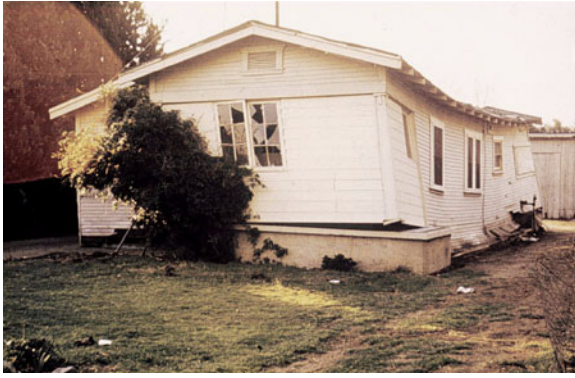
Figure F-8 House that slid off foundation, 1994 Northridge earthquake.

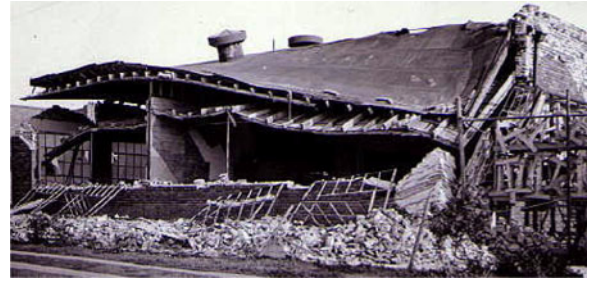
Figure F-11 Collapse of unreinforced masonry bearing wall, 1933 Long Beach earthquake.
