2007 LANDSLIDE SYMPOSIUM PROCEEDINGS & FIELD TRIP GUIDE

NEW TOOLS AND TECHNIQUES FOR DEVELOPING REGIONAL HAZARD MAPS
AND FUTURE RISK MANAGEMENT PRACTICES

Open-File Report O-07-06

Landslides in Oregon City and Coastal Lincoln County, Oregon

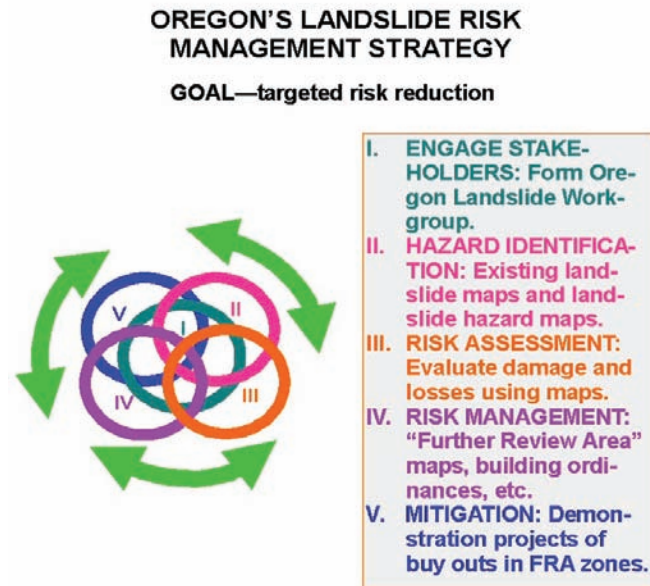
Figure 4.1-1. The five parts of Oregon's Landslide Risk Management Strategy

risk assessment, 4) risk management through prioritization of risks, and 5) mitigation. Figure 4.1-1 lists these five parts with examples of actions for each part—forming an "Oregon Landslide Workgroup" under "engaging stakeholders" is one example. It also depicts how these five parts are being integrated. Some of the activities of the program include: increasing awareness through education, brochures, field trips, existing landslide and landslide hazard maps; assisting local jurisdictions with technical expertise on sustainable policies and ordinances; and, supporting a statewide landslide warning system. For many years, the activities were sporadic and minimal due to funding limitations.

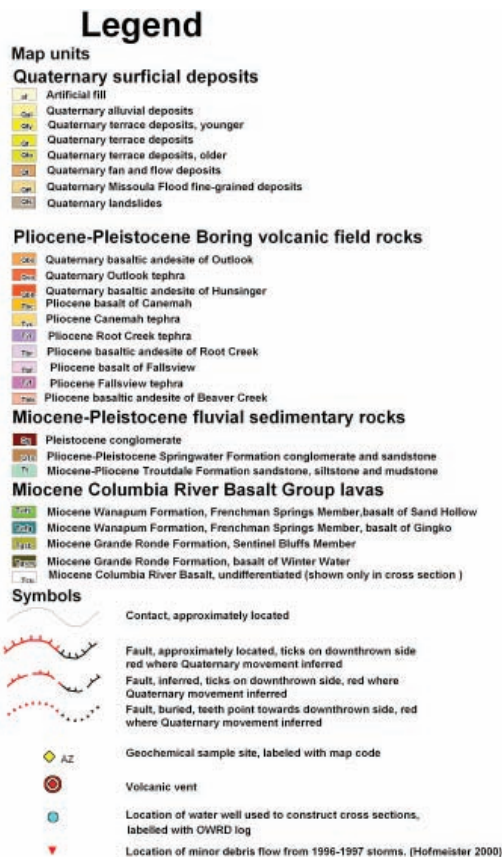
Figure 3. Generalized stratigraphy of Newell Creek Canyon, Oregon City, Oregon (Burns, 1999).

tion (Sandy River Mudstone), unconformably overlie the CRBG. The Springwater Formation consists mostly of pebble, cobble, and boulder conglomerate; the Troutdale Formation is largely mudstone, claystone, sandstone, and minor conglomerate and tuff. These sedimentary rocks are overlain by Pliocene-Pleistocene Boring volcanic field rocks. The Boring lavas are typically massive, with jointing restricted to well developed to crude columns. Weathering along the joint faces typically leads to the development of spheroidal weathering into large, rounded corestones in a matrix of red clay. Intact weathered basalt is typically soft and grey, white or pink, with abundant red clay coatings on joint faces. Quaternary surficial deposits, ranging from active channels and flood plains of rivers and streams to Missoula (Bretz) Flood Deposits (latest Pleistocene) consisting of silt, sand, and minor gravel, blanket the lower lying areas (Madin, in preparation; Burns, 1999).

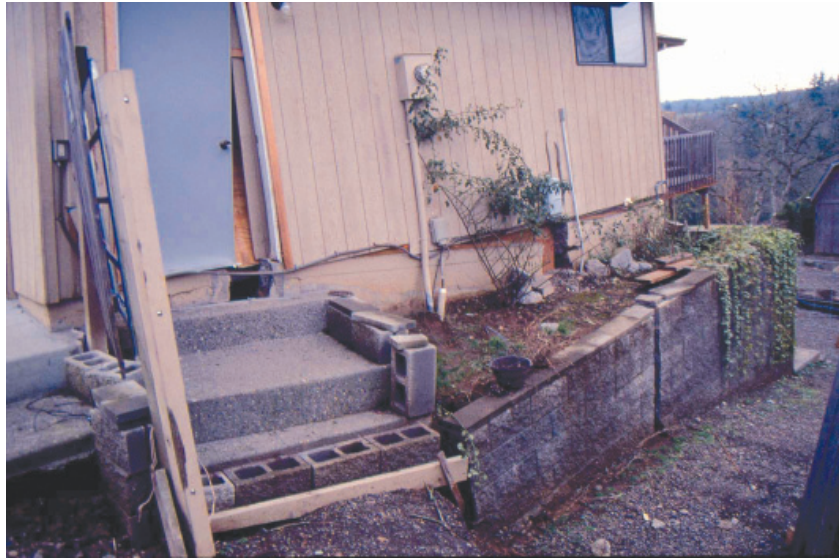
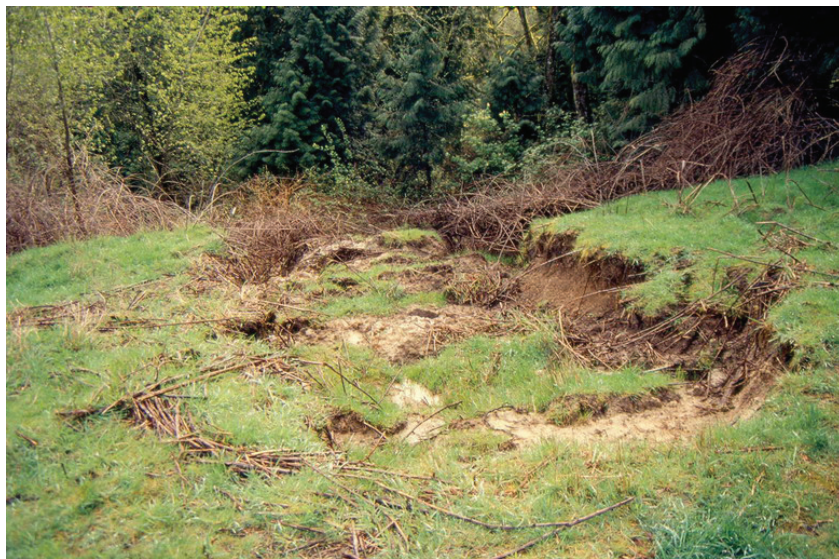
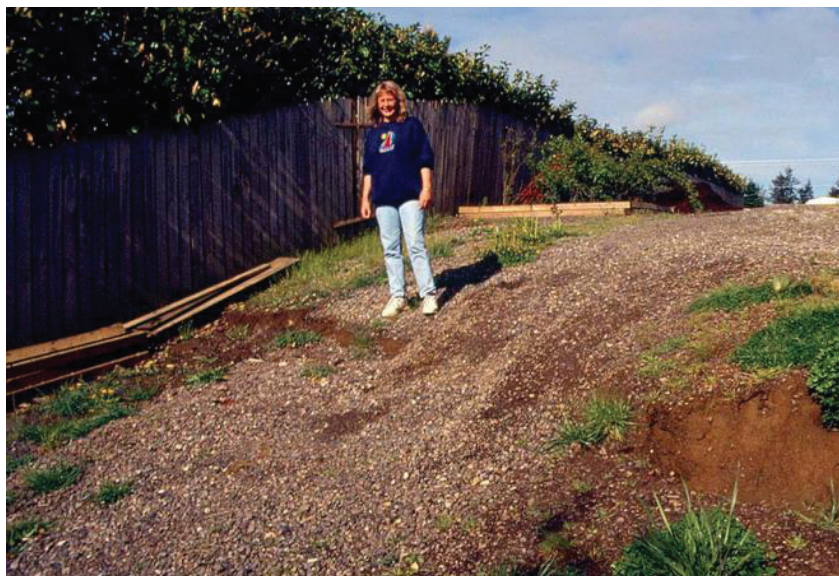
Figure 5. Photographs of the Moxley House in 1996: (top) cracks in foundation, (middle) movement along the toe of the landslide, (bottom) head scarp across driveway.

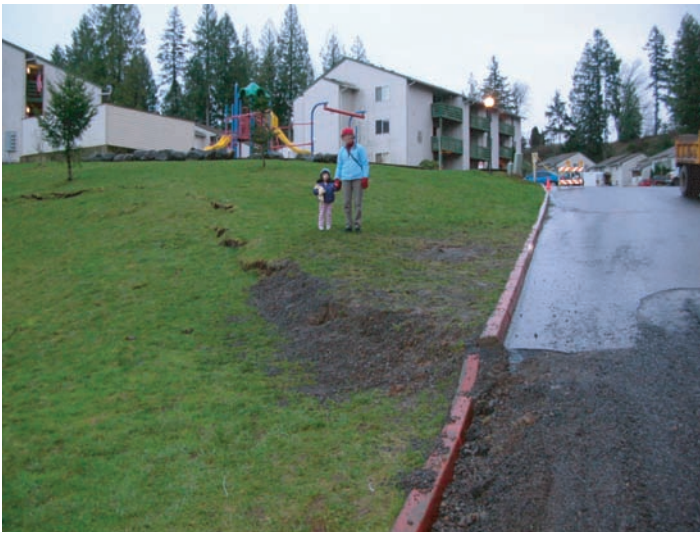
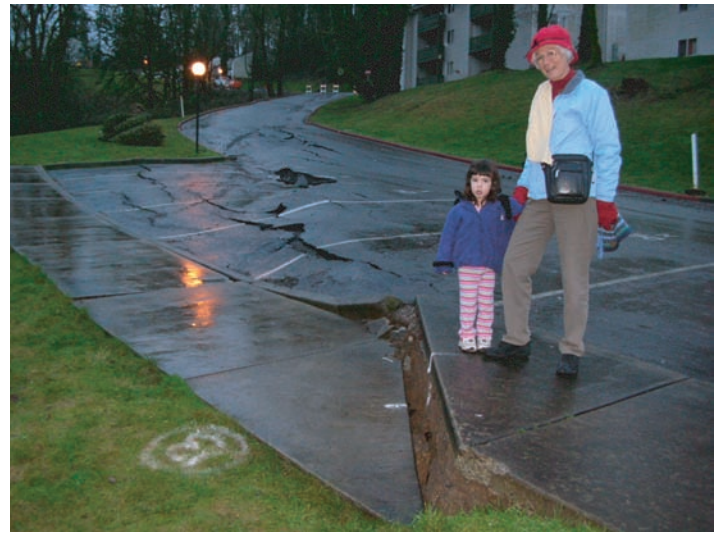
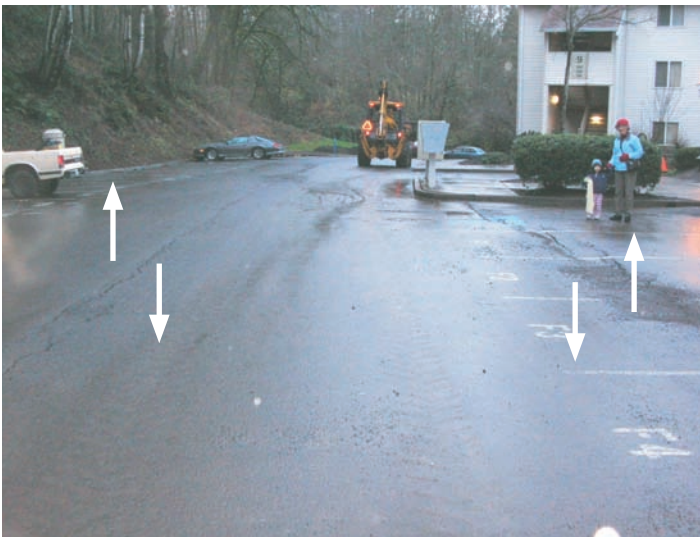
Figure 7. Photographs of Newell Creek Canyon Apartments in winter 2005, just after the landslide reactivated. (top left) Right flank of slide between the two apartment complexes. (top right) Central portion of the slide. (left) The beginning of a graben along the backside of the slide just below the ancient head scarp.

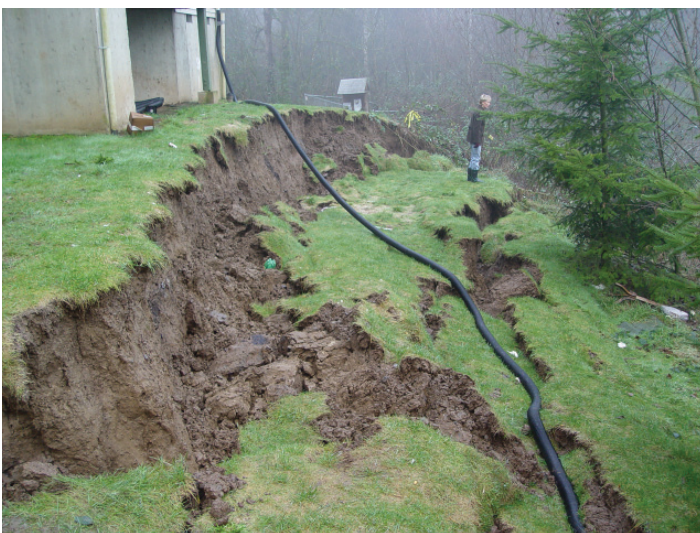
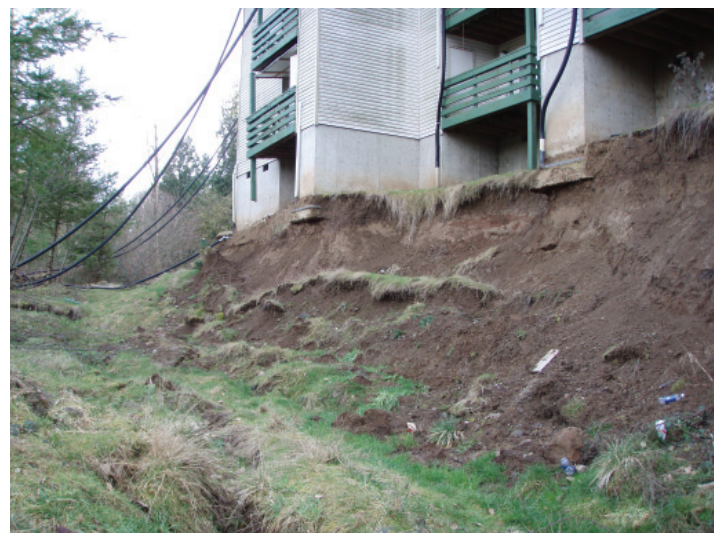
Figure 8. Photographs showing scarps along the crest of the toe of the large Newell Creek Apartment landslide from (left) 2006 and (right) 2007.

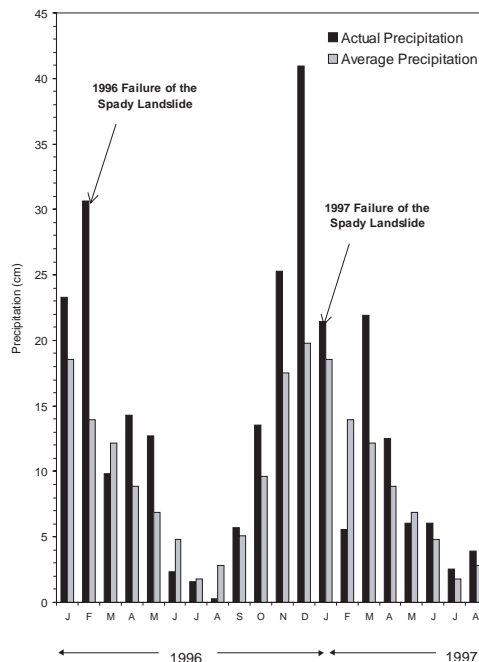
Figure 9. Histogram of monthly precipitation for Oregon City from 1996 to 1997 (August) (Burns, 1998).

This landslide occurred in many phases on a slope in the fine-grained Troutdale Formation. In February 2006 the earthflow began (Figure 9). It stabilized over the summer, but the following winter it increased in size (Figure 10). It increased in area almost 5 times (Figure 9 and Figure 10). It also developed into a debris flow downstream (Figure 10 and Figure 11) and ponded the adjacent channel. At this site we will also visit a landslide that occurred in an abandoned garbage dump. It is a classic earthflow with levees on the edges. It has been stabilized by a cutoff trench at the top of the slide. It showed movement at the toe in 1996 (Figure 11).

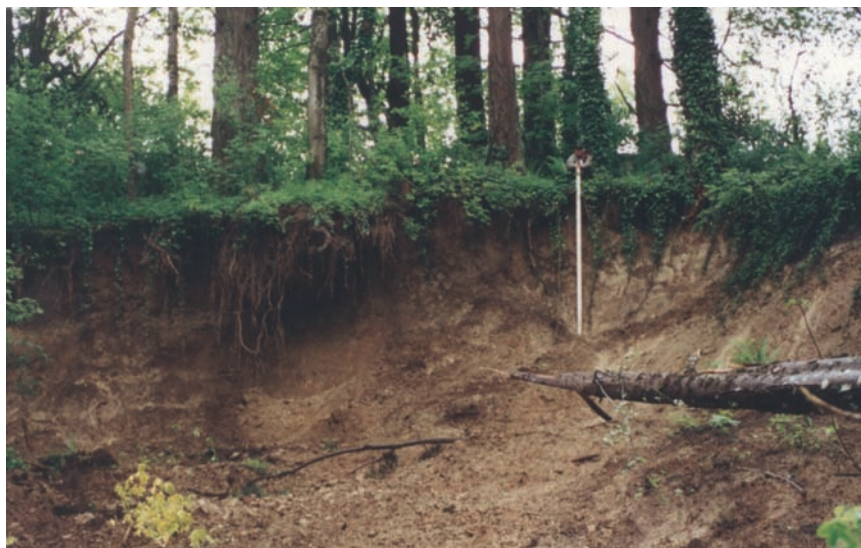
Figure 10. (top) Photograph of the head scarp Spady residence landslide after the 1996 activity Plane table survey rod is 4.572 m (15 ft) high. (bottom) Photograph of the scarp after enlargement during 1997.

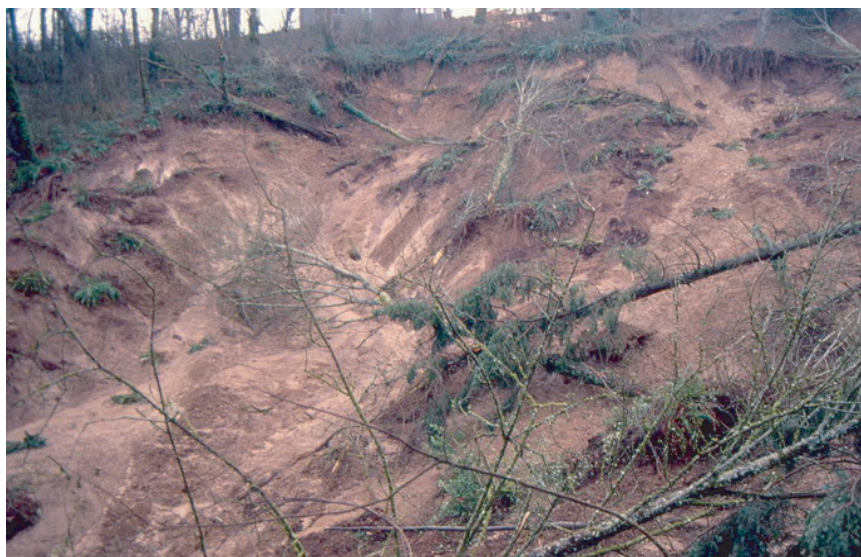
Figure 10. Detailed maps of the (top) 1996 Spady landslide and (bottom) 1997 Spady landslide (Burns, 1998). Diagrams include the debris flow section of the landslide and the ponded adjacent channel.

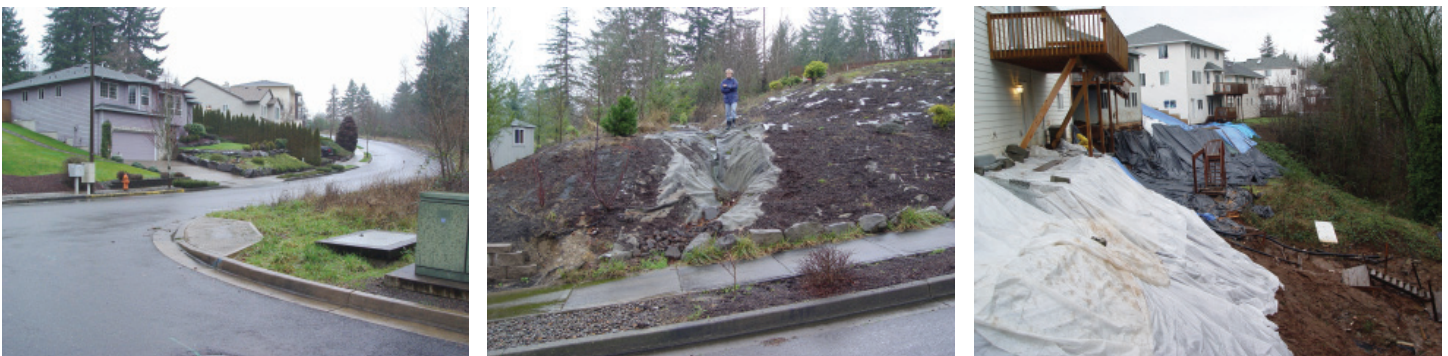
Figure 13. Barclay Hills subdivision. (left) In 1996 the toe of the slide moved 25 cm (10 in) and disconnected the sewage pumping station. (center) Upper part of the slide shows movement at the scarp. (right) In December 2006 the backyards of three homes at the end of Barclay Hills Drive slid away.

at the headscarp (Figure 12 and Figure 13). In December 2006 a break in the storm water drainage system saturated the steep slopes. This caused the backyards of three homes at the end of Barclay Hills Drive to slide (Figure 12 and Figure 13).

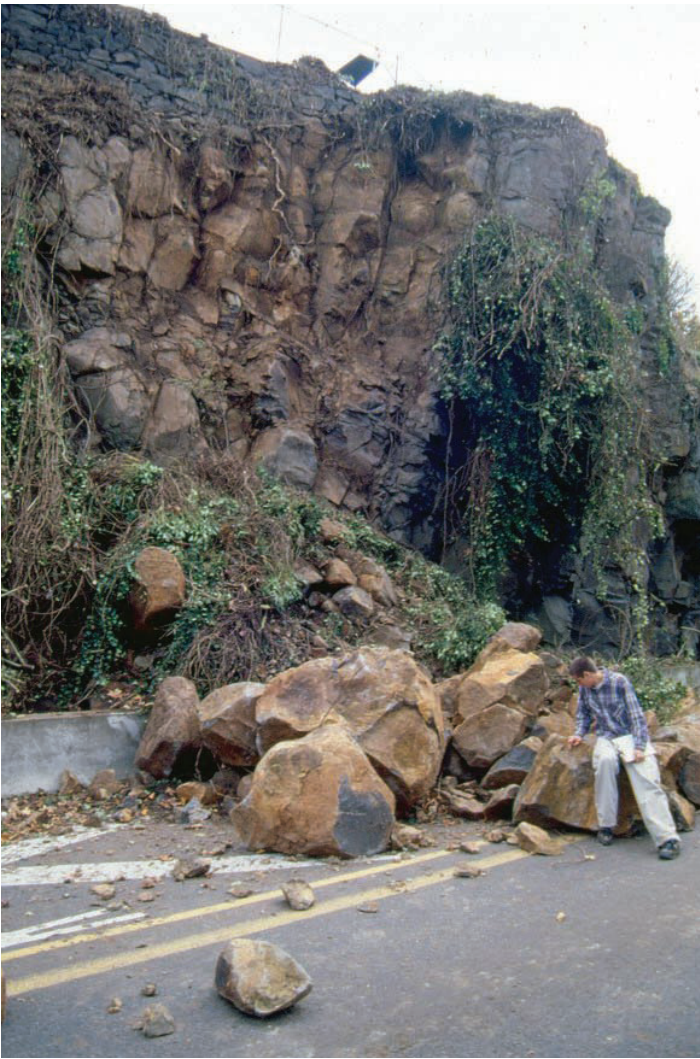
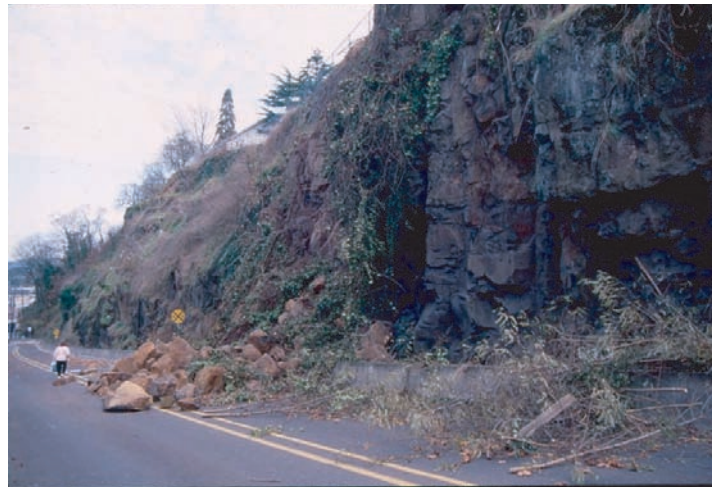
Figure 14. Photographs taken after the 1996 rockfall below the McLoughlin House.

This slope of columnar jointed Columbia River basalt has created many rockfalls over the years. After the rainfalls of February 1996 the road was closed due to significant rockfall (Figure 14 and Figure 15). This street is the main connection between old Oregon City and the upper part of the city, so periodic rockfall activity often hinders travel. The site is just below the famous McLoughlin House.

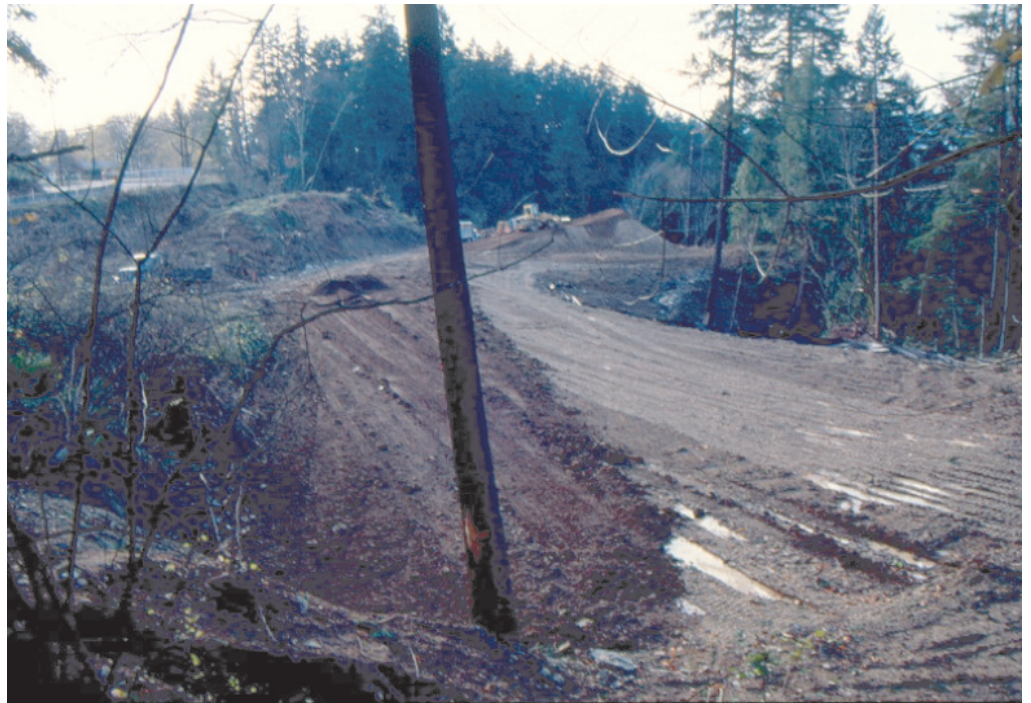
Figure 17. Photograph of Forsythe Road landslide during repair in 1997.

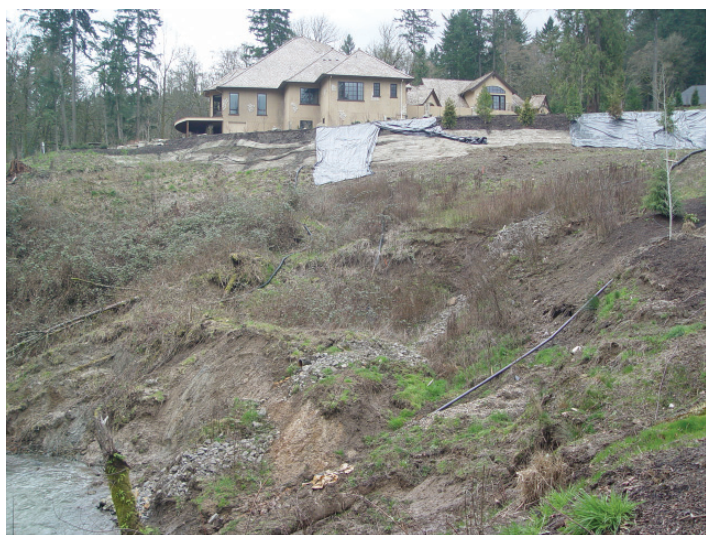
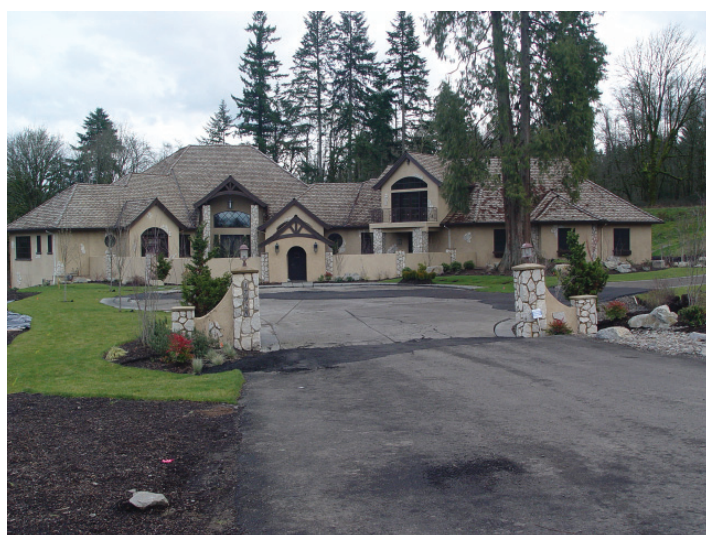
Figure 19. Site photographs of two homes in the Hidden Lakes Estates in 2007. (left) Slopes below the two house leading down to the creek. (right) Cracks in the driveway of the Romeo and Juliet house.

The neighboring Romeo and Juliet house had bigger problems. A large crack cut through the driveway and into the house (Figure 19).

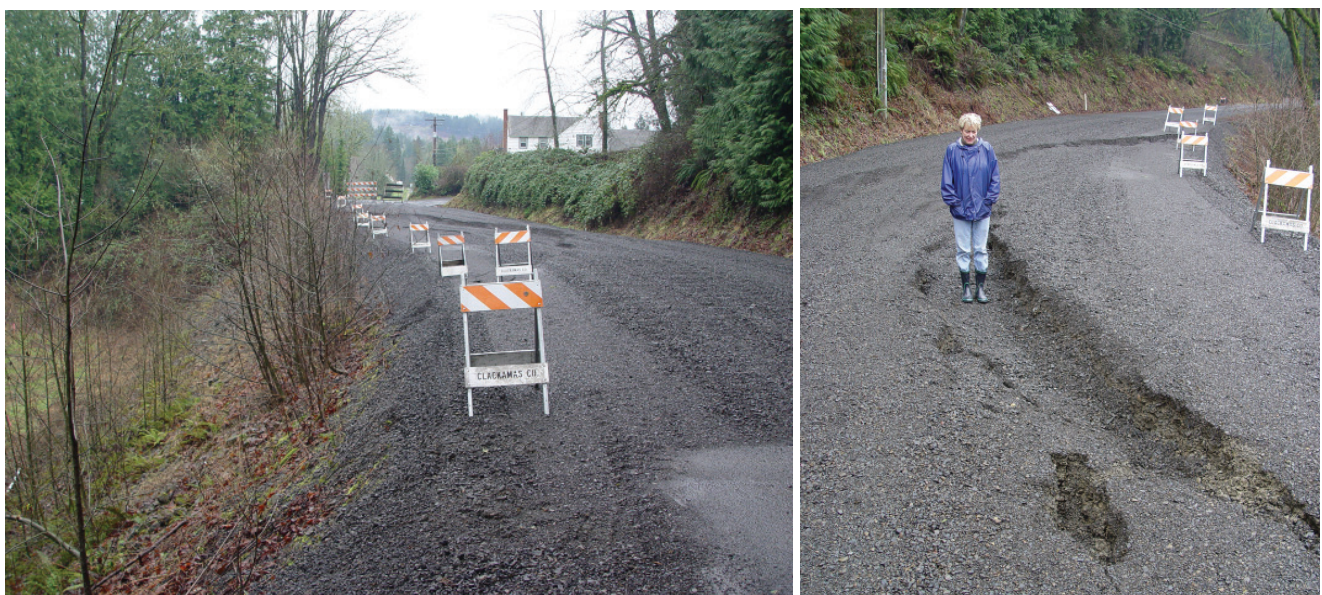
Figure 22. Site photographs in 2007 show fill failure just one month after the road was repaired for the third time.

What happened? The fill did fail, but it is because it is on an ancient slide that reactivated in 1996 and took the fill and the road on top with it. Again in the winter of 2005-2006 the ancient slide reactivated, and the road was destroyed.

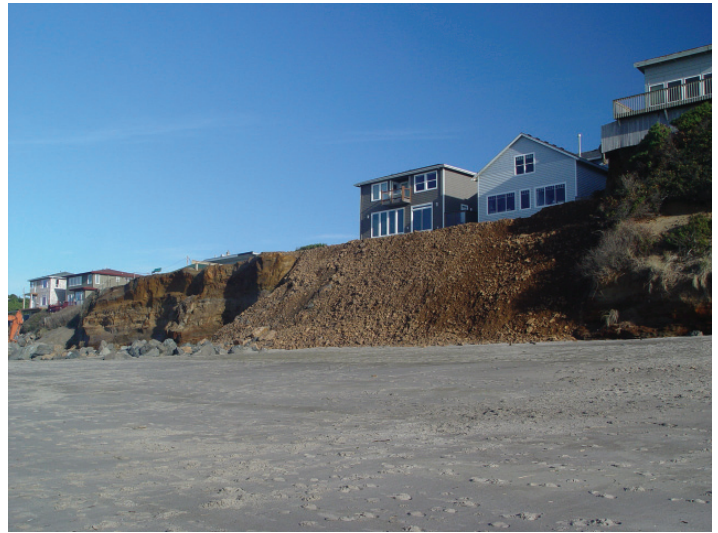
Figure 26. Site photograph in 2007 of rockfill and rip-rap along the beach (western) side.

Mitigation was twofold. First, rockfill was put in front of the three homes to give them back 5 m of cliff (Figure 26). Then, rip-rap was put at the base to protect the slopes.

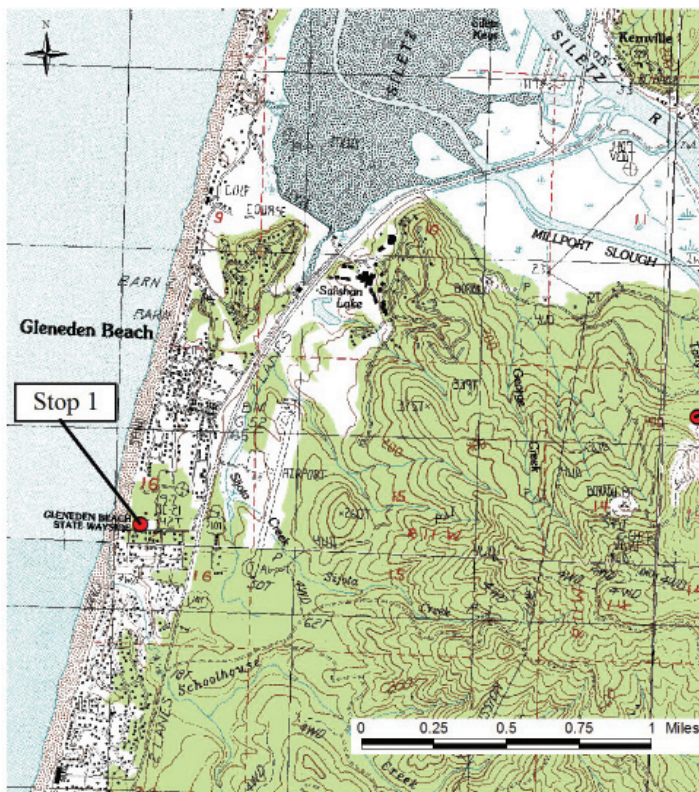
Figure 25. (left) Map of the Gleneden Beach location and (right) orthophoto of the site in Gleneden Beach.

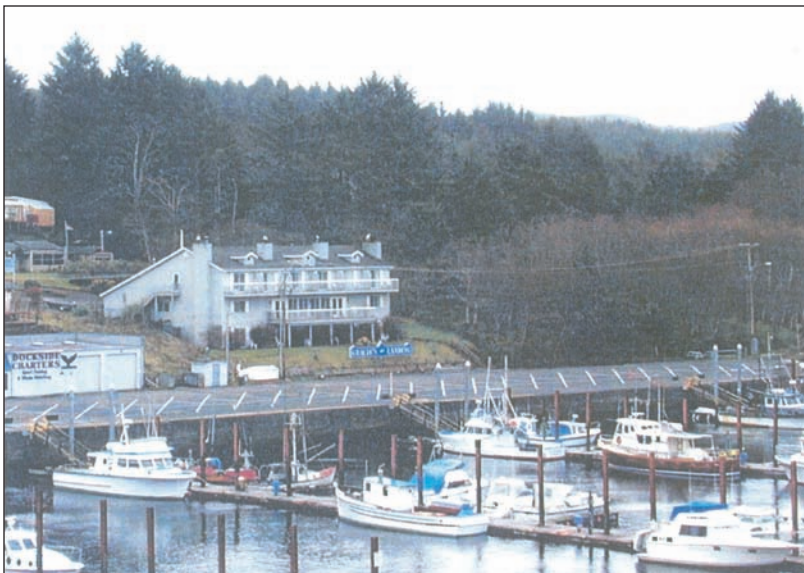
Figure 28. 1990s era site photograph of the Retaining Wall landslide at Depoe Bay.

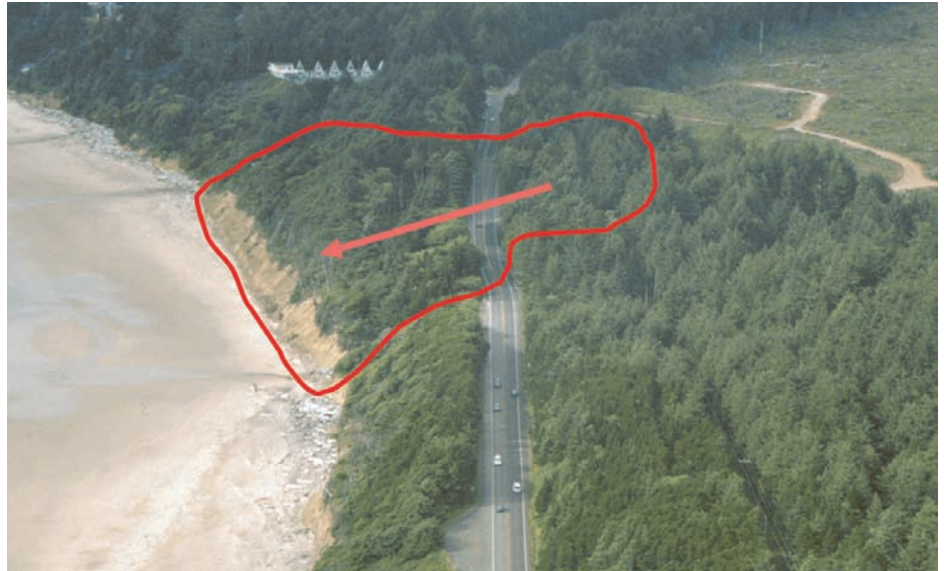
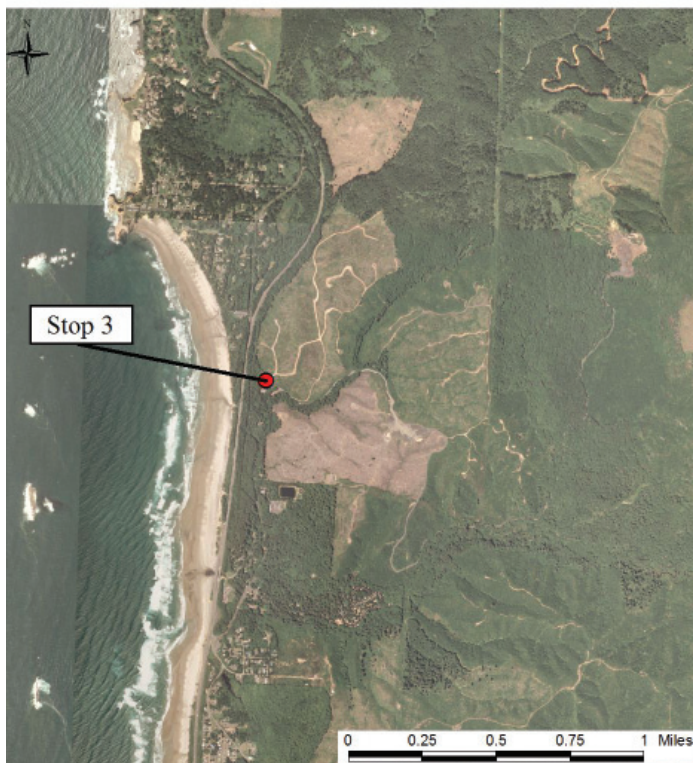
Figure 30. (right) Oblique air photograph, (bottom left) orthophoto, and (bottom right) topographic map showing location of the Johnson Creek landslide site.

The Johnson Creek landslide is a large translational slide in seaward-dipping siltstone and sandstone of the Tertiary Astoria Formation located just north of Newport, Oregon (Figure 30). The slide is representative of many large translational slides along the U.S. west coast. A 5-year research project started in the fall of 2002 is aimed at determining what makes the slide move and what are the most cost effective means of slowing or

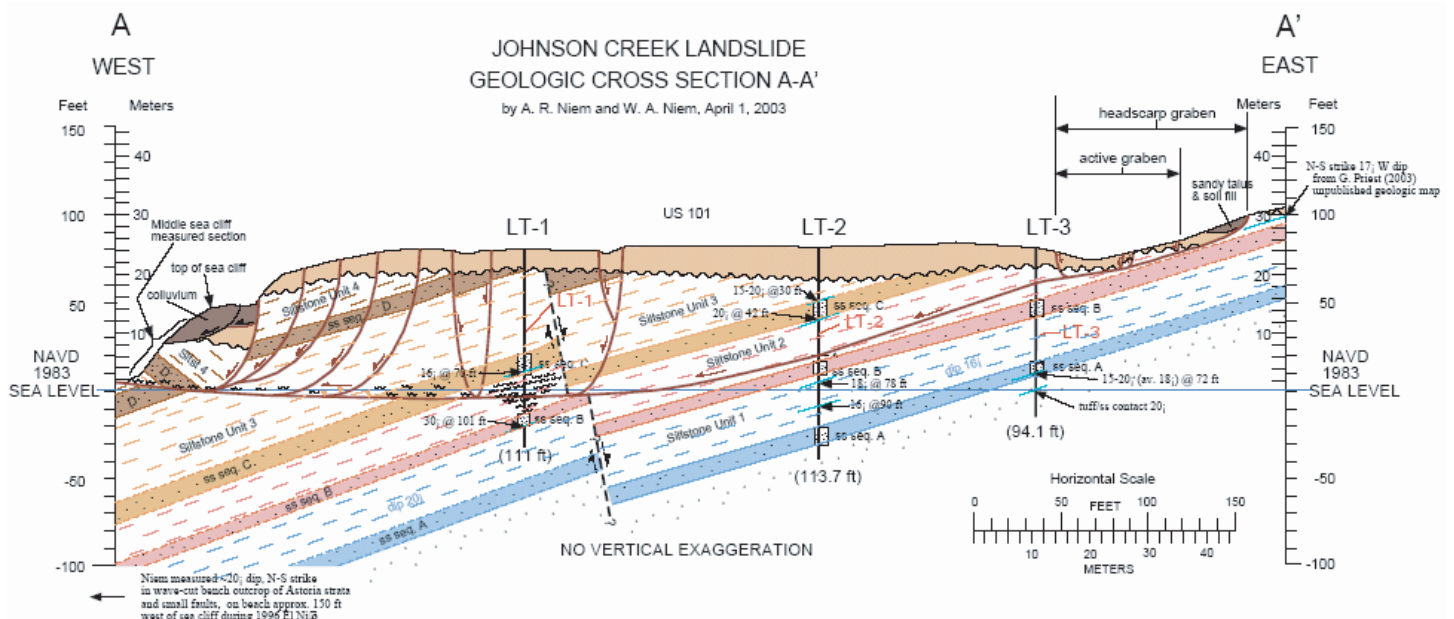
Figure 32. Johnson Creek landslide site cross-section (Niem, 2004).

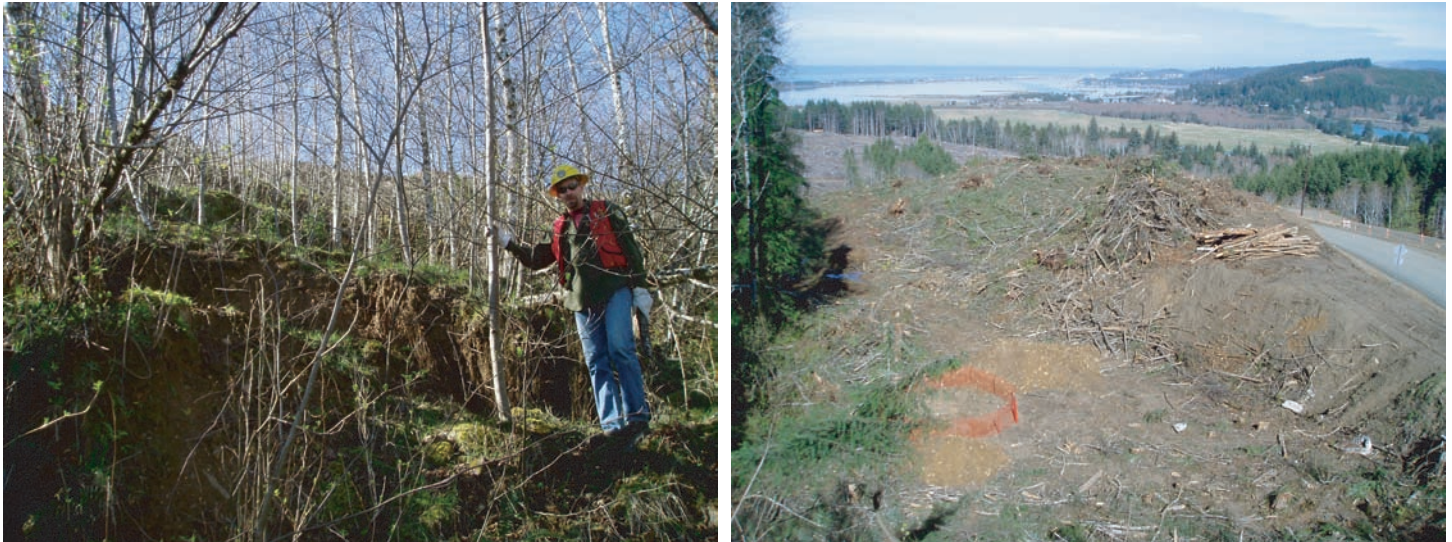
Figure 33. Site photographs of the Tony Creek landslide in 2007.
