**Open-File Report O-08-02**

## **BEACH AND SHORELINE RESPONSE DUE TO DUNE LOWERING ON THE ELK RIVER SPIT, CURRY COUNTY, OREGON**

By  
Jonathan C. Allan<sup>1</sup> and Roger Hart<sup>1</sup>

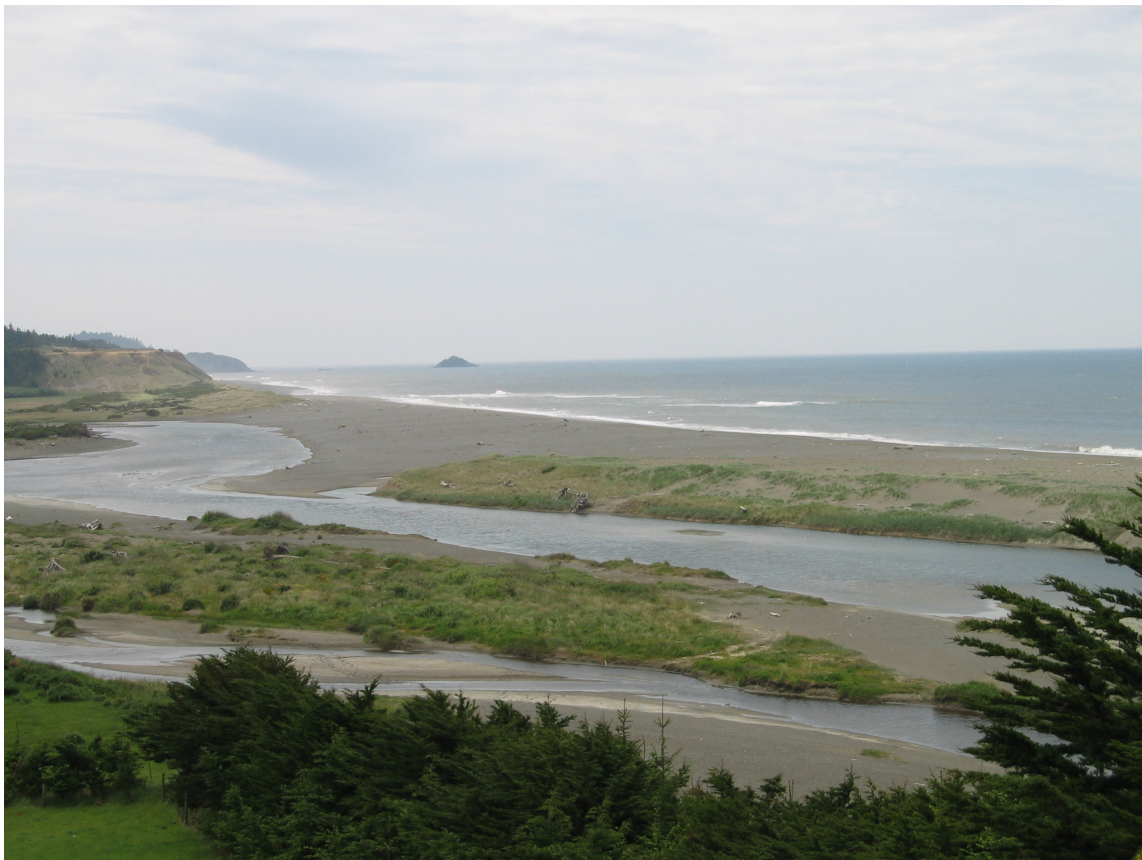
**Cover photo:** Southwest view overlooking the Elk River spit showing the area of dune lowering (photo right-center) relative to the area of natural spit overtopping and breaching (area of bare sand, mid-photo).

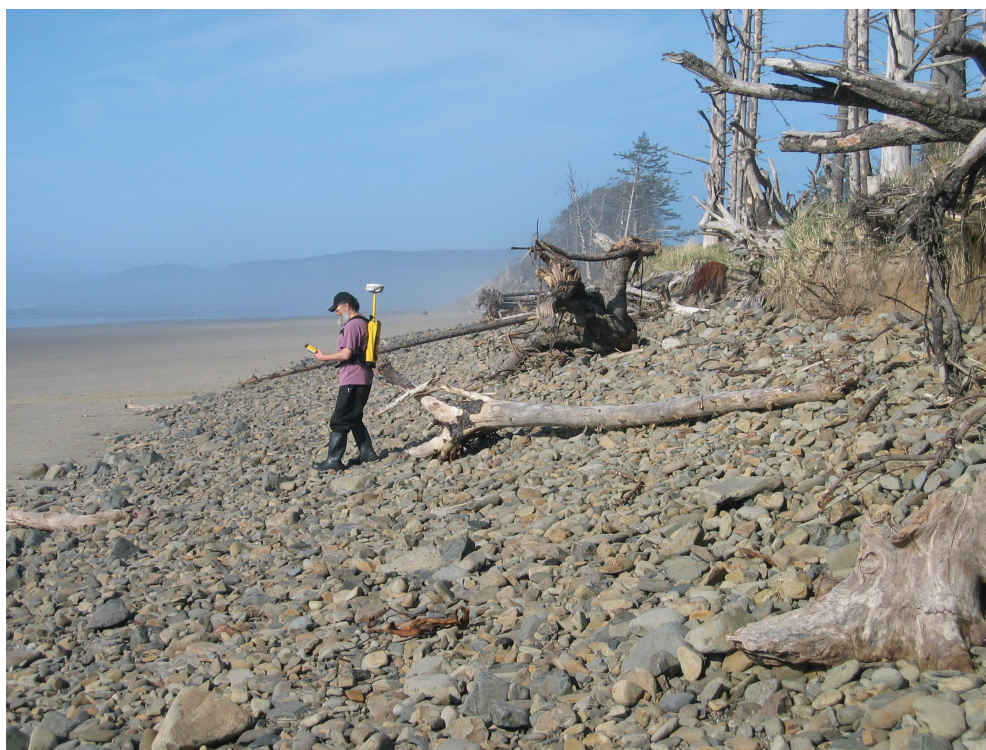
**Figure 5.** Beach surveys were undertaken by walking lines perpendicular to the waters edge, navigating along a predetermined line identified on a hand-held TSCe Trimble computer, connected to the Trimble 5800 GPS rover. Example here is of R. Hart undertaking a profile survey of the beach at Cape Lookout State Park.

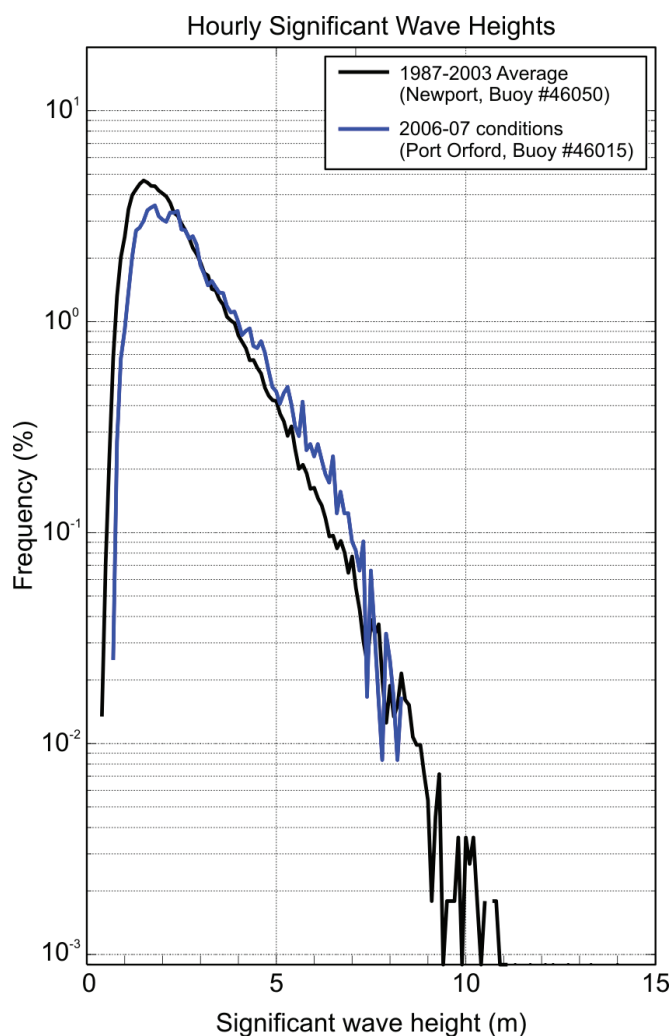
**Figure 6.** Frequency distribution plot depicting measured significant wave heights for the 2006-2007 period (blue line) relative to the long-term (1987-2003) curve (black line) offshore from Port Orford.

Figure 6 shows a frequency distribution plot for the hourly significant wave heights from January 1,

2006, to April 30, 2007, measured offshore from Port Orford (National Data Buoy Center (NDBC) wave buoy #46015) and compared with the long-term (1987-2003) curve measured by the Newport wave buoy (NDBC buoy #46050). Allan (2004) demonstrated that wave measurements made by the two buoy instruments are strongly correlated. As can be seen in Figure 6, wave conditions during the 2006-2007 period were broadly similar to the long-term curve, with the exception that the lower (<7 m) wave heights tended to be shifted to the right (i.e., to slightly higher wave heights), and there were few large (> 8 m) storm wave events in the 2006-2007 winter.

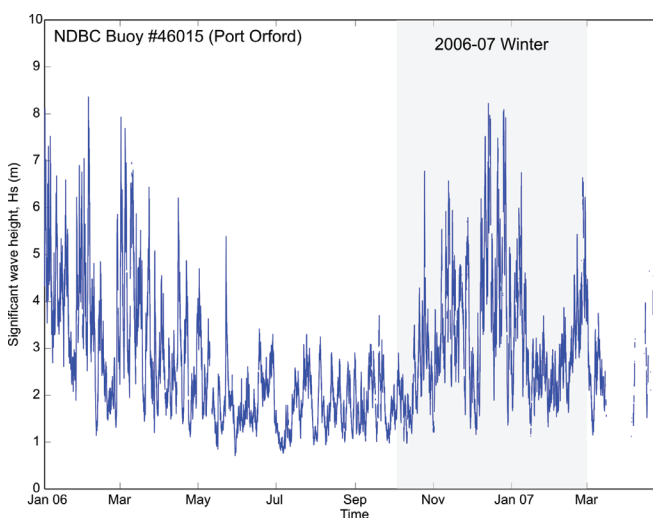
**Figure 7.** Hourly significant wave heights measured by the Port Orford NDBC wave buoy. Period shown is for January 1, 2006, to April 30, 2007. Note the 2006-2007 winter period is depicted by the grey band.

Figure 7 is a plot of the hourly significant wave heights for the period January 1, 2006, to April 30, 2007, measured offshore from Port Orford. As can be seen in the plot, the significant wave heights in the 2006-2007 winter peaked in December 2006 through January 2007. Interestingly, conditions in mid January to February were mild, characterized by very low wave energy conditions, comparable to conditions typical of the summer season.

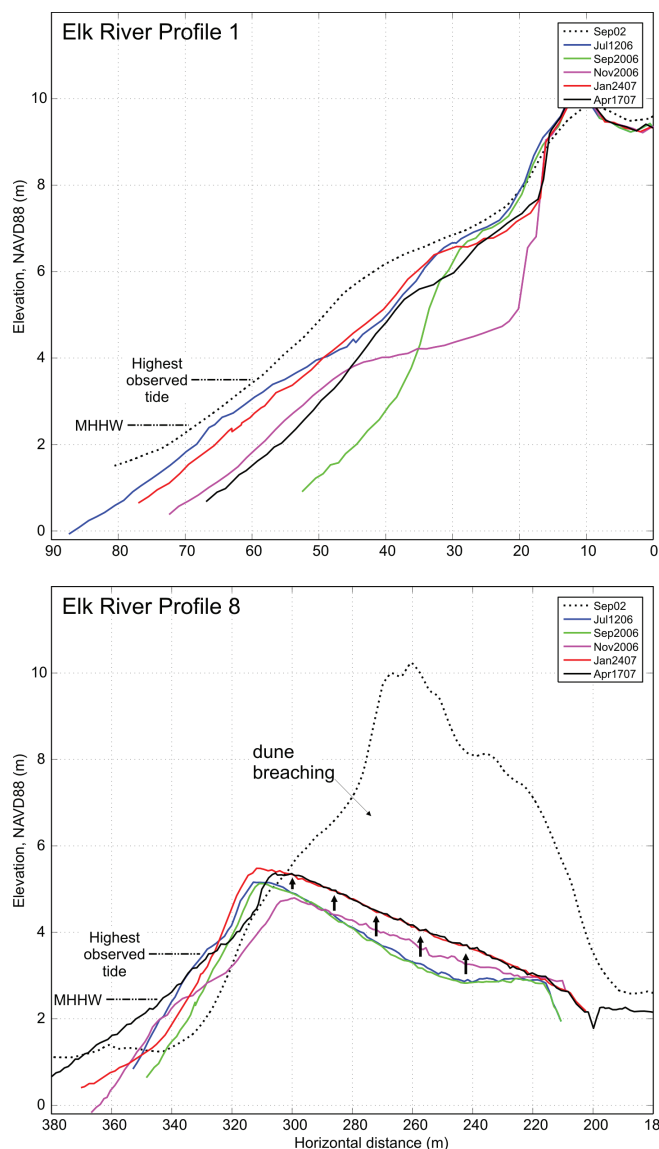
**Figure 8.** Beach profile responses determined for the Elk River profile 1 and 8 sites. Site locations are depicted in Figure 4.

Figures 8 and 9 show the response based on all surveys to date at four selected beach profile sites; site locations are indicated in Figure 4. As noted previously, in each case the data set has been supplemented with topographic information derived from the 2002 LIDAR survey of the Oregon coast. Elk 1 is located at the southern end of the spit. Foredune elevations in this area are typically on the order of 10 m (33 ft) high. The

beach is essentially composed of coarse sand and granules and as a result is characterized by a relatively steep (mean slope of  $\sim 7.4^\circ$ ) beach face. As can be seen in Figure 8, this section of the beach lost a small amount of its volume between 2002 and our initial survey in July 2006. With progress into winter, the site continued to lose additional sand as the beach face receded landward ( $\sim -10$  to  $-25$  m ( $-33$  to  $-82$  ft) of erosion). Interestingly, much of this occurred over the summer months, which is unusual as wave energy levels during the summer are typically much lower than in winter.

Erosion of this site reached its peak in November 2006, when the upper beach face was cut back about 15 m (49 ft), where it formed a 4-m (13 ft) vertical scarp. This was probably caused by a series of early winter storms that affected the area in late October through early November (Figure 7). However, by January 2007 the beach face had essentially rebuilt to the extent that its morphology and volume were comparable to the initial July 2006 survey.

Elk 8 is located approximately 400 m (1300 ft) north of the “elbow” and characterizes the area of the spit that

periodically breaches naturally (Figures 8 and 4). In fact, this section of the spit was breached in the 2005-2006 winter and resulted in approximately 100 m (300 ft) of the southern end of the vegetated dune being eroded and removed (Figure 8); note the change in profile morphology between 2002 and 2006. From the time of the initial survey in July, the breached area has infilled due to wave overwash of the beach berm, which has carried sand over the berm and landward. As can be seen in Figure 8, landward of the berm crest, the beach has effectively aggraded vertically by some 0.5 to 1.0 m (1.6 to 3.3 ft). Our most recent survey, undertaken in April 2007, indicated that the crest of the berm was raised about 0.25 m, with its elevation now located at ~5.5 m (18 ft) NAVD88. Interestingly, most of the aggradation occurred between November 2006 and January 2007. Since January 2007 the berm has not aggraded vertically; instead, it has prograded seaward. This last response suggests that wave conditions after January were much lower (Figure 7), so that the wave runup was unable to overtop the berm crest. These latter responses appear to reinforce the work of Allan (2004) that a crest elevation of ~5.5 m to 6.0 m (18 to 19.7 ft) is probably ideal, allowing for some periodic overtopping of the spit.

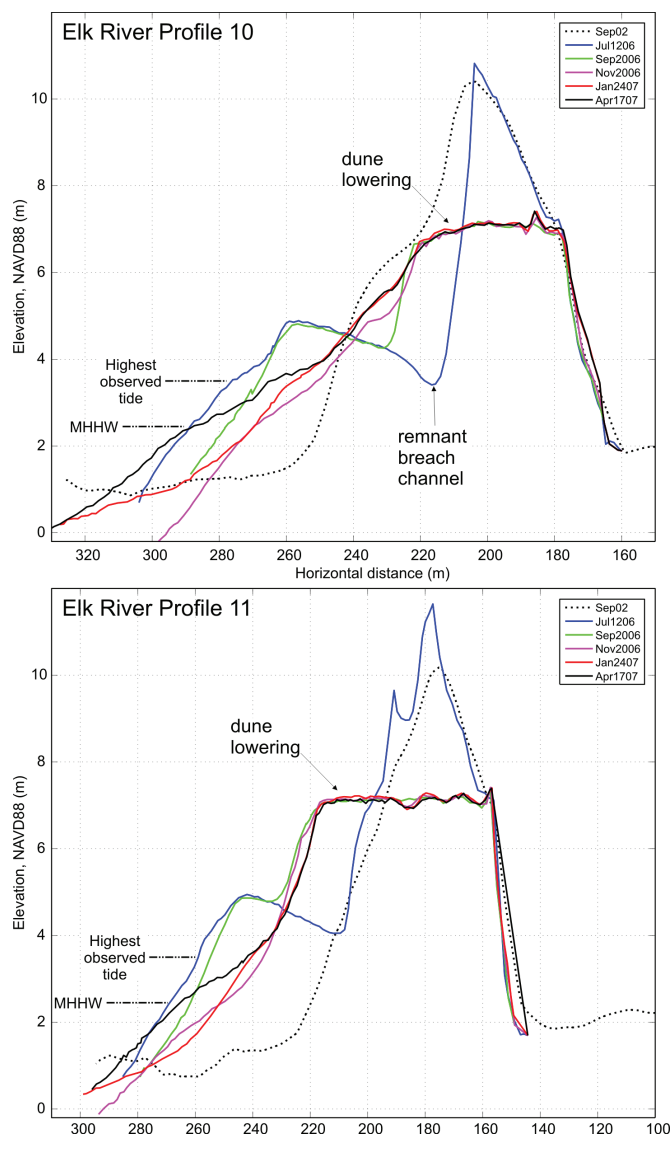
**Figure 9.** Beach profile responses determined for the Elk River profile 10 and 11 sites. Site locations are depicted in Figure 4.

Figure 9 shows the response of the beach and dune in the area that was effectively lowered in late July and early August 2006. Apart from the dune lowering, the most noticeable response identified on the beach is the effect of the natural breach of the spit by the Elk River, which resulted in the elimination of a substantial amount of the dune north of the profile 7 site and south of profile 10. As can be seen at the profile 10 site (Figure 9), following the spit breach, the river mouth began to migrate northward where it was eventually pushed up against the dune. This resulted in the characteristic pattern of erosion shown in Figure 9, whereby the dune became truncated.

As can be seen for the two profile sites shown in Figure 9, the effect of the dune lowering has had a minimal impact to the beach morphodynamics, with the natural level of variability (vertical and horizontal profile excursions) dominating the response at each of the transect sites. At those transect sites that span the area of dune lowering, the beach face was characterized by a prominent berm that formed prior to lowering of the dune. This again is a typical response of beaches in this area that reflects post-winter rebuilding of the beach face. Furthermore, it can be seen that the beach face had prograded significantly between 2002 and July 2006, which caused the beach face to advance seaward by up to 40 m (130 ft); further discussion of the along-shore change in shoreline response is described below. With progress into winter, the beach and reconstructed dune experienced only minor erosion between September and November 2006, probably due to the relatively wide beach present at the time in front of the dune. After November, sand accumulated in front of the profile 10 site, which caused the beach to prograde slightly seaward. This response may be due to a combination of alongshore and cross-shore transport of sediment at this site. As of April 2007, the upper part of the beach face (> 4 m elevation) had changed very little from the January 2007 survey, while the lower beach face had begun to rebuild. This latter response is consistent with the transition from higher wave energy conditions in winter to lower wave energy levels in summer. To the north, the response at profile 11 site was relatively similar to profile 10 site, with the exception that the reconstructed dune did experience a small amount of erosion between November 2006 and April 2007. It is probable that this response is due to the greater westerly extent of the reconstructed dune in the north, relative to the south, placing the dune face closer to ocean waves. In fact, erosion of the dune face characterized the overall response of the beach and spit morphodynamics north of profile 11.
