# **DYNAMIC REVETMENTS FOR COASTAL EROSION STABILIZATION: A FEASIBILITY ANALYSIS FOR APPLICATION ON THE OREGON COAST**

**Special Paper SP-37**

**Dynamic Revetments for Coastal Erosion Stabilization:  
A Feasibility Analysis for Application on the Oregon Coast**

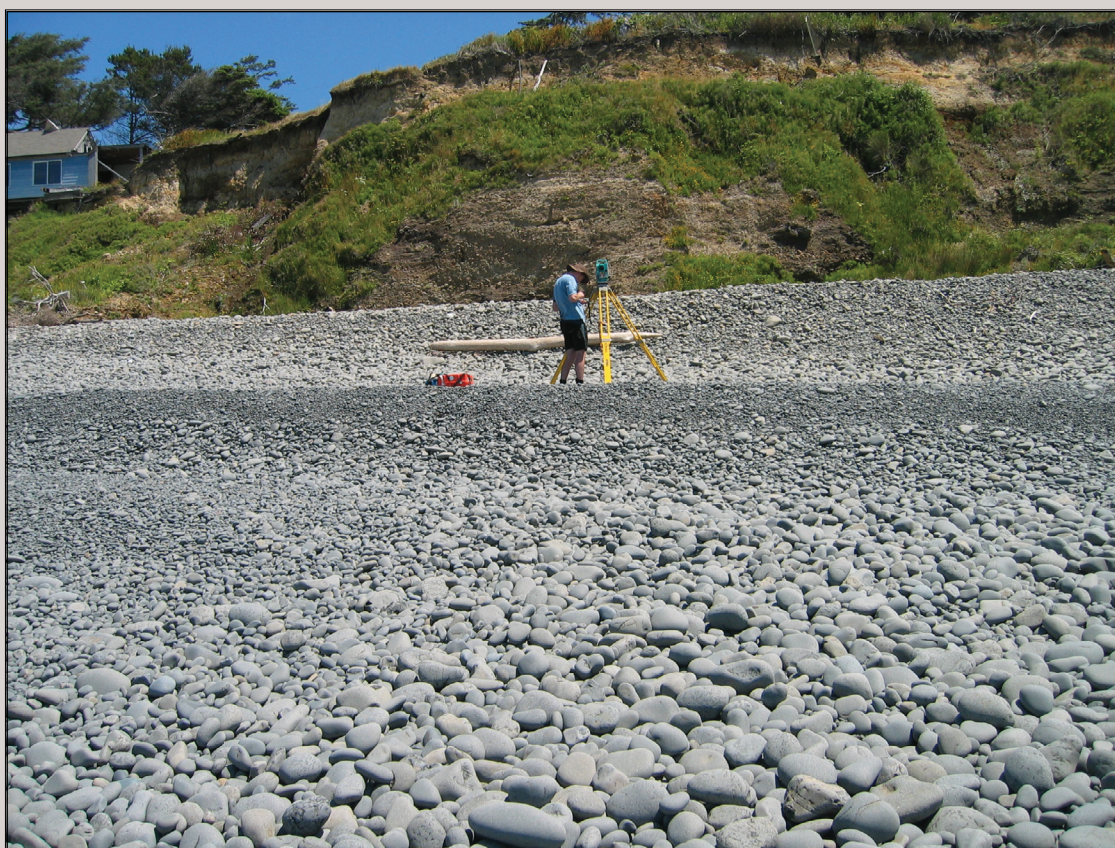
Cover photograph: Cove Beach gravel berm. The size and sorting characteristics of the sediments and the steep nature of the gravel face make this one of the most impressive and dynamic gravel beaches along the Oregon coast. View is looking landward (east).

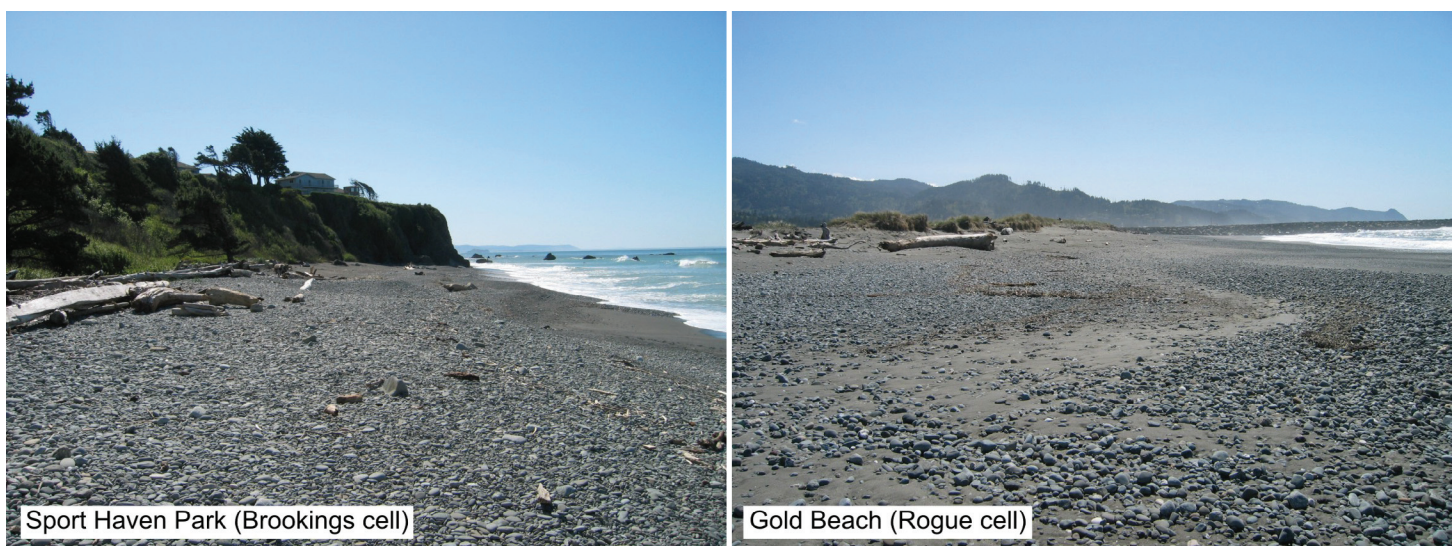
**Figure 13.** Example of a mixed sand and gravel beach. The backshore consists of a gravel and transitions to a wide, gently sloping, dissipative sand beach exposed primarily at low tide.

of the wave energy, sending waves seaward after being reflected from the beach face. The Oregon coast exhibits examples of each of the beach states in the Wright and Short (1983) morphodynamic model, although the dissipative beach is the most common beach type. As noted previously, reflective beaches are also found along the Oregon coast (Figures 13 and 14), but they are not as common as dissipative sand beaches.

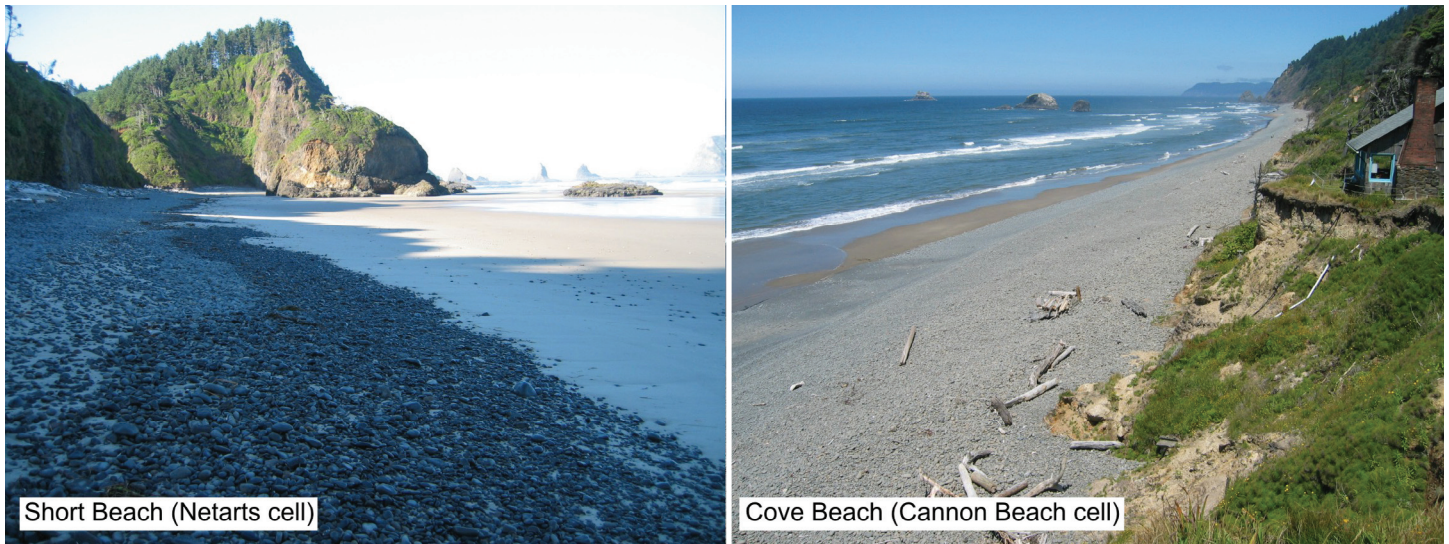
**Figure 14.** Composite beaches on the northern Oregon coast in Tillamook County. These beaches include a backshore consisting of a steep-faced gravel berm, which transitions to a wide, gently sloping, dissipative sand beach exposed at all tidal levels (Short Beach) or at low tide (Cove Beach).

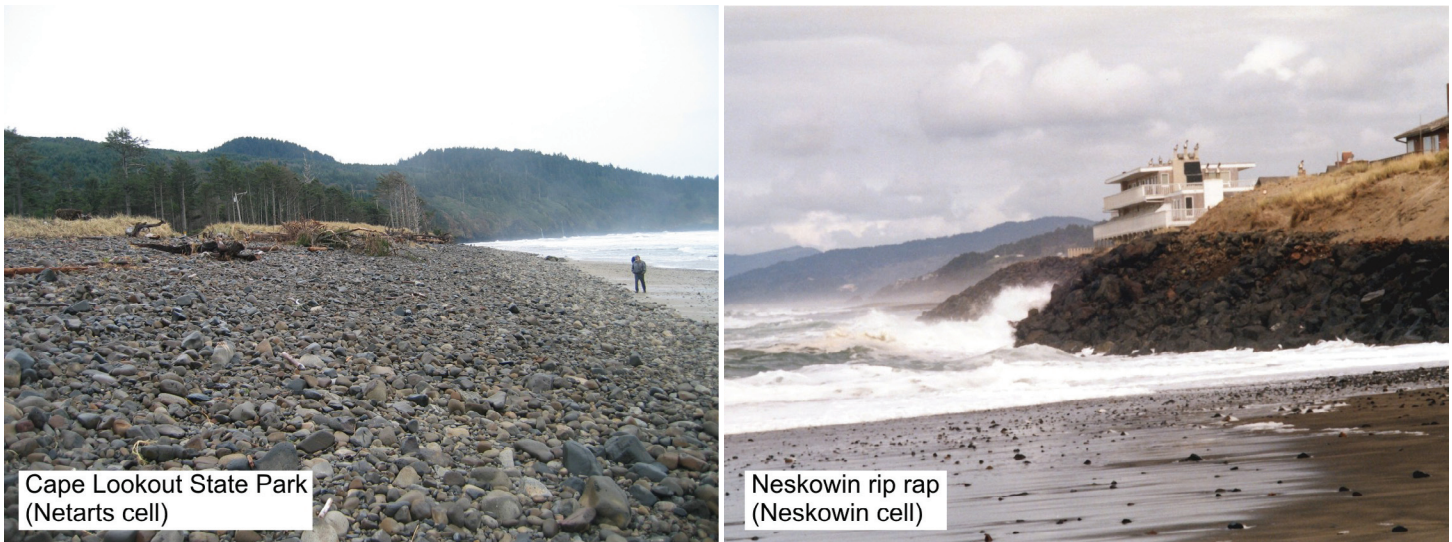
**Figure 16.** Comparison of a dynamic revetment constructed at Cape Lookout State Park (left) versus a conventional riprap revetment constructed at Neskowin (right).

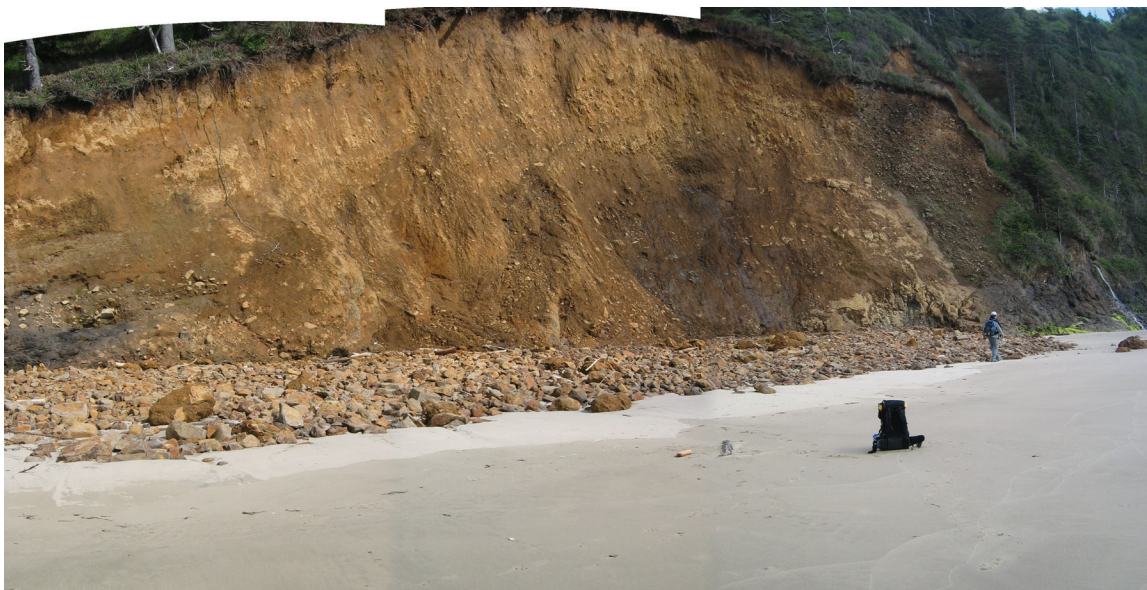
**Figure 20.** Photograph of landslide on the north side of Cape Lookout. The landslide occurred early in 2003 adjacent to Cape Lookout State Park. Such events periodically introduce significant quantities of coarse material to the coastal zone where the material is then redistributed along the shore to form cobble berms.

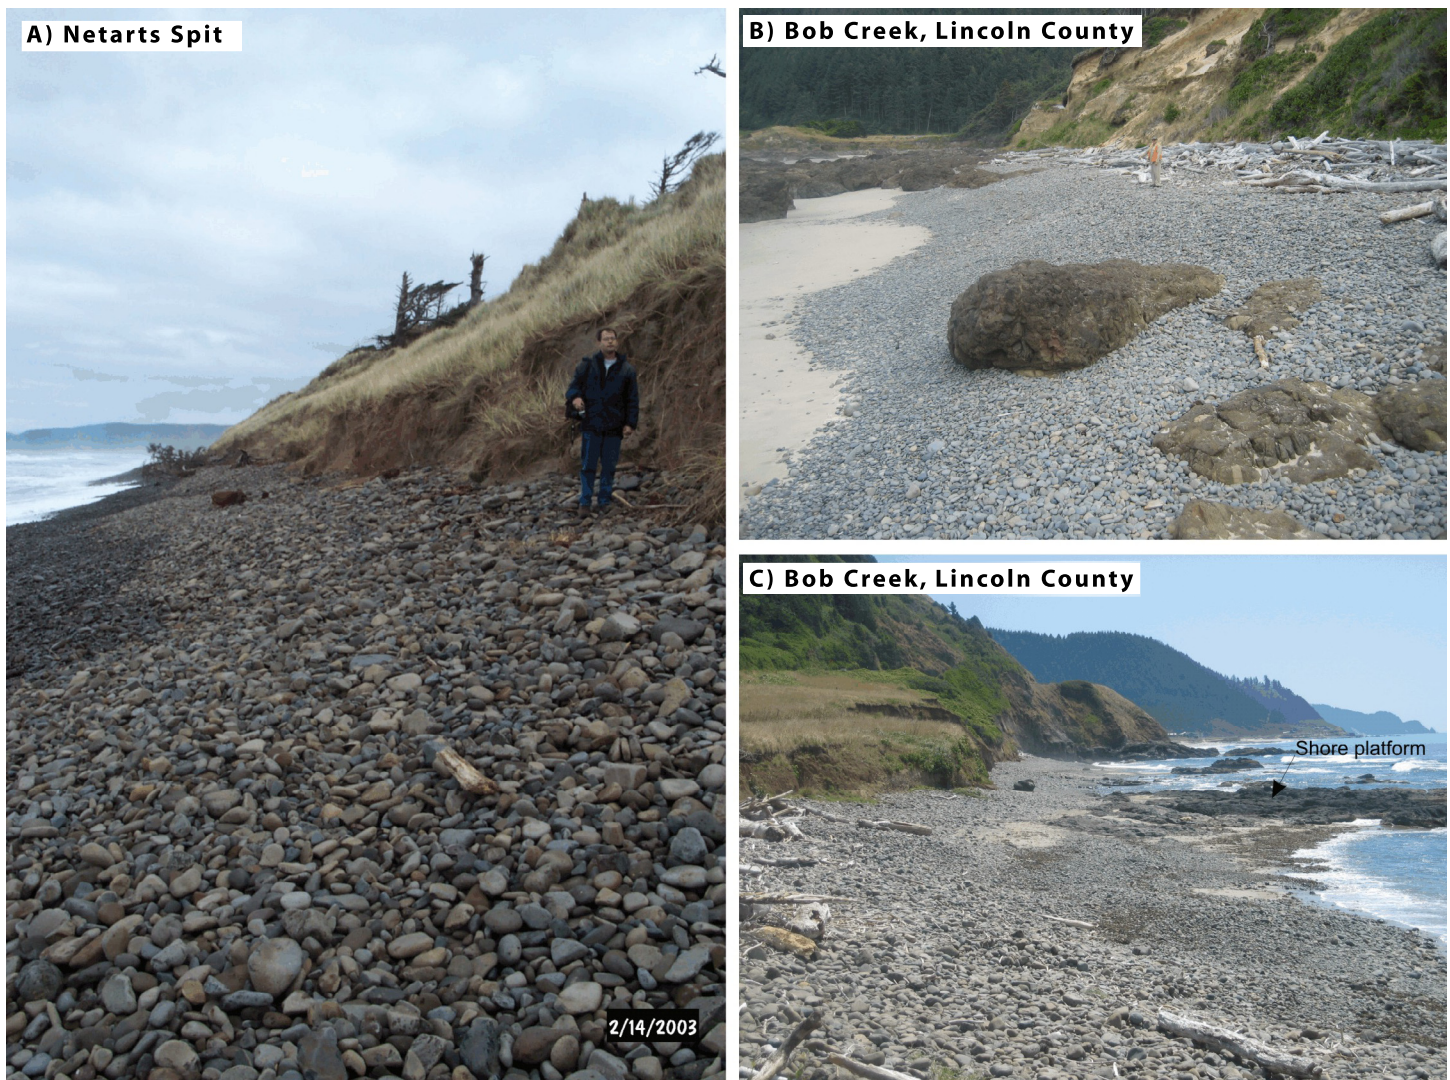
**Figure 21.** Examples of gravel beach types identified along the central and northern Oregon coast. (A) Netarts Spit gravel beach spans several thousand meters; (B) Bob Creek is characterized by smaller accumulations within a shoreline reentrant; (C) Bob Creek (view to the south) has a thin veneer on the landward edge of the shore platforms.

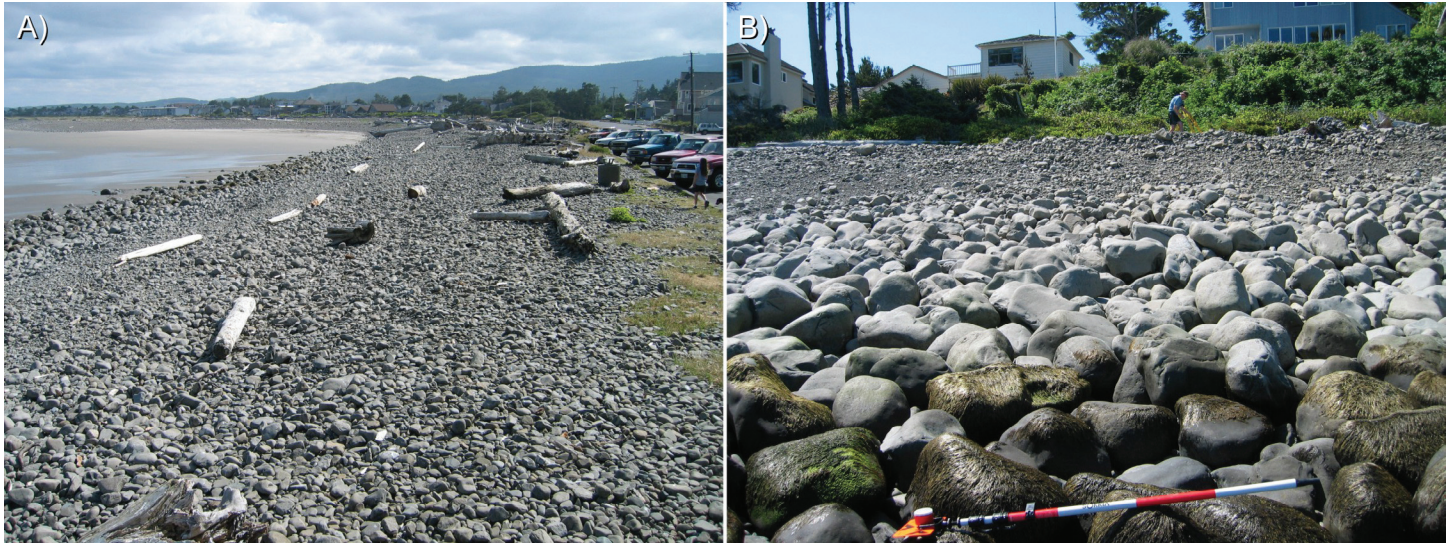
**Figure 24.** Gravel beach at Seaside. (A) Adjacent to profile 2. The presence of logs at the beach crest indicates the maximum wave runup height (about 6 m [19.6 ft]) achieved during the most recent storm event. (B) At profile 1, the lower portion of the gravel beach is protected by a boulder toe, with the finer gravels having been pushed up the cobble face to form the crest of the beach. Note the well-vegetated backshore and marine cliff landward of the cobble beach. The survey staff near the bottom of the photo shows 0.3-m (1-ft) graduations and indicates the size of the boulder toe at profile 1.

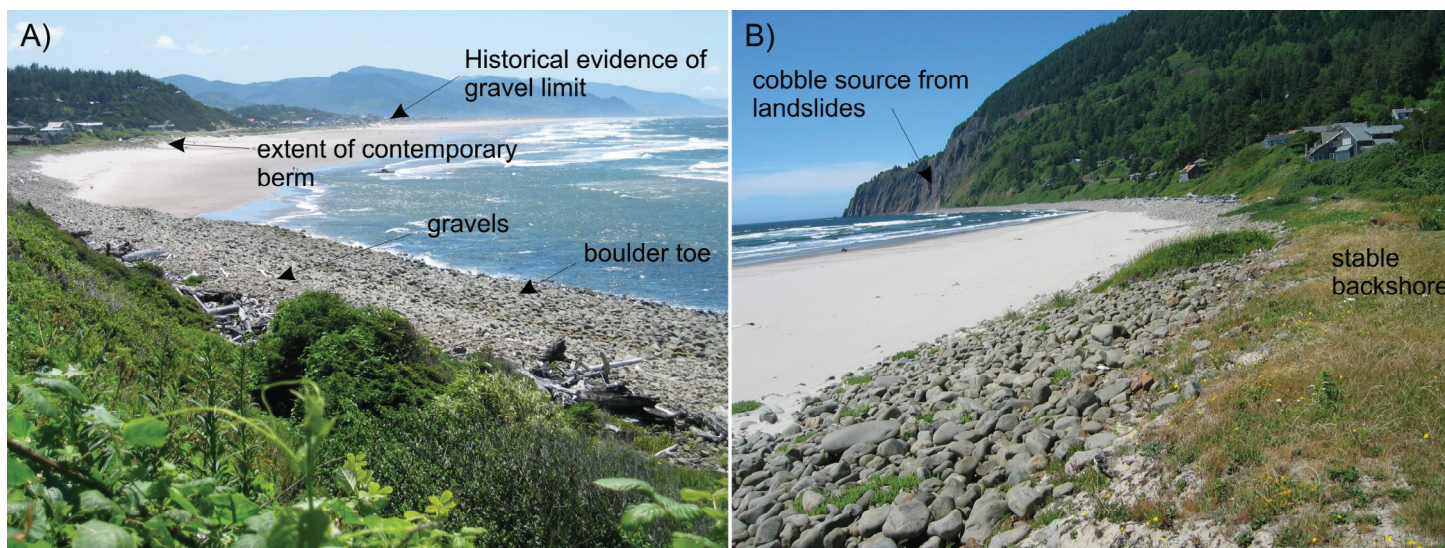
**Figure 30.** (A) Much of the Neahkahnie gravel berm gains significant additional protection and stability from having a toe composed of boulders. Photo was taken overlooking profile 3 and is looking toward the south. Note the historical limit of gravels identified adjacent to the town of Manzanita. (B) A well-vegetated backshore provides evidence of the stability of the gravel berm.

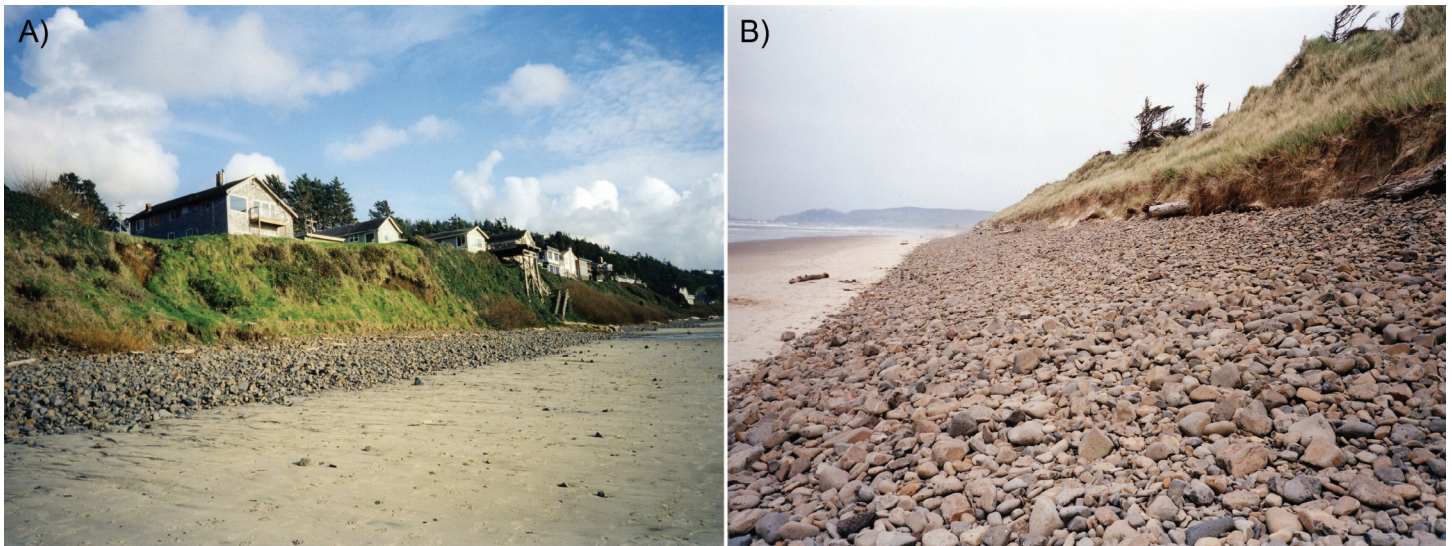
**Figure 35.** (A) The Oceanside gravel beach. Note the well-vegetated bluff face; photographs from the 1920s confirm that this site has been stable for a long time. (B) The gravel beach at Cape Lookout State Park. The photo was taken north of the constructed dynamic revetment and artificial dune. The beach is backed by an eroding scarp, which indicates that wave swash is attacking the toe of the dune during storms.
