# **DYNAMIC REVETMENTS FOR COASTAL EROSION STABILIZATION: A FEASIBILITY ANALYSIS FOR APPLICATION ON THE OREGON COAST**

**Special Paper SP-37**

**Dynamic Revetments for Coastal Erosion Stabilization:  
A Feasibility Analysis for Application on the Oregon Coast**

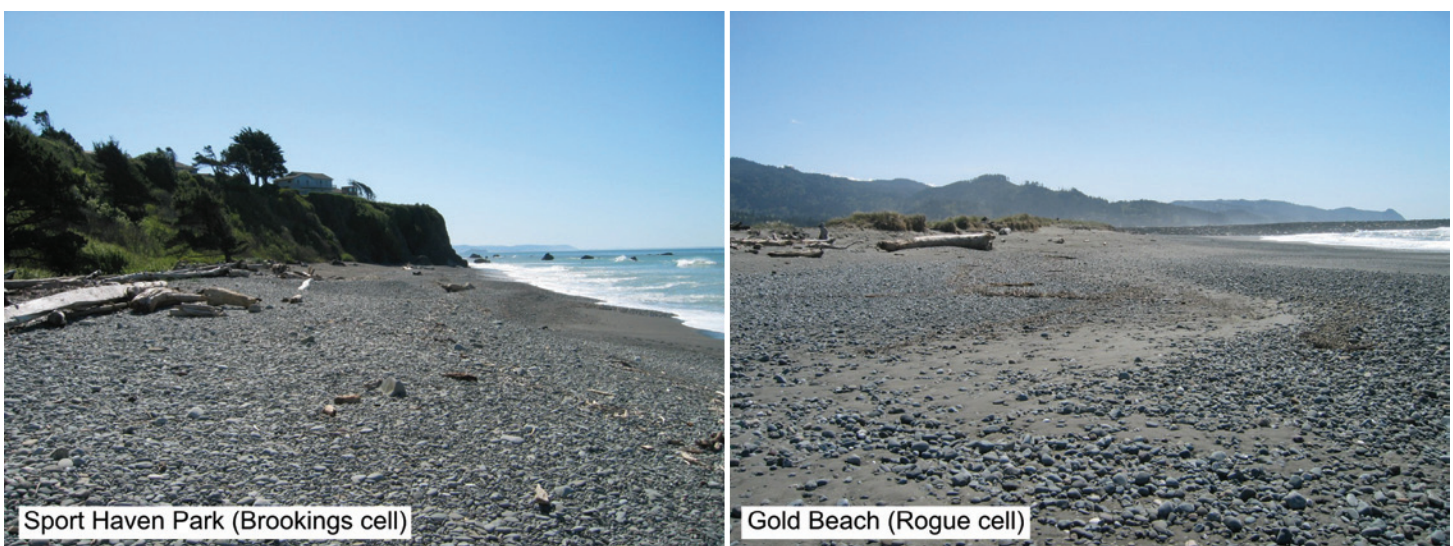
**Figure 13.** Example of a mixed sand and gravel beach. The backshore consists of a gravel and transitions to a wide, gently sloping, dissipative sand beach exposed primarily at low tide.

of the wave energy, sending waves seaward after being reflected from the beach face. The Oregon coast exhibits examples of each of the beach states in the Wright and Short (1983) morphodynamic model, although the dissipative beach is the most common beach type. As noted previously, reflective beaches are also found along the Oregon coast (Figures 13 and 14), but they are not as common as dissipative sand beaches.

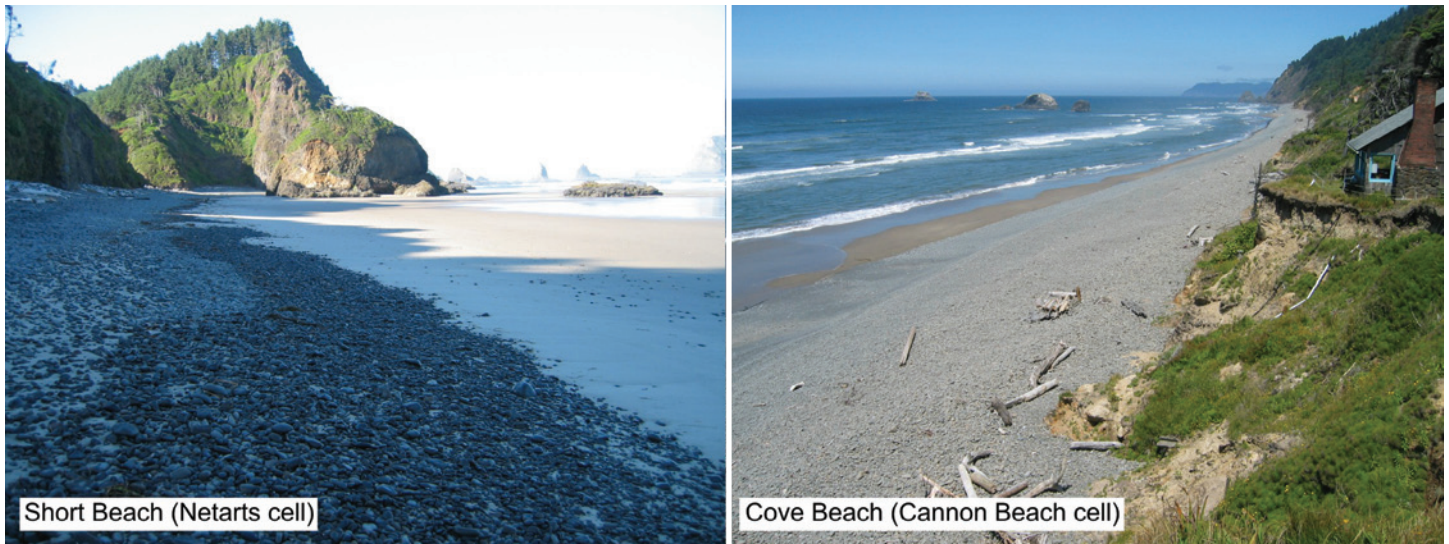
**Figure 14.** Composite beaches on the northern Oregon coast in Tillamook County. These beaches include a backshore consisting of a steep-faced gravel berm, which transitions to a wide, gently sloping, dissipative sand beach exposed at all tidal levels (Short Beach) or at low tide (Cove Beach).

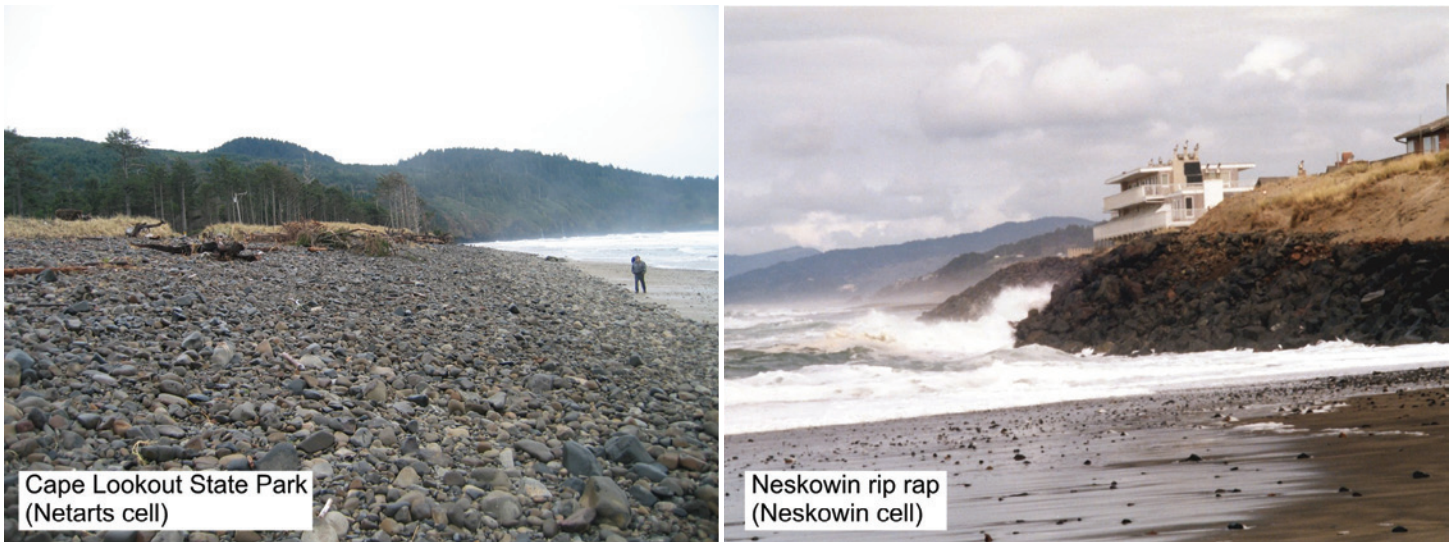
**Figure 16.** Comparison of a dynamic revetment constructed at Cape Lookout State Park (left) versus a conventional riprap revetment constructed at Neskowin (right).

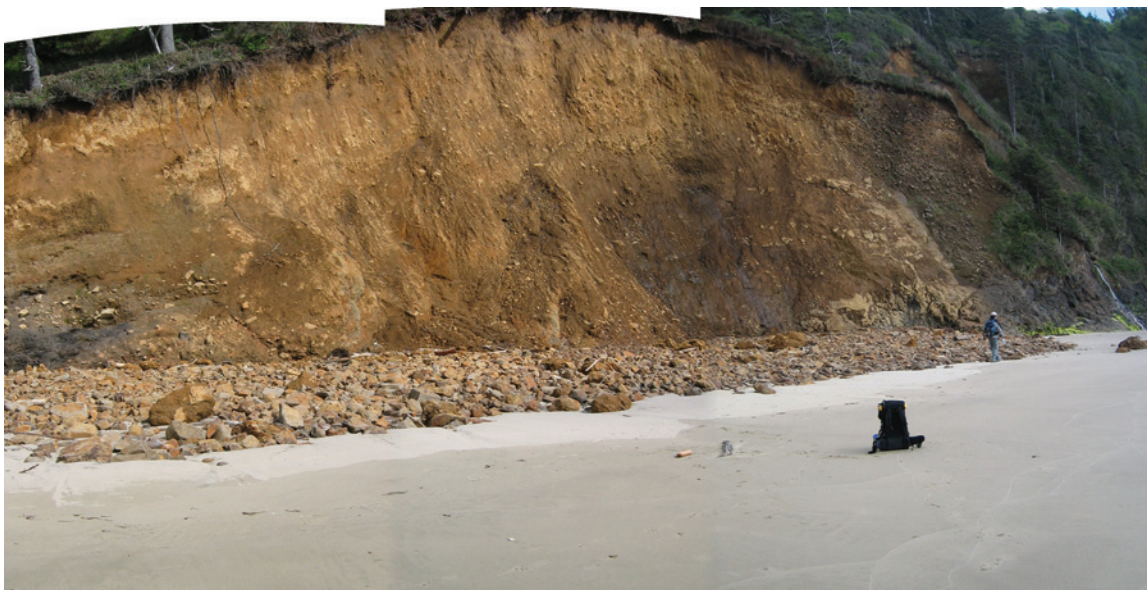
**Figure 20.** Photograph of landslide on the north side of Cape Lookout. The landslide occurred early in 2003 adjacent to Cape Lookout State Park. Such events periodically introduce significant quantities of coarse material to the coastal zone where the material is then redistributed along the shore to form cobble berms.

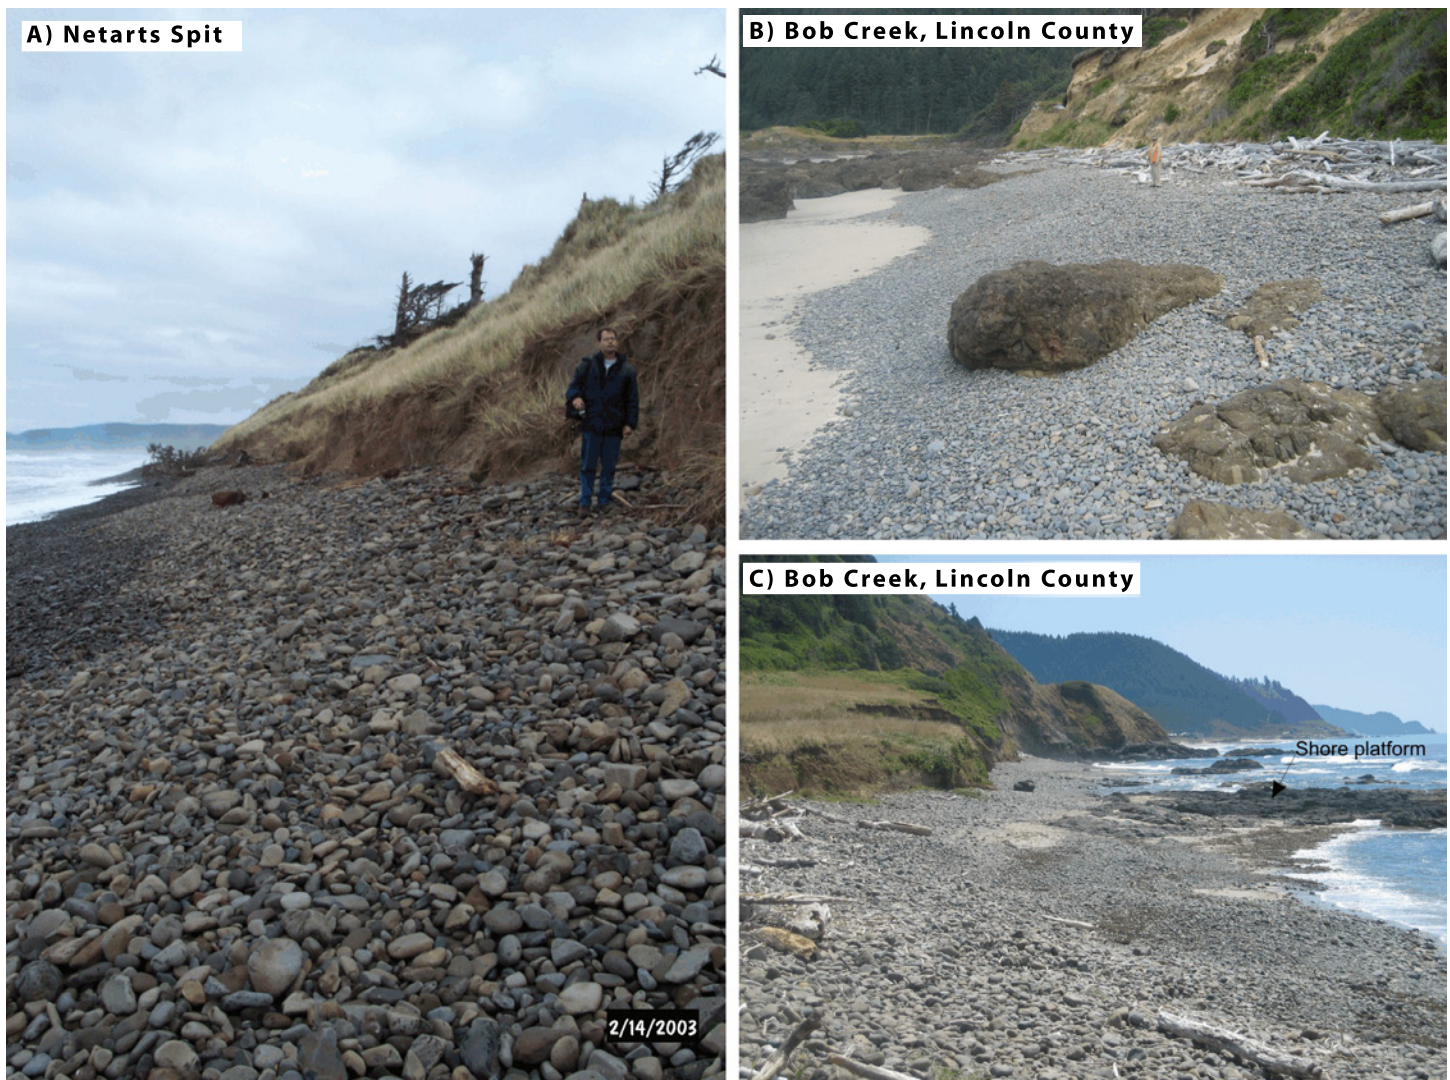
**Figure 21.** Examples of gravel beach types identified along the central and northern Oregon coast. (A) Netarts Spit gravel beach spans several thousand meters; (B) Bob Creek is characterized by smaller accumulations within a shoreline reentrant; (C) Bob Creek (view to the south) has a thin veneer on the landward edge of the shore platforms.

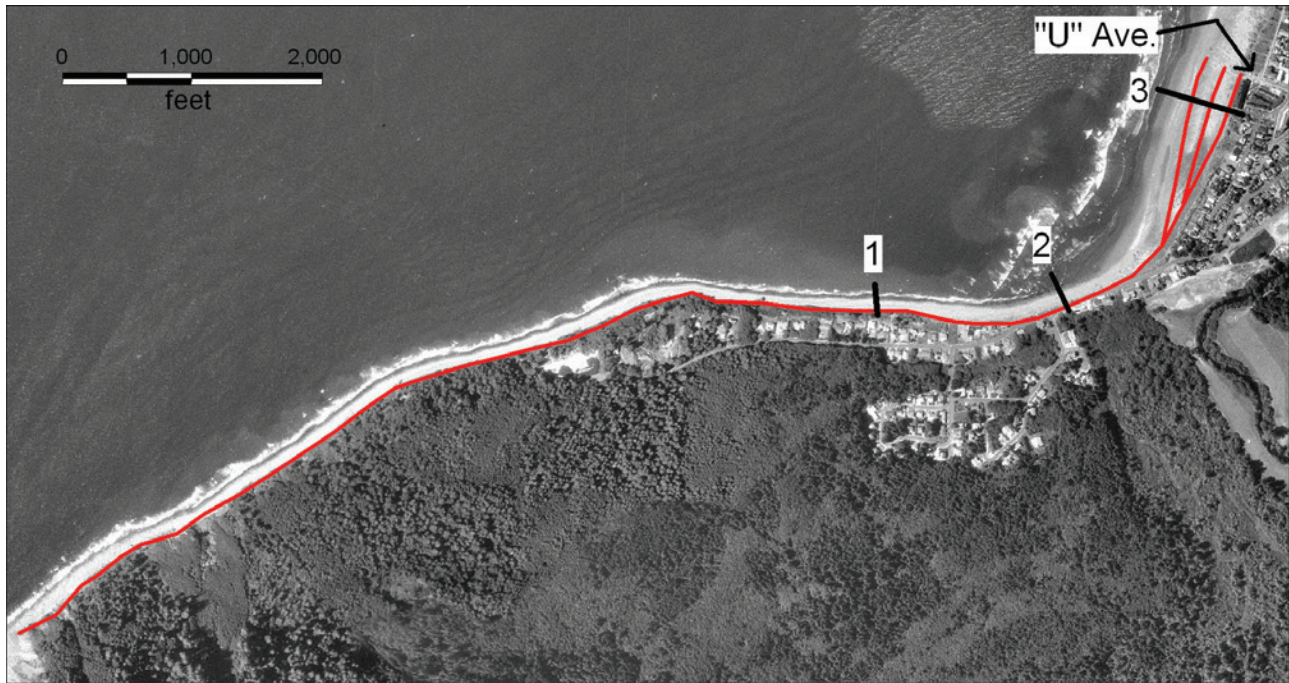
**Figure 22.** Seaside gravel beach showing locations of beach profile sites and grain-size sampling.

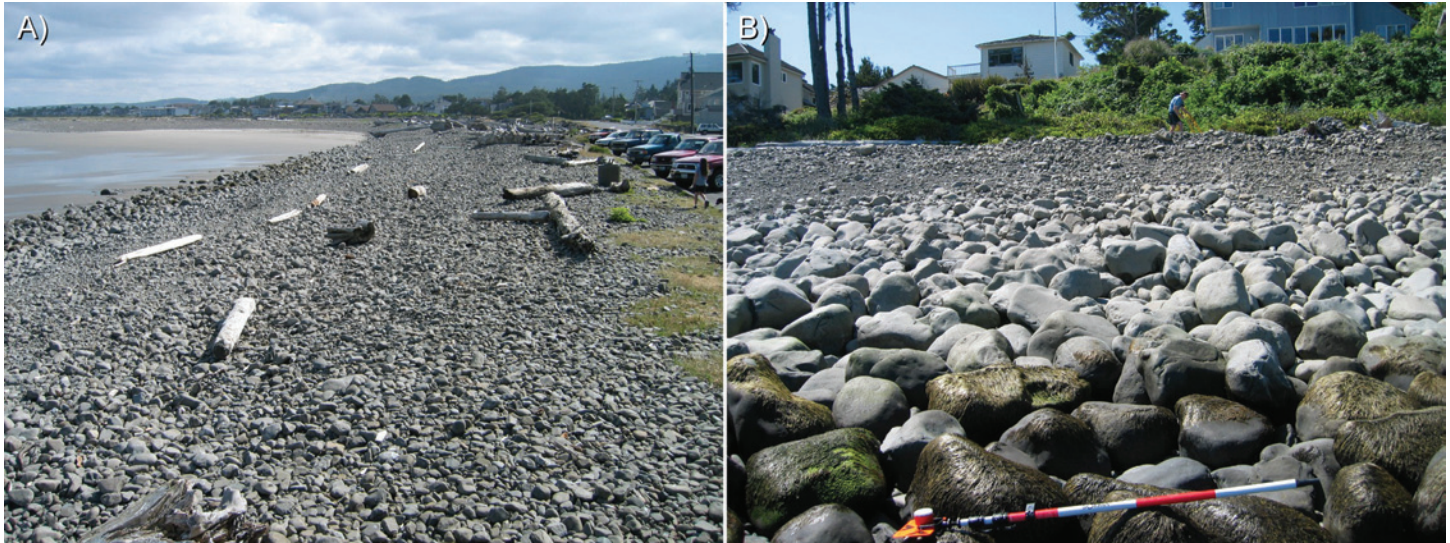
**Figure 24.** Gravel beach at Seaside. **(A)** Adjacent to profile 2. The presence of logs at the beach crest indicates the maximum wave runup height (about 6 m [19.6 ft]) achieved during the most recent storm event. **(B)** At profile 1, the lower portion of the gravel beach is protected by a boulder toe, with the finer gravels having been pushed up the cobble face to form the crest of the beach. Note the well-vegetated backshore and marine cliff landward of the cobble beach. The survey staff near the bottom of the photo shows 0.3-m (1-ft) graduations and indicates the size of the boulder toe at profile 1.

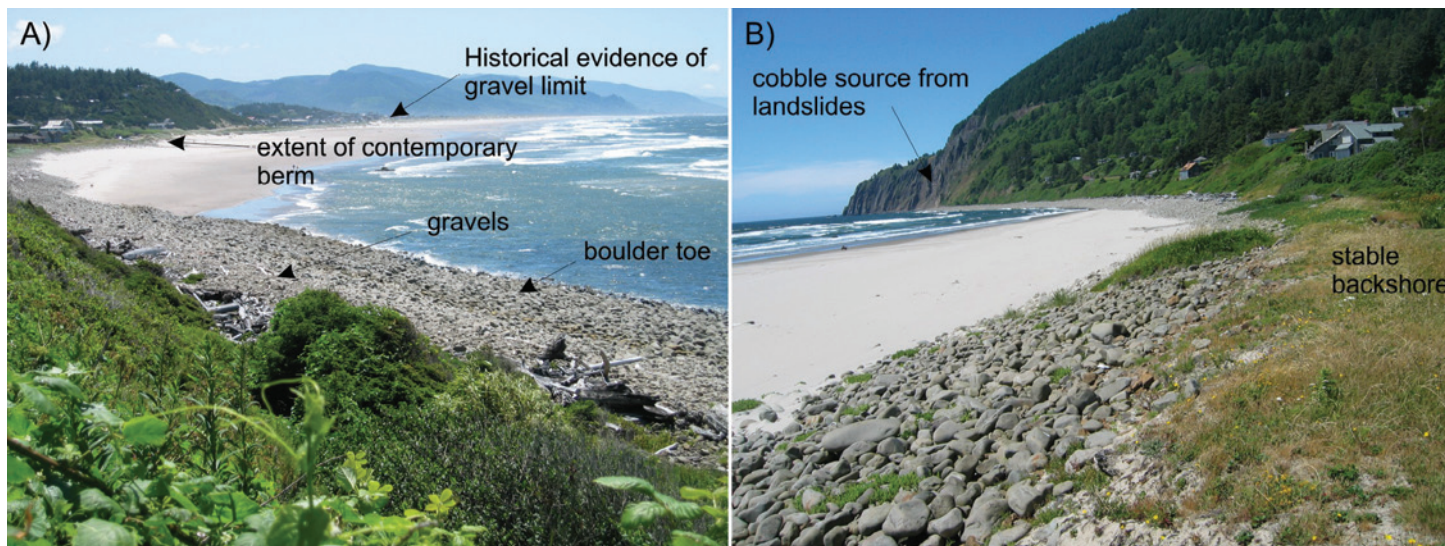
**Figure 30.** (A) Much of the Neahkahnie gravel berm gains significant additional protection and stability from having a toe composed of boulders. Photo was taken overlooking profile 3 and is looking toward the south. Note the historical limit of gravels identified adjacent to the town of Manzanita. (B) A well-vegetated backshore provides evidence of the stability of the gravel berm.

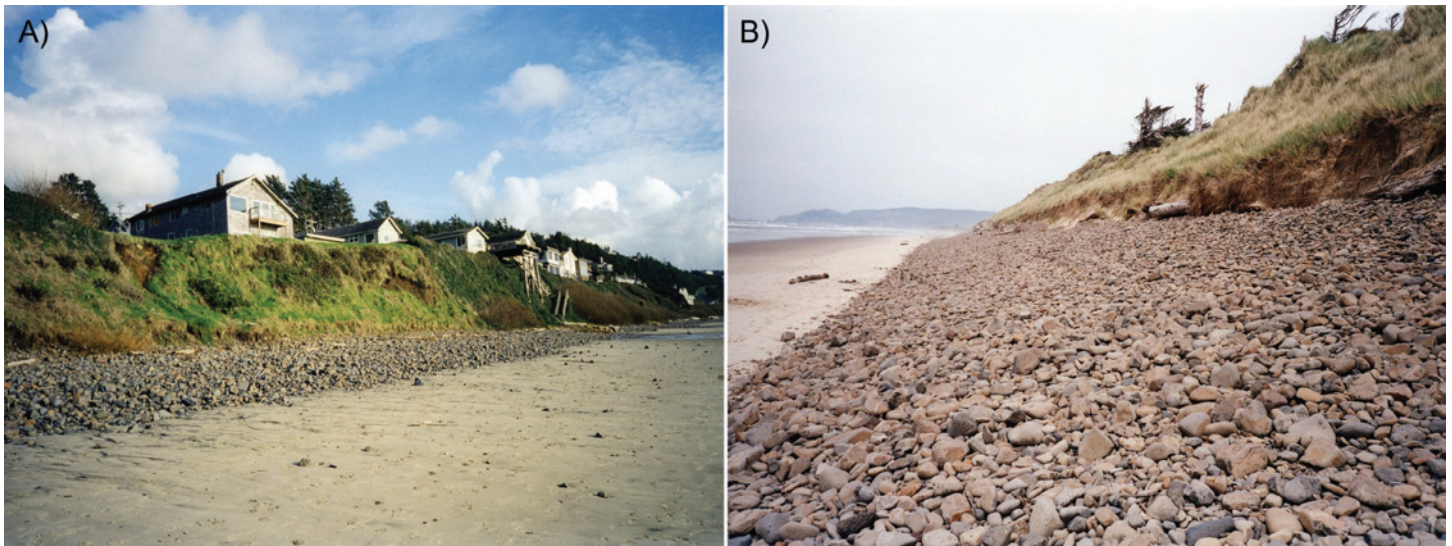
**Figure 35.** (A) The Oceanside gravel beach. Note the well-vegetated bluff face; photographs from the 1920s confirm that this site has been stable for a long time. (B) The gravel beach at Cape Lookout State Park. The photo was taken north of the constructed dynamic revetment and artificial dune. The beach is backed by an eroding scarp, which indicates that wave swash is attacking the toe of the dune during storms.
