APPENDIX G: MOVEMENT DATA FROM REFERENCE NAILS ON FRESH LANDSLIDE SCARPS

MEASUREMENT METHOD

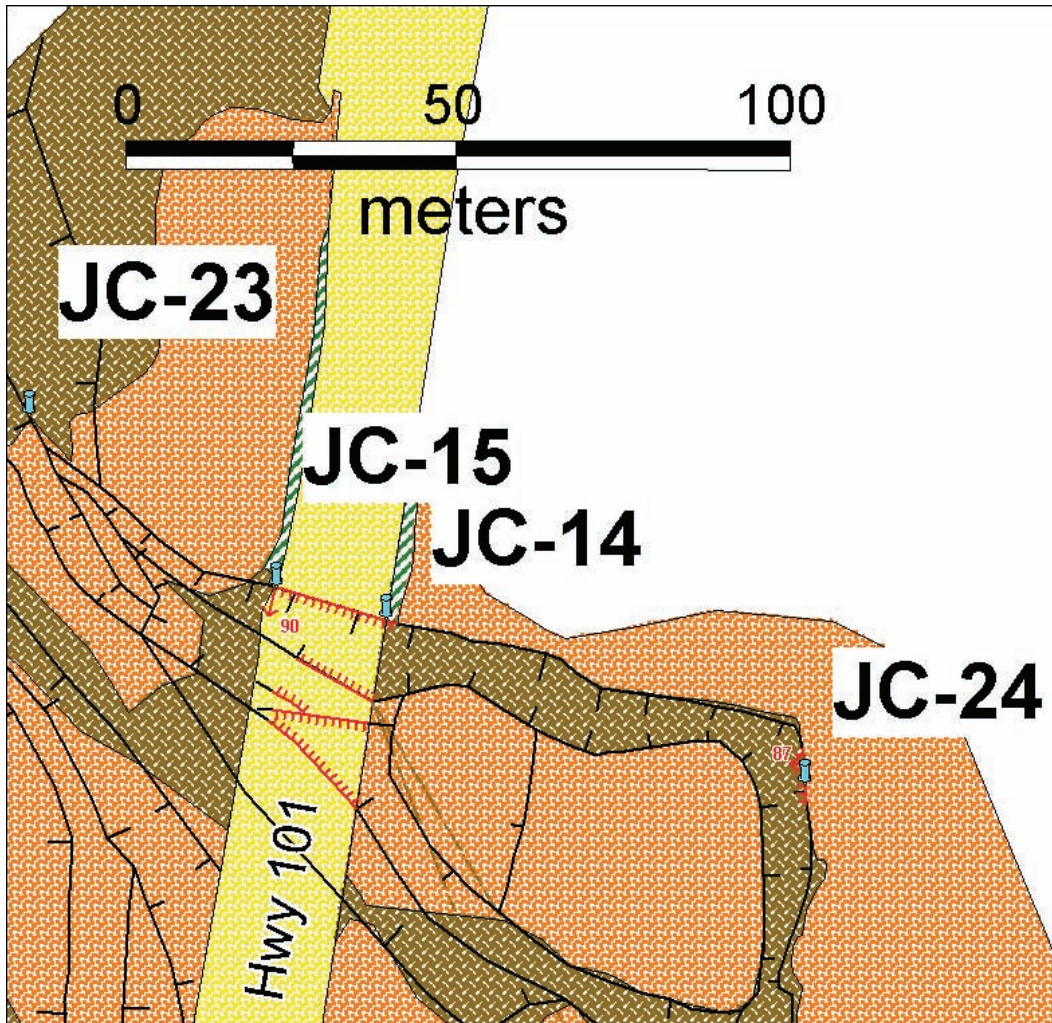
Figure G3. Marker nail locations in north part of slide. Orange unit is Pleistocene marine terrace sand; green striped unit is Astoria Formation; brown unit is colluvium; yellow unit is highway fill. Small red arrow indicates direction of dip of recently active slide scarp (red line with teeth in direction of scarp inclination); red number is dip in degrees.

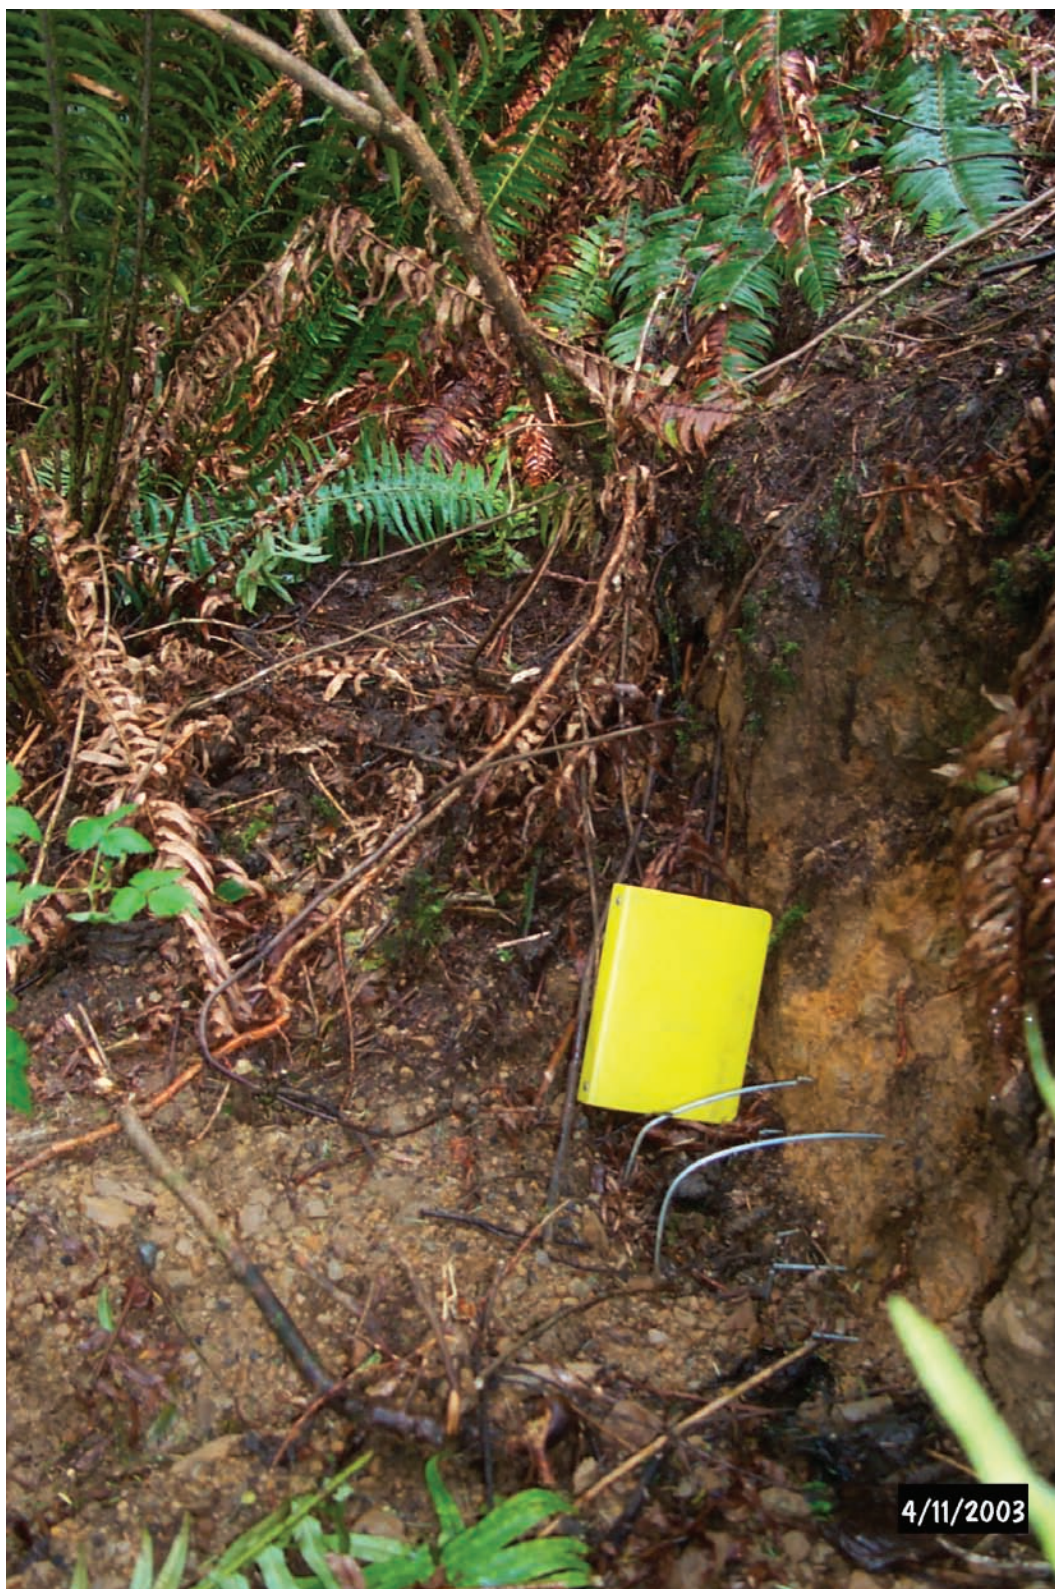
Figure G11. Marker nail site JC-20 looking south. Yellow field book is ~19 cm long.

Net horizontal movement at site JC-20 on the southern margin of the slide where it cuts the Old Coast Highway is 0.4 cm left lateral and 0.3 cm perpendicular to the scarp striking $N60^\circ E$. This corresponds to a net horizontal slip of 0.5 cm toward $N83^\circ W$. This is probably a reasonably good estimate of the net horizontal slip vector for this part of the Johnson Creek landslide, as it matches well with net direction of slip estimated independently from horizontal offset of the Old Coast Highway (see discussion in main text). Because most of the slip is subparallel to the slide margin, a narrow graben would be expected. This is one of the narrowest graben at the slide margin.

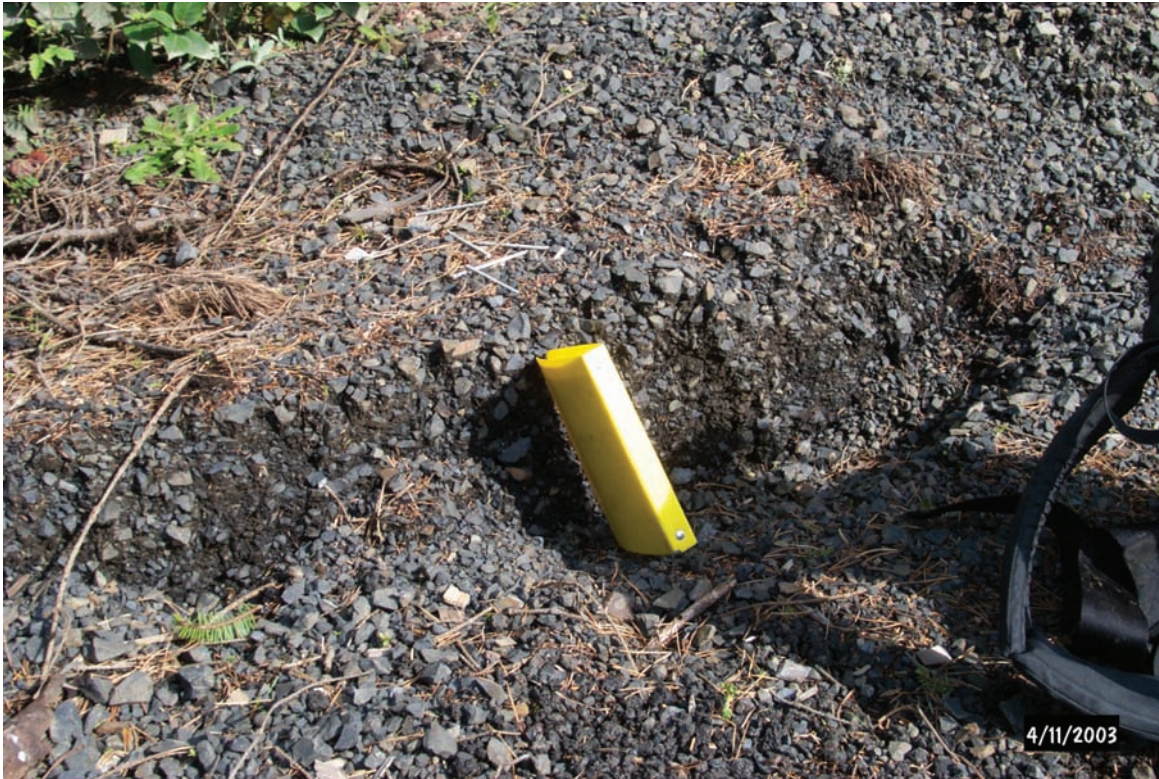
Figure G12. Marker nail site JC-21 looking southeast. Yellow field book is ~19 cm long. The scarp is in gravel fill from the Highway 101.

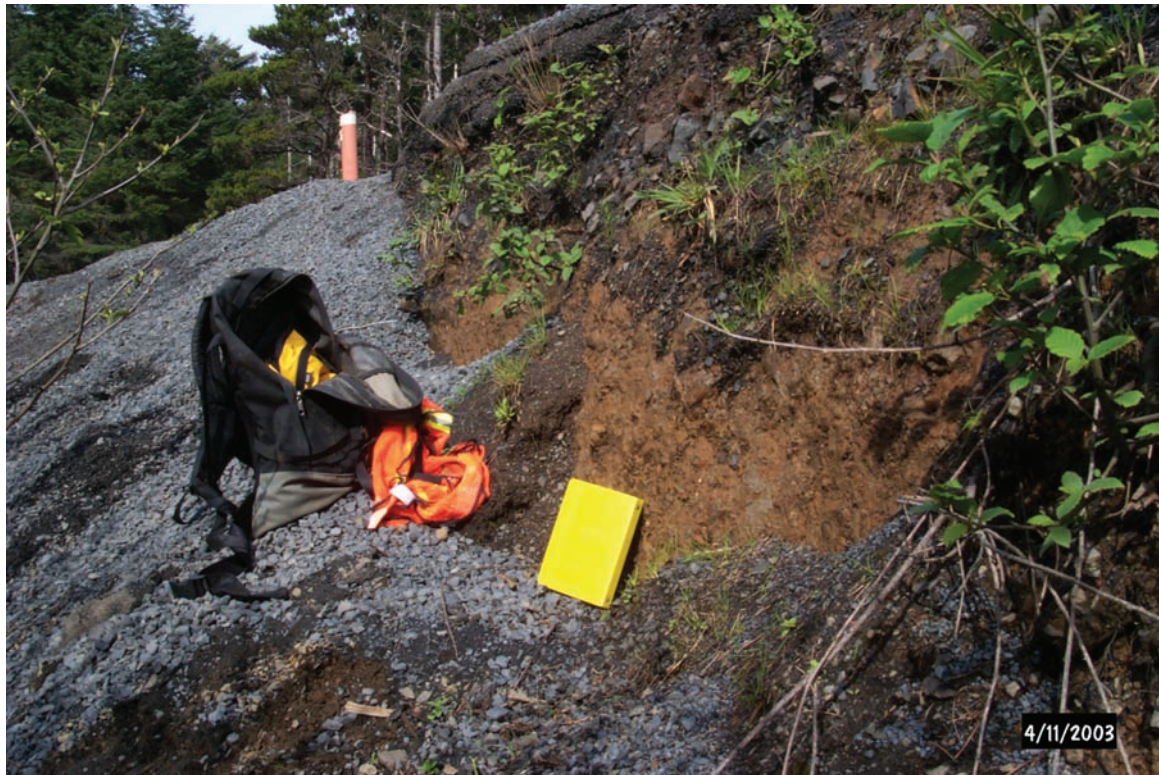
Figure G13. Marker nail sites JC-22 (near red highway cone at top of highway embankment) to JC-24 (to the right of the yellow field book) looking northeast parallel to the strike of the fresh headscarp (red orange fill of excavated Astoria Formation). Yellow field book is ~19 cm long. The near-vertical portion of scarp is ~1.2 m high.

The nails at the northern margin at U.S. Highway 101 recorded right-lateral movement of $0.3\text{--}0.6 \pm 0.1$ cm (sites JC-14 and JC-15). Nails at the northeast headscarp (site JC-24) recorded 0.3 ± 0.1 cm of dilation perpendicular to the scarp. Nails at the southern margin at the Old Coast Highway (site JC-20) recorded left-lateral movement of -0.4 ± 0.1 cm, while nails in the southernmost margin (sites JC-22 and JC-23) had left-lateral movements of 0 to -0.6 ± 0.1 cm. We conclude
