#### **BULLETIN 82**

# GEOLOGIC HAZARDS OF THE BULL RUN WATERSHED, MULTNOMAH AND CLACKAMAS COUNTIES, OREGON

John D. Beaulieu
Oregon Department of Geology and Mineral Industries

1974

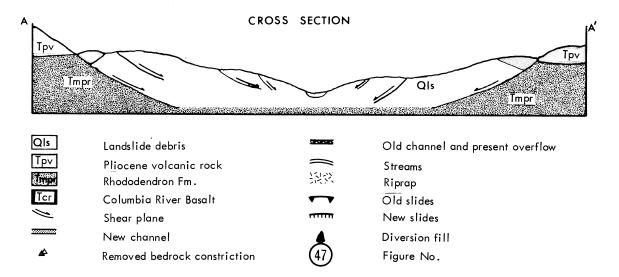
Figure 45b. Cross section of the North Fork slide.

Riprap and armor rock placed in and along the North Fork may not be sufficient to handle smaller floods of natural origin. Many of the naturally occurring boulders in the stream immediately upstream from the slide area are as large as many of the boulders in the riprap (Figure 50). Moreover, small floods in the winter of 1973 rearranged some of the riprap along the streambank. More detailed assessment of the riprap should be made; grouting may be required. Also, much more riprap may be required, especially along the west bank of the diversion channel (Figures 51 and 52). Removal of logs from the stream channel upstream and modification of drainage on the slide areas will not significantly alter slide potential at the North Fork slide.

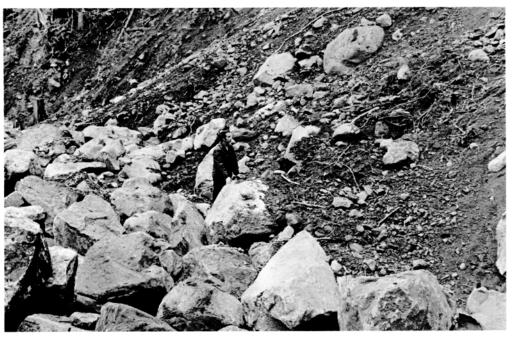
Figure 51. Material continues to slough
off the slopes oversteepened by streambank erosion during the North Fork
flood of January 1972.

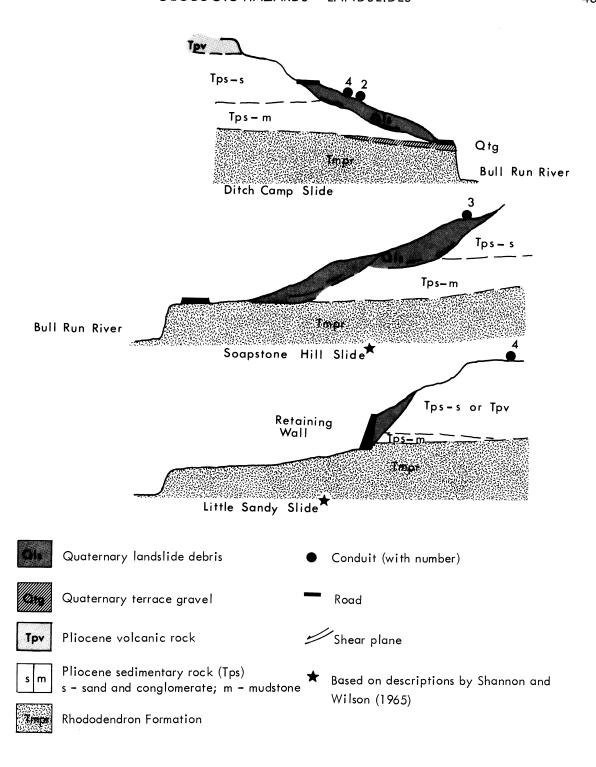
Figure 54. Diagrammatic cross sections of recent slides in the lower Bull Run drainage.

Natural factors causing sliding at the Ditch Camp site include moist climate, moderate slopes, and unfavorable bedrock. The Pliocene sedimentary rock (Tps) in which the slide is developed consists of sand-stone and conglomerate high on the slope and clayey siltstone or mudstone low in the section (Figure 54). Penetrative weathering and high pore pressures along the contact between the clay and the sandstone has produced a zone of failure above which friable coarse-grained clastics are undercut and below which slow moving earthflow is developed. The mantle of slide debris is approximately 40 to 45 feet thick (Shannon and Wilson, 1965).

Soapstone Hill slide: The Soapstone Hill slide is located approximately half a mile southeast of the community of Bull Run on the north side of the Bull Run River (Figure 53). Slopes are moderately steep. The slide occurs in Pliocene sedimentary rock and is analogous to the Ditch Camp slide. Moist climate and the abundance of clay-rich material low on the slope cause the instability of the rock (Figure 54).

Although local geology is obscured by vegetation, soil cover, and the road, the road and the metal retaining wall appear to be founded in bedrock of the Rhododendron Formation (Shannon and Wilson, 1965). Regional mapping indicates that the Pliocene sedimentary rock unit (Tps) is very thin. Soil material suggests the presence of clayey and sandy interbeds of that unit, however (Sandy River Mudstone of Shannon and Wilson, 1965). Steep slopes are the dominant factor in the sliding and the slides are shallow (Figure 54).

Approximately 6 to 8 feet of ballast was placed on the toe of the slide to arrest movement. Among other recommendations was the enhancement of drainage to lower the winter water table. Because movement on the Ditch Camp slide has not been completely eliminated (Figures 55 and 56), further corrective measures are necessary. Interruption of water supply to Portland provided by conduits 2 and 4 could have dire consequences. It is recommended that qualified personnel make a detailed engineering investigation of the Ditch Camp slide to evaluate possible future damage to the conduits through settling or sliding and to recommend corrective measures.

In view of the potential impact of possible future sliding, it is recommended that the Soapstone Hill area be studied in detail by qualified engineering personnel. If it is determined that the three buttresses which now stabilize the slide are not adequate, additional corrective measures should be taken.

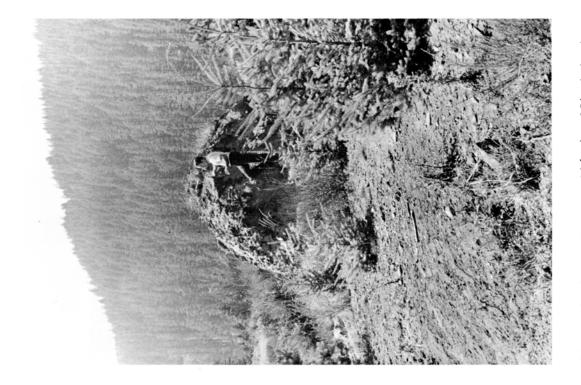
Figure 63. Large disoriented blocks of Rhododendron Formation breccia are present in the Headworks landslide.

Detailed engineering investigations are recommended for all future construction in the slide area. The potential for unpredictable cave-ins should be fully appreciated and guarded against in all excavations. In addition, piezometer readings and dam-water surface elevations should be monitored, recorded, and correlated with precipitation data. Deviations from the norm may indicate impending trouble.

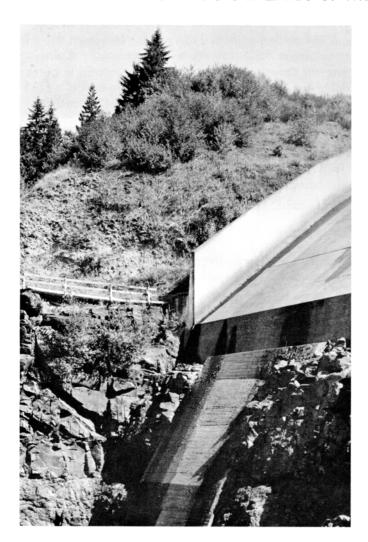
Figure 64. At the Headworks spillway, terrace gravel overlies the Columbia River Basalt and underlies slide debris.

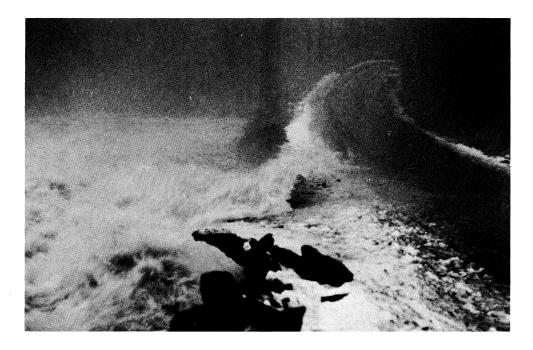
Rapid runoff: Occasionally during the wet season, the saturated soil conditions, steep slopes, and heavy rainfalls of the Bull Run Watershed produce hazardous runoff. Under exceptional circumstances the impact reaches disastrous proportions. Exceptionally heavy rains coupled with a rapidly melting snowpack produced a recorded flow of 35,000 cubic feet per second at the Headworks on December 22, 1964. Streambank erosion immediately downstream from the spillway plunge pool of Bull Run Dam No. 2 nearly severed conduits 2 and 4, a circumstance which would have severely restricted Portland's water supply (Figures 68, 69,70).

Figure 69. Streamflow at the Headworks on December 22, 1964 was 35,000 cfs (same location as Figures 68 and 70).

There is no way to restrict high runoff from the entire watershed during conditions as extreme as the flood of 1964. However, protective measures can be taken to prevent disastrous consequences in critical areas. For example, a qualified engineering geologist should examine the area of the stream bank attacked by the 1964 flood to determine what corrective measures, such as grouted riprap or piling, may be required to adequately protect it against similar erosion in the future.

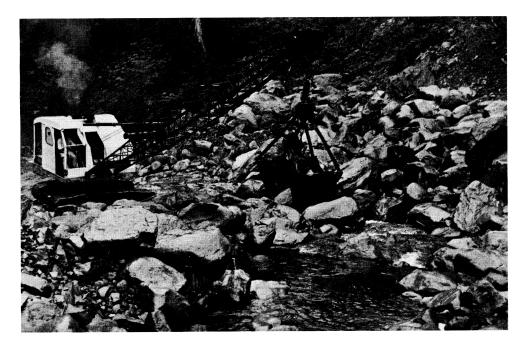
Figure 74. Large riprap is needed for channel modifications at the site of the North Fork slide.

Logging in the drainage basin of the North Fork should be restricted as a means of retarding the melting rate of the snowpack. Also, corrective measures employed to date at the slide area should be reevaluated in terms of new data regarding stream flow, channel roughness, and actual performance (Figure 74). Removal of red clay and other debris from the overflow channel (see North Fork slide) is recommended. Riprap may be needed to buttress the stream bank against further sliding.

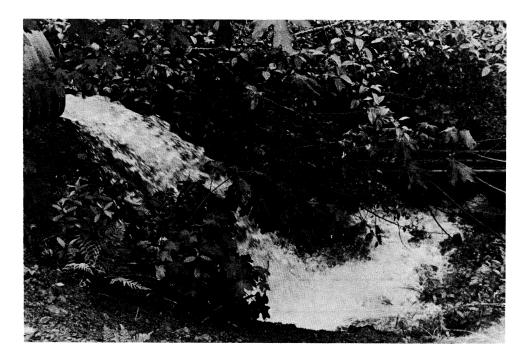
Most roads in the Bull Run Watershed are well constructed to allow for rapid runoff. Culverts generally are well-spaced and are of adequate size to handle surface water (Figures 75 and 76). However, problem areas of small culverts which might plug quickly are a matter of concern. Because much of the

Figure 76. For most roads, culverts are needed to handle rapid runoff after storms.

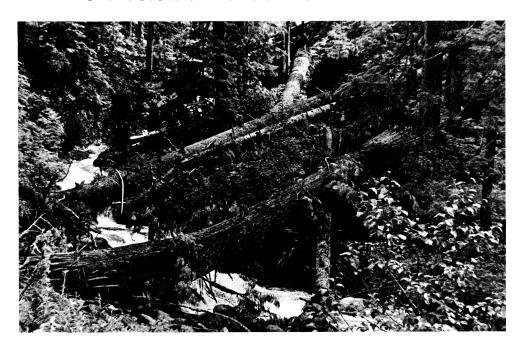
Log jams which redirect stream flow against the sides of the stream can easily initiate slides and increase turbidity (Figure 79). They should be removed (see Massive landslides - South Fork slides). Reservoir drawdown in the late summer months exposes silt and clay to wave action (Figure 80). No realistic means of control is known for turbidity generated in this way.

Figure 79. Log jams, windfalls, and other obstructions promote stream-bank erosion and turbidity; they should be removed wherever feasible.
