**OPEN-FILE REPORT O-23-09**

# **CAPE KIWANDA SINKHOLES AND THEIR FORMATION, TILLAMOOK COUNTY, OREGON**

By Jonathan C. Allan and Laura Gabel

This report evaluates the formation of two sinkholes during 2023 at Cape Kiwanda, Tillamook County, Oregon. The goal is to provide guidance to the Oregon State Parks and Recreation Department (OPRD) on recent and historical coastal changes as well as potential future impacts taking place at Cape Kiwanda.

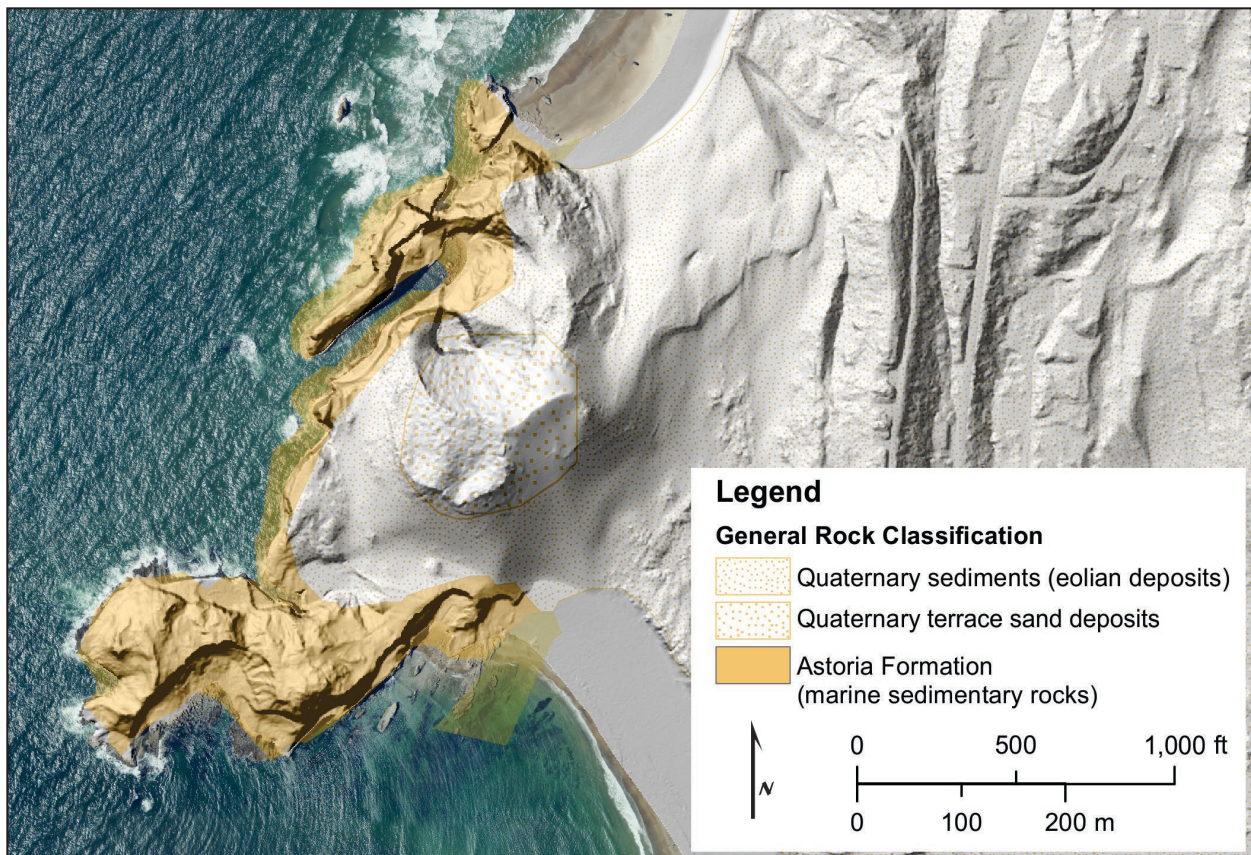
**Figure 3. Generalized geologic map of Cape Kiwanda draped on a 2009 1-m (3 ft) Lidar Digital Elevation Model (DEM) hillshade (geology from Schlicker and others, 1972).**

The geology of Cape Kiwanda consists of middle Miocene sandstone and siltstone of the Astoria Formation (Figure 3, orange shading). These rocks are  $\sim 15$  million years old and were laid down during a period of time when the Pacific Ocean extended over much of western Oregon (Lund, 1974). Although not shown here, the largest outcrops of Astoria Formation can be found in various road cuts near Cape Lookout and Cape Meares.

Over the past 2.6 million years (Quaternary) windblown sand has been deposited on top of the Astoria Formation (**Figure 3**), with the oldest deposits located atop Cape Kiwanda. These deposits provide evidence of the former greater extent of dunes that were deposited when Haystack Rock was connected to the mainland (Schlicker and others, 1972). Intermixed within these older sediments are sandy deposits that have accumulated over the past 15,000 years (Late Pleistocene and Holocene). The most recent sand deposits are reworked beach deposits that are presently accumulating over much of the headland through eolian (wind) processes. Where the headland abuts against the ocean, waves coupled with fluctuating tides are eroding and wearing away the sandstone, producing wave-cut channels, sea caves, arches and rockfalls. These erosive features as well as the Holocene dunes sitting on top of the Astoria Formation can be seen in oblique photographs of the headland (**Figure 4**).
