BULLETIN 99

# **GEOLOGY AND GEOLOGIC HAZARDS OF NORTHWESTERN CLACKAMAS COUNTY, OREGON**

1979

**HERBERT G. SCHLICKER, Engineering Geologist**

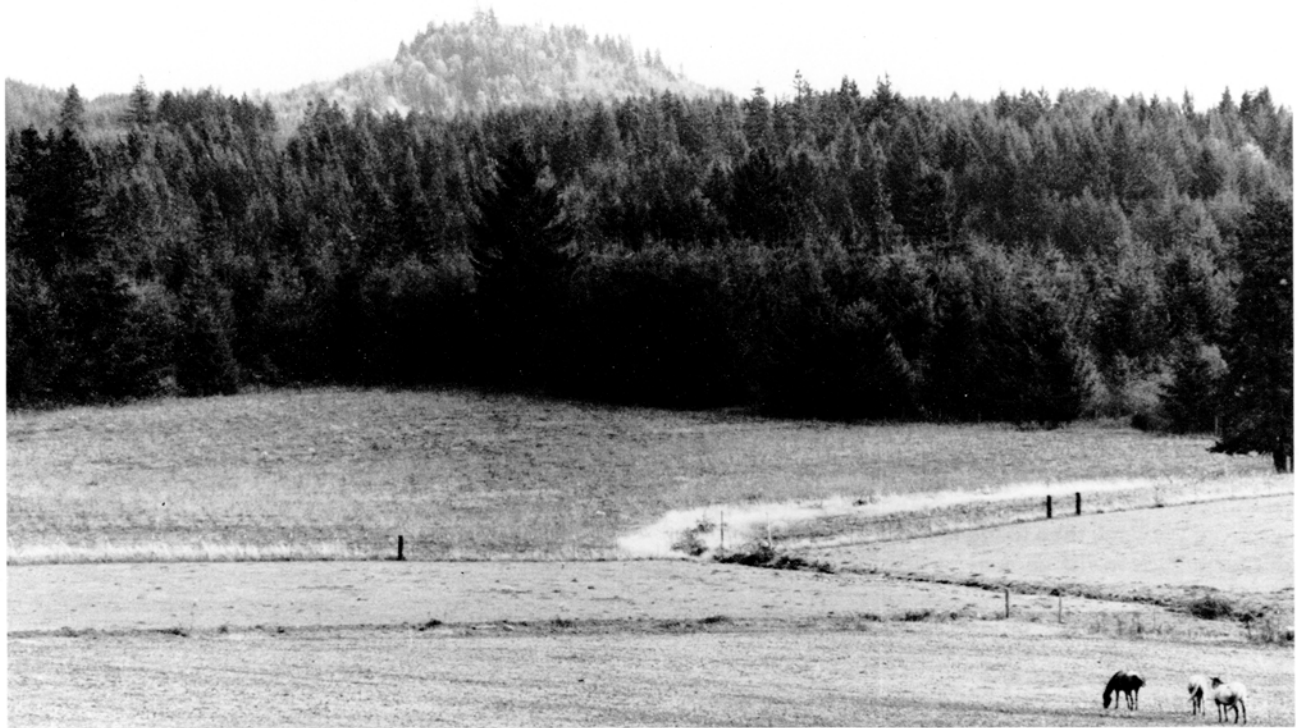
*Figure 4. Looking south toward Highland Butte, located 4 mi southwest of Estacada. Butte shown on the skyline is Boring Lava (Qtb) vent. Valley in foreground has thin alluvial soil overlying weathered Boring pyroclastic and lava flow rocks.*

Late Pliocene to early Pleistocene volcanism produced the viscous lavas, agglomerates, and flow breccias of the Boring Lava in the present-day areas of Clackamas and Multnomah Counties. These Boring Lava flows emanated from vents, now the sites of numerous volcanic buttes such as Highland Butte (Figure 4). In places where the lava flows were thin, weathering has nearly completely altered the lavas to red clay soils.

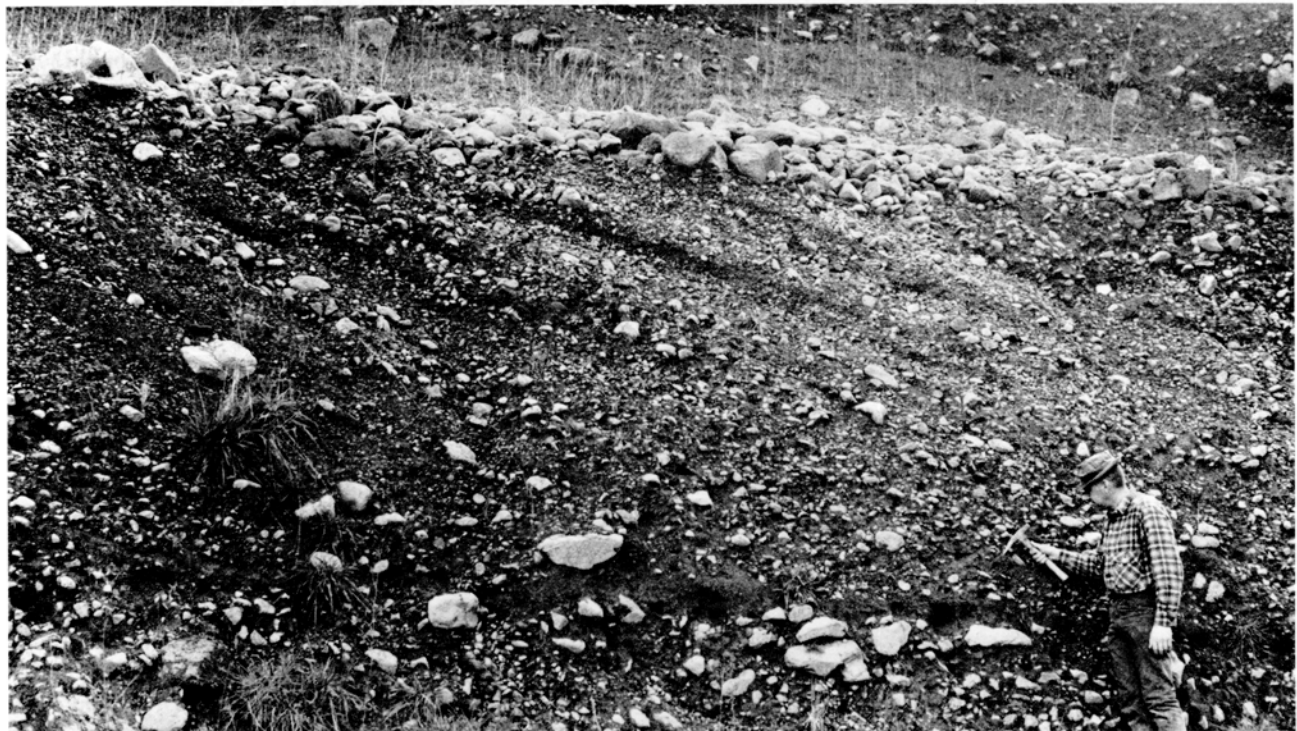
*Figure 5. Steep foreset bedding of deltaic gravels (Qdg) in Durham gravel pit, caused by torrential current of Missoula Flood. Floodwaters poured through gap at Lake Oswego and flowed in northwesterly direction at this locality.*

Following the Boring Lava event, gravel and finer sediments were deposited in the Portland area. Glacial floods of great magnitude produced channeled scablands and deltaic deposits of torrentially cross-bedded gravels (Figure 5).

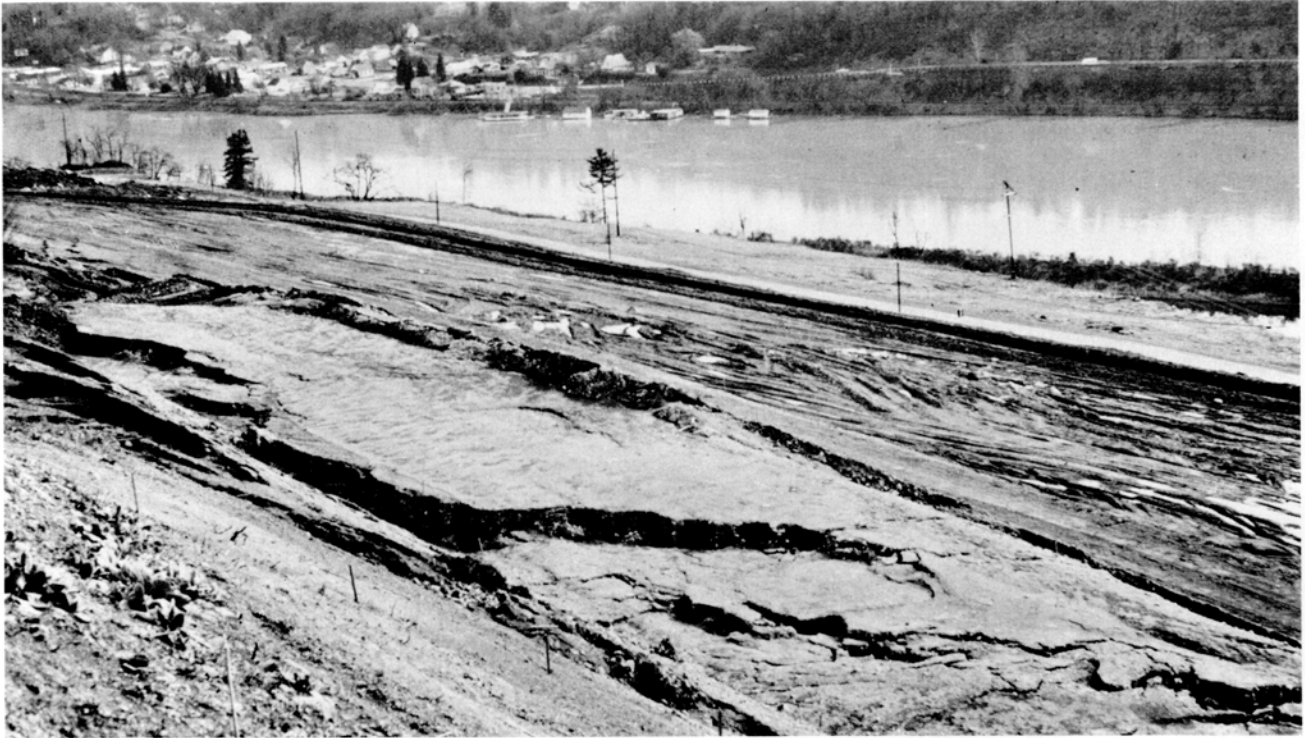
*Figure 7. Landslide destroyed cut slopes and roadbed during I-205 construction 1 mi south of Willamette River bridge in West Linn. Several million cubic yards of material had to be removed to correct slide problem.*

informally called the Vantage horizon (Beeson and others, 1975). Where the bedding dips adversely (out of the cut face) at about 10° or more, but less steeply than the cut face, bedding plane slides can be expected to occur (Figures 7 and 8). This not only affects the cut area, but surface failure can progress upslope and cause damage in those areas. The Vantage horizon is particularly significant with regard to bedding plane slides.

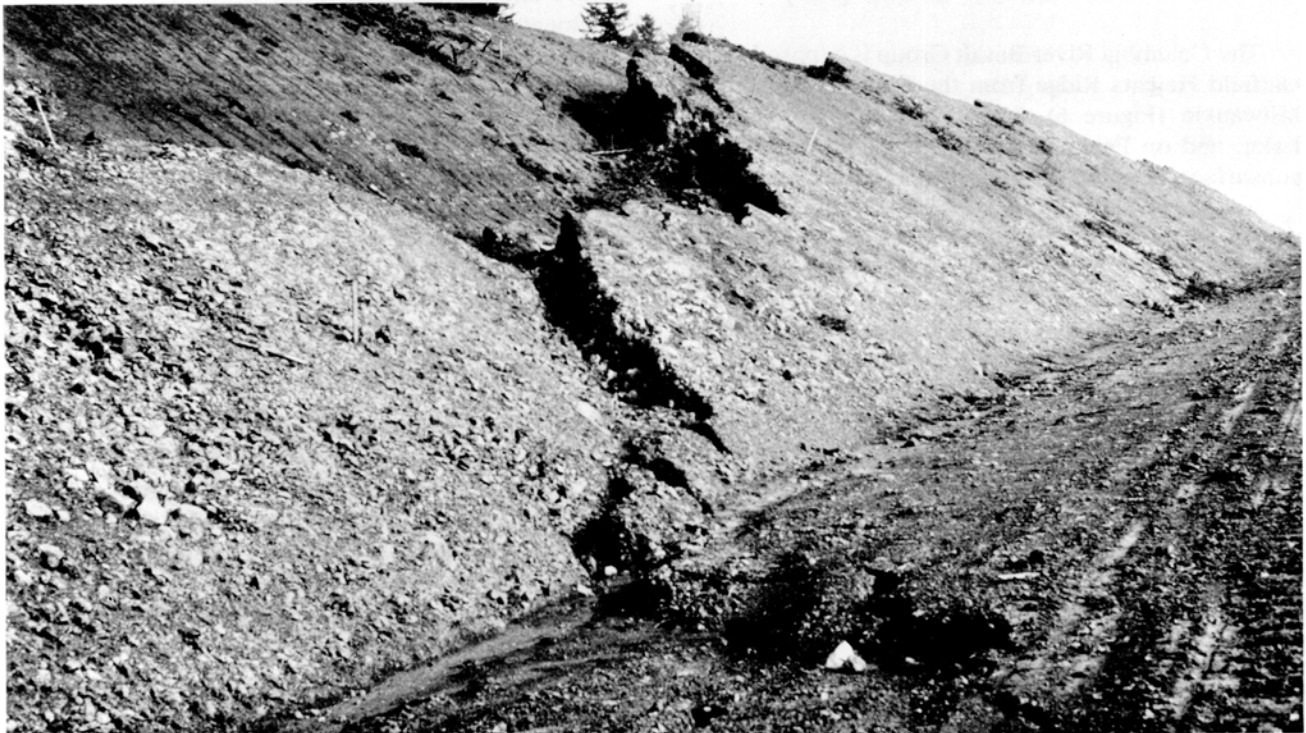
*Figure 8. Closeup of same landslide. Weathered Columbia River basalt (Tcr) overlying Vantage horizon failed during construction of large cuts.*

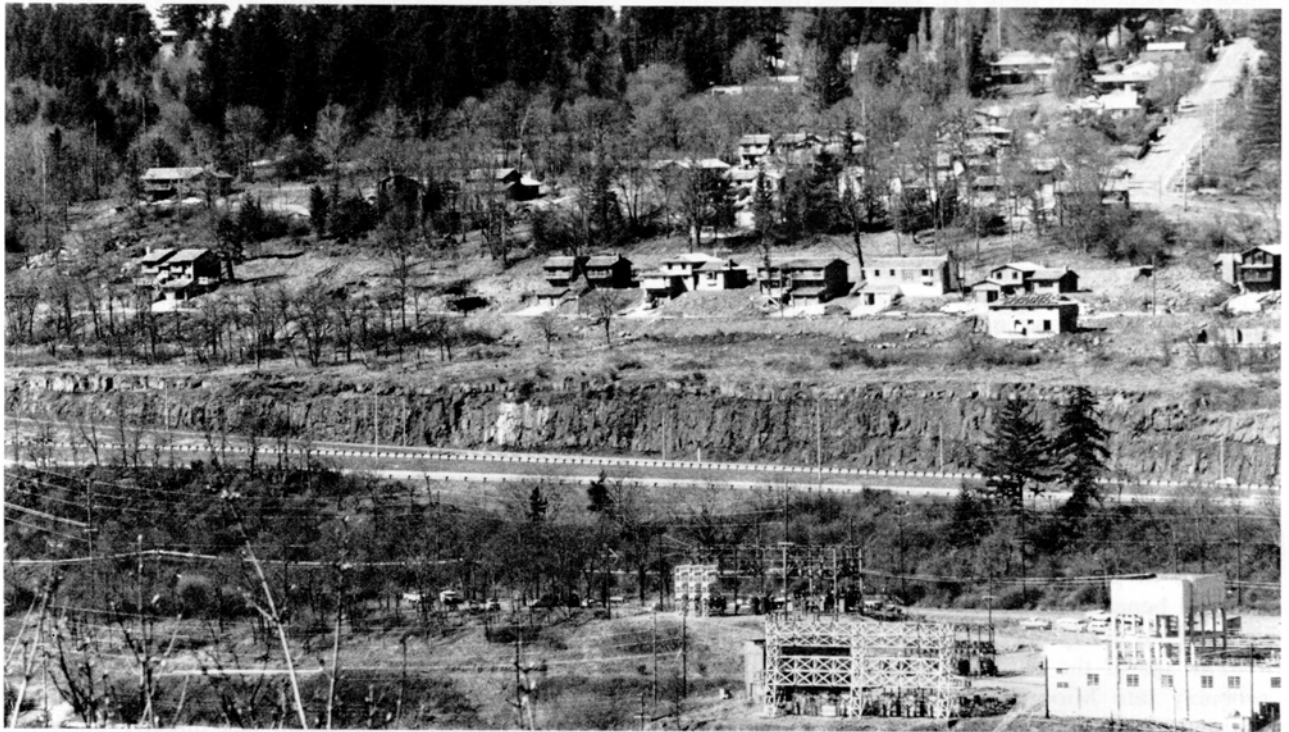
*Figure 10. New housing development in West Linn, southwest of I-205 bridge. Freeway cut is in Columbia River basalt (Tcr). Steep cut slopes may present rockfall hazards. Weathered basalt and residual boulders overlie basalt at building site.*

In addition, steep to vertical rock faces in Columbia River basalt often produce rockfall (Figure 10). For example, major roadcuts on Highway 99E have experienced rockfall problems in the past.

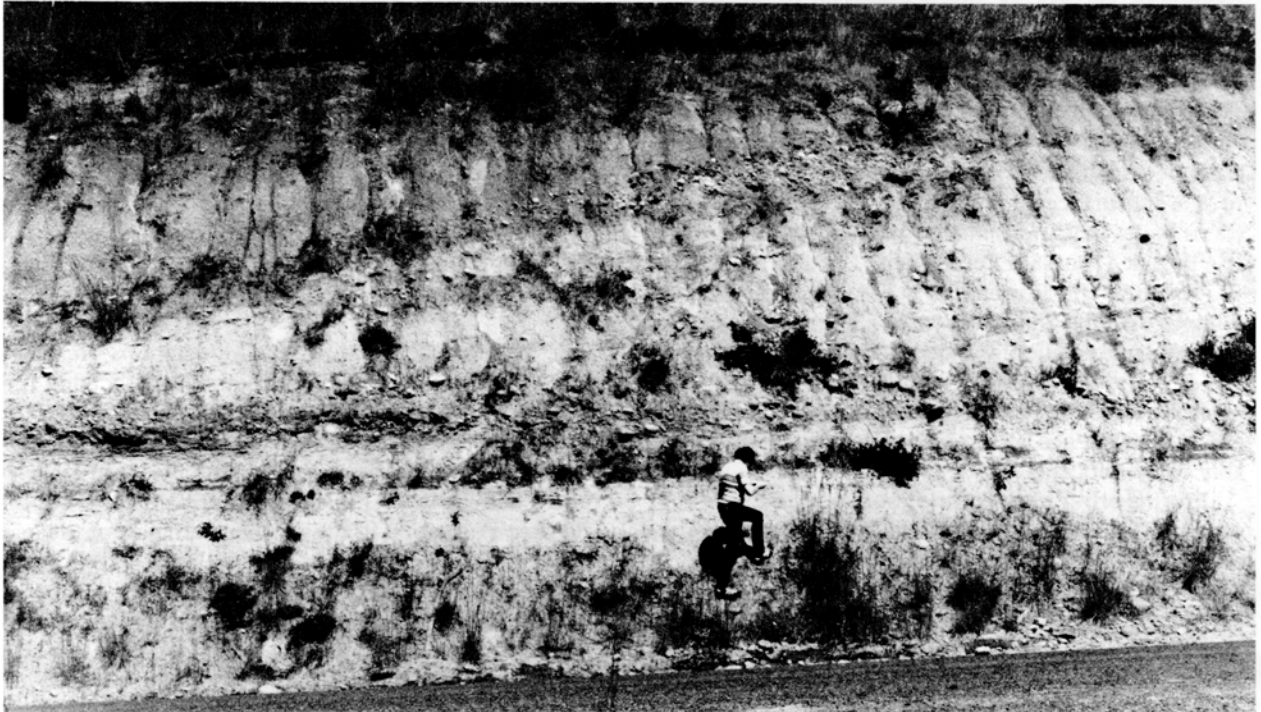
*Figure 13. Sandy River Mudstone (Tsr) exposed in roadcut near Viola in southeast part of map area. Thin gravel lenses are present within mudstone layers.*

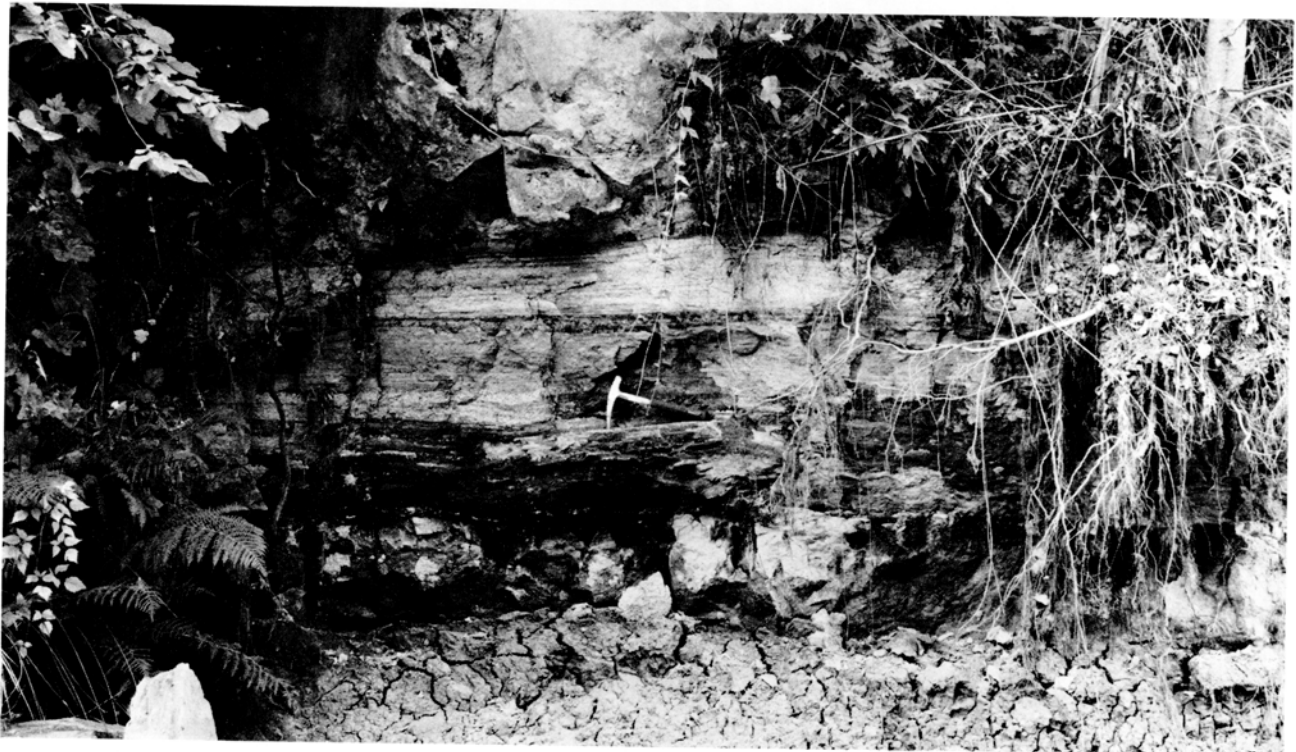
*Figure 15b. Contacts between Sandy River Mudstone (Tsr) (bottom unit), thin section of Troutdale Formation (Tpt) (middle unit), and overlying Boring Lava (Qtb). Photo was taken along Kellogg Creek adjacent to I-205. Note cracks in high shrink-swell soil of Sandy River Mudstone.*

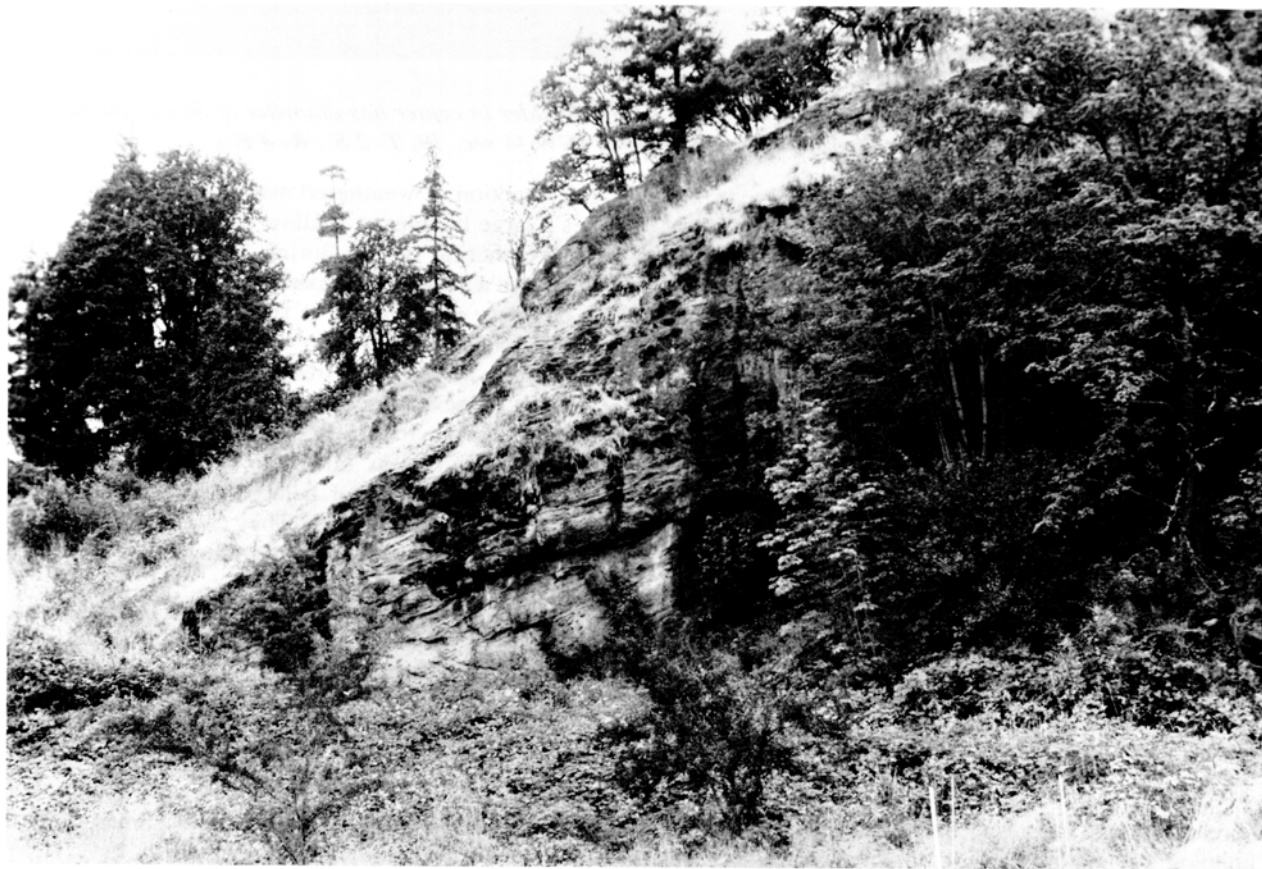
*Figure 17. Boring agglomerate and tuff breccia (Qtb) containing scattered quartzite pebbles. Explosive volcano vent apparently penetrated Troutdale gravels, which then became incorporated in tuff breccia.*

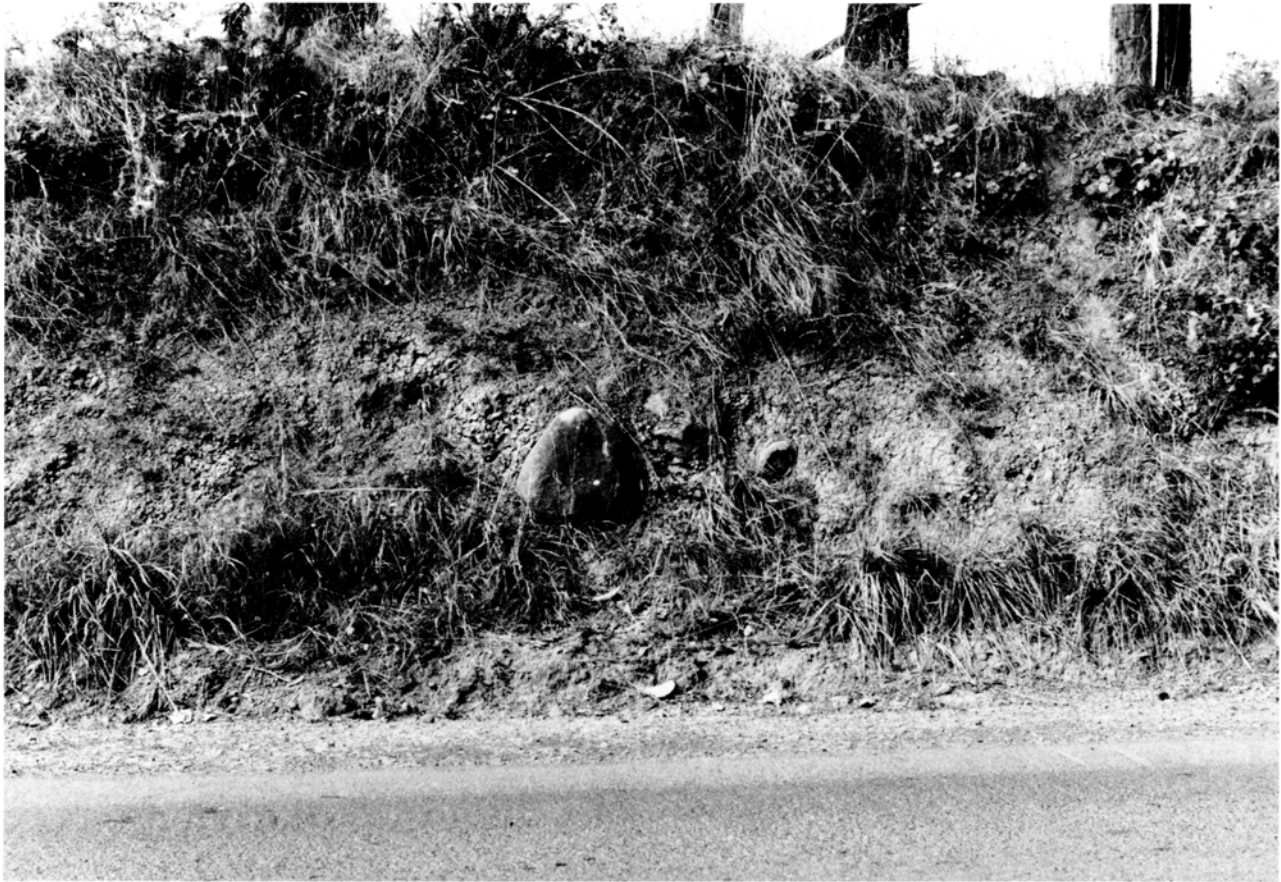
*Figure 18. Roadcut in weathered Boring Lava (Qtz). Boulder in center has diameter of 30 in.; surrounding clay is residual soil formed by weathering of lava flow rock (NW ¼ sec. 19, T. 2 S., R. 4 E.).*

The Boring Lava occurs as blocky intracanyon flows, volcanic cones, or shield volcanoes which are composed of thick basalt flows, flow breccia, and agglomerate that extend for several miles from a central vent. The uneroded thickness of the formation varies from 25 to over 500 ft. The flows, where thin, are sometimes completely weathered to a red clay and scattered residual boulders (Figure 18). These weathered flows are marked "Wx" on the geologic maps.

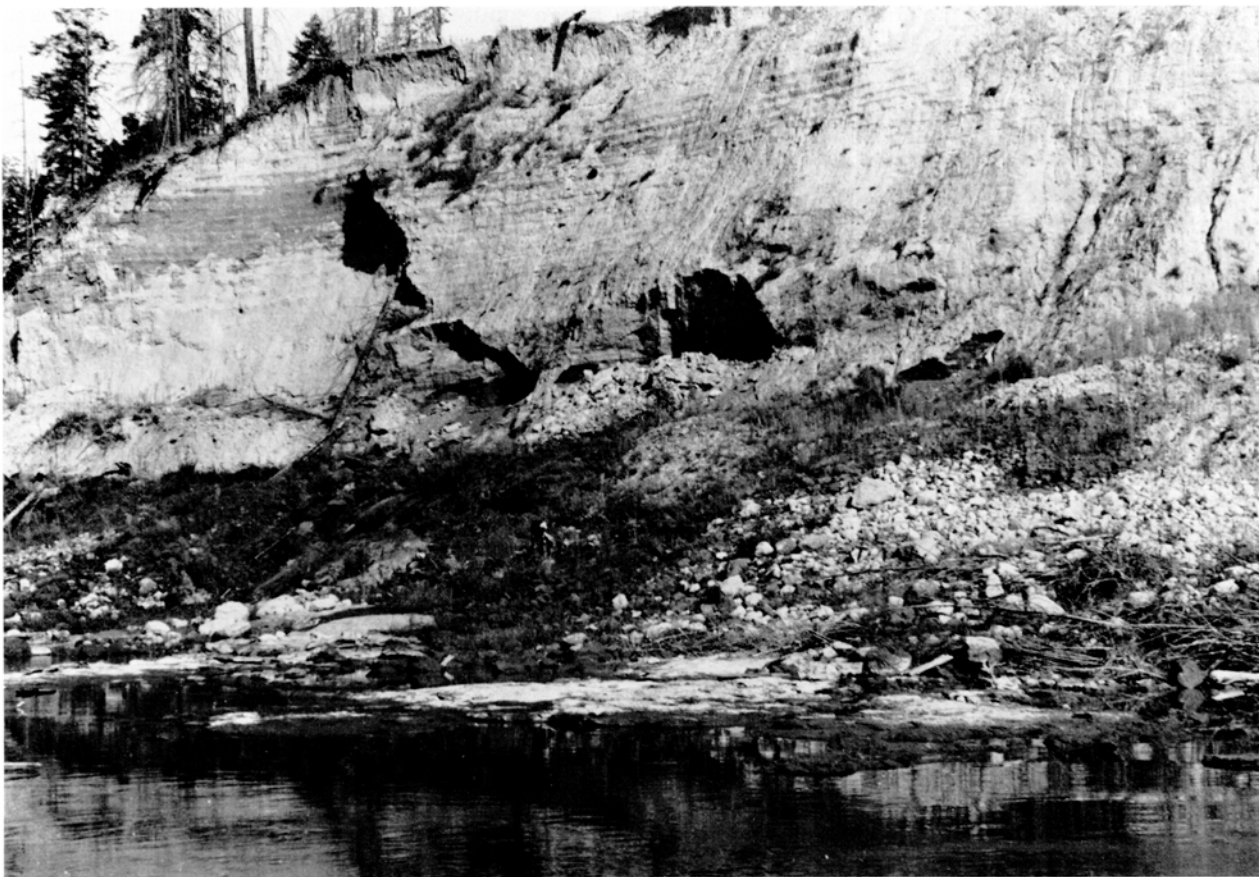
*Figure 19. Bedding of Willamette Silt (Qws) in bank of Willamette River upstream from Wilsonville. This 40-ft-thick exposure, with beds ranging from 6 in. to 1 ft in thickness, overlies Sandy River Mudstone.*

The unit is composed of unconsolidated beds and lenses of fine sand, silt, and clay. Stratification is commonly in the order of 4- to 6-in. beds, with 3- to 4-ft beds locally present (Figure 19). In many areas, the silt is massive, without distinct stratification. Lenses of pebbly, fine- to medium-grained sand with scattered cobbles of granite and quartzite occur in some of the outcrops. The silt is usually light brown to buff and occasionally light gray where granular soils predominate.

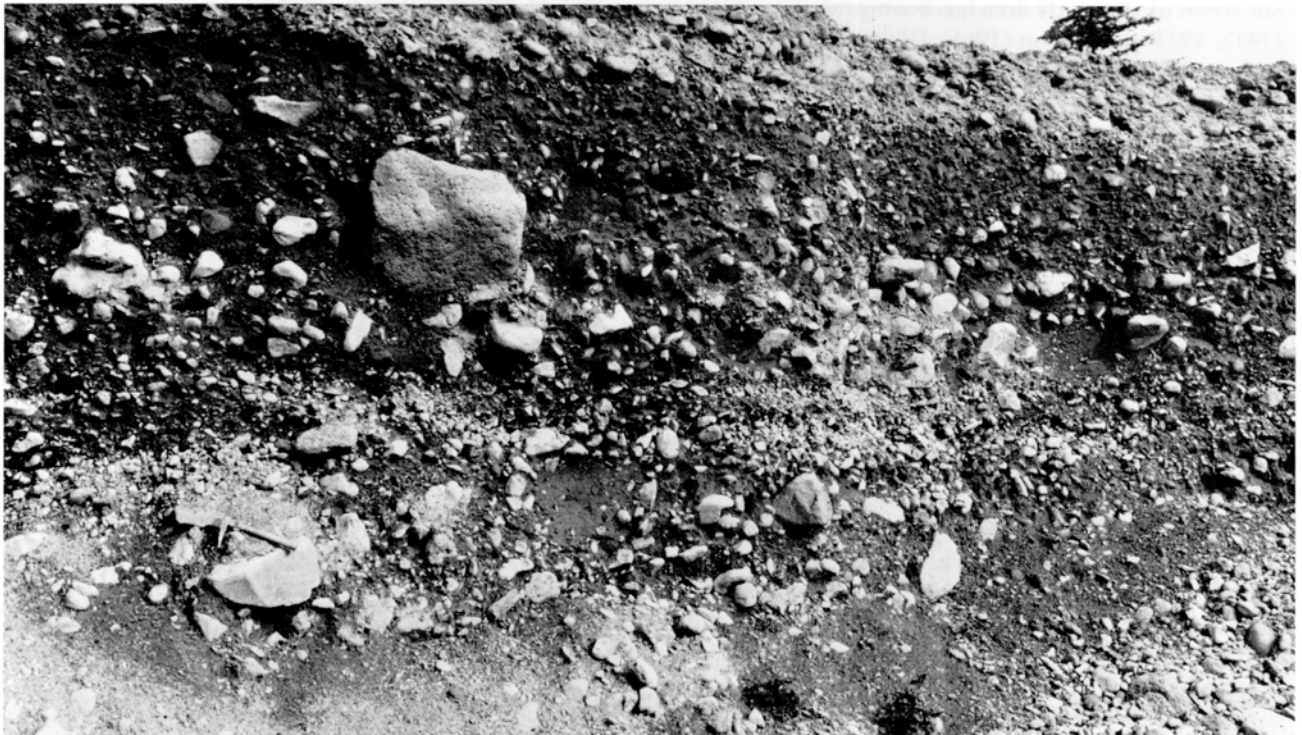
*Figure 21. Unsorted deltaic gravels (Qdg) in old pit at Durham.*

The gravels at Durham and Wilsonville are of similar composition and gradation; they consist of cross-bedded, unsorted, bouldery pebble and cobble gravel in a matrix of silt and medium- to coarse-grained sand (Figure 21). Boulders in the gravel are as much as 5 ft in diameter. The gravels are principally of basaltic clasts, with scattered granitic, metamorphic, and limonite clasts (Figure 22). Most of the basalt clasts were derived from the Boring Lava and Columbia River Basalt Group in the Tualatin Mountains adjacent to Lake Oswego. Quartzite and granite cobbles are from gravel deposits of southeast Portland across from Lake Oswego. Limonite cobbles have their source in a limonite deposit at Lake Oswego.

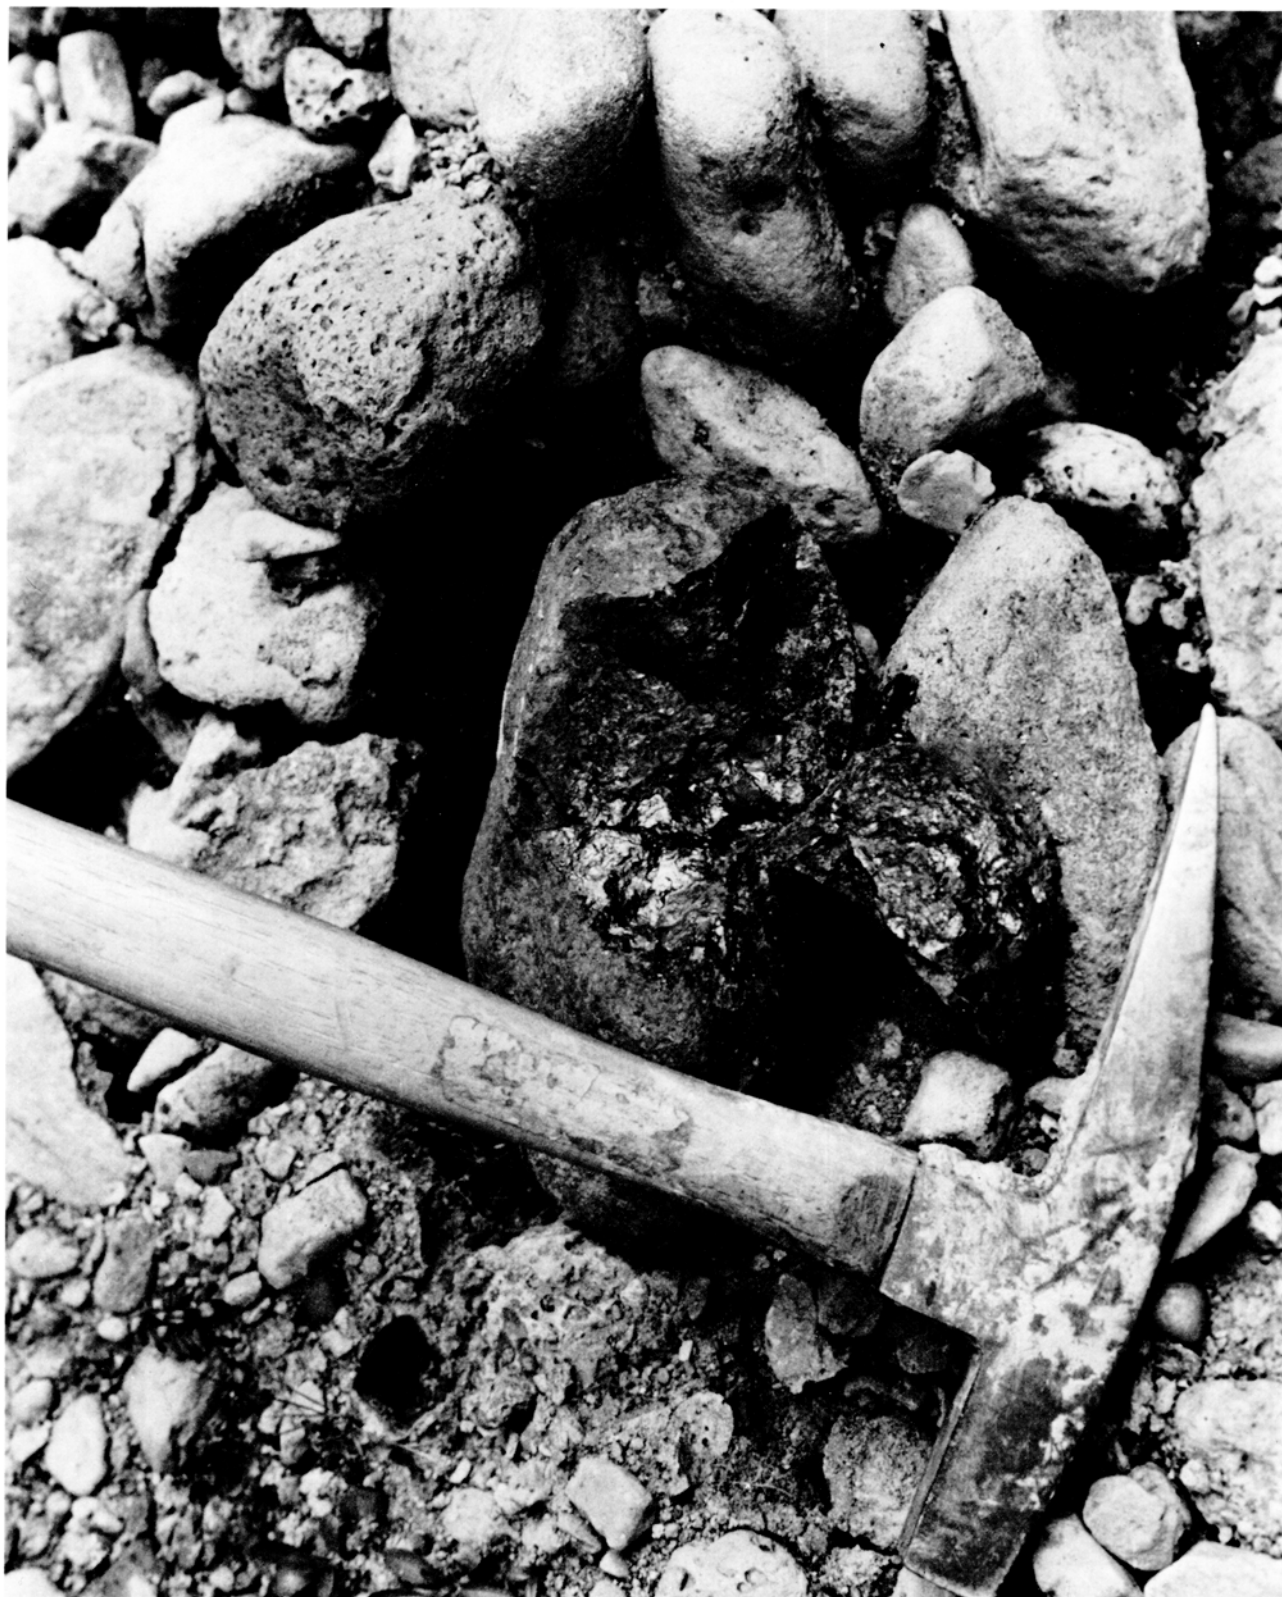
*Figure 22. Limonite cobble in gravel deposit (Qdg) at Durham. Limonite was carried from its point of origin near Lake Oswego by waters from Missoula Flood. Limonite deposit occurs just below water tower at 325-ft elevation in NW  $\frac{1}{4}$  sec. 9, T. 2 S., R. 1 E.*

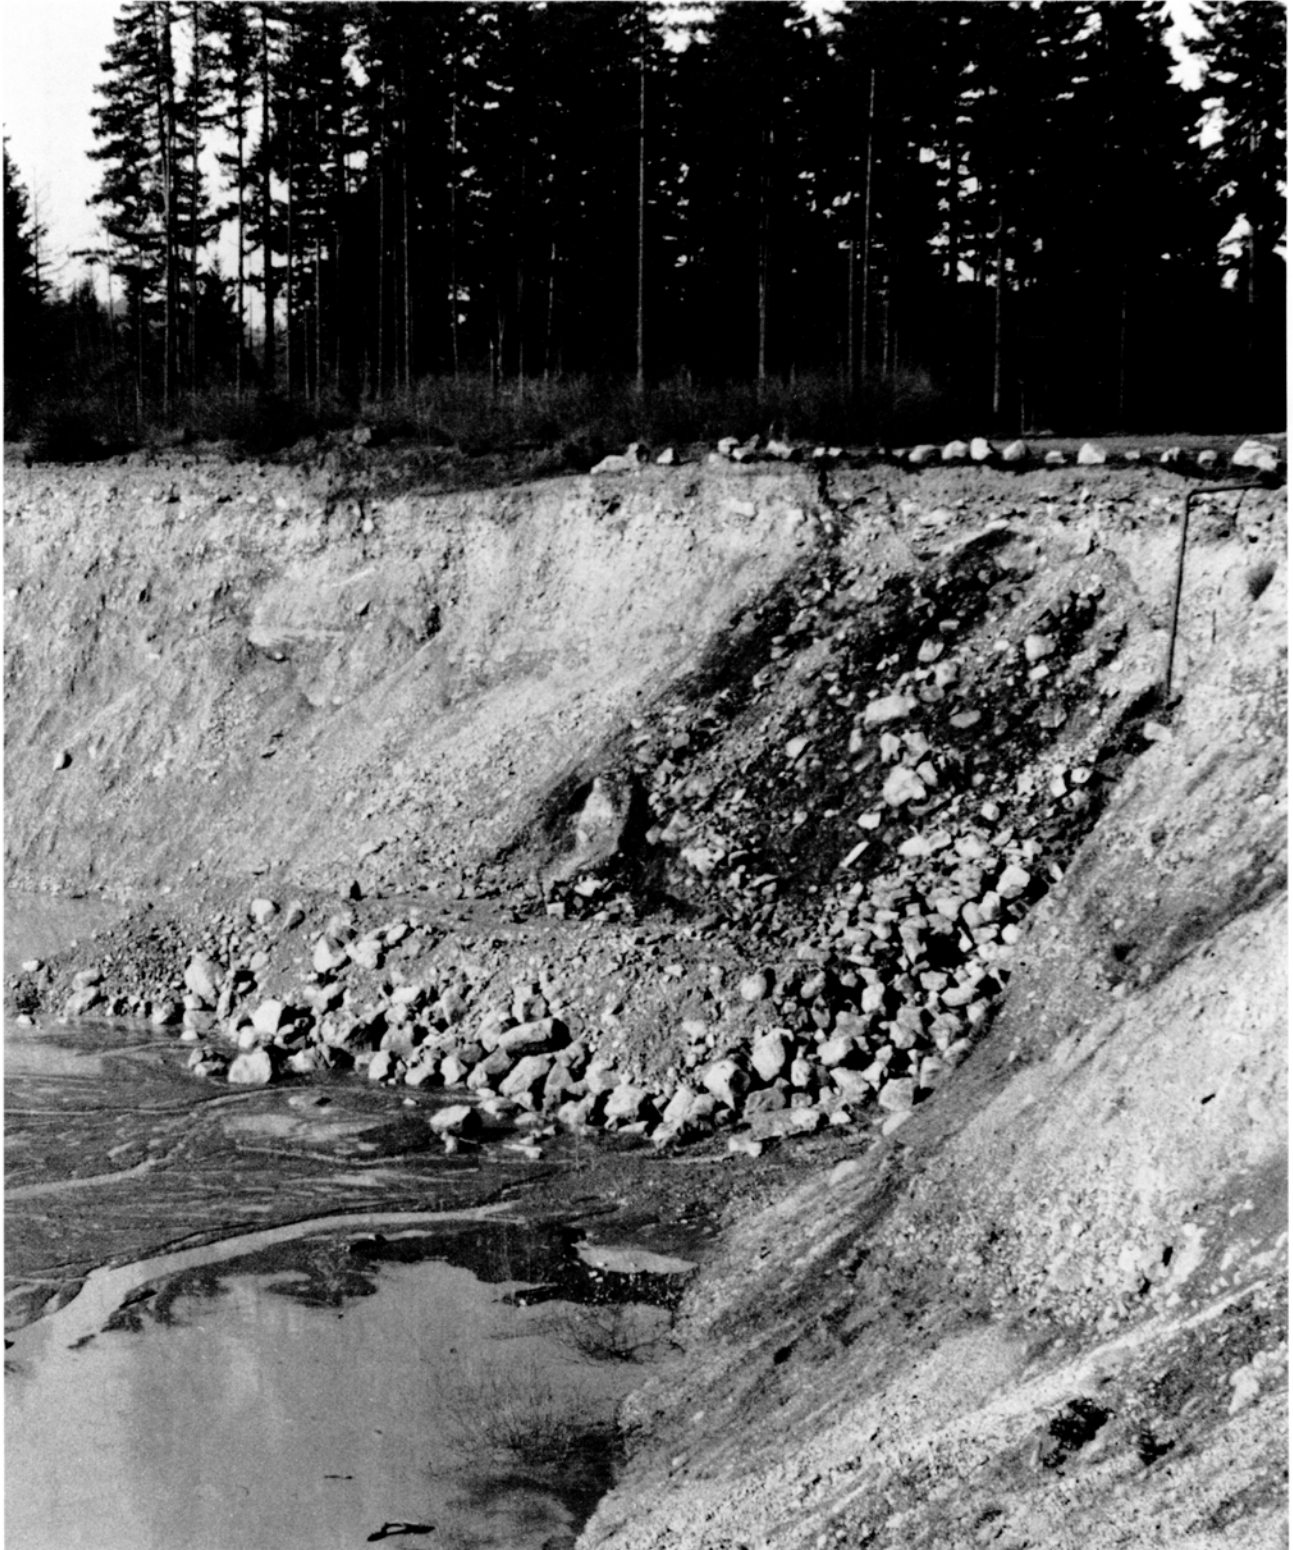
*Figure 23. Deltaic gravel (Qdg) in old pit northwest of intersection of I-5 and Carman Road. Photo taken about 1961. Large unsorted boulders scattered throughout deposit were carried from Lake Oswego channel several miles to right (east) of site shown in photo. Note pollution of standing ground water from discharge pipe near upper right margin.*

Moderate amounts of ground water can be obtained from this unit. In areas adjacent to deep excavation, contamination can occur from infiltration of surface water and pollutants (Figure 23).

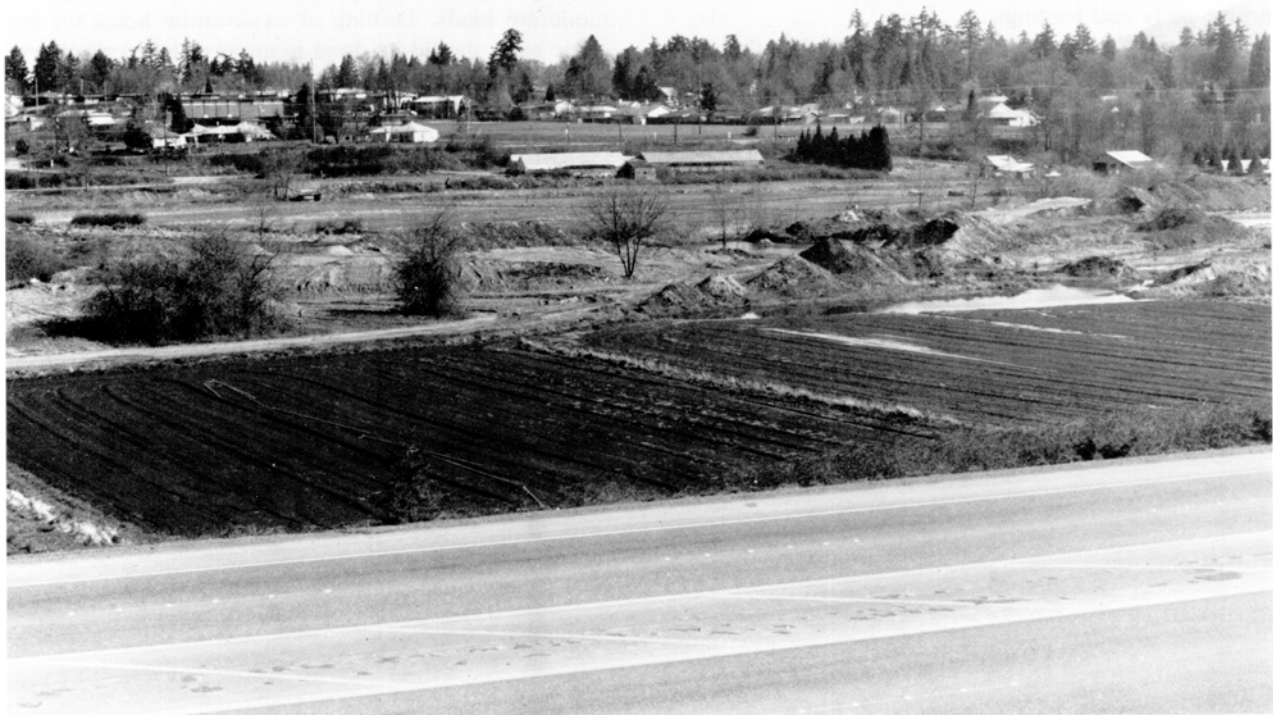
*Figure 24. Omark industrial park development area on Minthorn Creek, 1 mi east of Milwaukie. At this location, underlying peat soils need to be considered.*

Foundation strength ratings are weak to very weak. The weakest foundation soils are found in the bottomland areas of small streams or abandoned channels underlain by wet silt or organic soils (Figure 24). Organic soils will compress excessively under light to moderate loads. Drilling of exploration holes for organic soils should be done in areas of lake or bottomland sediments.

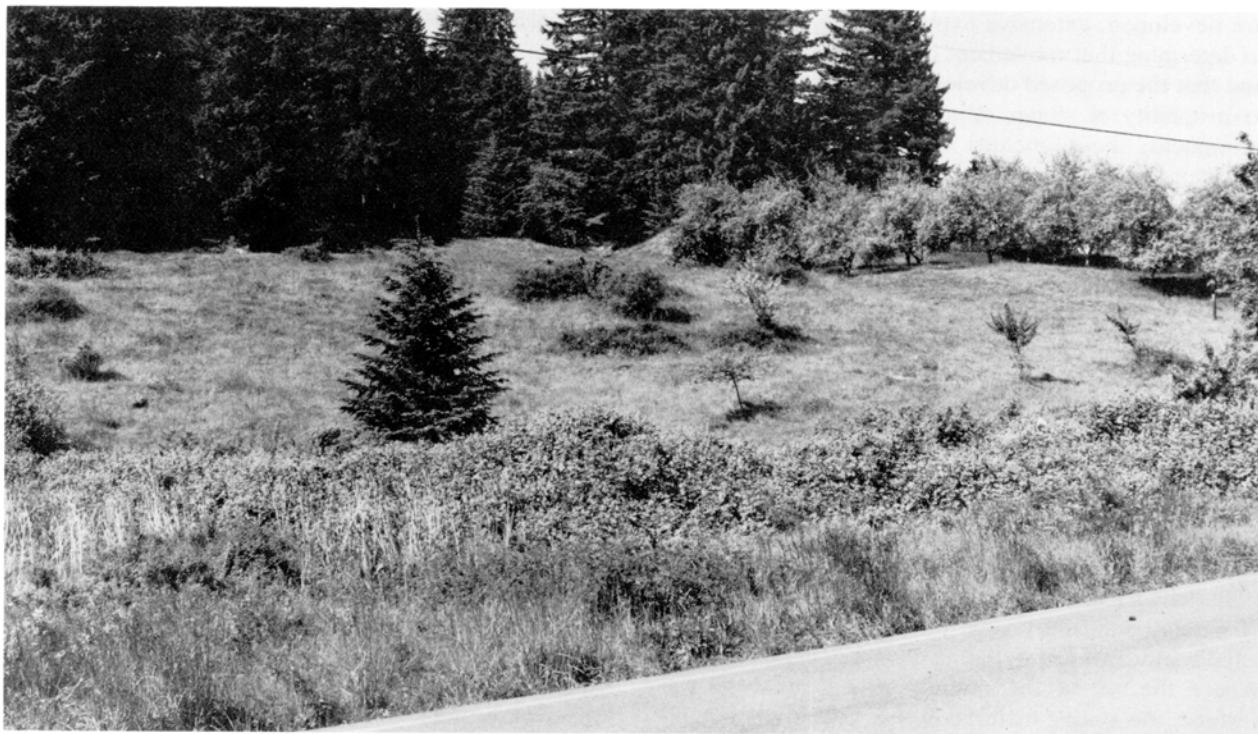
*Figure 25. Landslide topography ½ mi south of Carver in Pleistocene terrace deposits (Qpt). Sliding occurs along most terrace escarpments.*

**Landslide topography:** Landslide topography refers to large areas in which bedrock failure has produced an irregular, hummocky topography (Figures 25 and 26) and includes ancient landslides that have been stable for many years. Erosion may have greatly modified the ground surface, and original landslide features

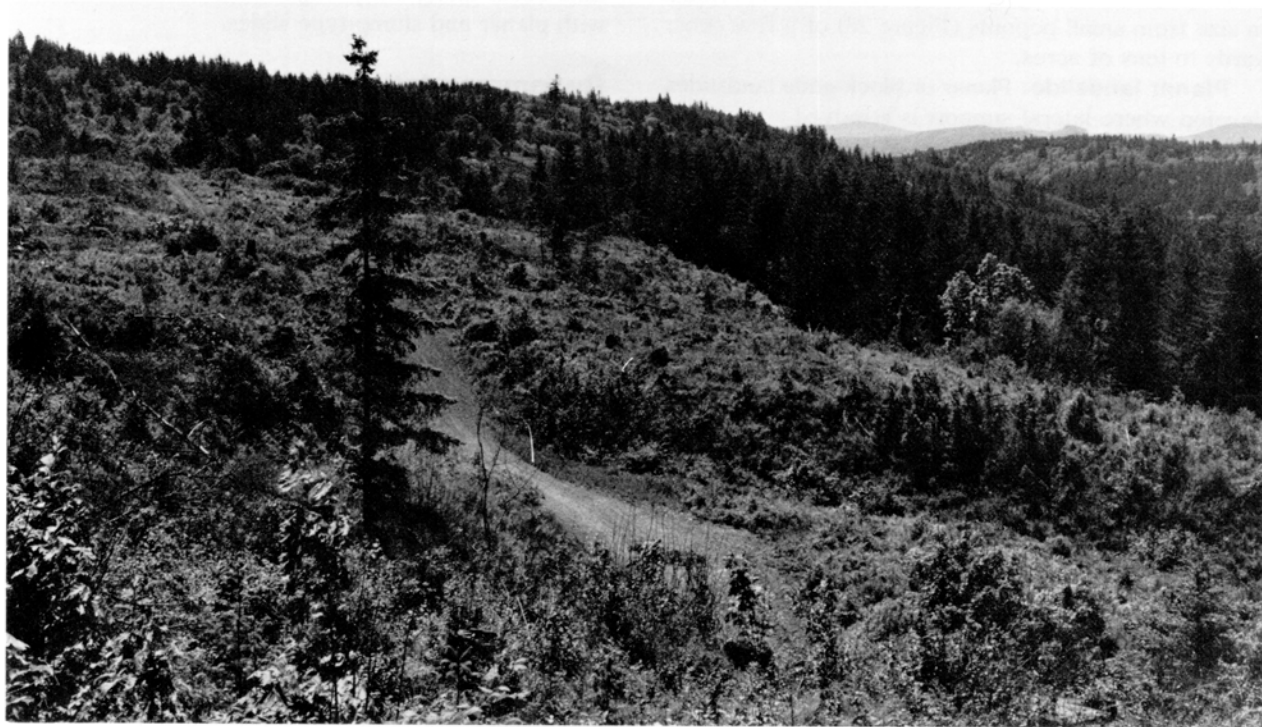
*Figure 26. Hummocky landslide topography in Sardine Formation (Tsa), north of Cazadero. Cutting of Clackamas River channel has caused massive landslides in the geologic past.*

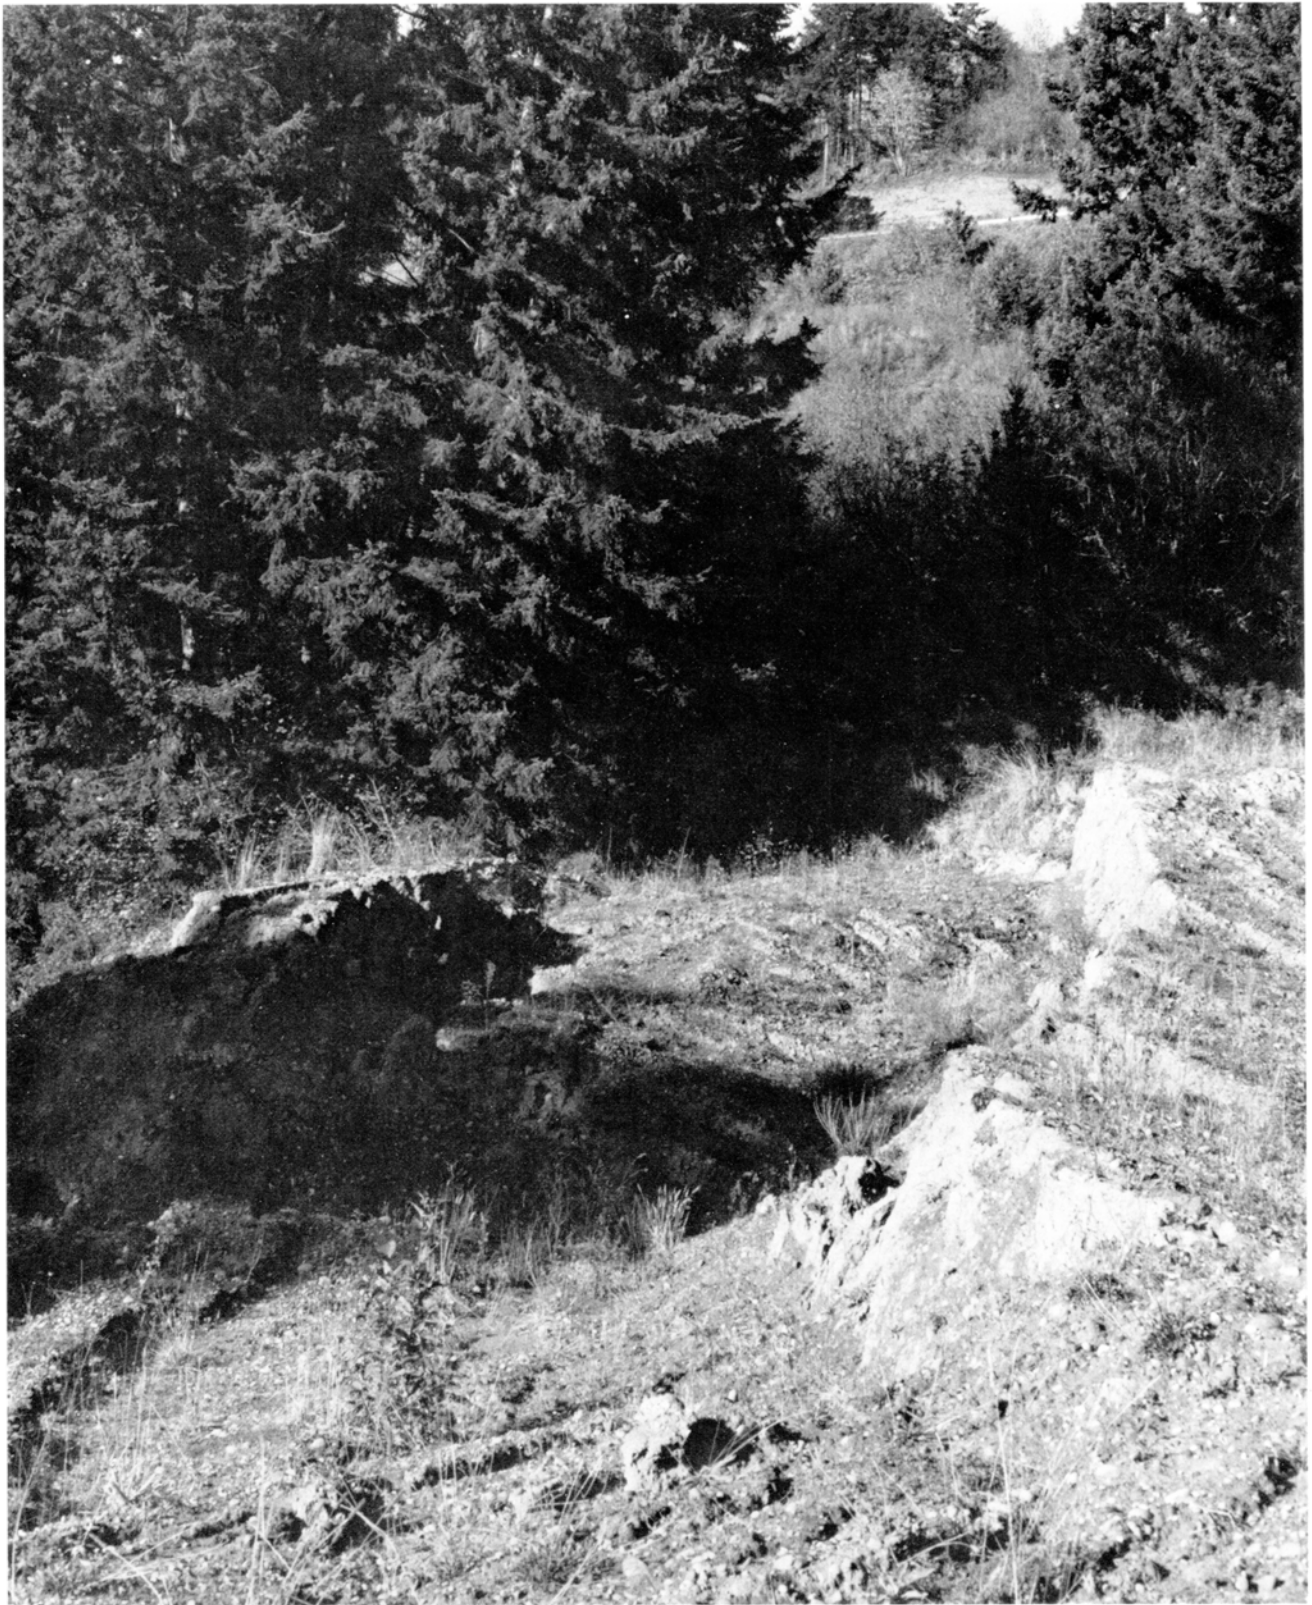
*Figure 27. Slump in Sandy River Mudstone (Tsr) adjacent to settling pond at Barton quarry, secs. 24 and 25, T. 2 S., R. 3 E. Note grabenlike block and tipped trees.*

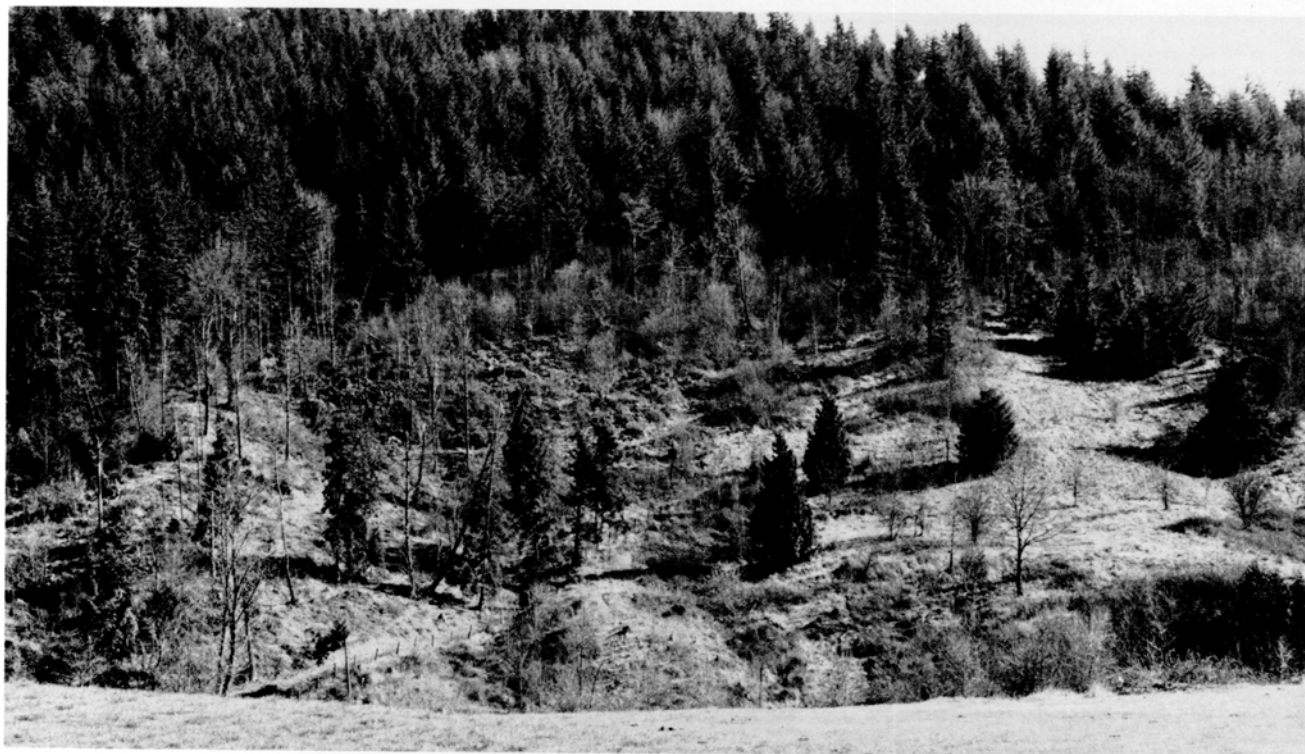
*Figure 29. Debris-type landslide on north slope of Mount Talbert, NW ¼ sec. 3, T. 2 S., R. 2 E. Note tipped trees and large amount of mudflow debris in small valley at left center of photo. Rolling topography was developed by previous slide.*

**Mudflow and debris flow:** Mudflows and debris flows are common types of slope failure on construction projects and natural slopes (Figure 29). When moisture-sensitive soils become oversaturated, they begin to move as a mass due to added weight and loss of strength. The subsequent decrease of pore space caused by the shifting of the silt and sand grains as movement begins produces excessive pore water pressure which buoys the soil mass, promoting movement down even gentle slopes. Once these slides begin moving, they can travel hundreds of feet after they reach horizontal surfaces, often riding up the slopes on the opposite sides of valleys. Slides occur on steep slopes overlain by granular rock fragments and soil
