BULLETIN 99

# **GEOLOGY AND GEOLOGIC HAZARDS OF NORTHWESTERN CLACKAMAS COUNTY, OREGON**

1979

**HERBERT G. SCHLICKER, Engineering Geologist**

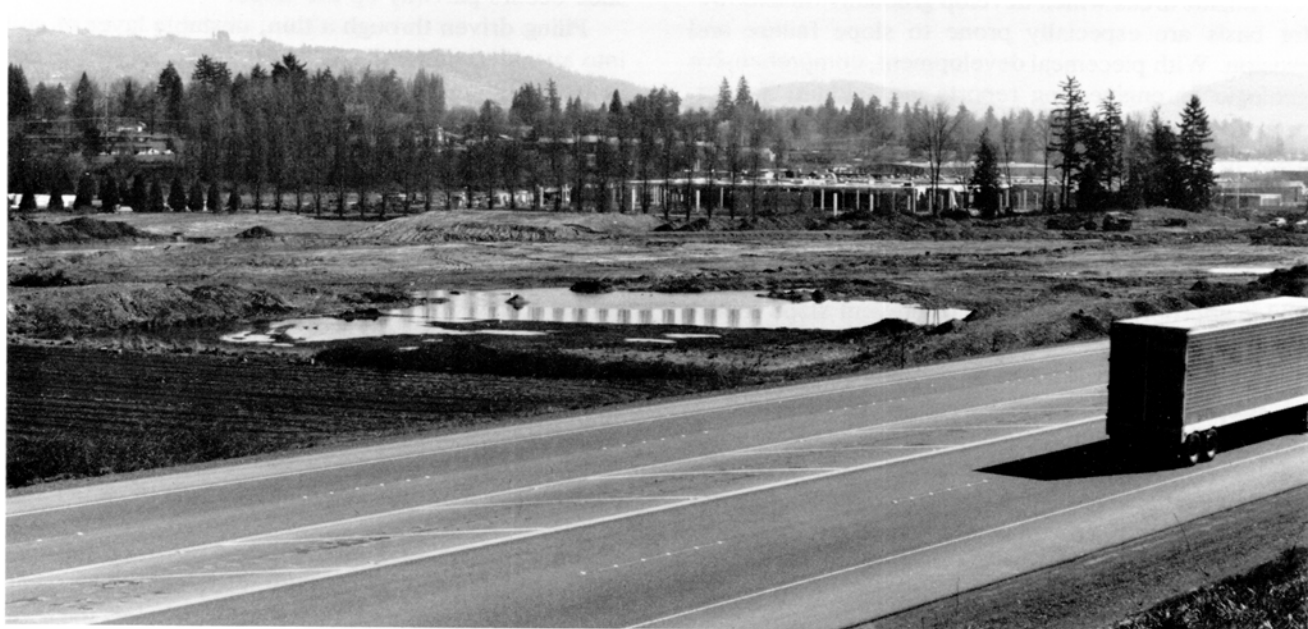
*Figure 30. Omark industrial park development area on Minthorn Creek, 1 mi east of Milwaukie. Problems caused by organic soils and high water table have been considered during construction at this location.*

presence (Figure 30). It is usually water saturated and can consolidate under moderate loads to less than 50 percent of its original volume. In addition to causing excessive uneven foundation settlement, the soil can fail by shearing under heavy embankment loads. Heavy embankments can produce an elevated ridge parallel to the toe of the embankment as the fill sinks.

**Wet soils — high water table:** Wet soils are soils having a high water table. In these areas, water will stand in open holes 18 in. or less below the surface (Figure 30). During wet periods, water may stand on the surface.

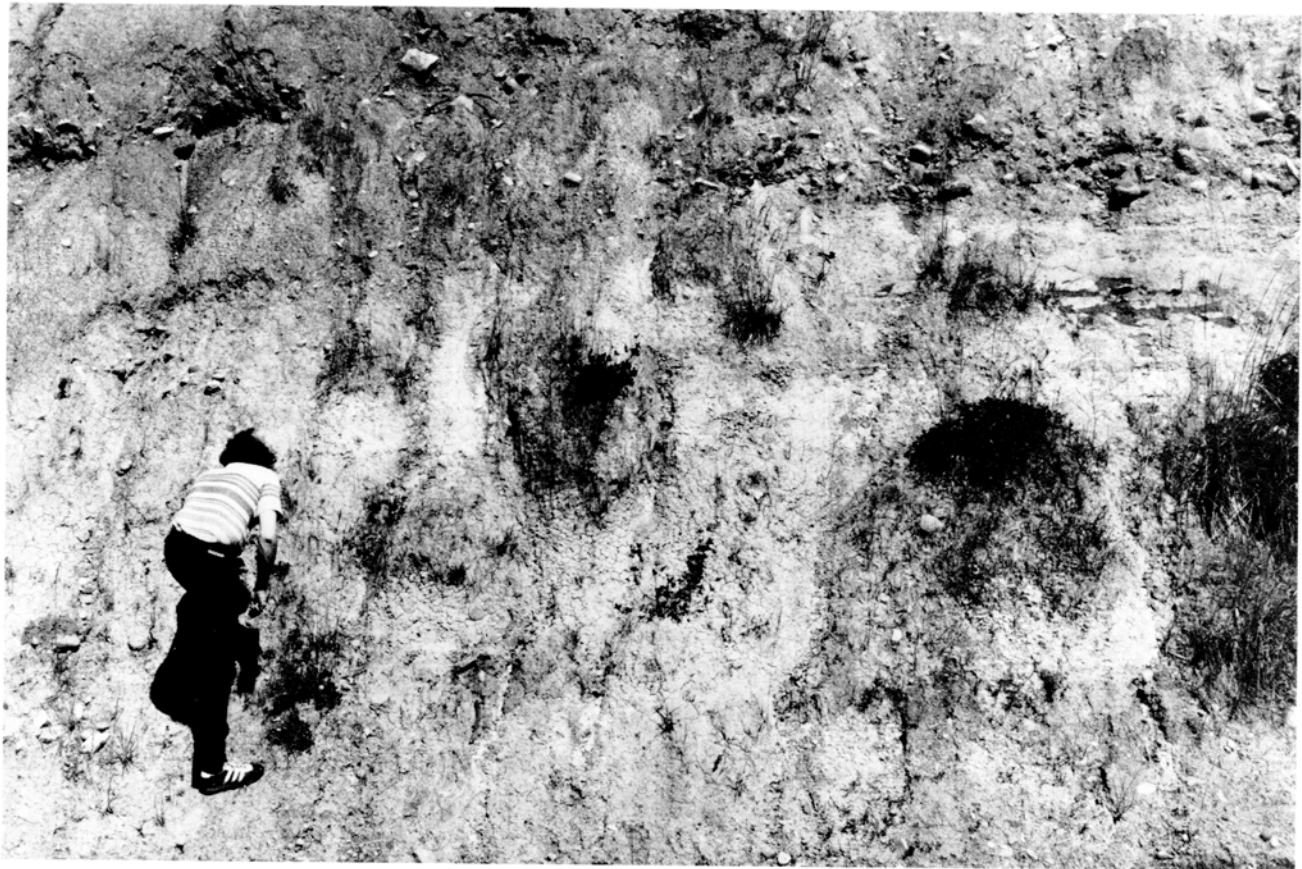
Figure 31. Expansive clay in roadcut exposure of Sandy River Mudstone (Tsr), 1½ mi north of Viola in valley of Clear Creek.

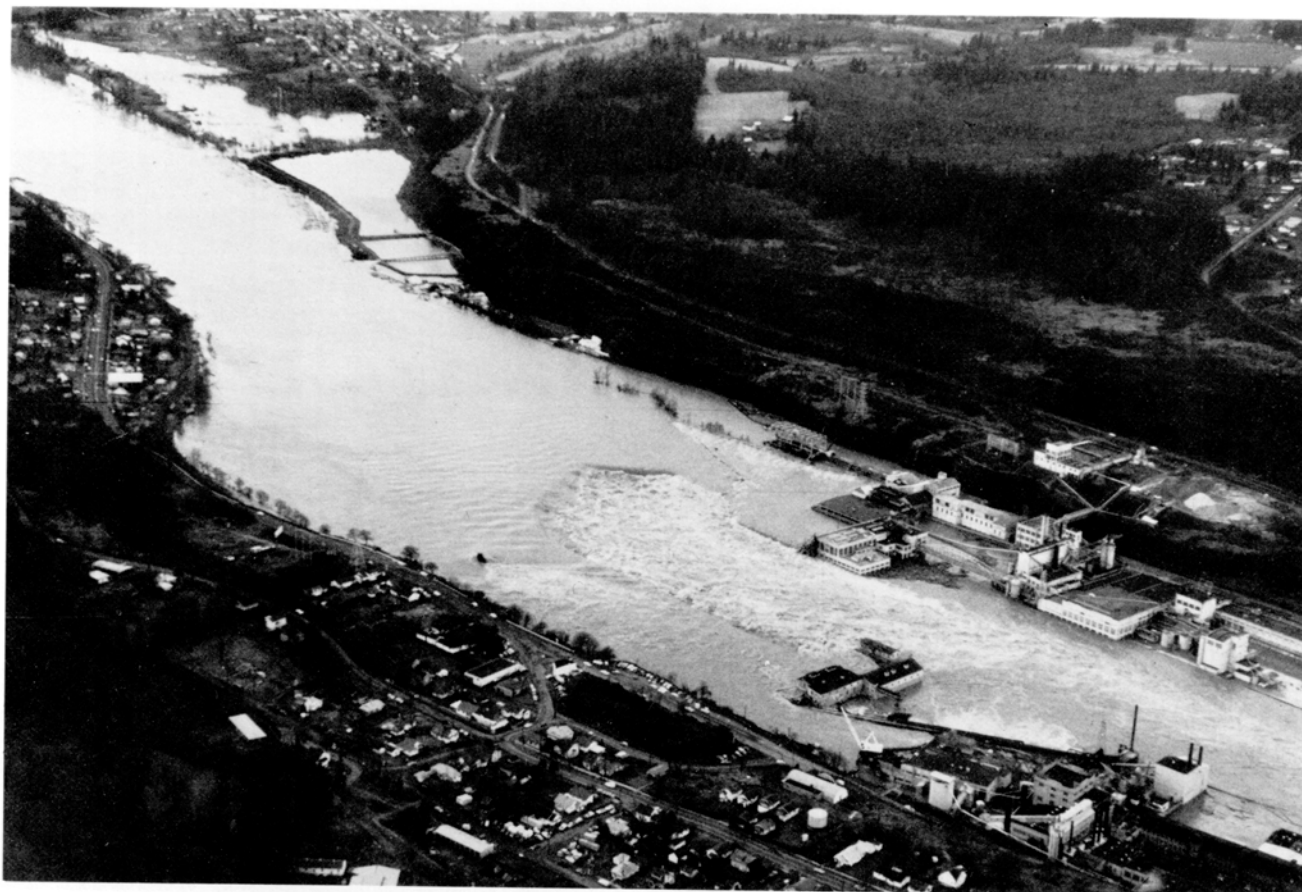
*Figure 33. Willamette River falls at Oregon City, nearly obscured by December 1964 floodwater.*

Many structures in the flood plain have been damaged or destroyed by past floods. A papermill, sewage treatment plant, shopping center, lumberyard, sawmill, County shops, filling station, athletic field, and some residential areas sustained heavy damages during the December 1964 flood (Figures 33 to 37).

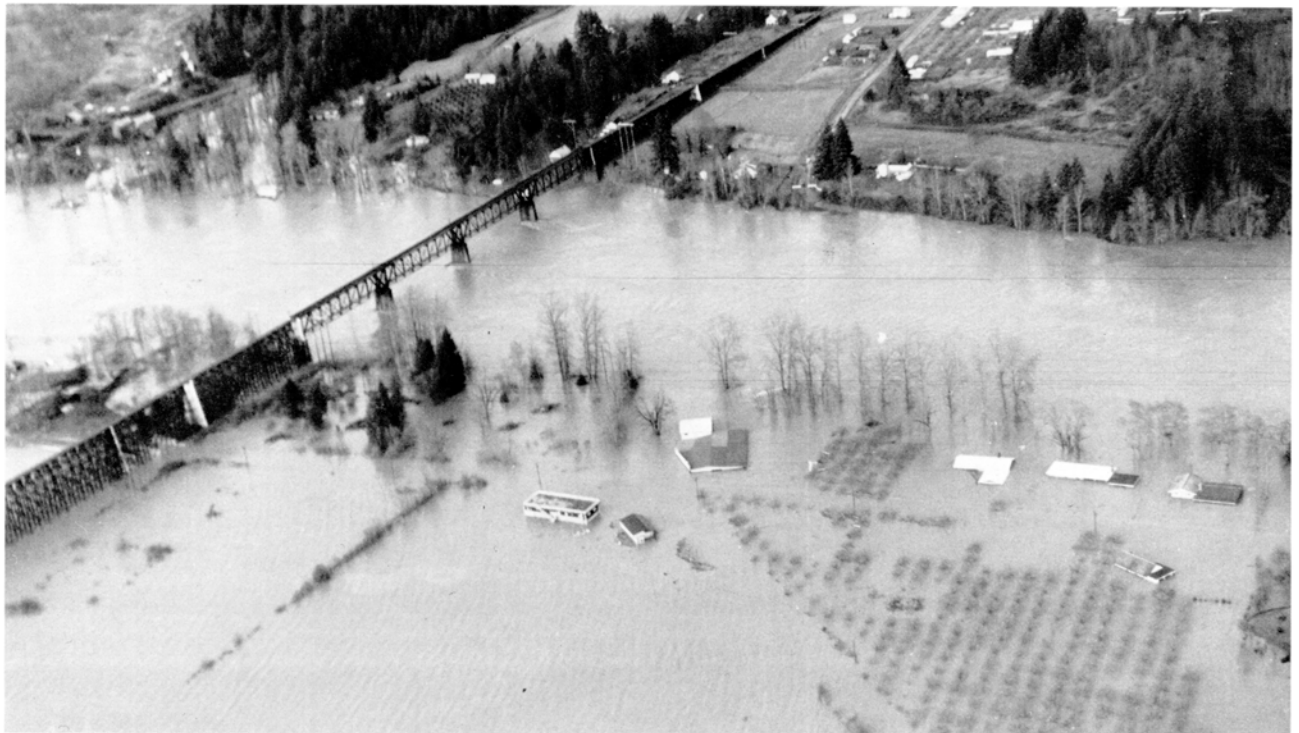
*Figure 37. 1964 flood—Willamette River at Wilsonville. Water came to eaves of houses. After flood, houses were raised about 8 ft for floodproofing.*

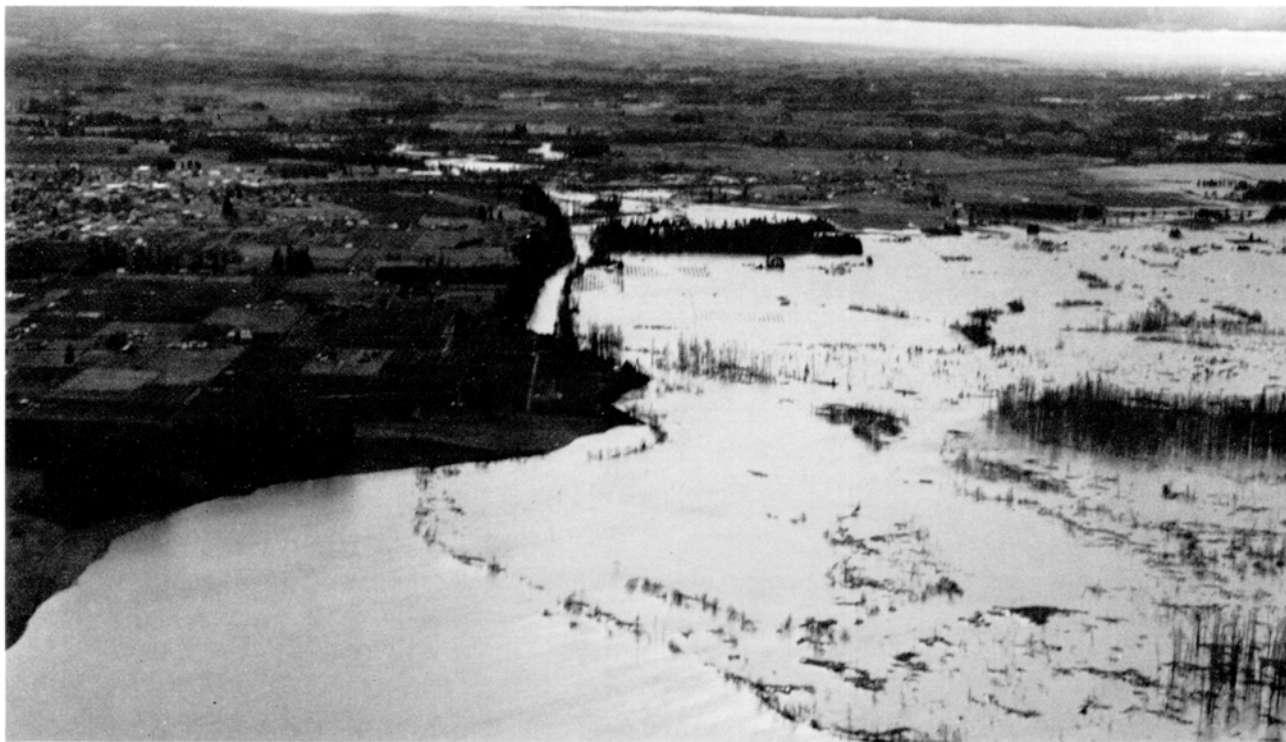
*Figure 38. Flood plain at confluence of Pudding and Molalla Rivers near Canby during 1964 flood.*

and Pudding River flood plains merge, they form a common flood plain nearly 2 mi wide (Figure 38).

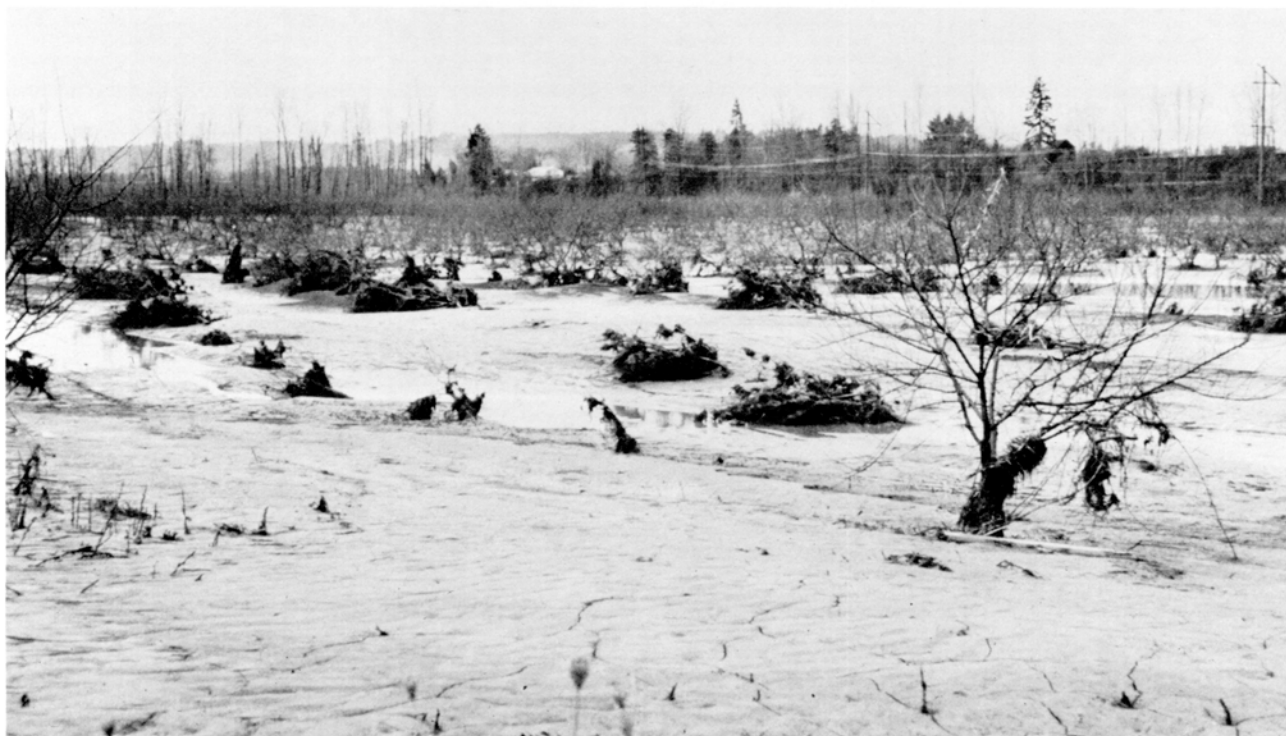
*Figure 39. Orchard sustained heavy damage from erosion and siltation of 1964 flood on Molalla River west of Canby. Orchards are visible in floodwaters near center of Figure 38.*

Nearly all of the flood plain is used for agricultural production (Figure 39). The major developed area is the city of Canby, which lies partly within the Molalla River flood plain. Barlow, however, is located entirely within the flood plain.

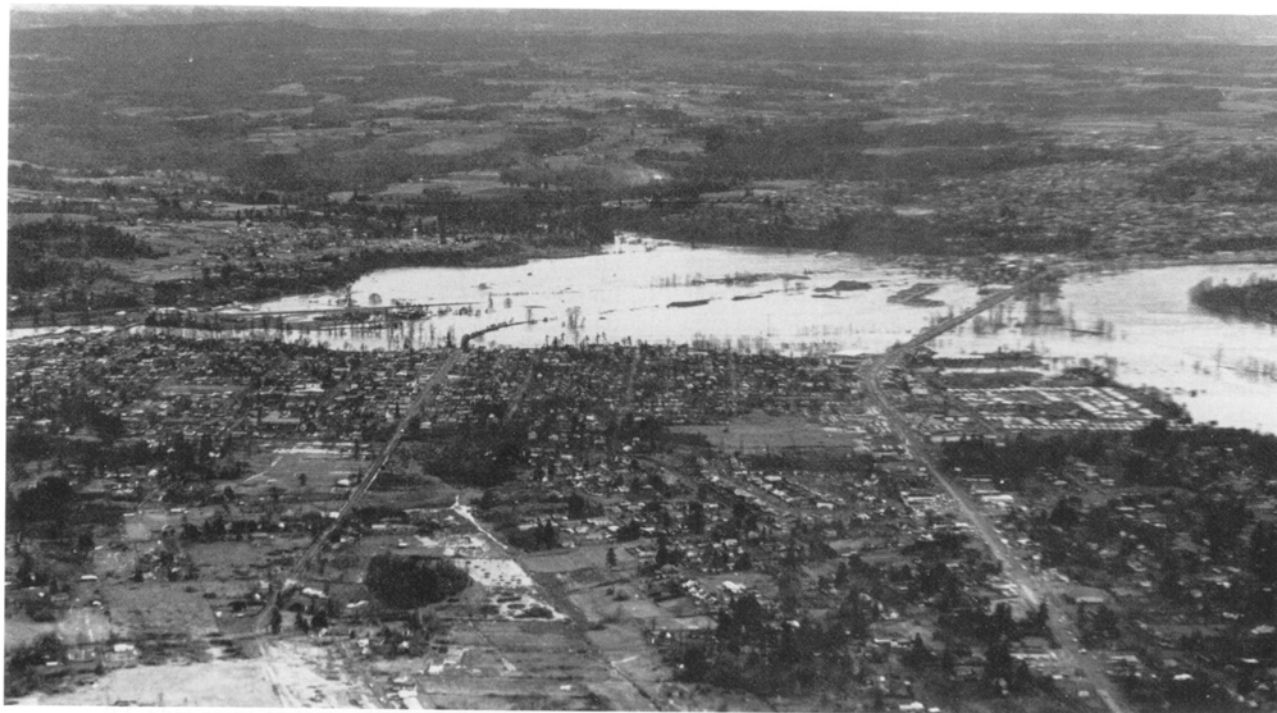
Figure 40. Aerial view looking south from Milwaukie toward Gladstone and Clackamas River during 1964 flood. Note Highway 99E (right) and railroad (left of shopping center) under water.

The flood plain near Oregon City and Gladstone is highly developed (Figure 40). Most of the remaining

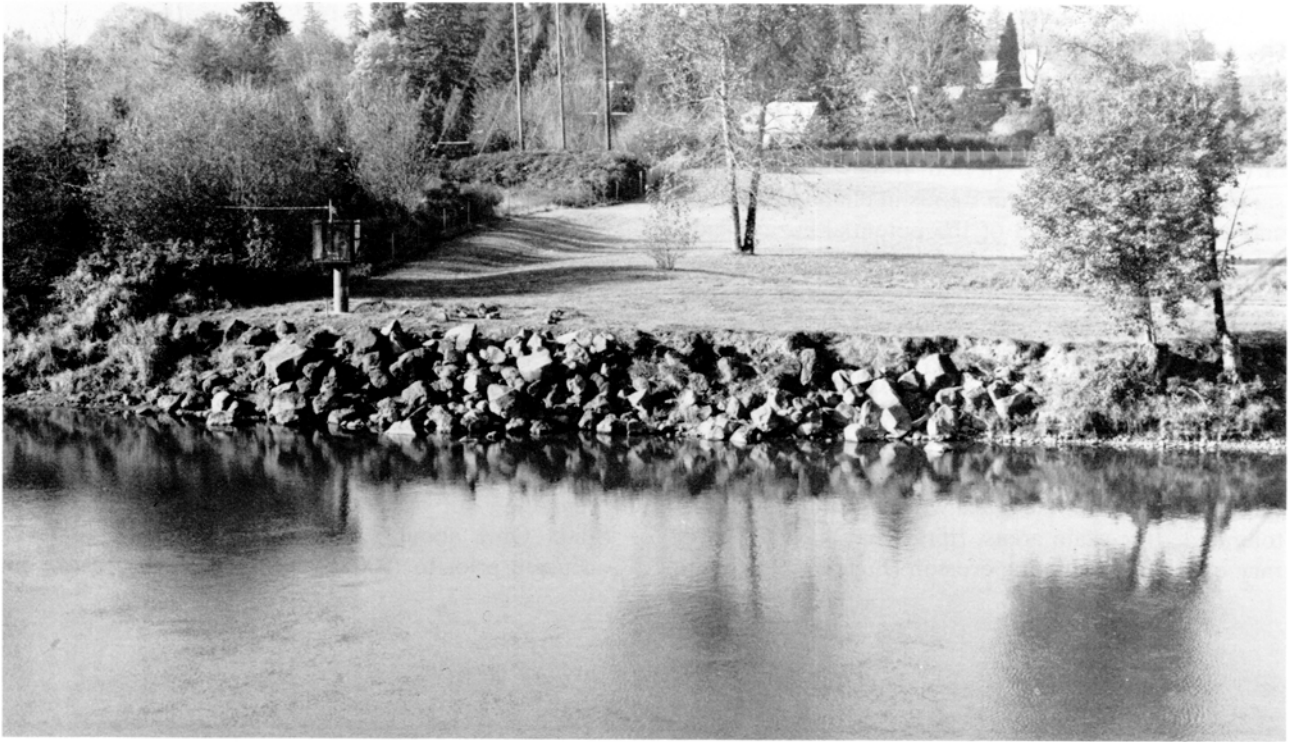
*Figure 42. Riprap being used to prevent erosion of north bank of Clackamas River at Clackamet Park.*

Development along an older meandering stream should accommodate the direction and rate of lateral stream migration. The study required for such development should utilize data covering a sufficient period of time to give an accurate estimate of the rate of erosion that can be expected. It may also be necessary to consider long-term trends in channel migration and cutoff to assess all of the potential hazards adequately. The rate of erosion may be estimated from eye-witness accounts of long-time residents or from comparison of older maps or aerial photographs with recent ones. Normally, a setback from the edge of the eroding bank is the surest means of protection from stream-bank erosion. The amount of setback required depends upon the average annual rate of stream-bank erosion, the anticipated life expectancy of the structure, and minimum setback which can be physically tolerated. In certain areas, riprap may have a temporary effect in preventing erosion (Figures 42 and 43).

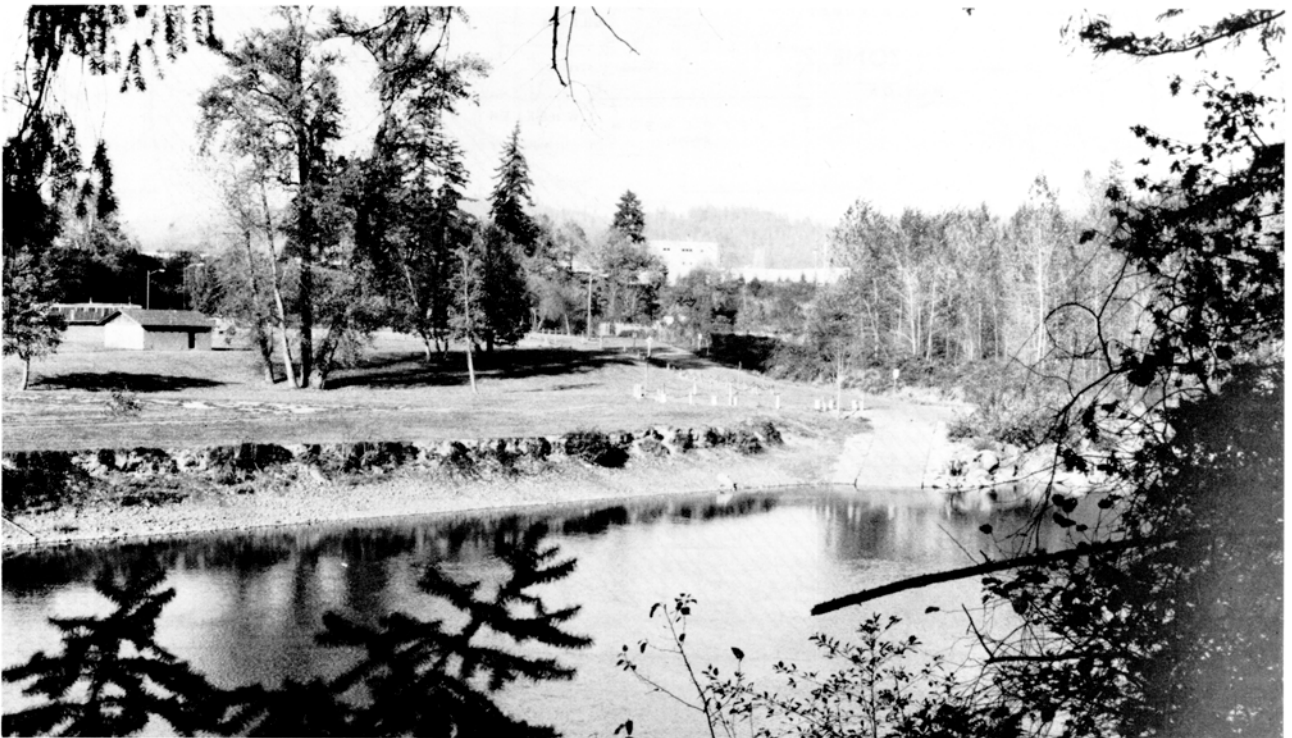
*Figure 43. Erosion where banks were not riprapped at Clackamet Park.*

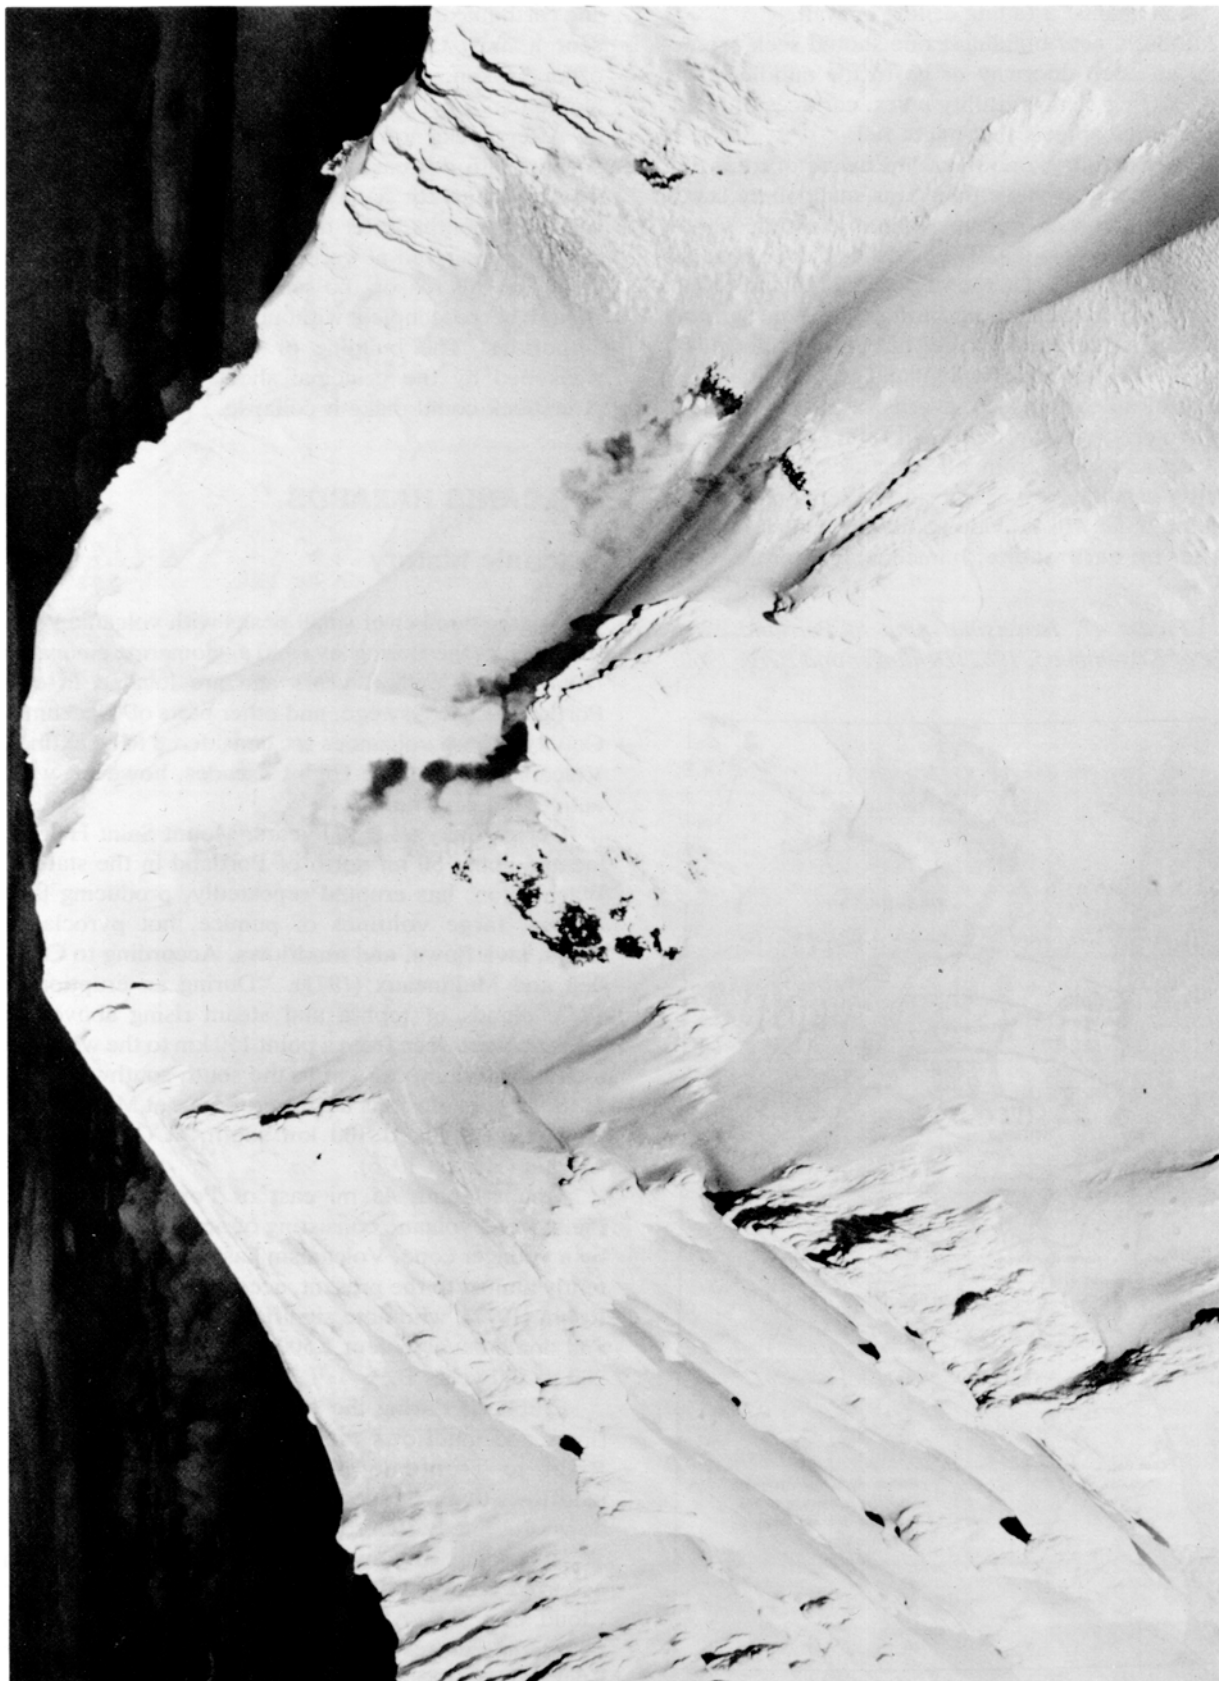
*Figure 48. Fumarolic activity at Crater Rock on Mount Hood, January 1974.*

According to Lawrence (1948), an ash eruption occurred around 1800, 300 m below the summit near Cloud Cap Inn. At present, a number of fumaroles with temperatures as high as 85°C are active at Crater Rock (Figure 48).

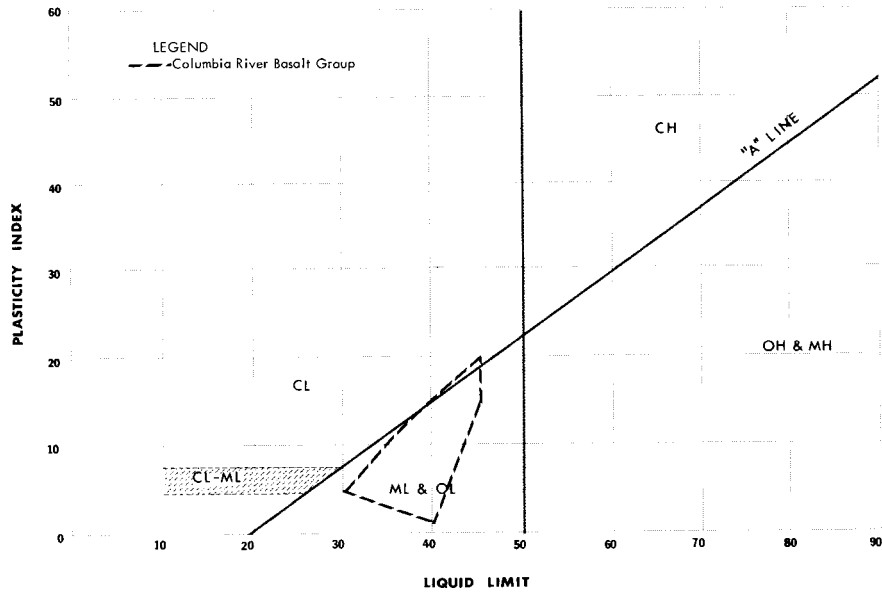
PLASTICITY CHART

*Soils developed on Columbia River Basalt Group (Tcr)*

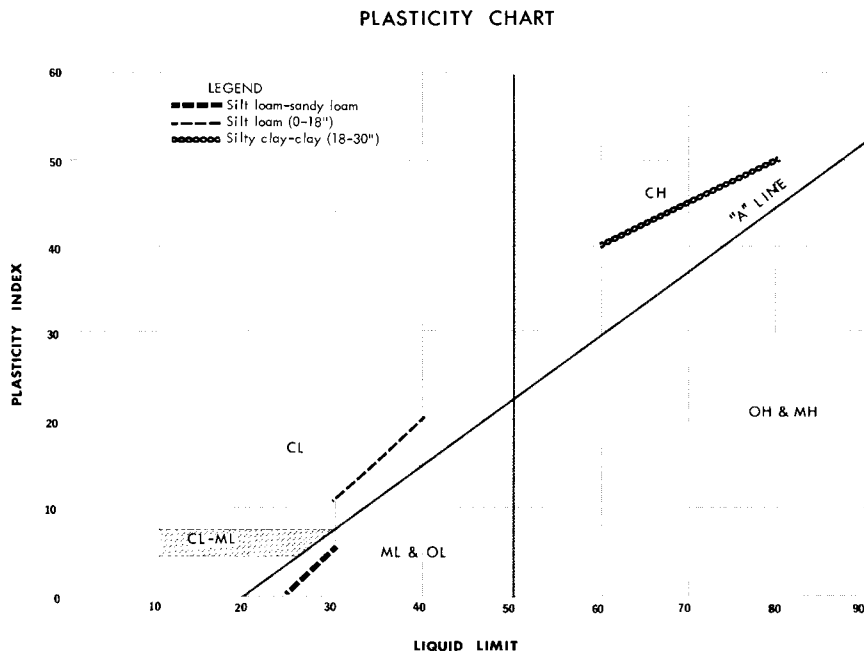
*Soils developed on Troutdale Formation (Tpt)*

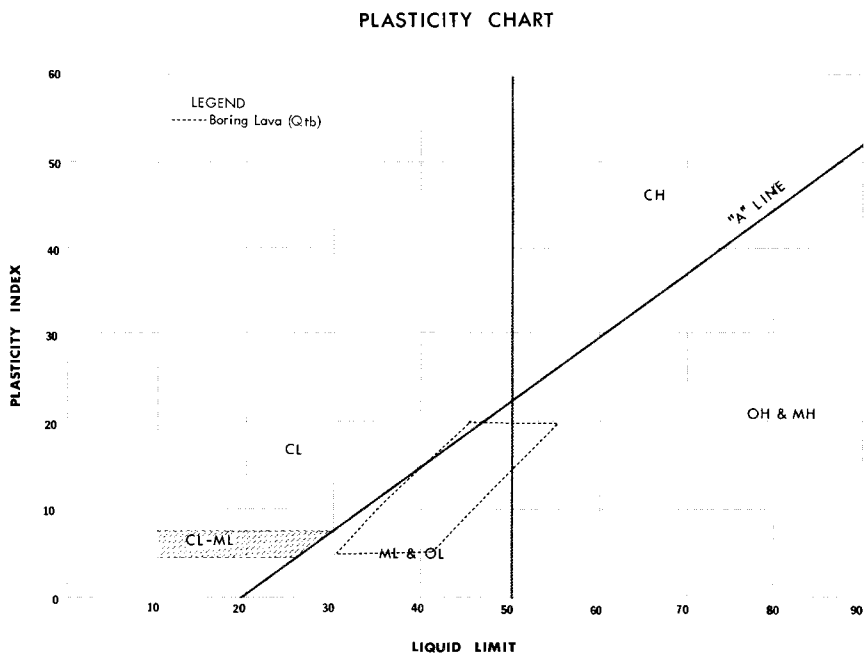
*Soils developed on Boring Lava (Qtb)*

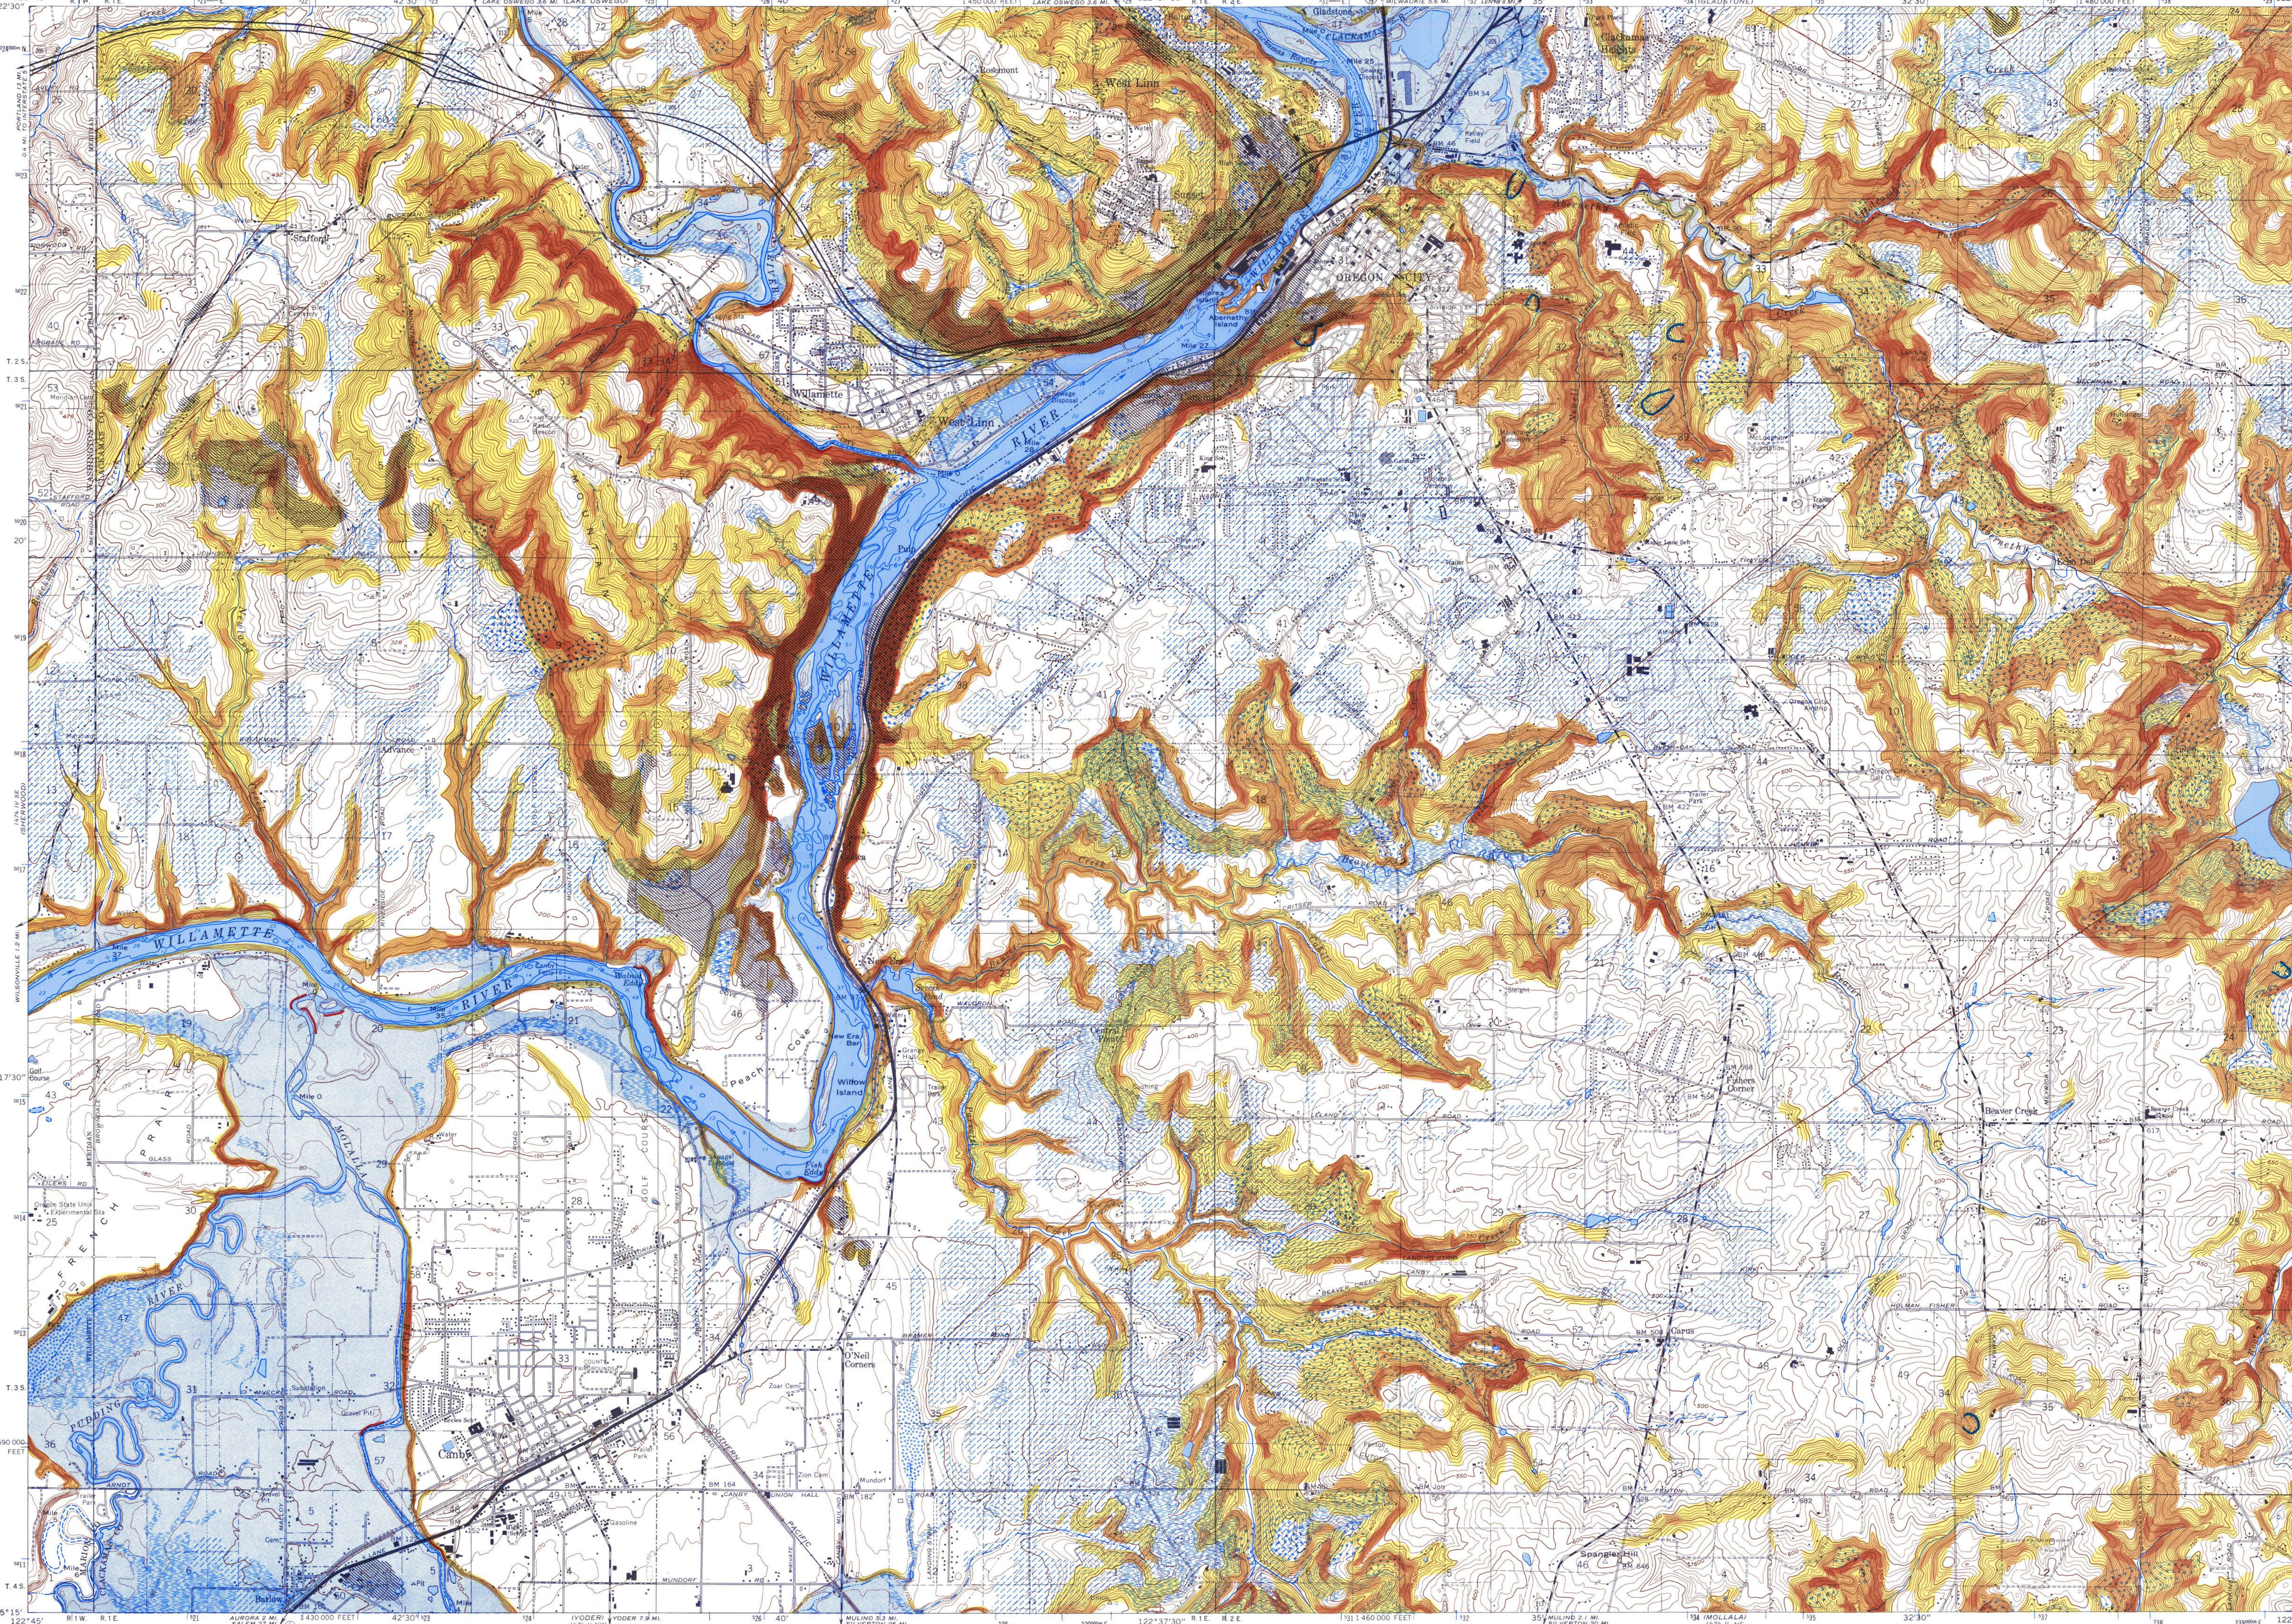
# GEOLOGIC HAZARDS MAP OF THE CANBY AND NORTH OREGON CITY QUADRANGLES, OREGON

**>50%:** Bedrock exposures, steep terrace escarpments, areas of severe stream erosion, talus slopes, and debris flow and debris avalanche landslide areas. Steepest slopes in this category may be subject to rockfall. Geological input necessary for engineering design of roads, cuts, embankments, and drainage in these areas. Development should be limited to certain categories such as roads, recreation, and timber harvest, except for small properly engineered projects shown to be safe.
