Landslide Inventory Map of the Southeast Quarter of the Oregon City Quadrangle, Clackamas County, Oregon

IMS-30

Landslide Inventory Maps of the Oregon City Quadrangle,
Clackamas County, Oregon

PLATE 2

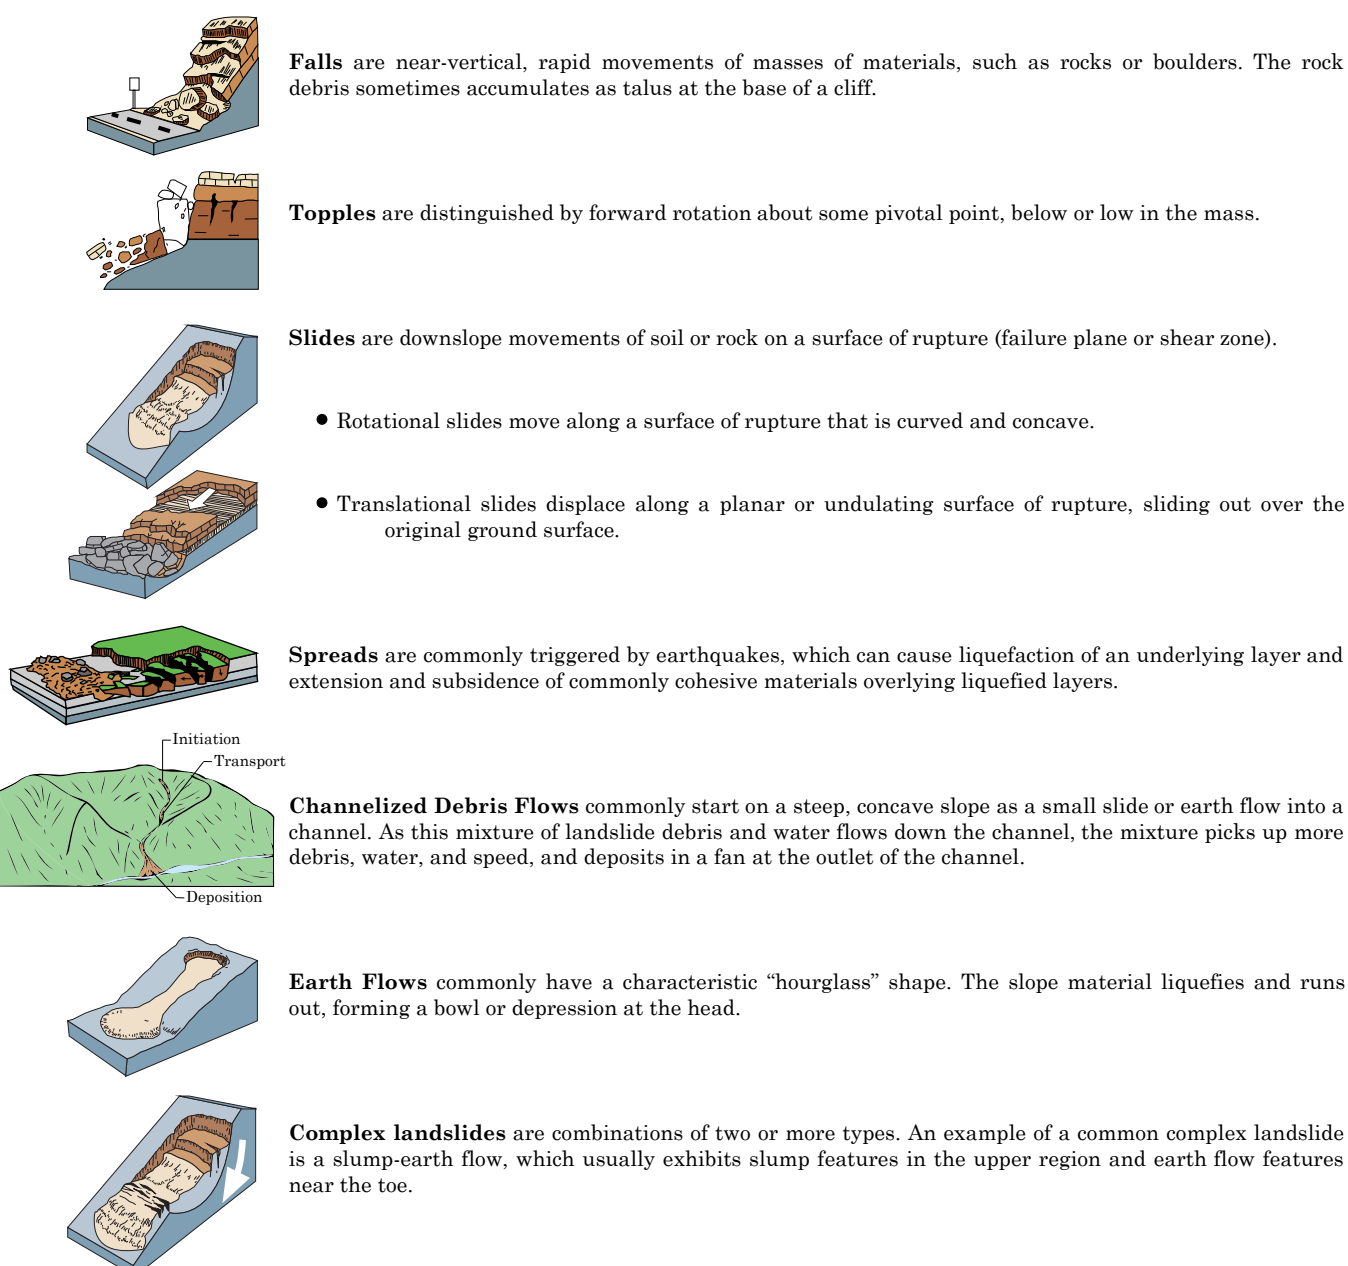
EFL	EFL - Earth Flow - Abbreviation for class of slope movement. The table below displays the types (Varnes, 1978). Generalized diagrams (some modified from Highland, 2004) showing types of movement are displayed below the table.
-----	---

Type of Movement	Rock	Debris	Soil
Fall	RF rock fall	DF debris fall	EF earth fall
Tumble	RT rock topple	DT debris topple	ET earth topple
Slide rotational	RS-R rock slide-rotational	DS-R debris slide-rotational	ES-R earth slide-rotational
Slide translational	RS-T rock slide-translational	DS-T debris slide-translational	ES-T earth slide-translational
Lateral spread	RSP rock spread	DSP debris spread	ESP earth spread
Flow	RFL rock flow	DFL debris flow	EFL earth flow
Complex	C complex or combinations of two or more types (for example, ES-R + EFL)

CLASSIFICATION OF MOVEMENT: Each landslide was classified with the type of landslide movement. There are five types of landslide movement: slide, flow, fall, creep, and spread. These movement types are combined with material type to form the landslide classification. Not all combinations are common in nature, and not all are present in this quadrangle.

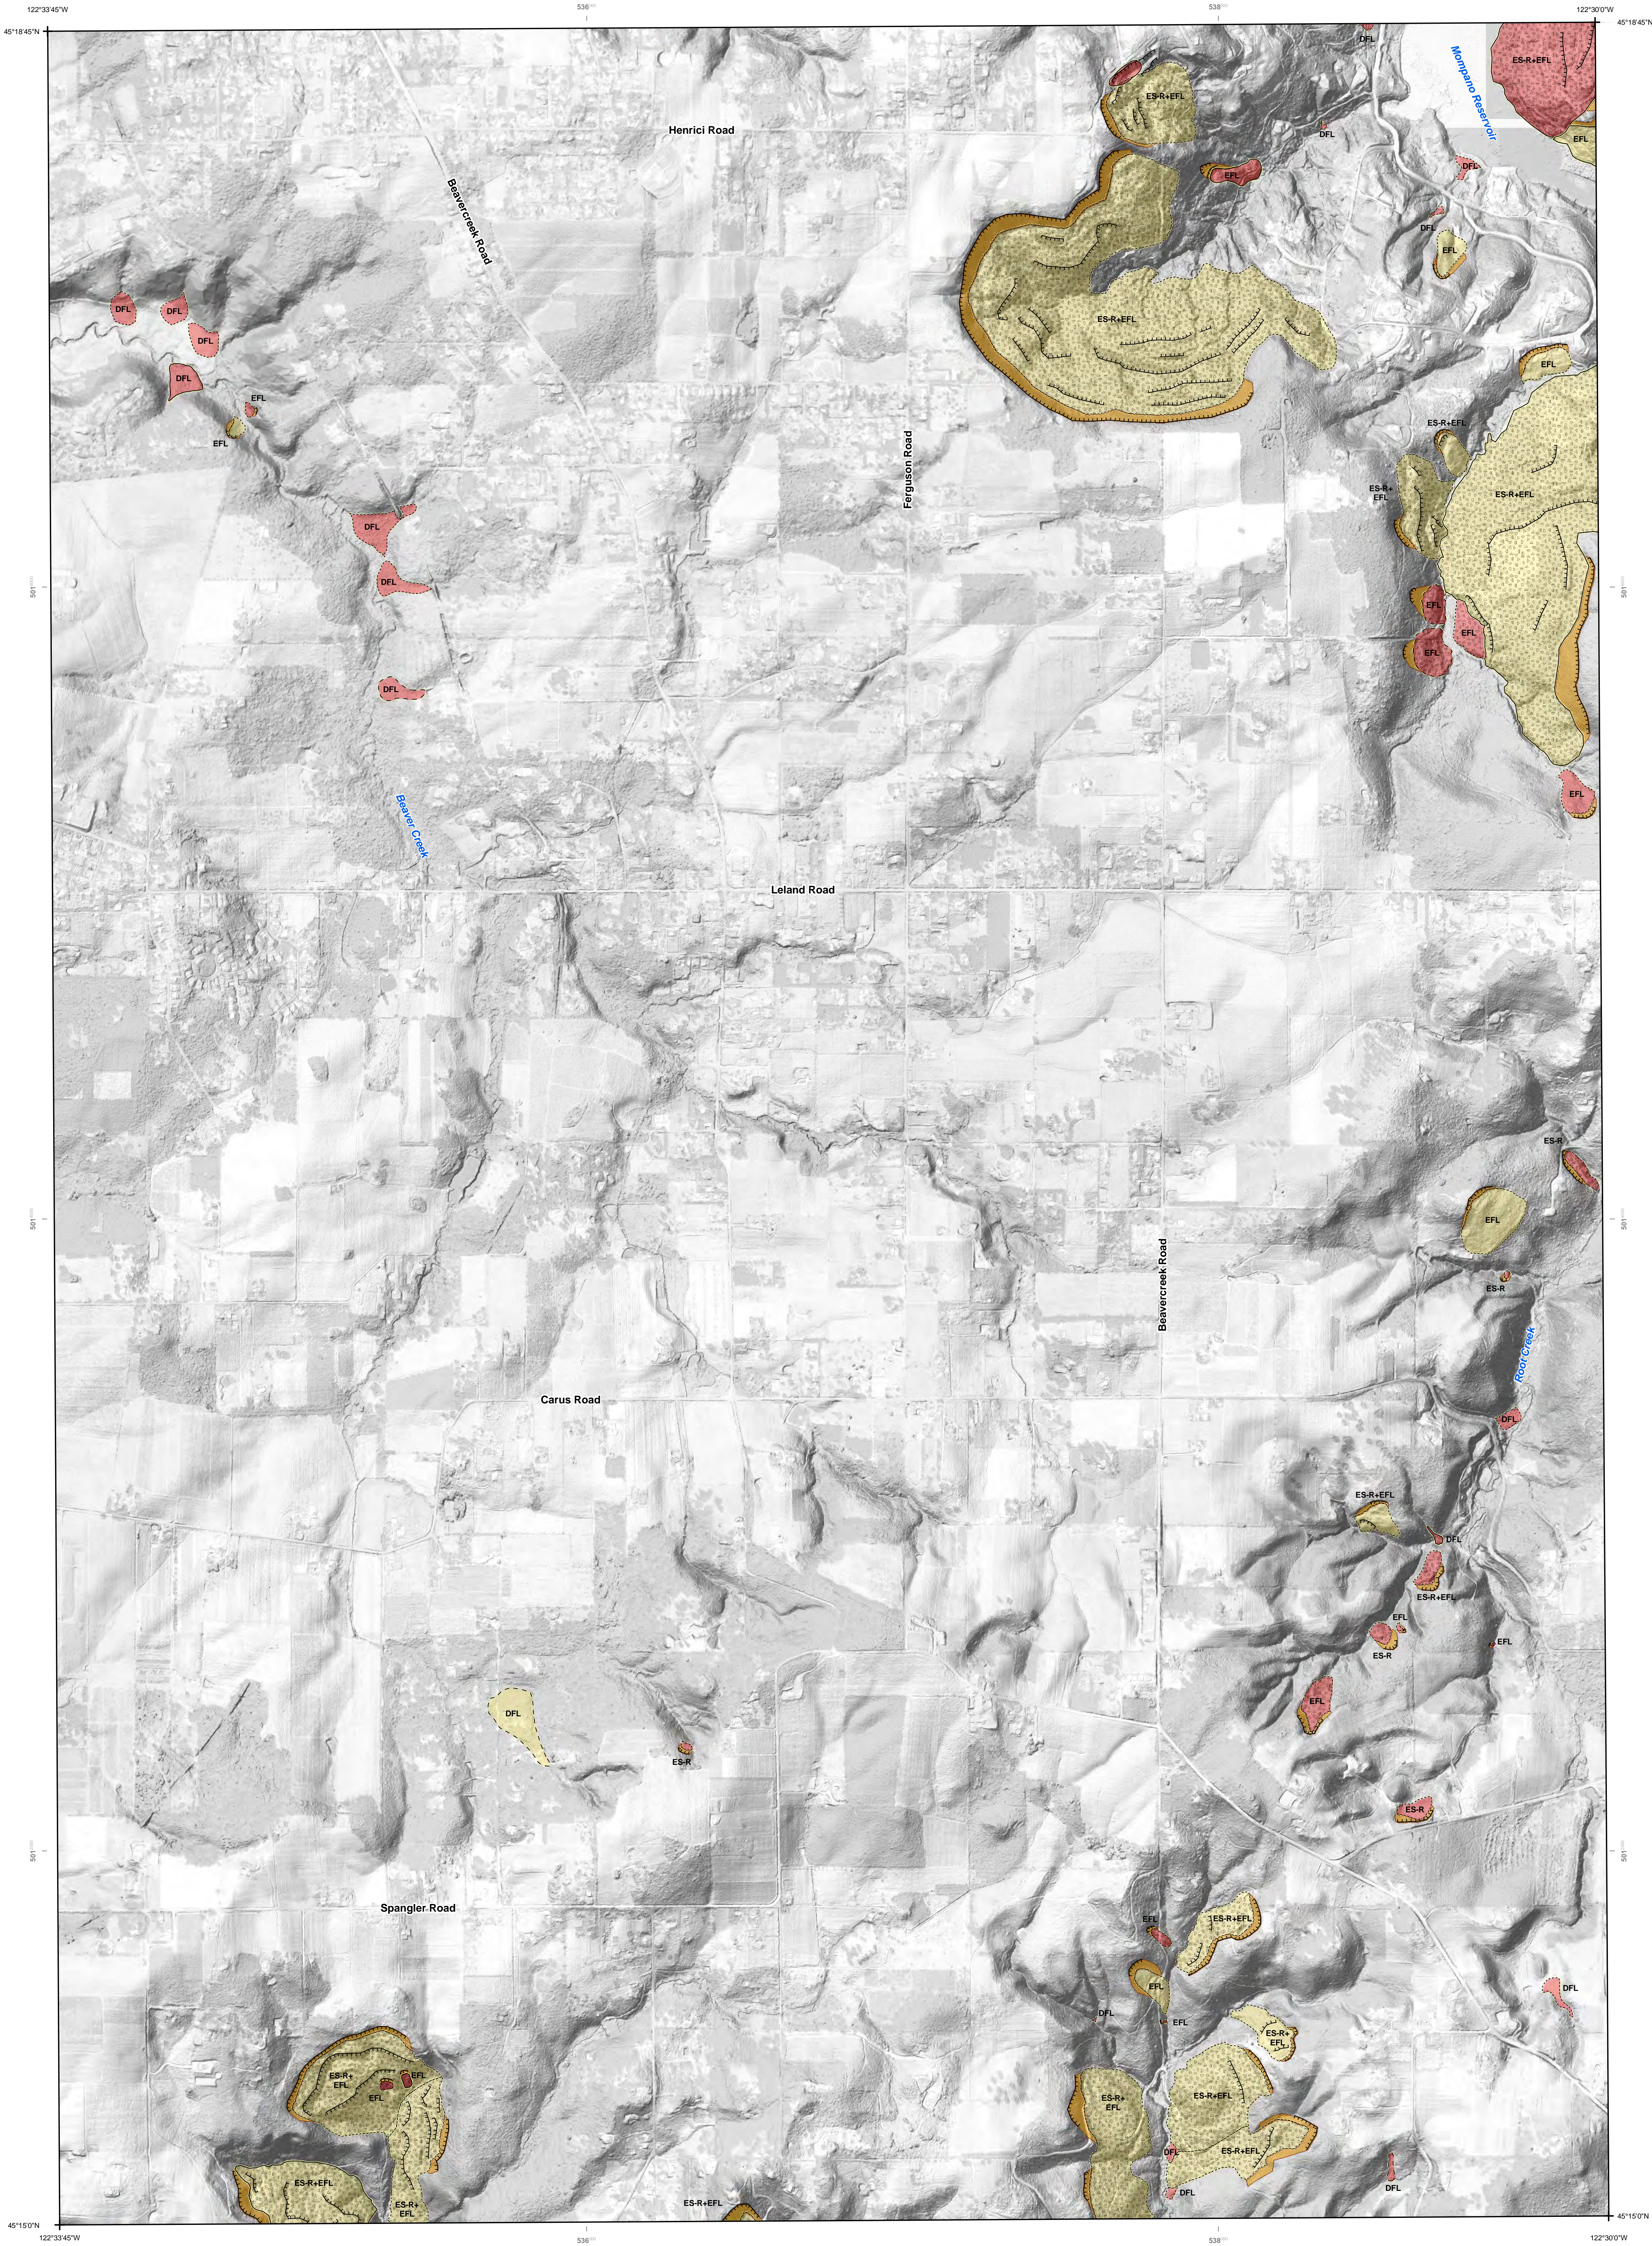
This map is an inventory of existing landslides in this quarter quadrangle. The landslide inventory is one of the essential data layers used to delineate regional landslide susceptibility. This landslide inventory is not regulatory, and revisions can happen when new information regarding landslides is found or when future new landslides occur. Therefore, it is possible that landslides within the mapped areas were not identified or occurred after the map was prepared.

Base Map:
Lidar-derived elevation data are from the Oregon Lidar Consortium (2007). Digital elevation model (DEM) consists of a 3-foot square elevation grid that was converted into a hillshade image with sun angle at 315 degrees at a 45 degree angle from horizontal. The DEM is multiplied by 5 (vertical exaggeration) to enhance slope areas.

Orthophoto is from Oregon Geospatial Enterprise Office, 2005 and consists of 2005 orthophoto draped over DEM with transparency.
