Landslide Inventory Map of the Southeast Quarter of the Mount Tabor Quadrangle, Multnomah County, Oregon

IMS-41
INTERPRETIVE MAP SERIES

Landslide Inventory Maps of the Mount Tabor Quadrangle,
Multnomah County, Oregon, and Clark County, Washington

PLATE 4

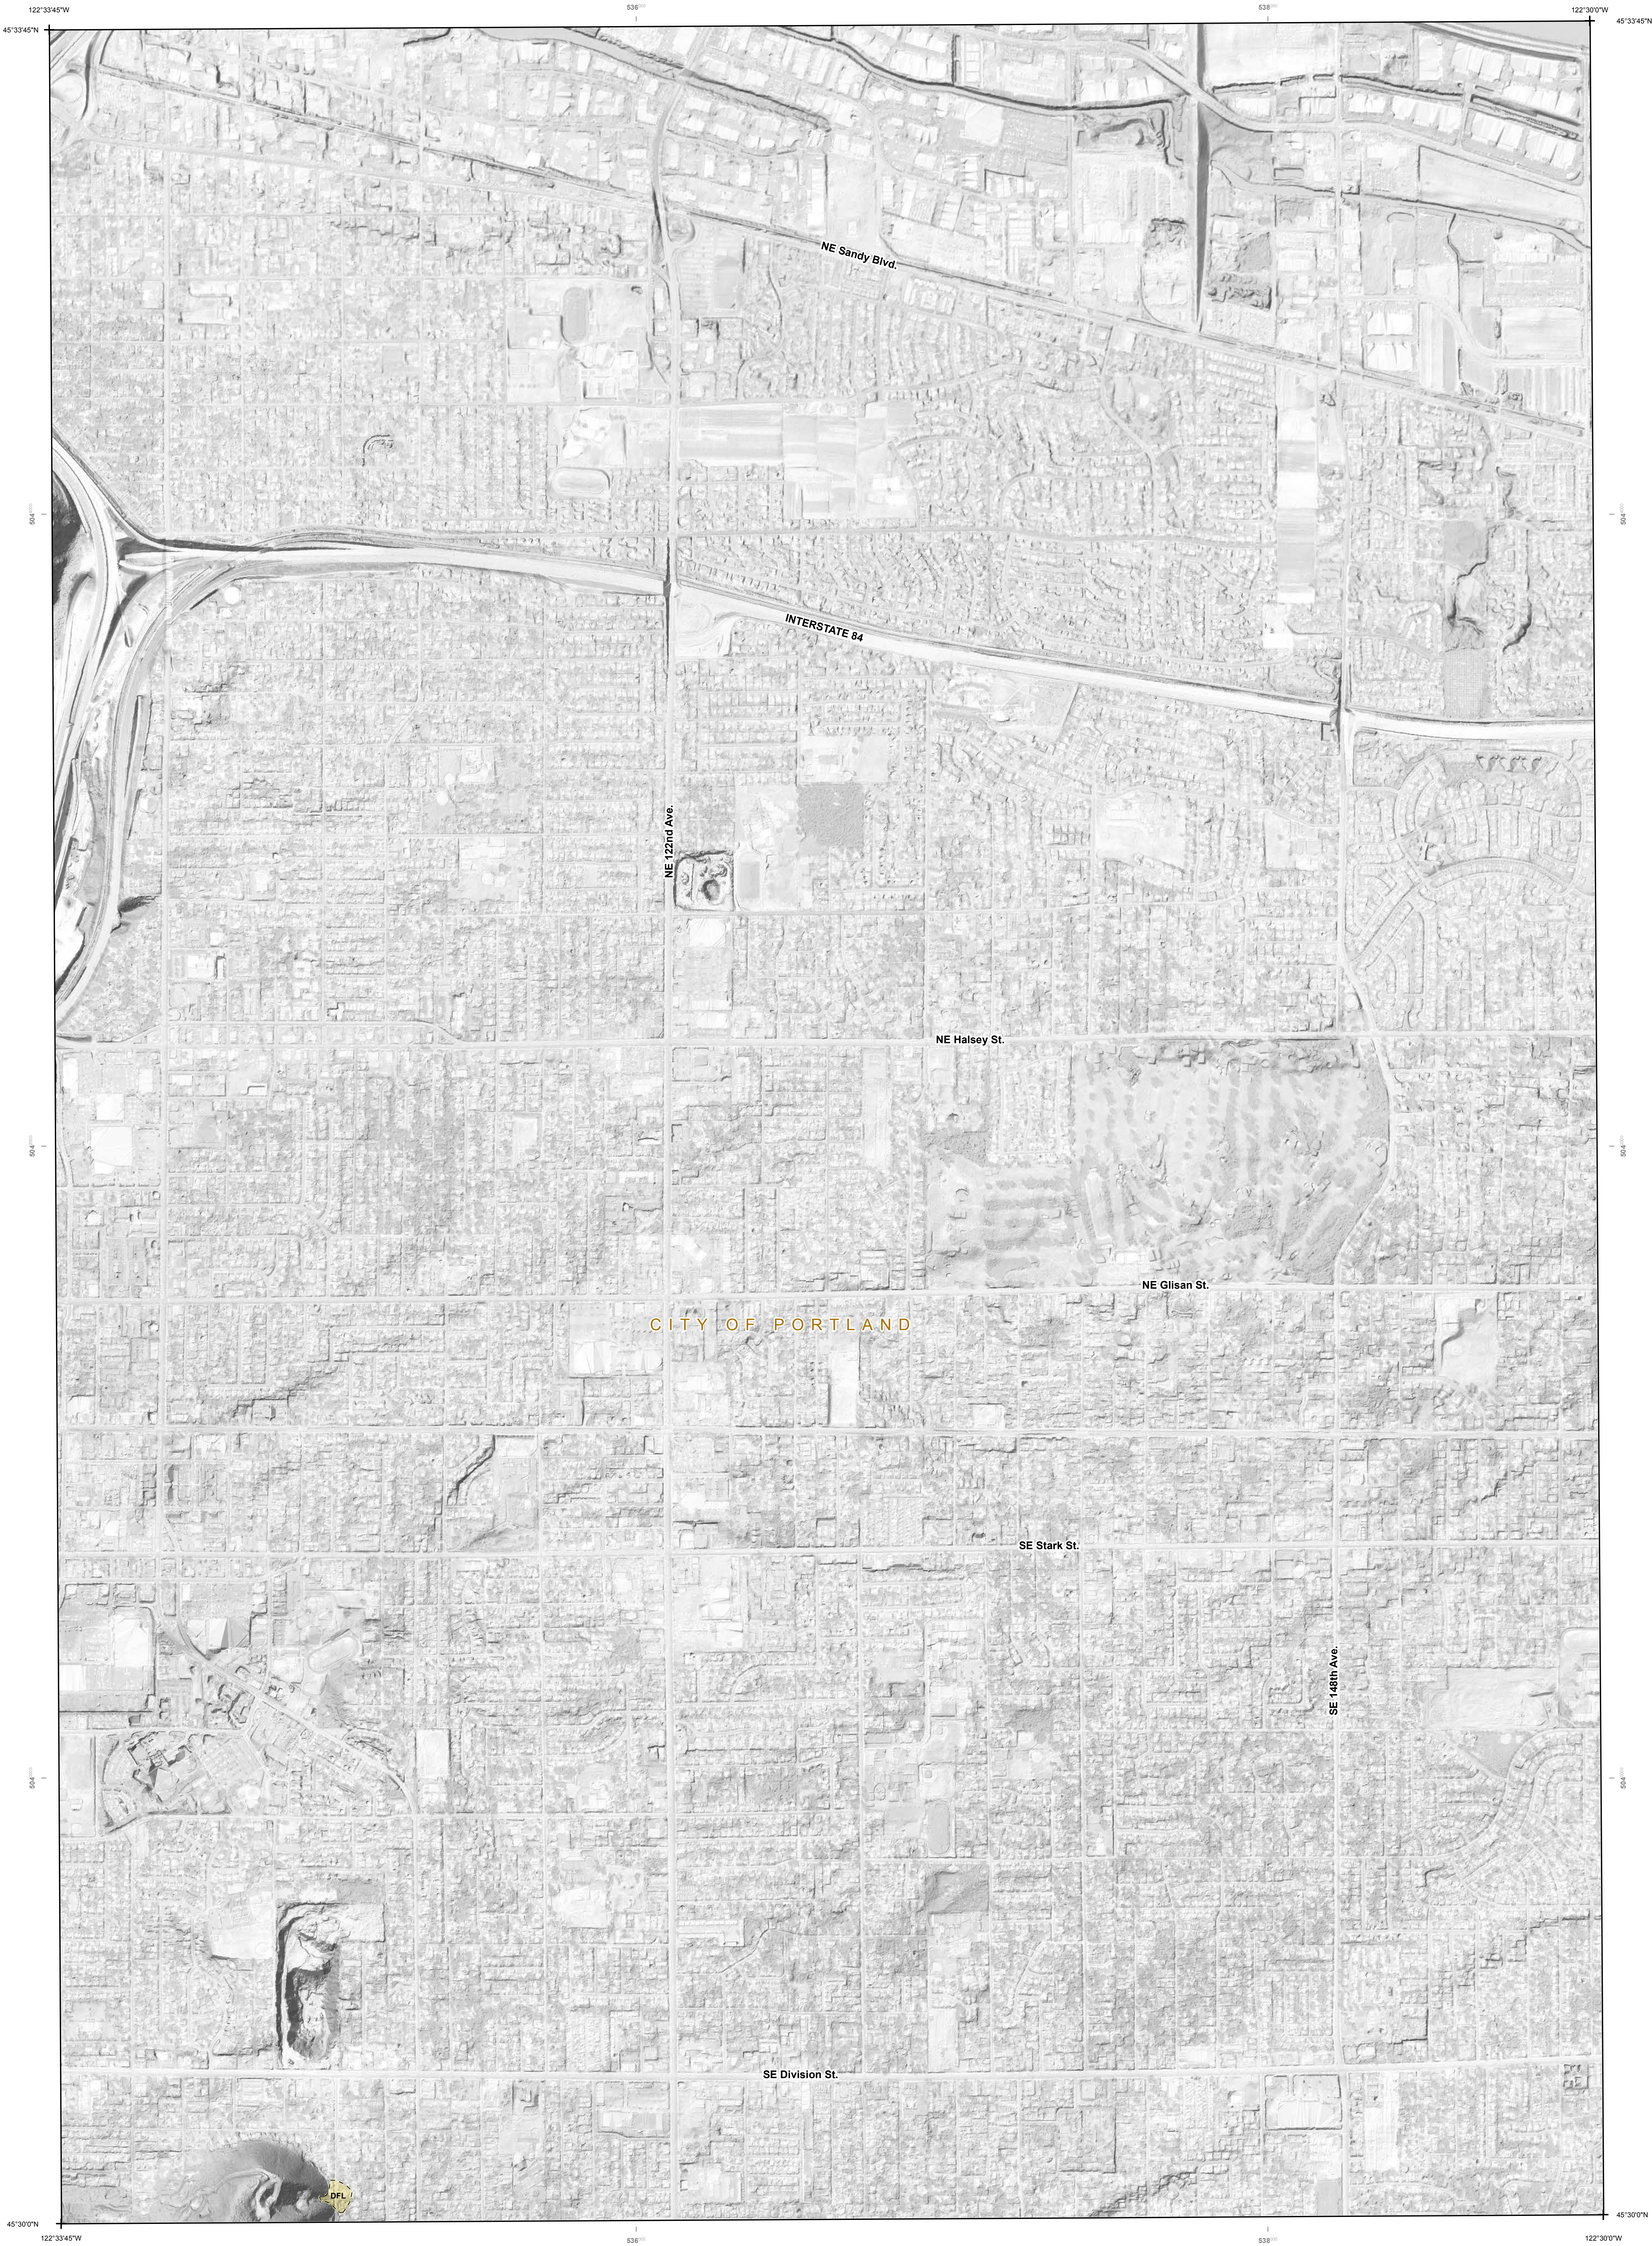
Base Map:
Lidar data from DOGAMI Lidar Data Quadrangle LDQ-2009-4512255-Mount Tabor. Digital elevation model (DEM) consists of a 3 foot square elevation grid that was converted into a hillshade map with sun angle at 315 degrees at a 60 degree angle from horizontal. The DEM was multiplied by 5 (vertical exaggeration) to enhance slope areas.
2003 orthophoto imagery is from Oregon Geospatial Enterprise Office and is draped over the hillshade map with transparency.
Projection: North American Datum 1983, UTM zone 10 North.
Software: Esri ArcMap 10, Adobe Illustrator CS2.
Source File: Project\USGS Portland Landslide\MtTabor.mxd

This map is an inventory of existing landslides in this quarter quadrangle. The landslide inventory is one of the essential data layers used to delineate regional landslide susceptibility. This landslide inventory is not regulatory, and revisions can happen when new information regarding landslides is found or when future (new) landslides occur. Therefore, it is possible that landslides within the mapped area were not identified or occurred after the map was prepared.
