Oregon Department of Geology & Mineral Industries
800 NE Oregon St, Suite 965
Portland, OR 97232

OLC Lower Malheur 2015 Lidar Project Lidar QC Report – January 3rd, 2017

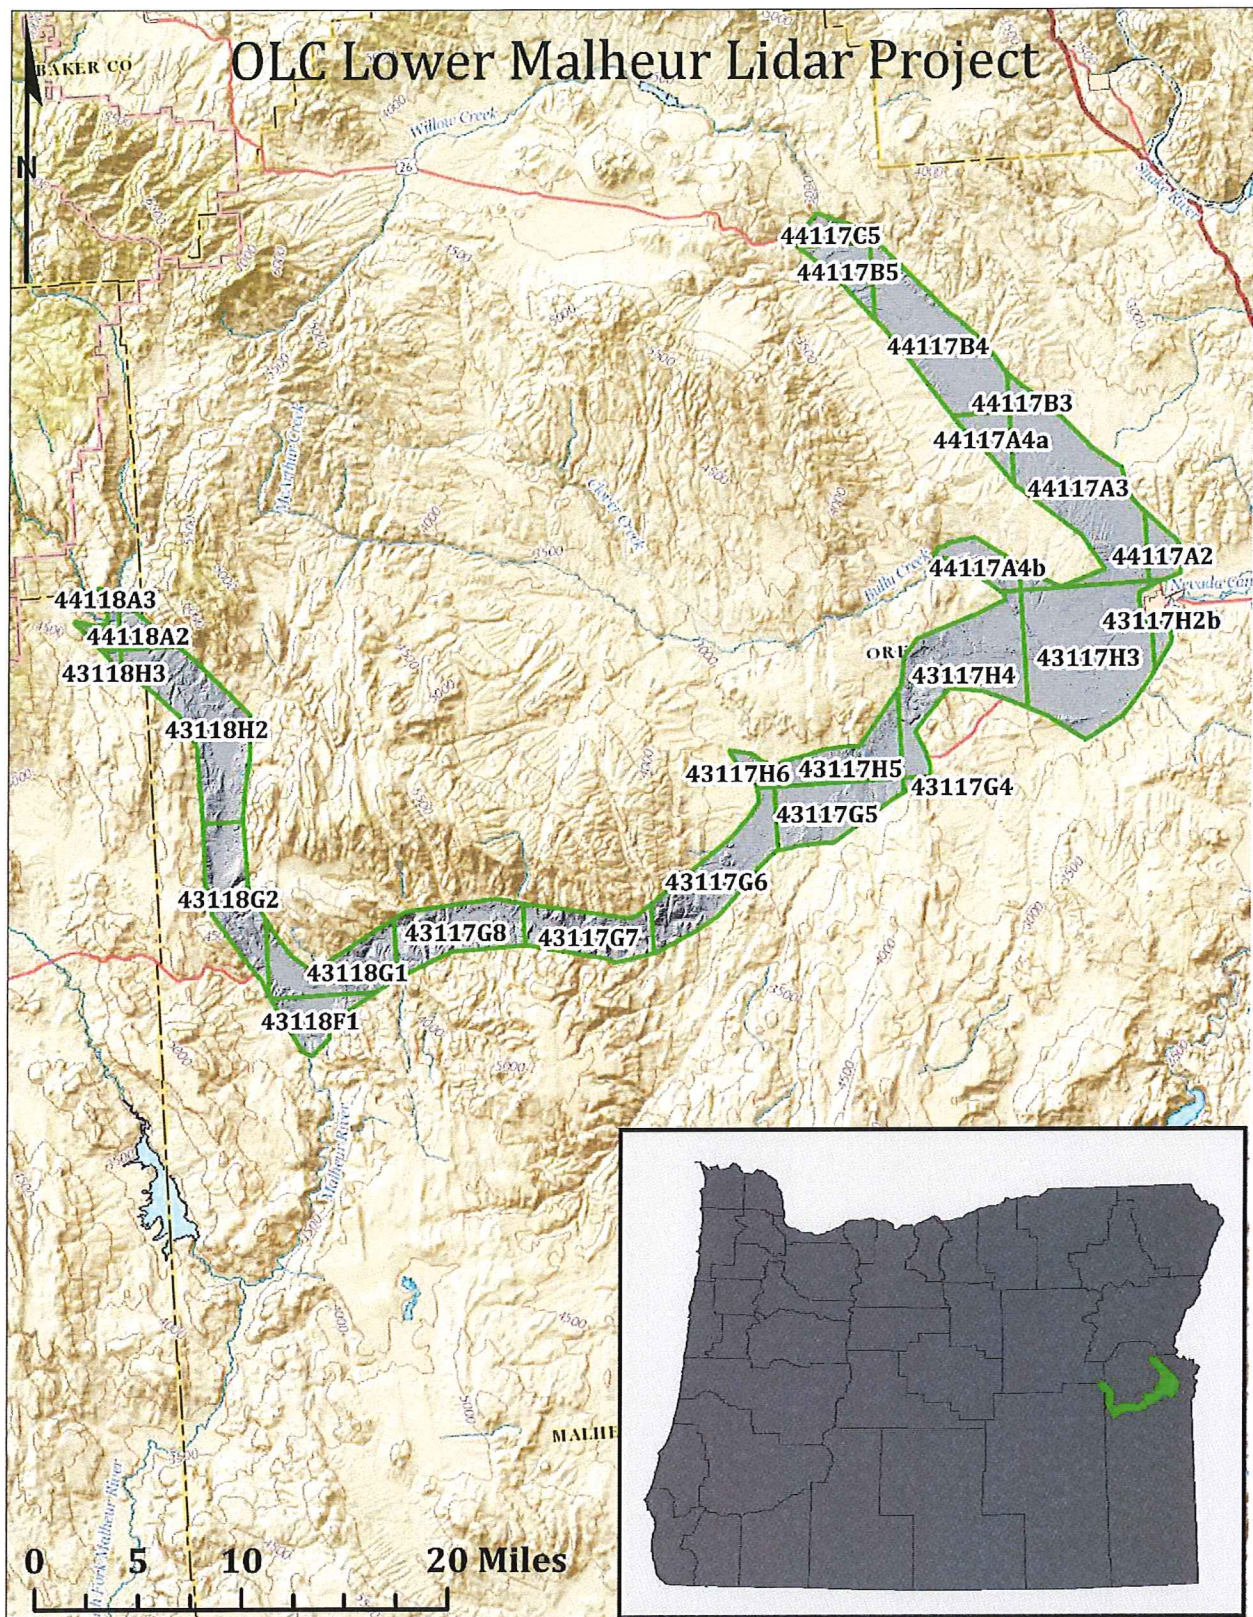
Figure 2: OLC Lower Malheur 2015 Lidar Project collection area. Data is referenced to USGS 7.5 minute quadrangles within the extents of the OLC Lower Malheur 2015 Lidar Project.

Data for OLC Lower Malheur 2015 Lidar Project areas were collected during May 28th, 2015 through June 5th, 2015. Total area of delivered data equals 307.96 square miles. This delivery contains data for the following 27 USGS 7.5 minute quads (listed by Ohio Code #) within the boundary of the OLC Lower Malheur 2015 Lidar Project survey collection area (Figure 2):

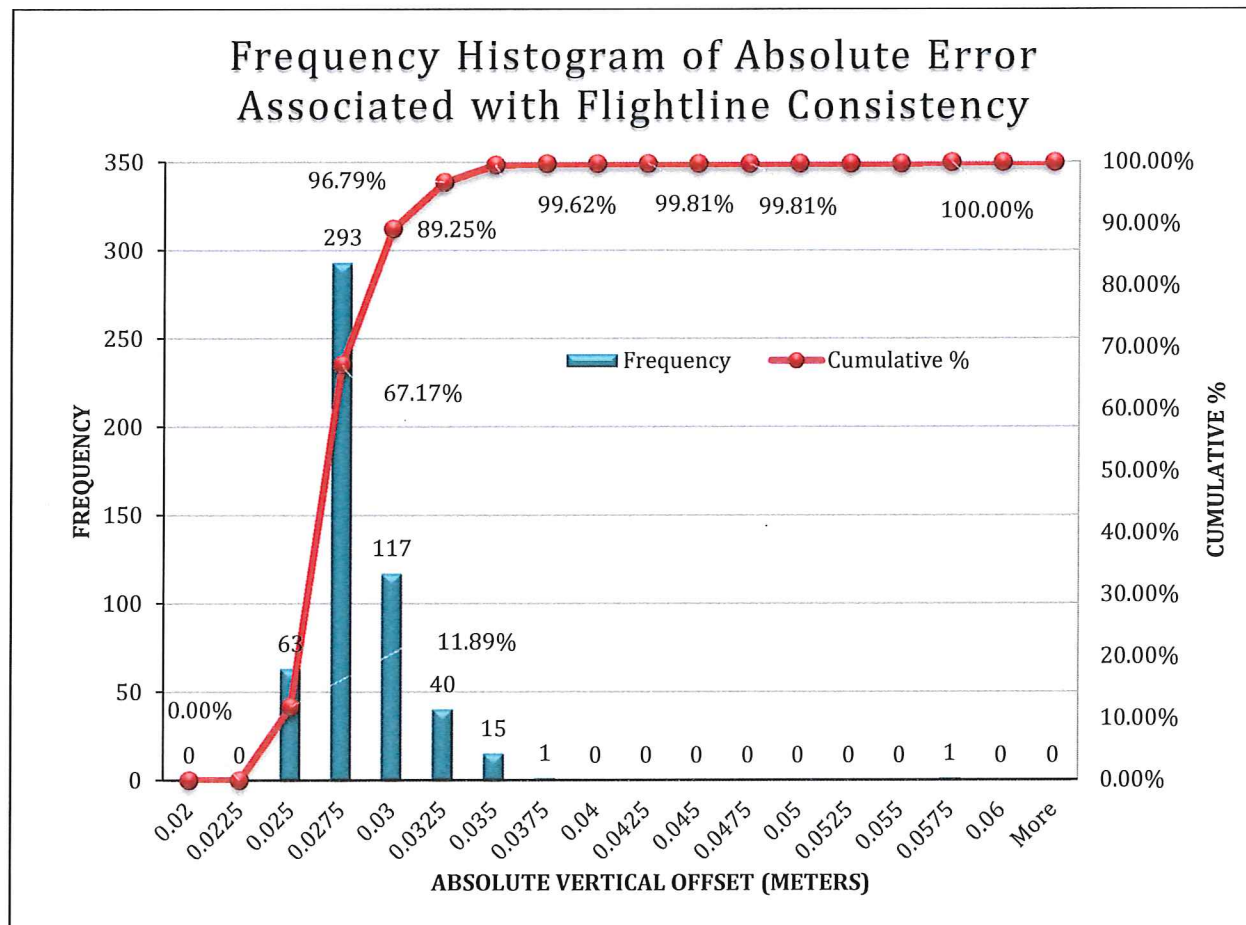
**Figure 4: Flight line Consistency Histogram in meters**

Results of the consistency analysis found the average flight line offset to be 0.03 meters (0.09 feet) with a maximum error of 0.06 meters (0.19 feet) (Table 8b). Distribution of error showed 99.8% of all error was less than 0.05 meters (0.25 feet) and 100% less than 0.06 meters (0.19 feet) (Figure 4 and 5). These results show that all data are within specification.

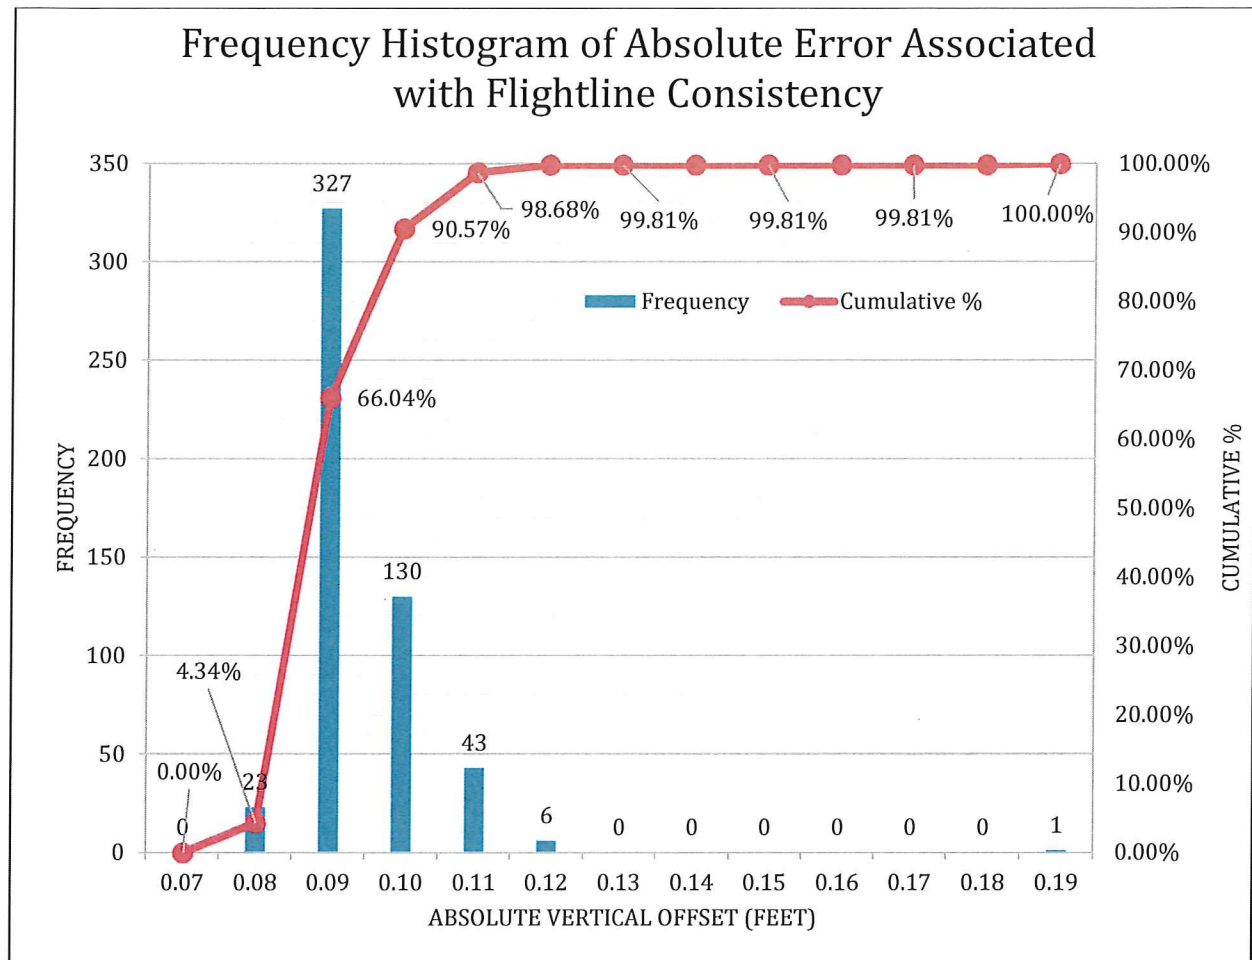
Figure 5: Flight line Consistency Histogram in feet

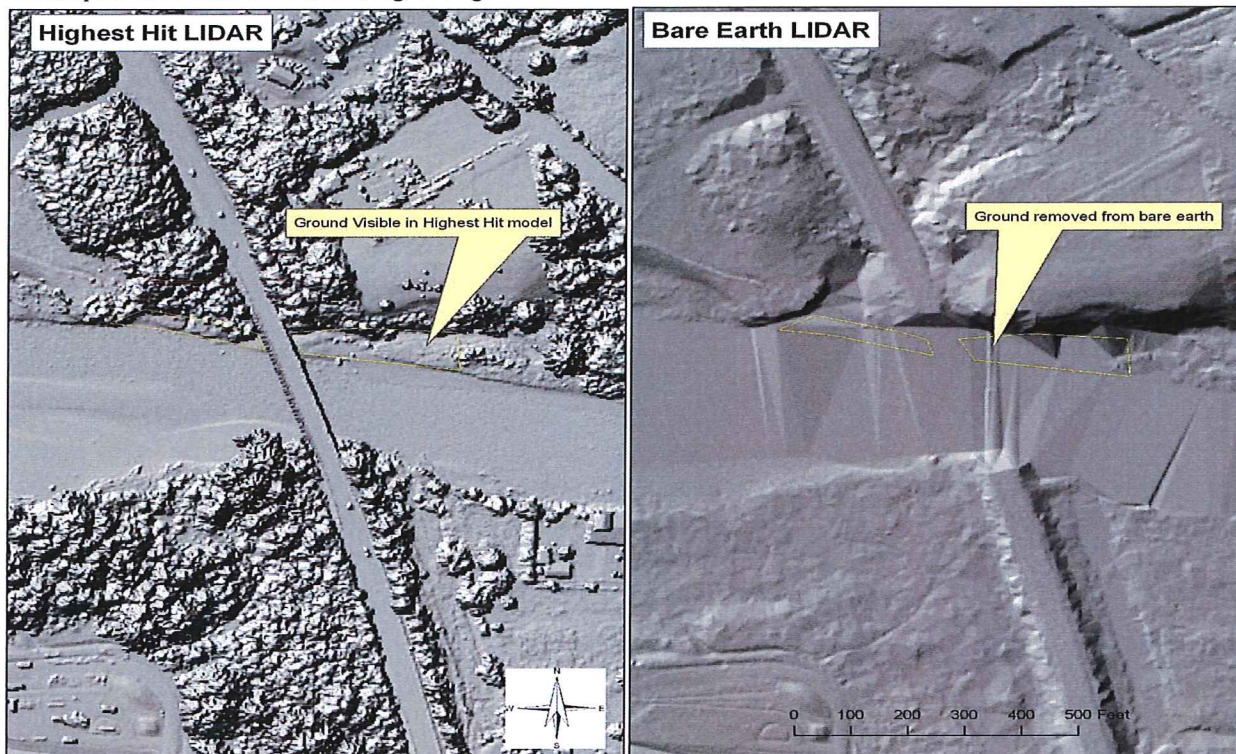
Figure 6: Example of missing ground in lidar bare earth data. Ground is clearly visible in highest hit model, but has been removed from the bare earth model. This type of classification error is common near water body features

Lidar 3ft grids were loaded into ArcGIS™ software for visual analysis. Data were examined through slope and hillshade models of bare-earth returns. Hillshades of the highest hit models were used to identify areas of missing ground (Figure 6). Both bare-earth and highest hit models were examined for calibration offsets, tiling artifacts (Figure 7), seam line offsets, pits (Figure 8), and birds.

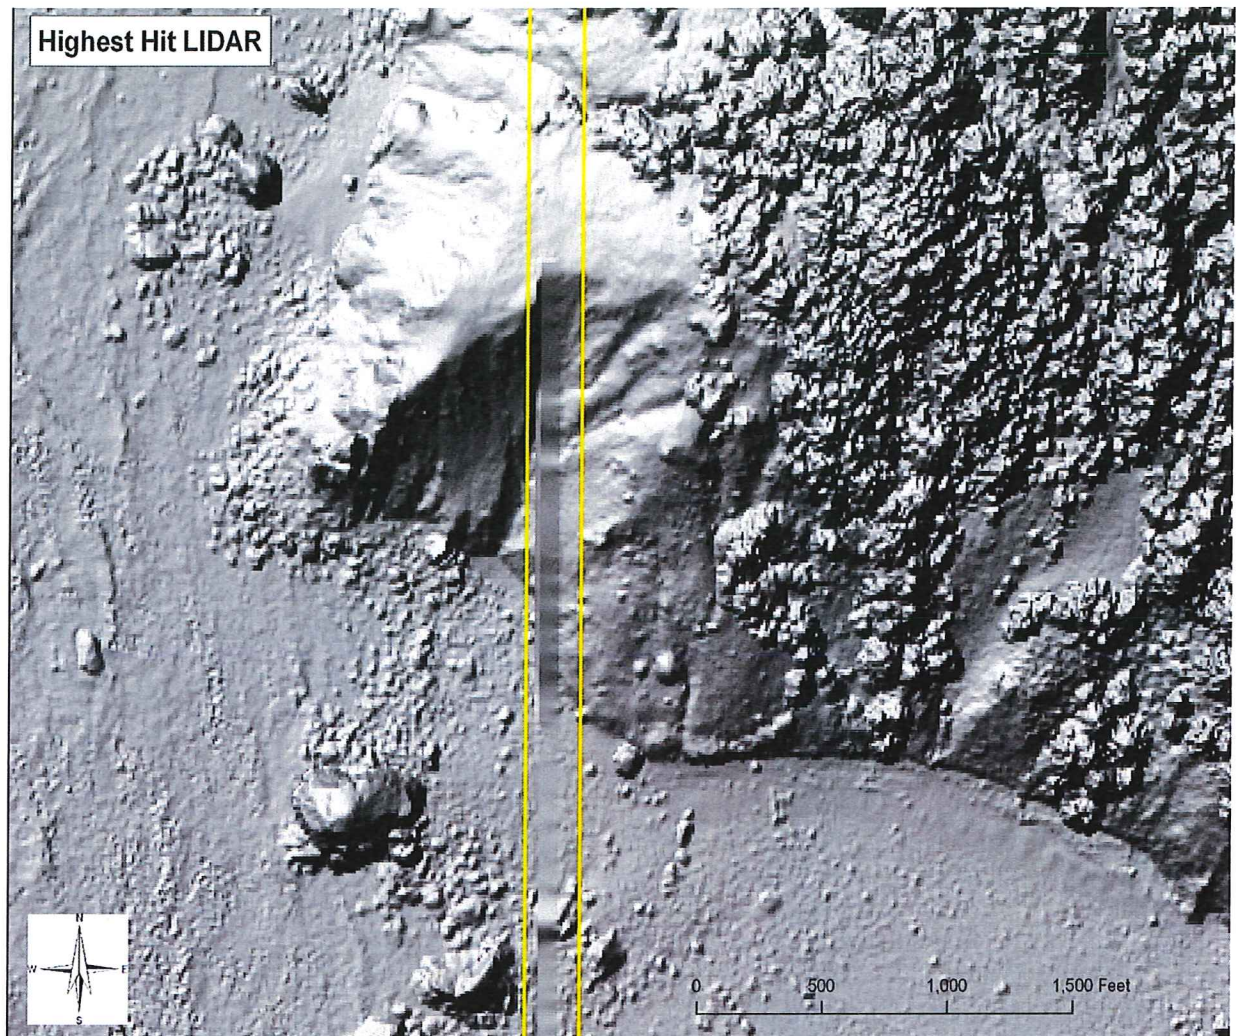
Figure 7: Example of tile artifact found in highest hit lidar data. Artifact is a seam line error created due to misclassification of ground at edge of lidar processing tiles.

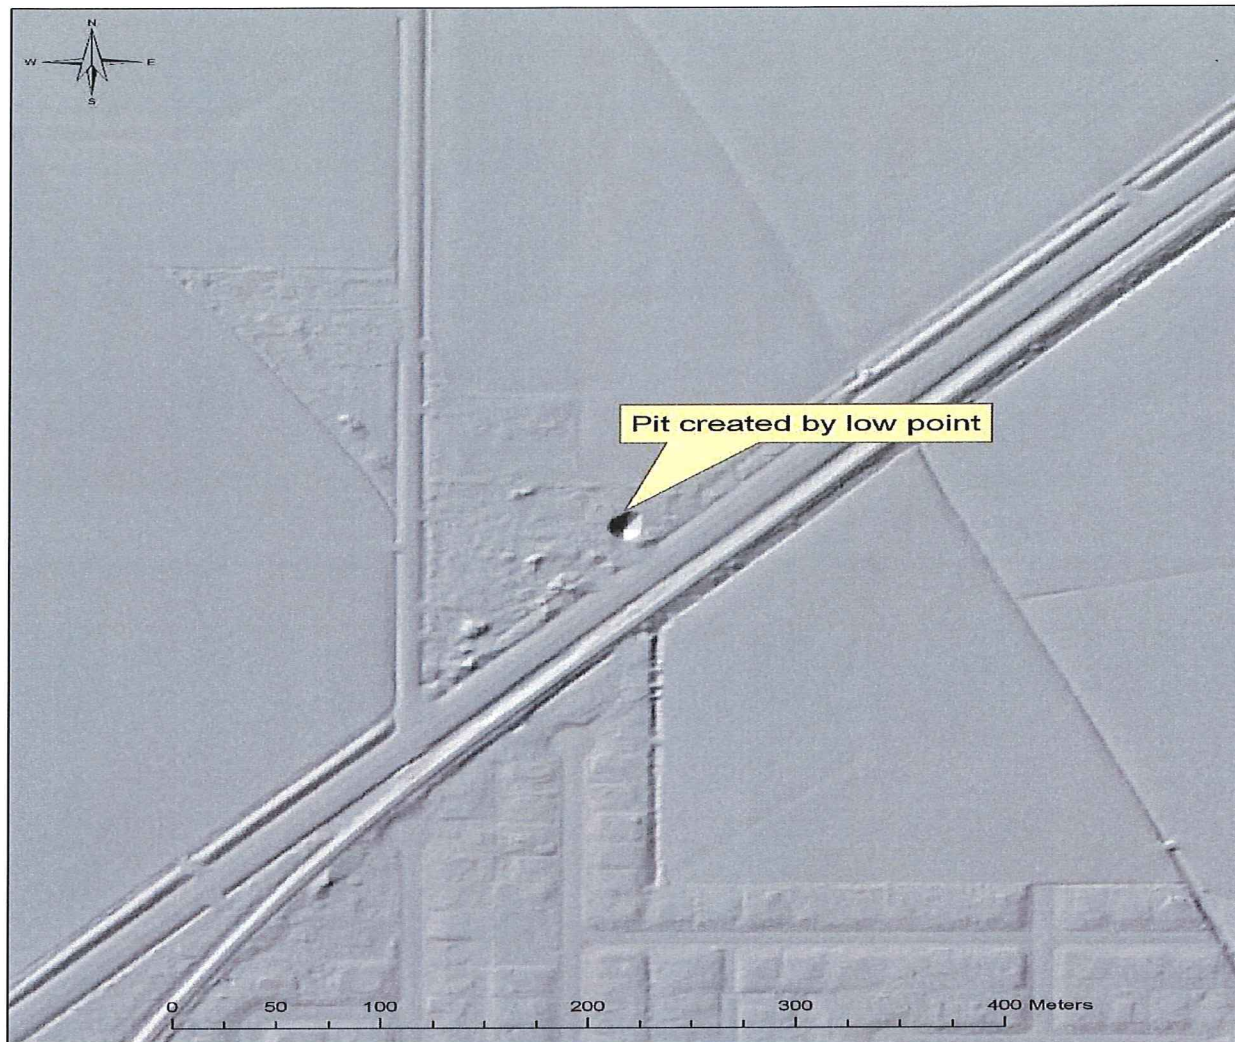
Figure 8: Example of "Pit" caused by low point in ground model. Pits are caused when standing water absorbs the lidar pulse. Pits are evident in ground model as the lowest point elevation is assigned to the grid cell value. Inversely the pit is not observable in the highest hit model as the highest point elevation is assigned to the grid value.

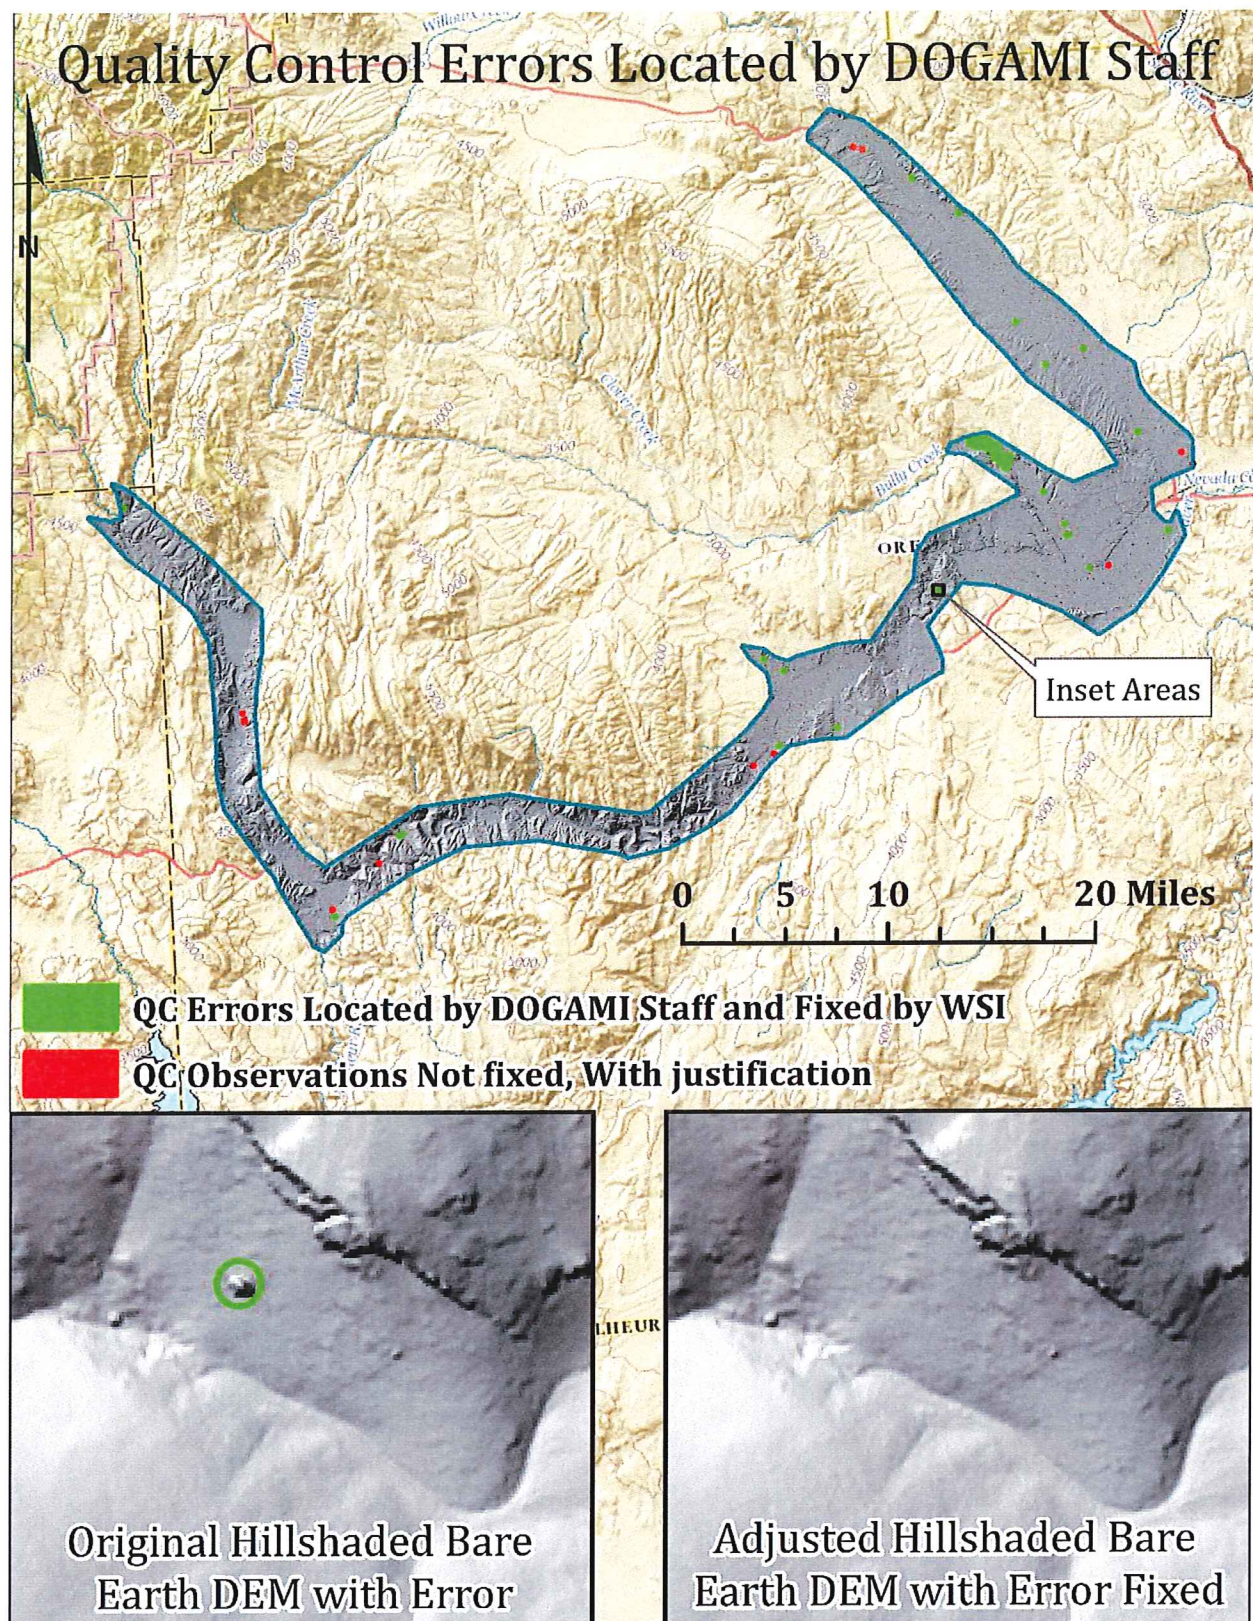
Figure 9: Spatial distribution of visual QC errors located by DOGAMI staff.

During visual analysis of OLC Lower Malheur 2015 Lidar Project raster data, 37 observed errors were digitized for spatial reference and stored in Esri™ shapefile format. Each feature was assigned an ID value and included a brief description of the observed error. The shapefile was then delivered to the vendor for locating and fixing errors. Upon receiving the observed error locations, the vendor performed an analysis to conclude whether the error was valid and provided comments on how the data was adjusted. 26 out of the 37 observed errors (70%) were adjusted and the data was reprocessed to accommodate fixes. Final sets of lidar 3 ft. grids were loaded into ArcGIS™ software and examined to ensure edits were made and visually inspected an additional time for completeness (Figure 9).

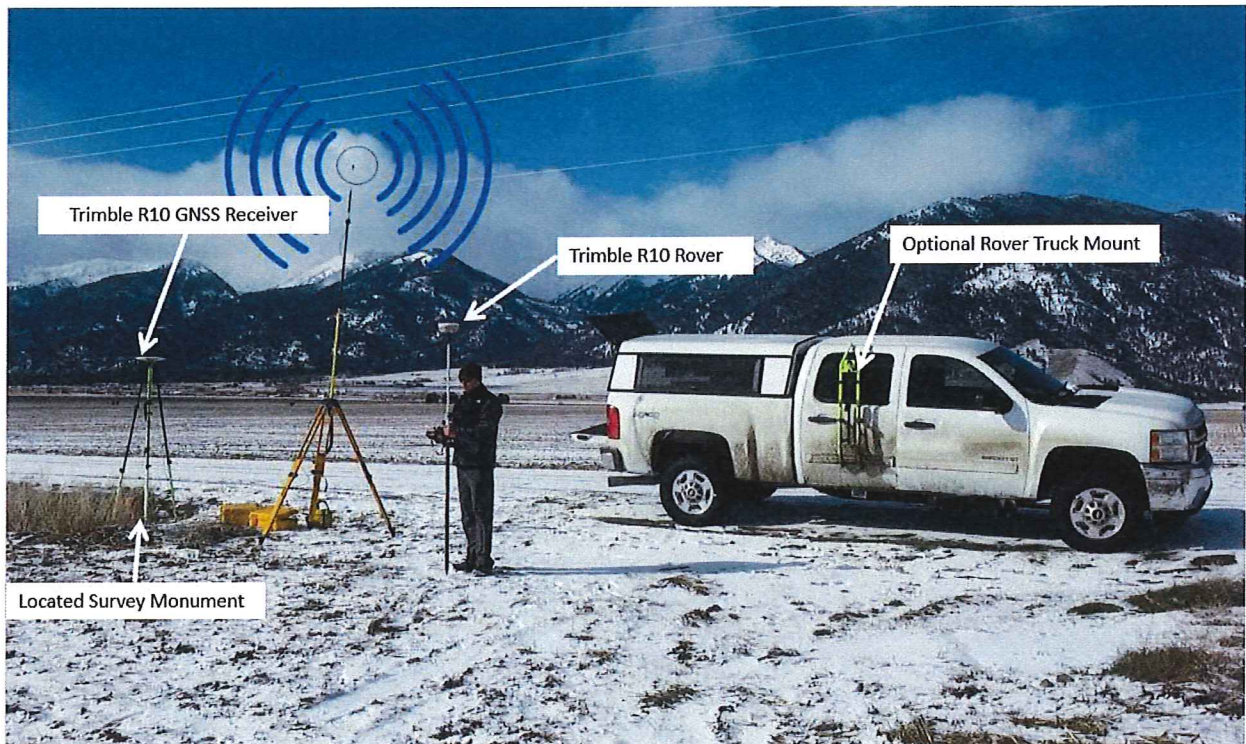
Figure 10: The Trimble R10 base station antenna located over a known reference point outside Baker City. Corrected GPS position and elevation information is then transmitted either by Internal Radio or by a Trimmark III base radio to the 5700GPS rover unit.

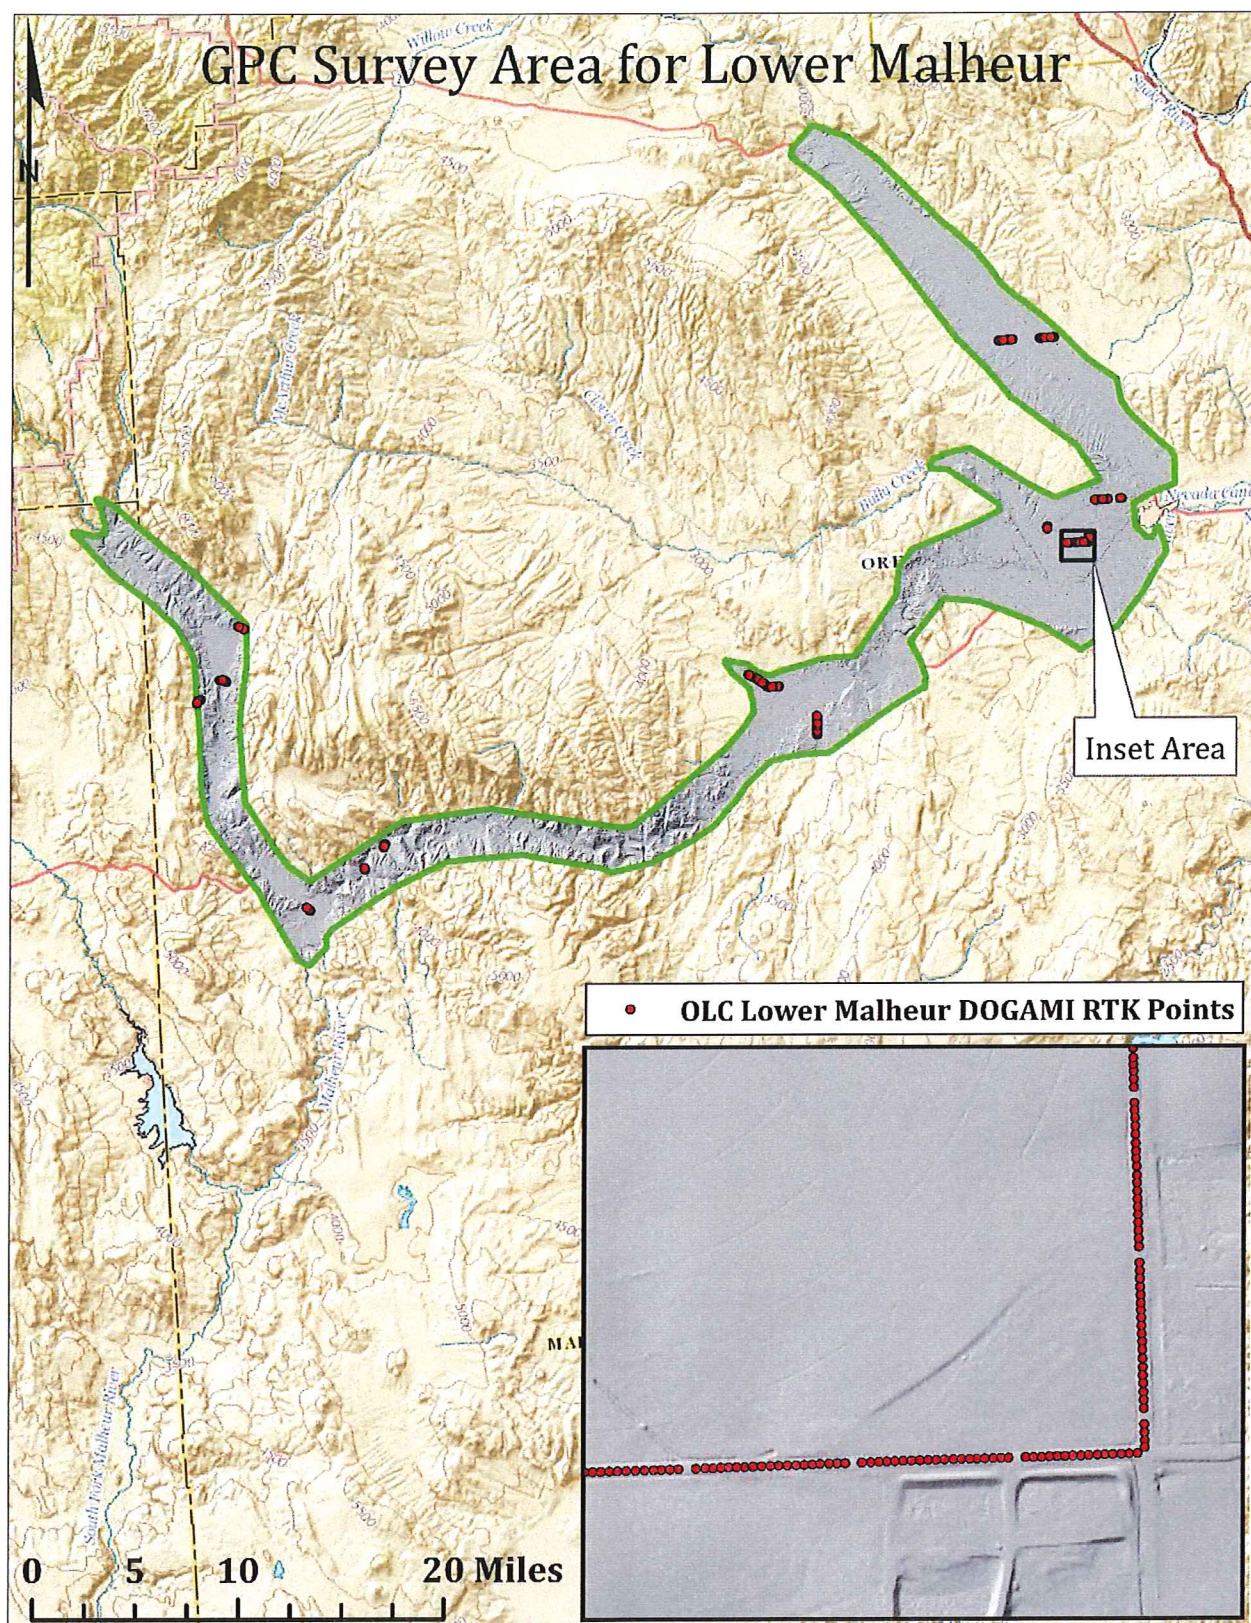
Figure 11: Locations of GCPs surveyed by DOGAMI staff. Data was used to test absolute accuracy for the OLC Lower Malheur 2015 Lidar Project areas.

A total of 956 measured GCP's were obtained in the OLC Lower Malheur 2015 LIDAR Project area and were compared with the lidar elevation grids (Figure 11). The data delivered to DOGAMI was found to have a mean vertical offset of -0.04 meters (-0.13 feet) and an RMSE value of 0.06 meters (0.18 feet). Offset values ranged from -0.18 meters (-0.58 feet) to 0.10 meters (0.34 feet) (Table 10, Figure 12, and Figure 13).

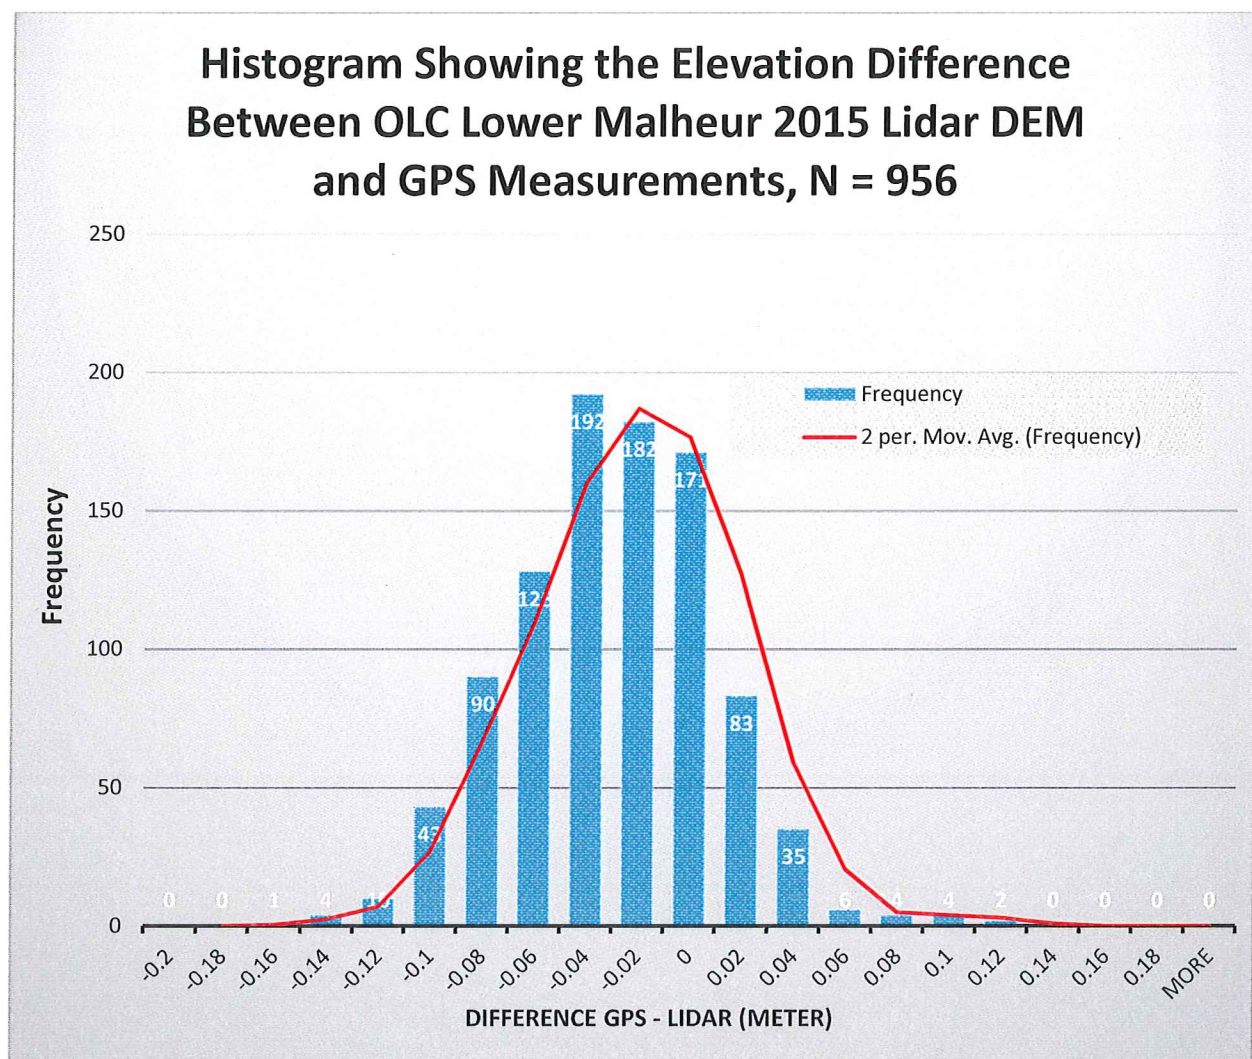
**Figure 12: Histogram of absolute vertical accuracy in meters.**

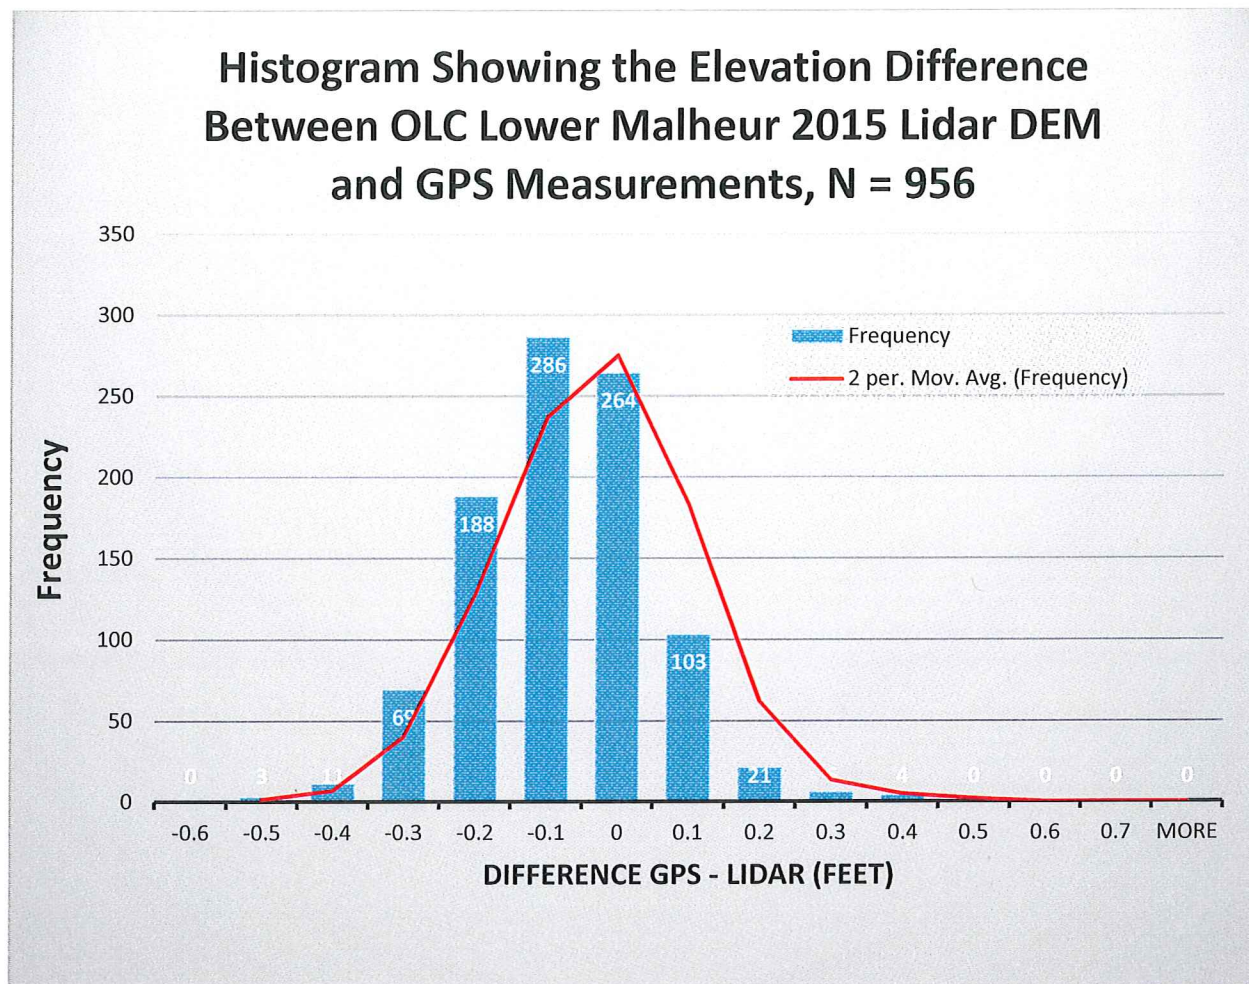
Figure 13: Histogram of absolute vertical accuracy in feet.

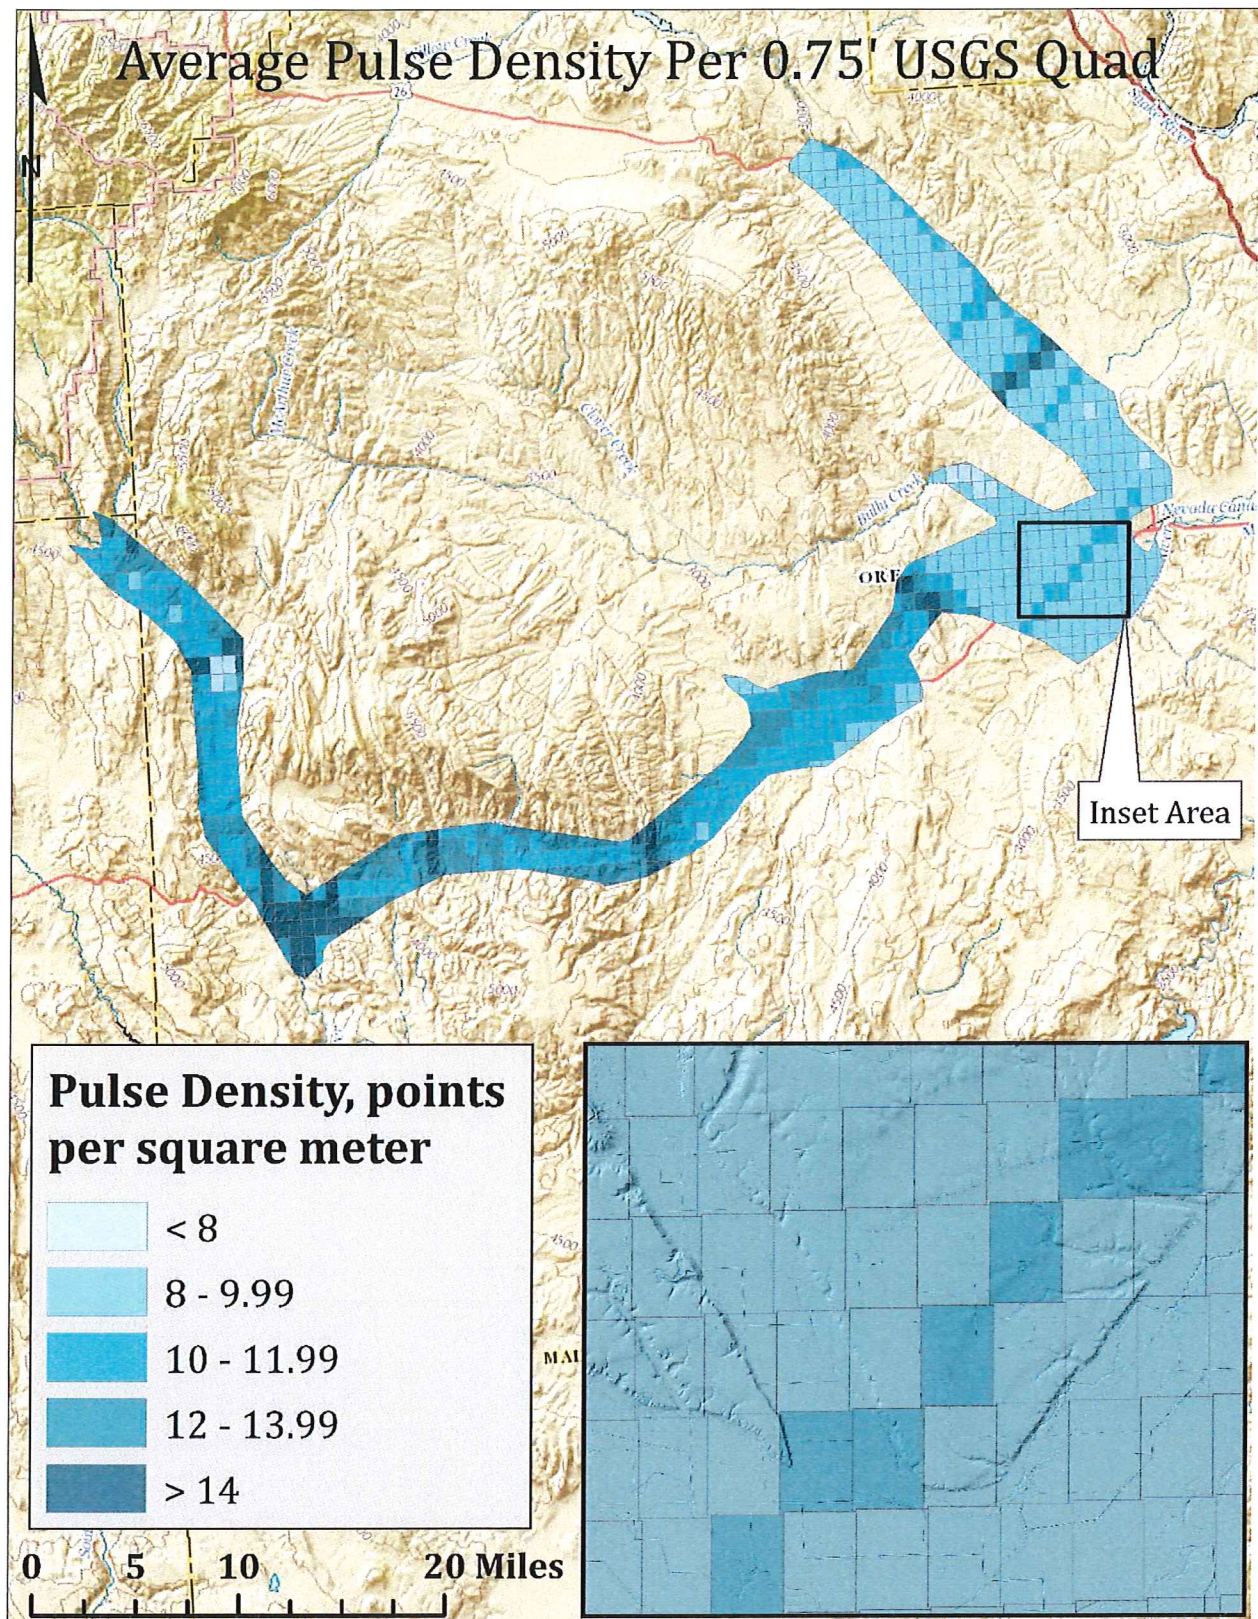
Figure 14: Pulse Density of 1/100th USGS 7.5 minute quadrangle LAS tiles.

Using the 1/100th USGS 7.5 minute quadrangle extents, DOGAMI staff created polygons that graphically depict the pulse density of the project area (Figure 14).

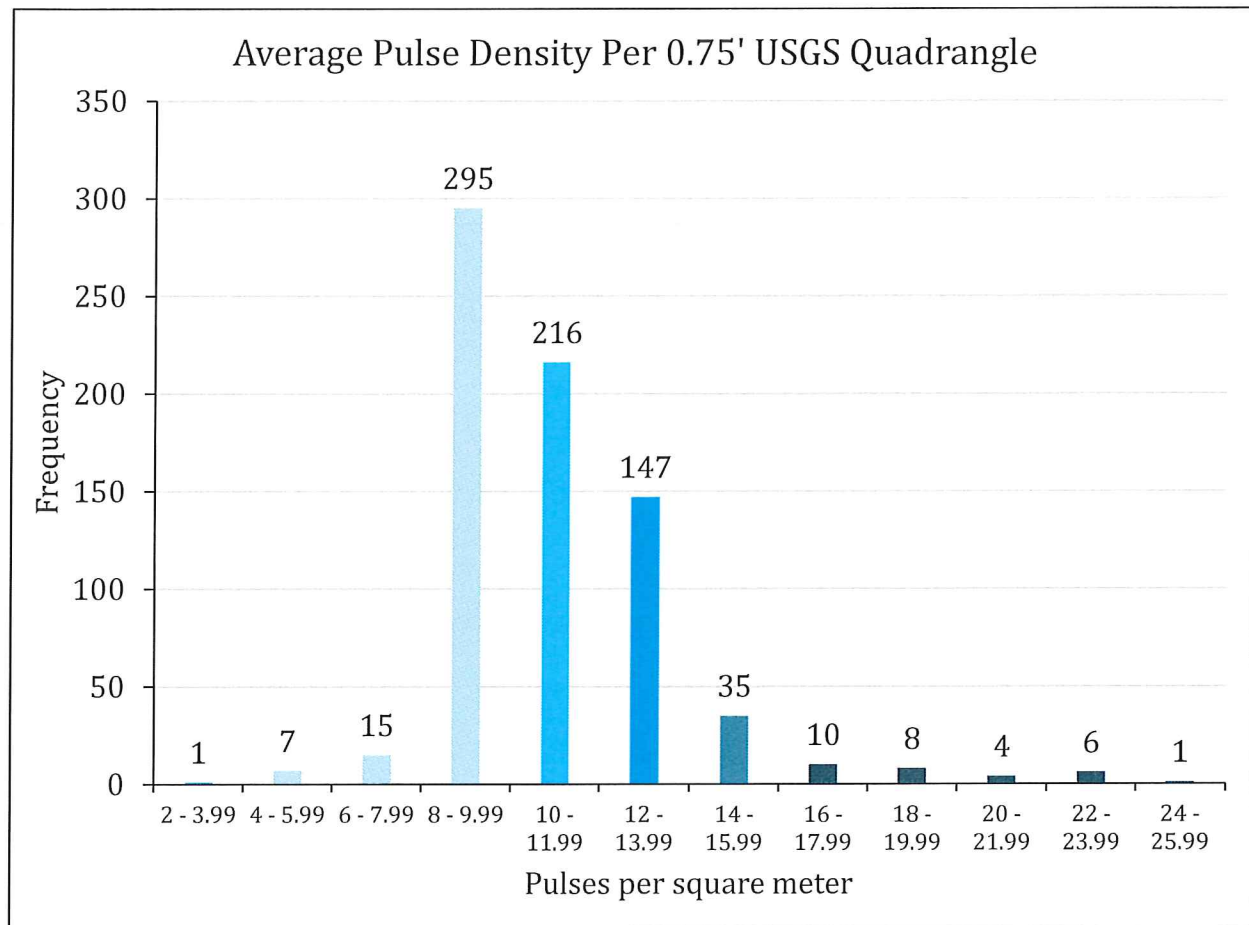
Figure 15: Histogram of Average Pulse Densities for OLC Lower Malheur 2015 Lidar Project.

To quantify pulse density of the OLC Lower Malheur 2015 Lidar Project, 745 all-return LAS files (100%) were parsed into first-return point files and compared to their data extents. Results of the pulse density analysis found the average pulse density to be 10.8 pulses per m² (Table 3). Certain types of surfaces (dense vegetation, water) may return fewer pulses than the laser originally emitted; therefore density values can vary according to terrain and land cover. Pulse densities for OLC Lower Malheur 2015 Lidar Project LAS tiles ranged from 3.3 pulses per m² to 24.0 pulses per m². 722 LAS files out of 745 (97%) have a pulse density of ≥ 8.00 pulses per m² (Figure 15). These results show that all data are within tolerances of pulse density according to the contract agreement.
