Department of Geology & Mineral Industries
800 NE Oregon St, Suite 965
Portland, OR 97232

North Coast LIDAR Project, 2009 – Delivery 11 QC Analysis
LIDAR QC Report – December 17th, 2009

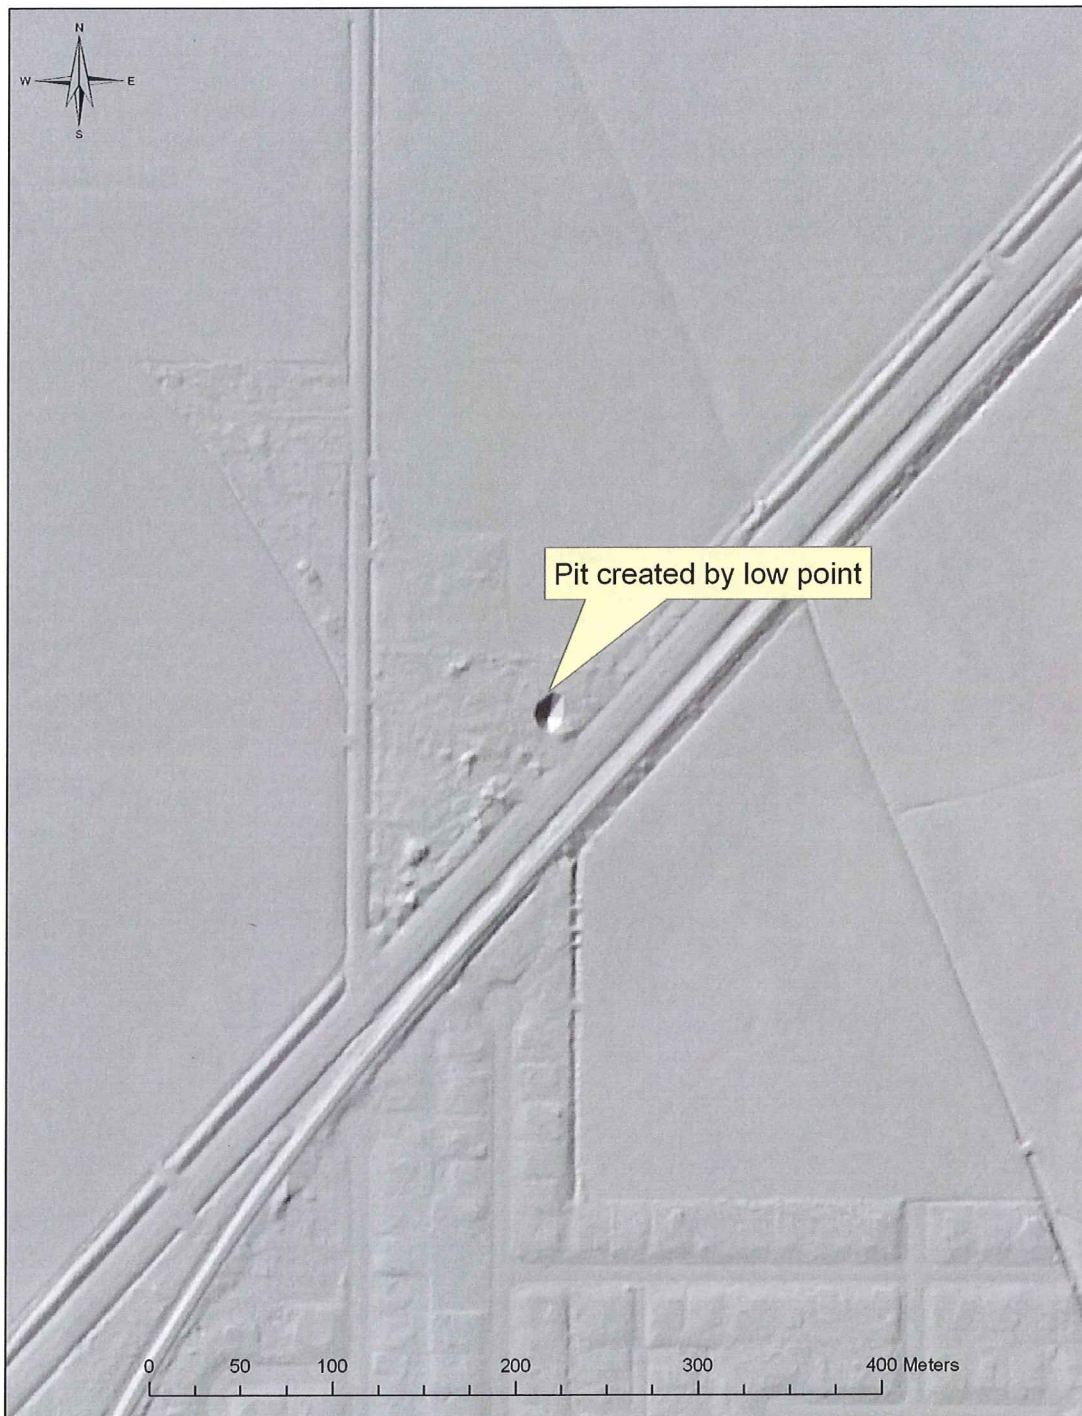
Figure 5. Example of “Pit” caused by low point in ground model. Pits are caused when standing water absorbs the lidar pulse. Pits are evident in ground model as the lowest point elevation is assigned to the grid cell value. Inversely the pit is not observable in the highest hit model as the highest point elevation is assigned to the grid value

Lidar 3ft grids were loaded into ArcGIS software for visual analysis. Data were examined through slope and hillshade models of bare earth returns. Hillshades of the highest hit models were used to identify areas of missing ground (Figure 3). Both bare earth and highest hit models were examined for calibration offsets, tiling artifacts (Figure 4), seam line offsets, pits (Figure 5), and birds.

overlap. Errors occur as a result of improper absolute vertical error adjustments. These errors are typically visualized as a linear stair step running along the edge of connecting flight lines. Pits and birds refer to uncommonly high or low points that are the result of atmospheric and sensor noise. Pits (low points) typically occur where the laser comes in contact with water on the ground (Figure 5). Birds (high points) typically occur where the laser comes into contact with atmospherics¹.

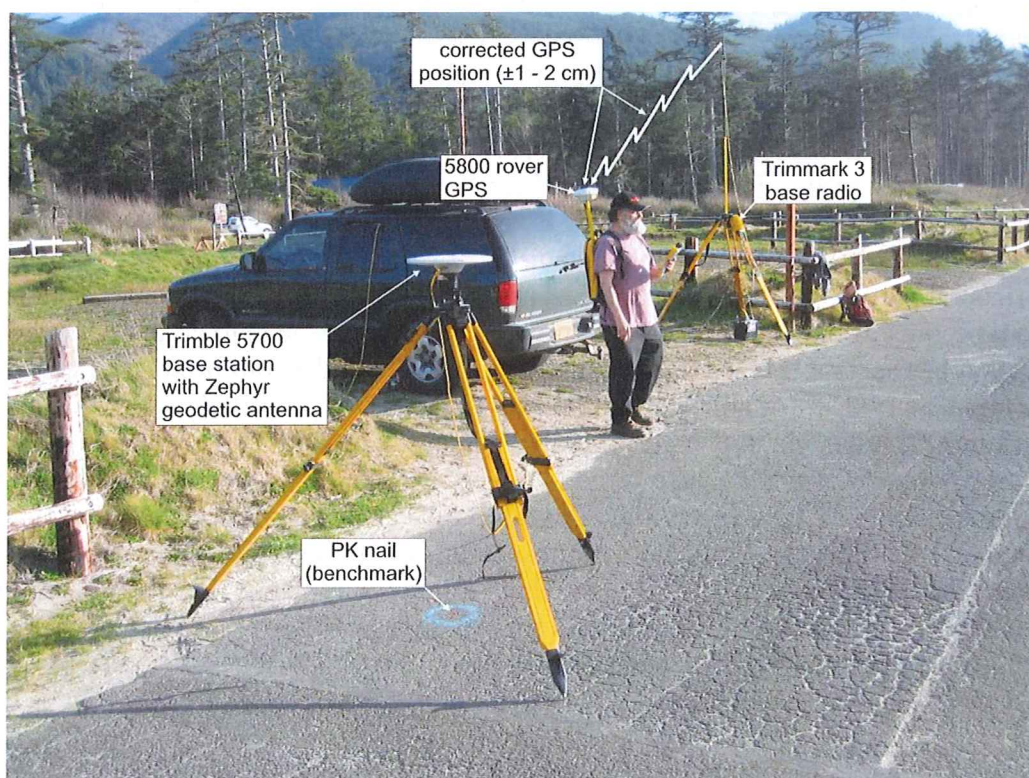
Figure 5. The Trimble 5700 base station antenna located over a known reference point at Cape Lookout State Park. Corrected GPS position and elevation information is then transmitted by a Trimmark III base radio to the 5800 GPS rover unit.

Absolute accuracy refers to the mean vertical offset of lidar data relative to measured ground-control points (GCP) obtained throughout the lidar sampling area. DOGAMI used a Trimble™ 5700/5800 Total Station GPS surveying system (Figure 5) to measure GCP's. This system consisted of a GPS base station (5700 unit), Zephyr Geodetic antenna, Trimmark 3 radio, and 5800 "rover". The 5700 base station was mounted on a fixed height (typically 2.0 m) tripod and located over a known geodetic survey monument followed by a site calibration on several adjacent benchmarks to precisely establish a local coordinate system. This step is critical in order to eliminate various survey errors. For example, Trimble reports that the 5700/5800 GPS system have horizontal errors of approximately $\pm 1\text{-cm} + 1\text{ppm}$ (parts per million * the baseline length) and $\pm 2\text{-cm}$ in the vertical (TrimbleNavigationSystem, 2005). These errors may be compounded by other factors such as poor satellite geometry, multipath, and poor atmospheric conditions, combining to increase the total error to several centimeters. Thus, the site calibration process is critical in order to minimize these uncertainties.
