OPEN-FILE REPORT O-02-05

**LANDSLIDE LOSS ESTIMATION
PILOT PROJECT IN OREGON**

**Yumei Wang, Renee D. Summers, and R. Jon Hofmeister
Oregon Department of Geology and Mineral Industries**

2002

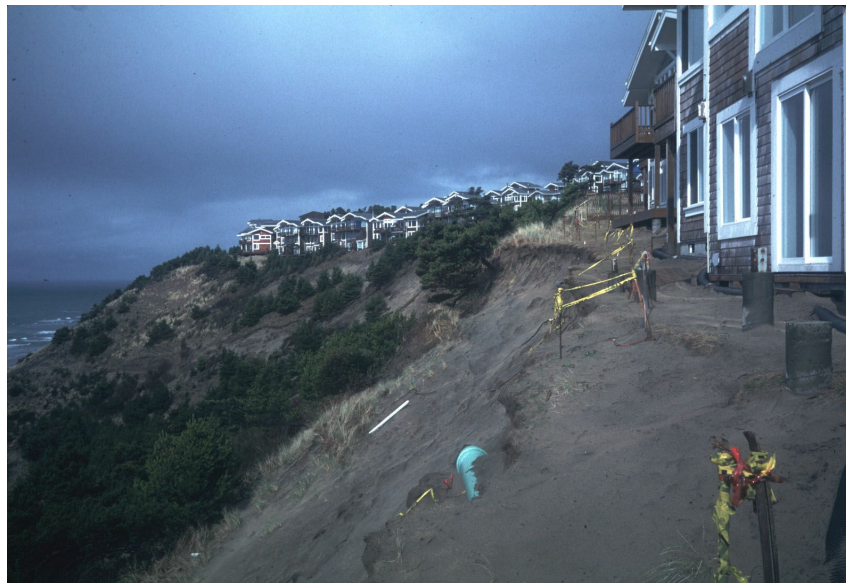
Figure 1. The Capes private housing community experienced landslide and coastal erosion damage associated with the 1997-8 El Nino event. Residents were evacuated and short-term mitigation was implemented. Long-term mitigation options, which need to accommodate coastal building regulations, are still being evaluated. Photo: Paul Komar

Each year, many damaging landslides are triggered due to Oregon's geologic, topographic, climatic conditions and construction practices. Steep slopes and high rainfall lead to many slope failures in Oregon with a high concentration in western Oregon's coast, Coast Range, Willamette Valley and Cascade Range. In a typical year, Oregon receives over 80 inches of rain in places along the coast, 40 to 45 inches in the Willamette valley and about 60 inches in the Cascades. See Figures 1 and 2.

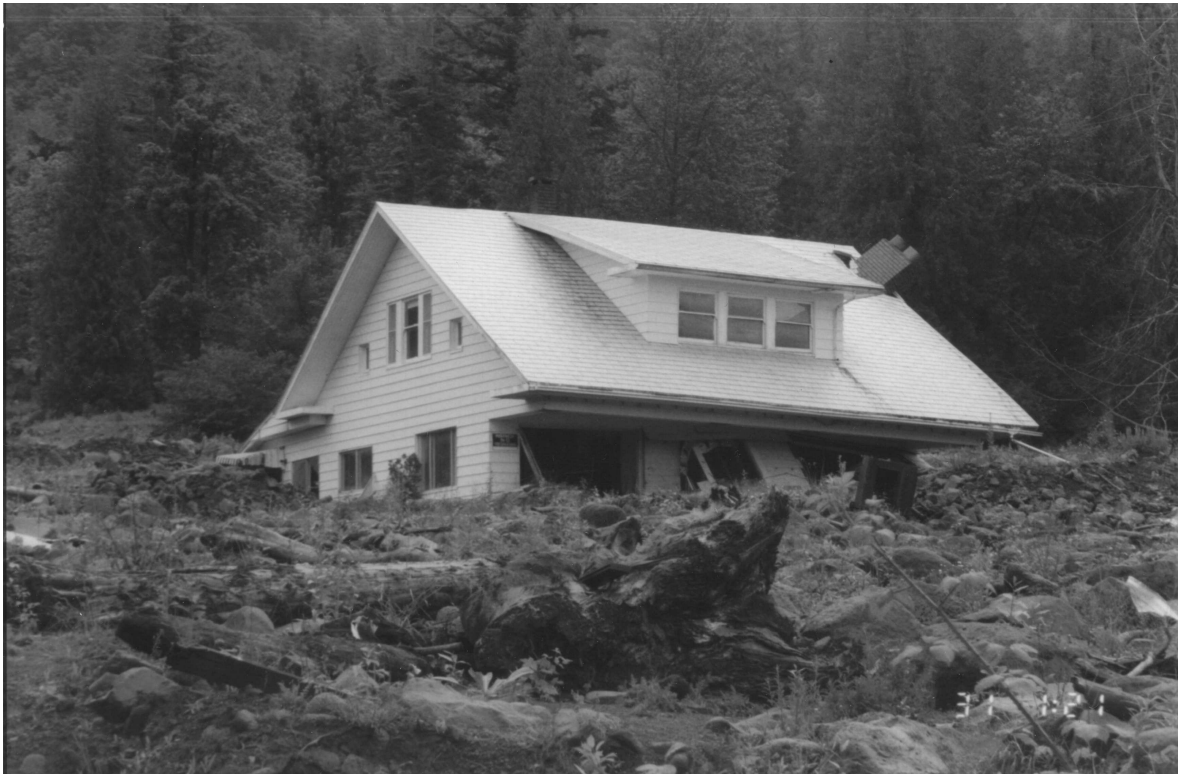
Figure 5. A debris flow destroyed this 2-story residence in Dodson, Oregon in the February 1996 FEMA-OR-1099-OR disaster.

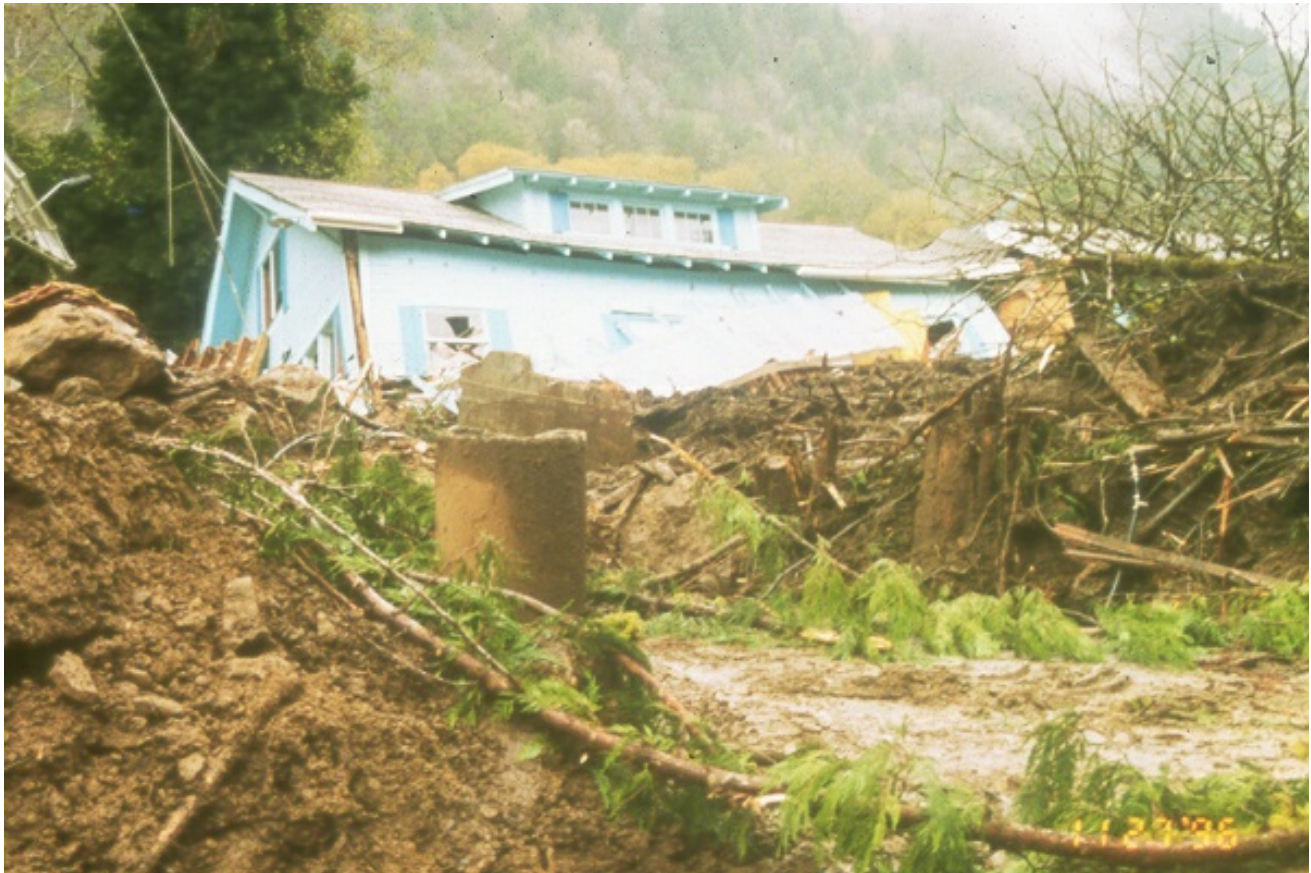
Figure 6. A debris flow destroyed this residence in Scottsburg, Oregon, in late 1996.

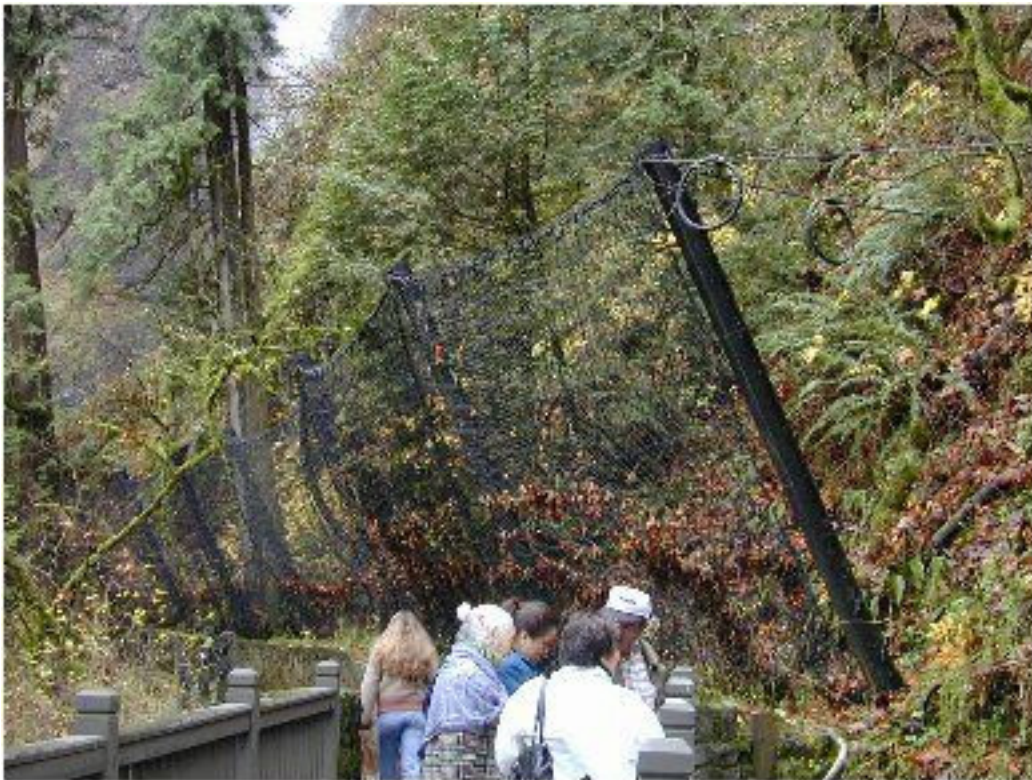
Figure 8. Multnomah Falls rock catchment net on footpath. This was installed by the USDA Forest Service as a result of a severe injury from a rockfall (modified from Wang and others, 2002)

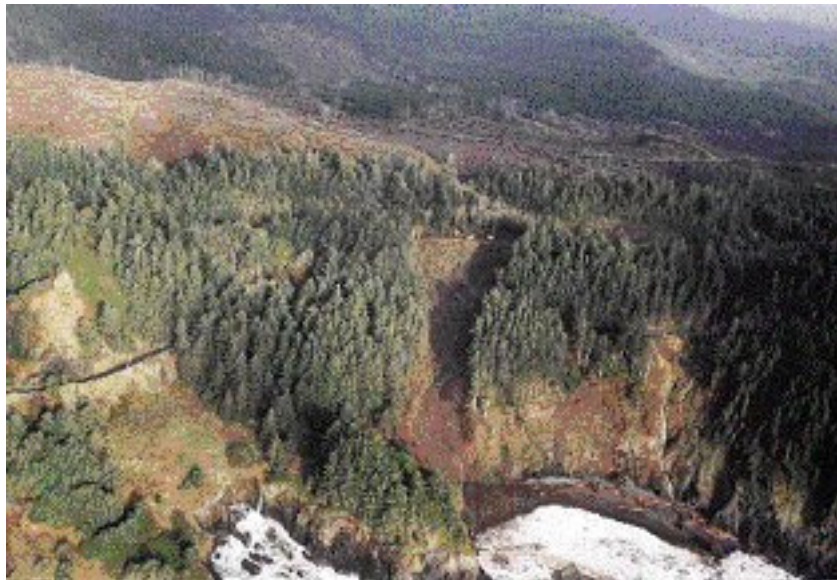
Figure 10. Cape Foulweather landslide. The downslope lanes of coastal US Highway 101 was damaged from a fill slope failure in December 1999. Repair work lasted about one month. (ODOT photo)

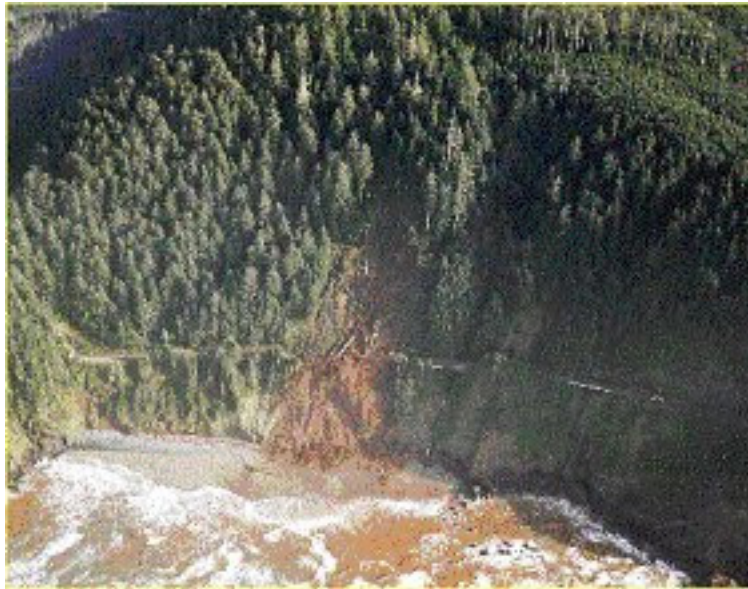
Figure 11. Cape Cove Landslide. A damaging landslide interrupted traffic in both directions of US Highway 101 in January 2000. Repair work forced an approximate three-month road closure. (ODOT photo)

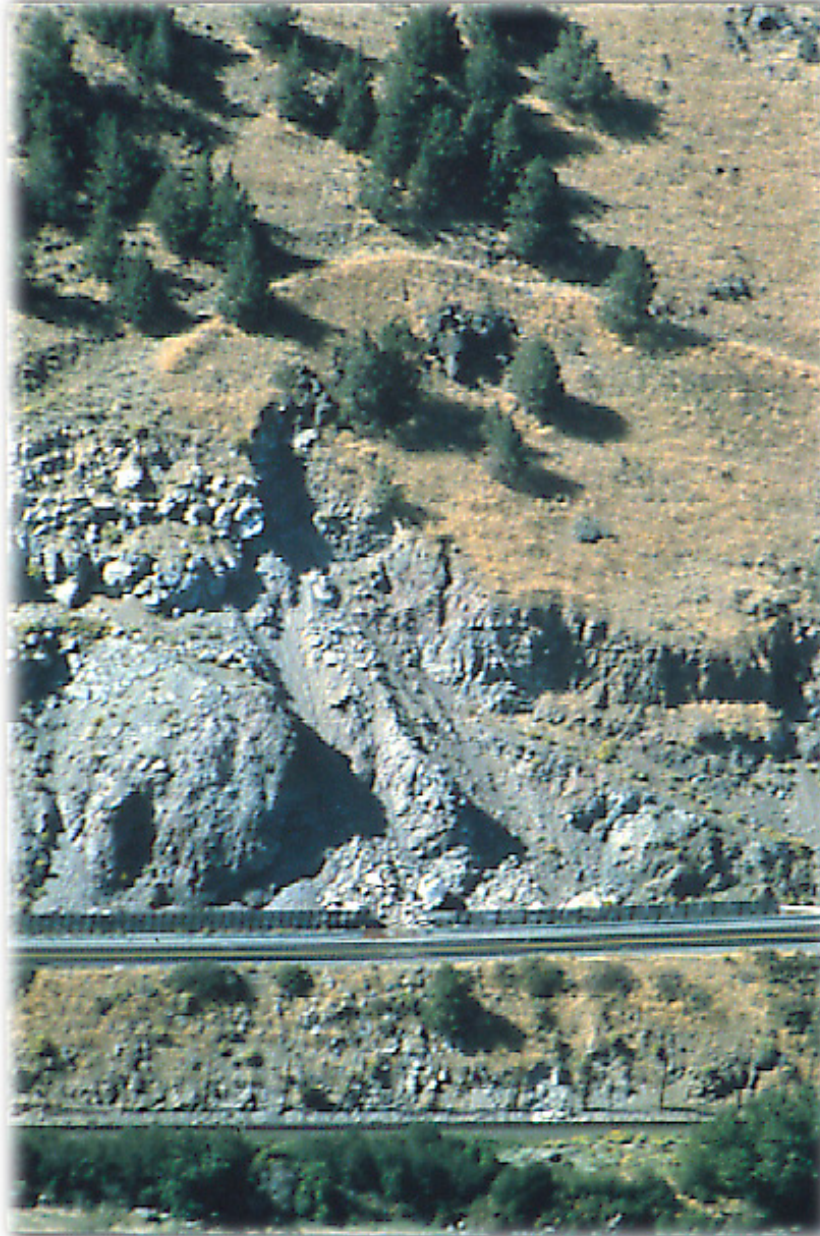
Figure 14. The 1993 Klamath Falls earthquake triggered a fatal rockfall on US I-97.

Also, a better understanding of landslide processes and detailed maps of high-risk areas for landslides are needed. To effectively reduce risk, mitigation needs to be applied and institutionalize in appropriate ways. As one example, rainfall patterns need to be investigated to discern how wet cycles affect landslide occurrences and to obtain an accurate account of the rainfall intensity during storm events. Landslides are highly dependent upon weather conditions and patterns. Earthquake-triggered landslides need to be investigated (see Figure 14).
